(11) **EP 2 050 926 A2**

(54) **Method for restoring airfoil contour on integrally bladed rotors**

(57) An integrally bladed rotor includes a central hub and a plurality of airfoils or blades (22). The blades (22) are repaired by rebuilding their surfaces beyond the orig-

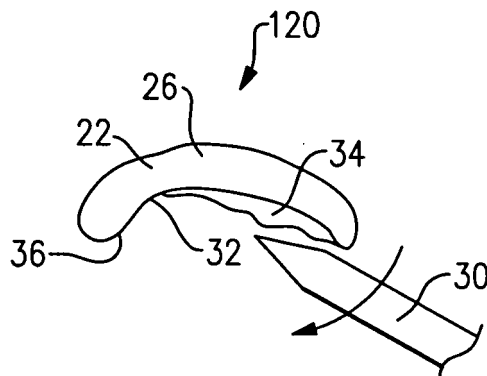
FIG. 3A

[0014] Thus, as shown at 120 in Figure 3A, a superabrasive quill 30 is now used to machine the contour 32 of the airfoils 22. As shown, there may be excess weld material 34 which is cut away by the SAM quill 30 to define the final shape 36.

diameter quill 30 is used to form the contour 32 as shown in Figure 3A. In this manner, a blade having a relatively small radius of curvature can be machined back to its desired shape.

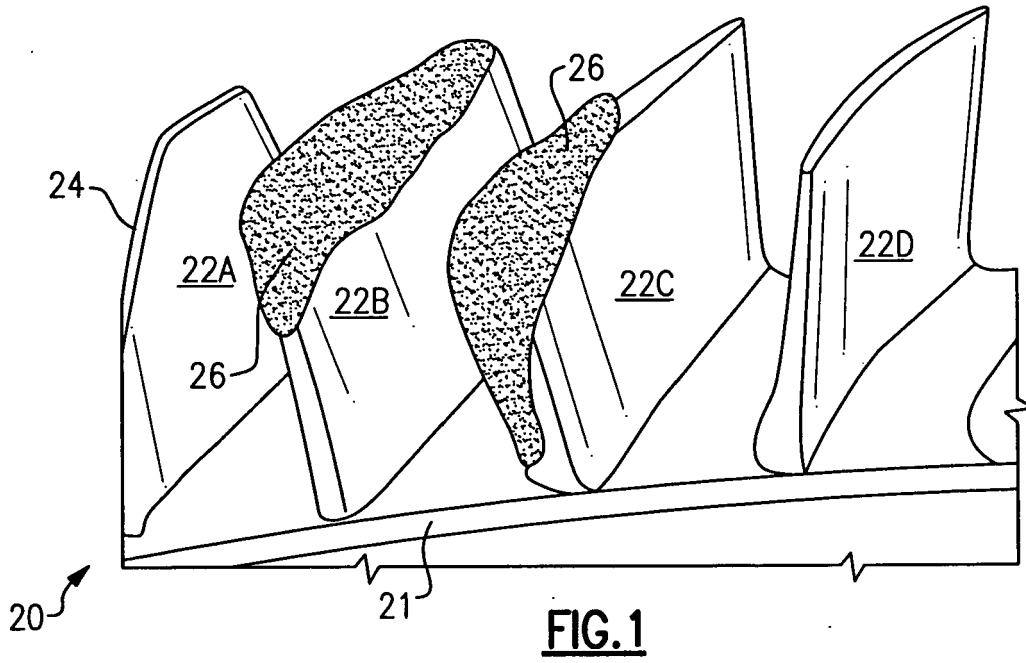
Figure 1 shows a first step in the repair of a rotor.

[0011] Figure 1 shows a damaged and worn integrally bladed rotor (IBR) 20. As known, blades having airfoils 22 extend toward a tip from a rotor hub 21. Some machining may be done to remove damaged areas of the airfoils. Figure 1 shows the first several steps in the method of this application. As shown at 22A, worn material is cut away from an airfoil, leaving removed areas such as 24 on blade 22A. The next step would be to add material, such as weld material at 26, and as shown on blades 22B and C.

[0012] The final step is to cut away the material leaving the desired contour as shown on blade 22D. Such an IBR 20 will typically be taken out of service for repair. The IBR may be part of a compressor for a gas turbine engine.

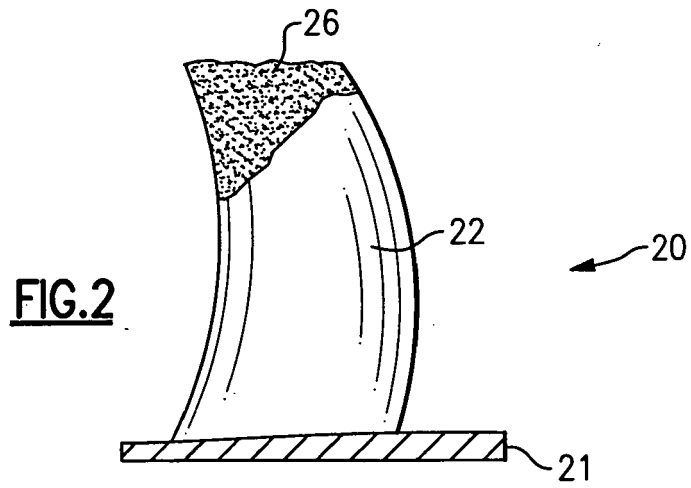
Figure 2 shows a second step.

[0013] Figure 2 shows a second step in the repair of the IBR 20. As shown, the airfoil 22 now is returned beyond an original contour and height by adding weld material 26 to extend beyond the desired original surfaces. See also airfoils 22B and 22C in Figure 1.

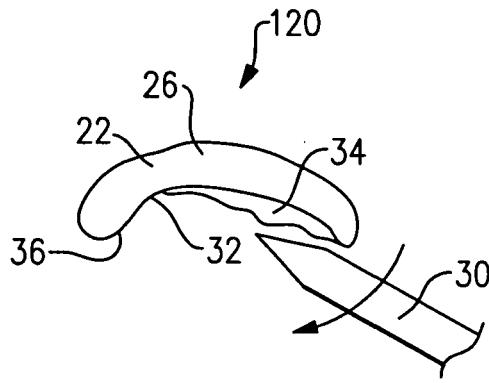
FIG. 3A

Figure 3A shows a subsequent step to repair the shape.

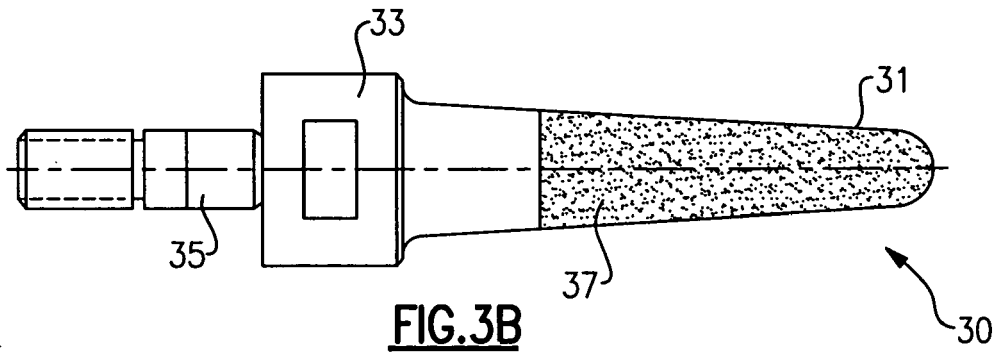
FIG. 3B

Figure 3B shows a tool for performing the Figure 3A step.

[0015] Figure 3B shows a known SAM quill 30. As known, the edge and the tip 31 perform the actual machining, and has a smaller diameter than a base portion 33. The base portion 33 has a larger diameter than a pilot shaft 35 that is received in a spindle for driving the SAM quill 30 at relatively high speeds. As known, SAM quills have their abrasive material 37 formed from a group including diamond, and cubic boron nitride. An example of a known quill is disclosed in U.S. Patent 7,101,263, the description of which is incorporated herein by reference.

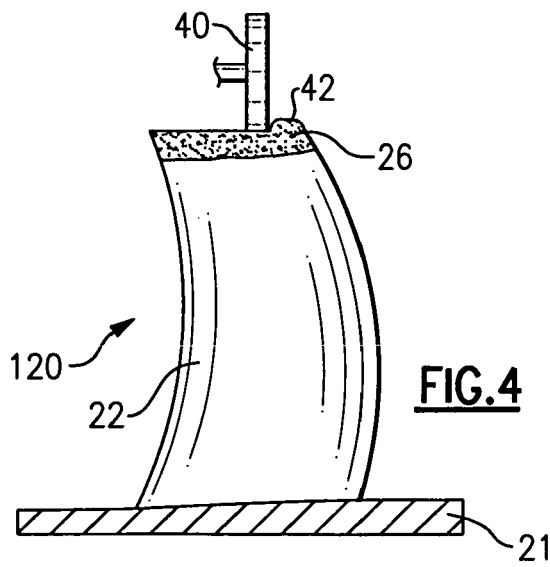
FIG. 4

Figure 4 shows the tip height being ground.

[0017] Figure 4 shows a subsequent step, wherein weld material 26 beyond the desired height is cut away by a SAM grinding wheel 40 to remove excess material 42, and return the airfoil 22 to its desired height.
