(10) **Patent No.:** **US 7,056,071 B2**
(45) **Date of Patent:** **Jun. 6, 2006**

(54) **BUSHING REPAIR APPARATUS FOR USE IN REPAIRING A MACHINE GUN FEEDER HOUSING**

An apparatus for repairing a pair of non-conforming bushings on the M89E1 Declutching Ammo feeder for the M197 machine gun. The apparatus includes a central body and a pair of large drill plates which allows a user to drill out the non-conforming bushings from the ammo feeder. The user then press fits replacement bushings into the ammo feeder. The apparatus also includes a pair of small drill plates which allows the user to drills pin mounting holes into the replacement bushings.

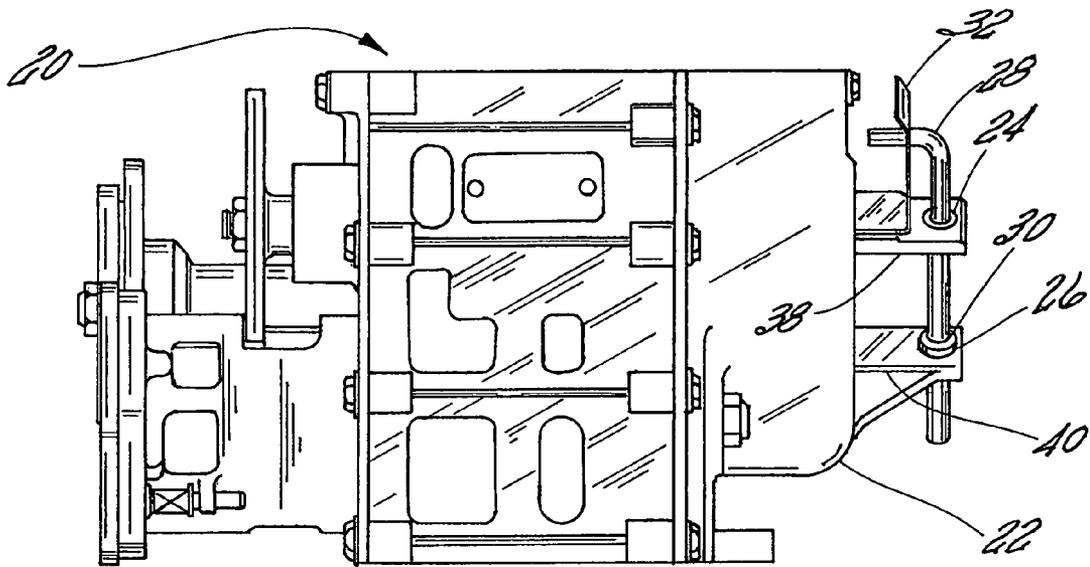
Fig 1

FIG. 1 is a view illustrating the ammo feeder for the M197 machine gun including the bushings to be replaced using the alignment fixture of the present invention;

Referring first to FIGS. 1 and 2, there is shown the M89E1 Declutching Ammo feeder assembly **20** for which when coupled to the M197 machine gun feeds ammunition to the machine gun. The M197 machine gun is used on board the Copra Helicopter. The feeder assembly **20** is coupled to the machine gun housing with two mounting pins which have a diameter of 0.2400 inches. The forward housing **22** of the feeder assembly **20** has two bushings **24** and **26** which receive one mounting pin **28** of the two mounting pins. Each of the bushings **24** and **26** has a mounting pin aperture/hole **30** for securing the mounting pin **28** to the forward housing **22** of the feeder assembly **20**. A lock **32** which is affixed to the forward housing **22** by a pair of slotted screws **34** and **36** which lock mounting pin **28** in a fixed position relative to feeder assembly **20**.

The bushings **24** and **26** are permanently cast into a pair of arms **38** and **40** which extend from the forward housing **22** as is best shown in FIG. 1.

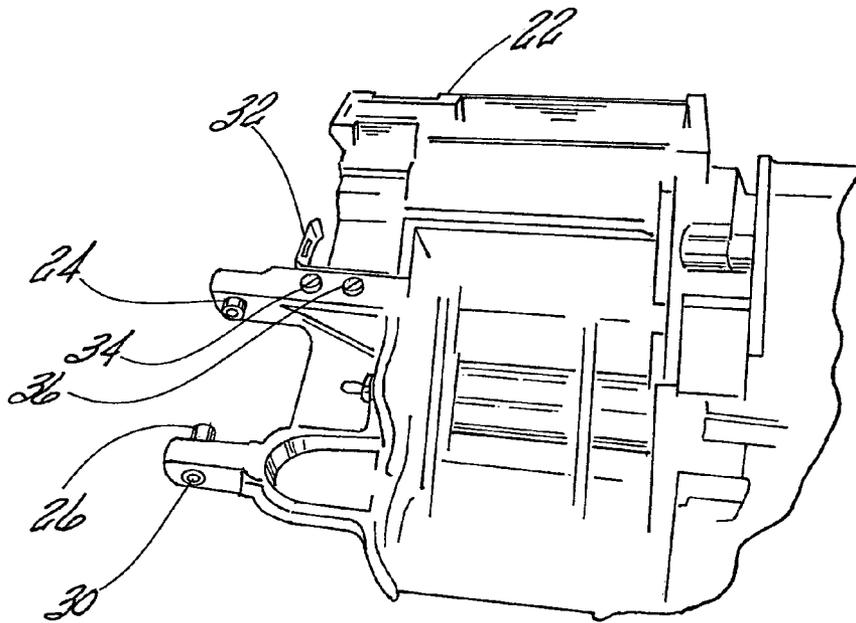
Fig 2

FIG. 2 is another view illustrating the ammo feeder of FIG. 1;

Referring to FIGS. 1, 3 and 5, prior to removing the 24 and 26 from the forward housing 22 of the feeder assembly 20, the user should consult the maintenance manual for the feeder assembly 20 to determine if the two mounting pin holes 30 in bushings 24 and 26 exceed specified limits. The bushings 24 and 26 are to be replaced only if the mounting pin aperture/hole 30 in each bushing 24 and 26 exceeds the maximum hole diameter of 0.245 inches. When the specified limit is exceeded, the user removes the lock 32 from the forward housing 22 by unscrewing and then removing the pair of slotted screws 34 and 36 shown in FIG. 2.

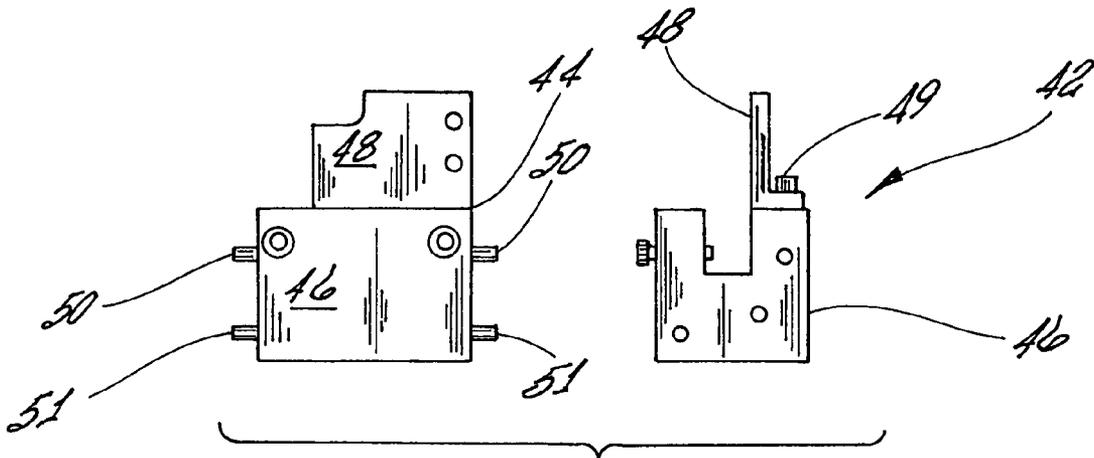
Fig 3

FIG. 3 illustrates the central assembly for the bushing repair apparatus of the present invention;

Referring to FIGS. 1, 3, 4 and 5 to replace the bushings **24** and **26**, a user drills out the out of tolerance bushings **24** and **26** within the arms **38** and **40** of forward housing **22** using the bushing repair fixture **42** illustrated in FIG. 3 and FIG. 4 to align a drill bit with the bushings **24** and **26**. As shown in FIG. 3, the bushing repair fixture/apparatus **42**

includes a central assembly 44 comprising a central body 46 and a mating plate 48 affixed to the central body 46 by a pair of cap screws 49. Attached to opposite sides of the central body 46 are a pair of stainless steel alignment pins 50 and 51.

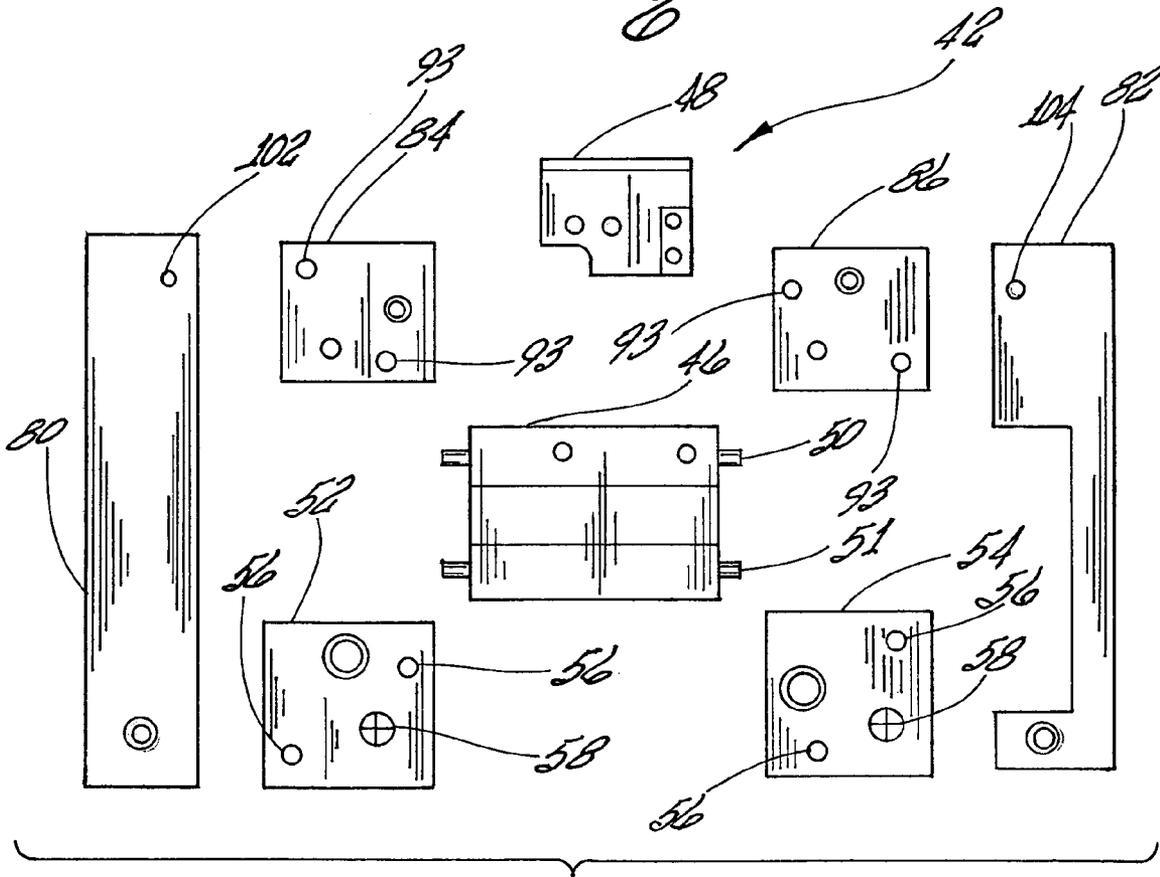
Fig 4

FIG. 4 illustrates each of the components of the bushing repair apparatus of FIG. 3;

Referring to FIG. 4, the alignment pins 50 and 51 allow a user to align each of the two rectangular shaped large drill plates 52 and 54 to the central body 46. Each drill plate 52 and 54 has pair of alignment holes 56 which are adapted to receive the alignment pins 50 and 51 located on each side of the central body 46 of bushing repair fixture 42. Each drill plate 52 and 54 also has a cap screw 58 which is used to secure the drill plates 52 and 54 to the central body 46 of bushing repair fixture 42.

Referring again to FIGS. 4 and 6, the bushing repair fixture 42 include a pair of locating plates 80 and 82 and a pair of rectangular shaped small drill plates 84 and 86. Each locating plate 80 and 82 has a bushing 87 or 89 attached to its forward end on an inner surface of the locating plate.

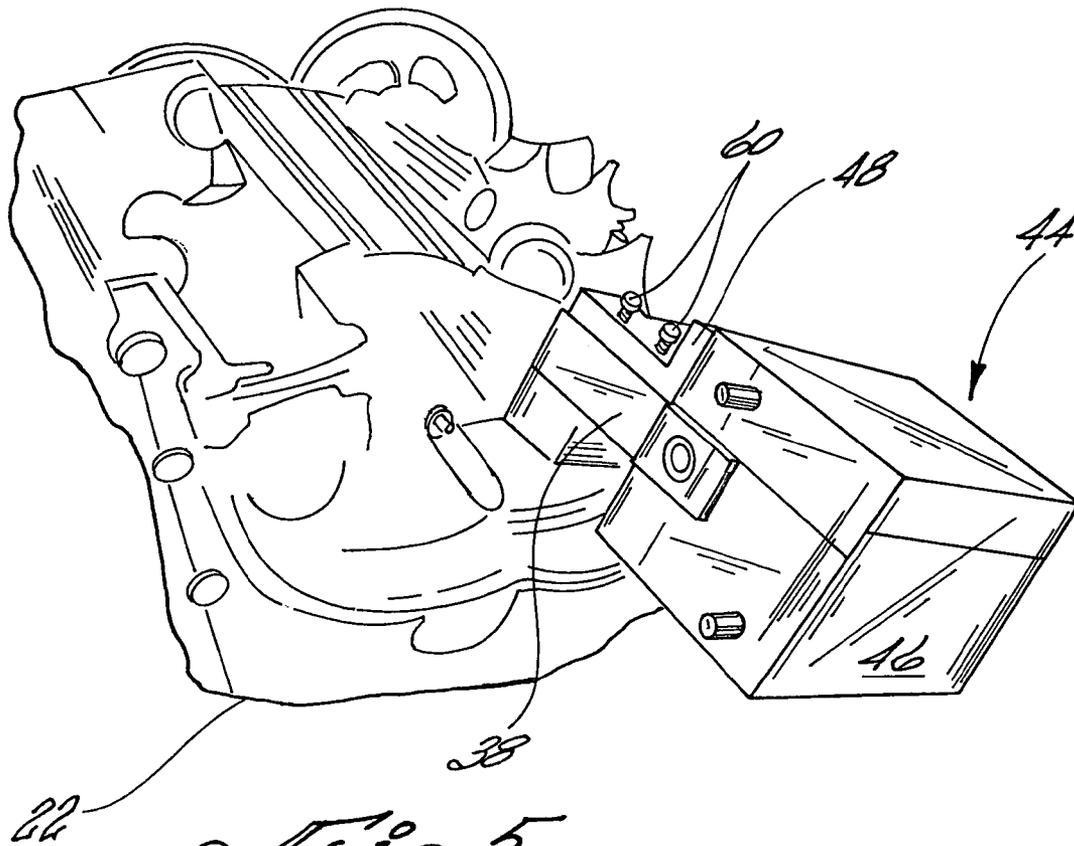
Fig 5

FIG. 5 is a view illustrating the central assembly for the bushing repair apparatus affixed to the ammo feeder for the M197 machine gun;

To remove the bushings 24 and 26 after the bushings 24 and 26 are determined to be non-conforming, the user positions the central assembly 44 of the bushing repair fixture 42 onto the arms 38 and 40 of forward housing 22 as shown in FIG. 5. A pair of cap screws 60 are inserted through mating plate 48 into the threaded holes for lock 32 within arm 38 of forward housing 22. The user then hand tightens caps screws 60 securing the central assembly 44 of the bushing repair fixture 42 to the forward housing 22.

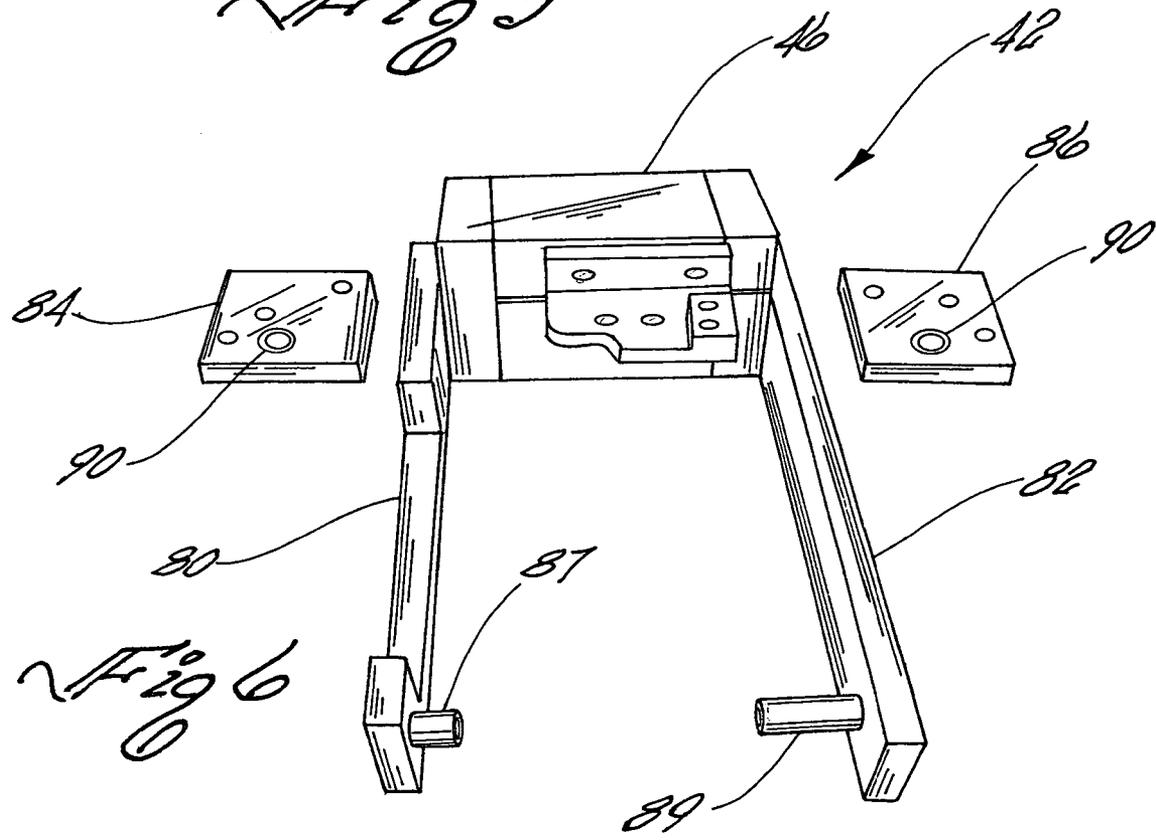
Fig 6

FIG. 6 illustrates the bushing repair apparatus completely assembled;

As shown in FIG. 6, the when the bushing repair fixture 42 is fully assembled one of the locating plates 80 and 82 is attached to each side of the central body 46 extending forward from the central body 46 of bushing repair fixture 42. This is the configuration of the bushing repair fixture 42 when fixture 42 is used for drilling the mounting pin holes 88 in bushings 74 and 76. Each of the small drill plates 84 and 86 includes a mounting pin hole/opening 90 used for drilling out a 6.1 mm mounting pin hole 88 in each replacement bushing 74 and 76.

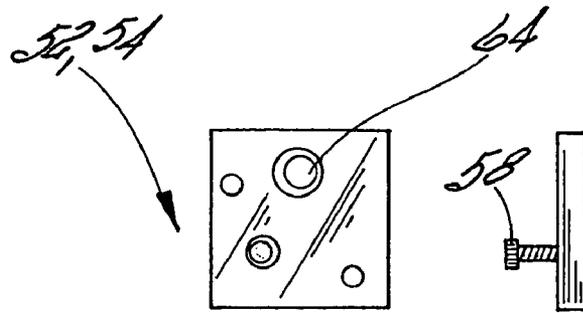
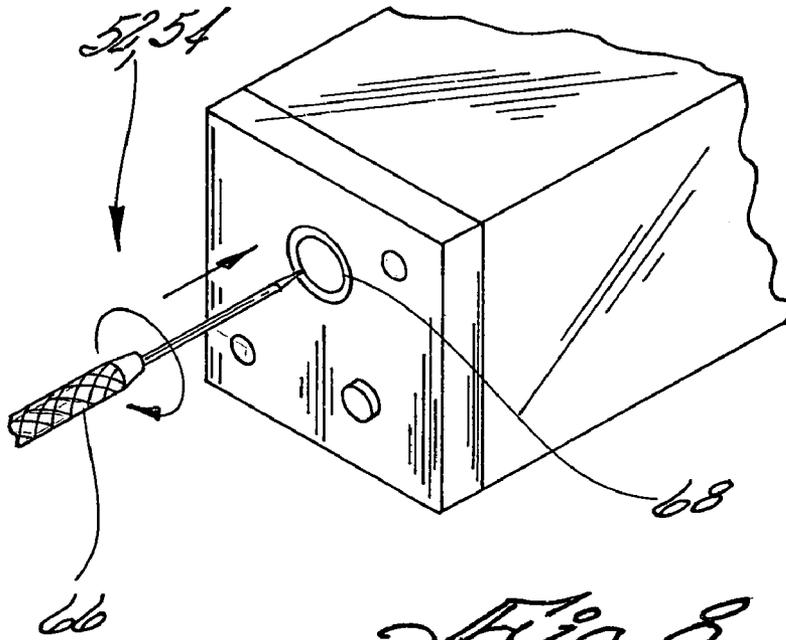
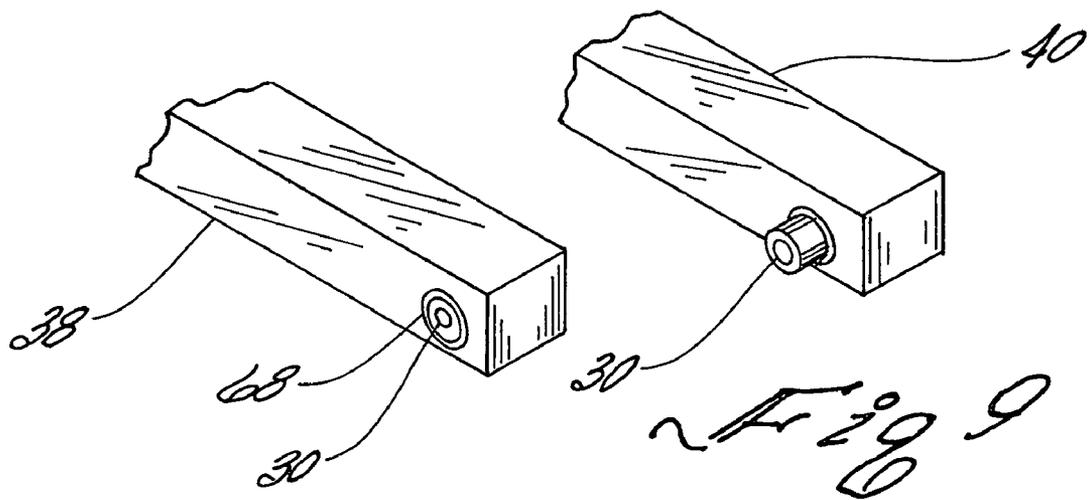
FIG. 7 illustrates the large drill plates for the bushing repair apparatus of FIG. 4;

FIG. 8 illustrates the use of a scribe tool to mark a circle for drilling out an out of tolerance bushing on the ammo feeder for the M197 machine gun;

FIG. 9 illustrates the scribed circle after removal of the bushing repair apparatus from the ammo feeder;

Referring to FIGS. 3, and 7, the user next attaches the drill plates 52 and 54 to opposite sides of the central body 46 of bush repair fixture 42 using cap screws 58 to secure the drill plates 52 and 54 to the central body 46. The stainless steel alignment pins 50 and 51 align a 0.4688 inch drill bushing hole 64 within each drill plate 52 and 54 with the out of tolerance bushings 24 and 26. The 0.4688 inch drill bushing hole 64 in each drill plate 52 and 54 is used for removal of the out of tolerance bushings 24 and 26 within the forward housing 22 by drilling out the bushings 24 and 26.

Referring to FIGS. 7, 8 and 9, the user using the scribe tool 66 illustrated in FIG. 8 scribes a circle 68 on an outer surface of each arm 38 and 40 of forward housing 22. This circle 68 is scribed around the circumference of the 0.4688 inch drill bushing hole 64 in each drill plate 52 and 54. Circle 68 indicates where the drilled hole is to be located to remove out of tolerance bushings 24 and 26. The user's scribing of circle 68 is required since positioning of the bushings 24 and 26 can vary when the forward housing 22 is first cast at the foundry. The user's scribing of circle 68 also assist in drilling out bushing 24 and 26 with much as accuracy as possible.

The user next removes the drill plates 52 and 54 and central assembly 44 to examine the scribed circle 68 as shown in FIG. 9. If the scribed circle 68 aligns with the mounting pin apertures 30, the user re-installs the bushing repair fixture 42 including drill plates 52 and 54. If the circles 30 and 68 do not coincide, the user applies shims to the drill plates 52 and 54 to position the 0.4688 inch drill bushing hole 64 within each drill plate 52 and 54 coaxially with the mounting pin apertures 30.

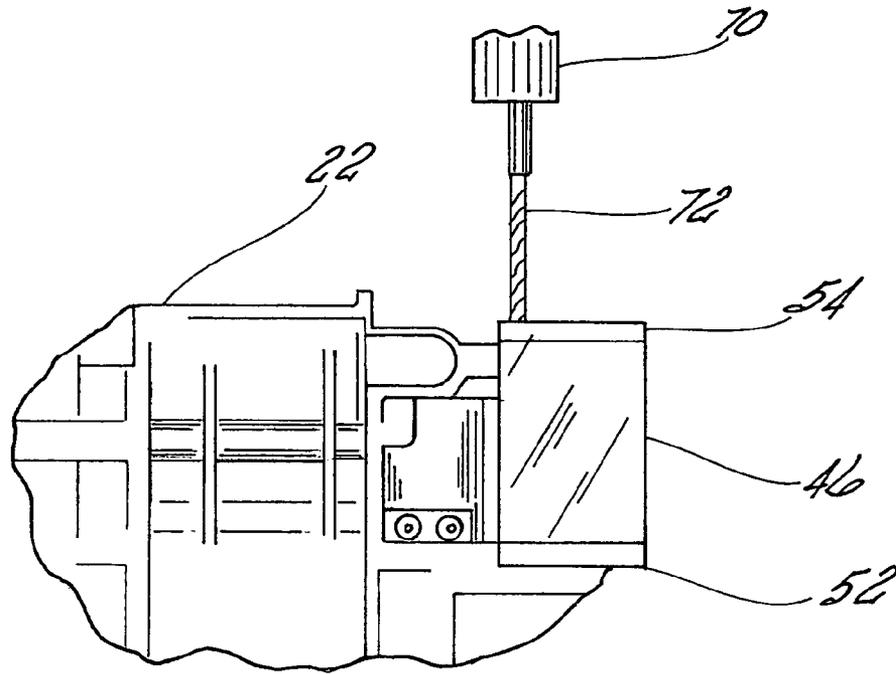
Fig 10

FIGS. 10 and 11 illustrate the out of tolerance bushings being drilled out of the forward housing of the ammo feeder;

scribed circles 68, the user utilizing a drill 70 and a 0.4688 inch drill bit 72 drills out the out of tolerance bushings 24 and 26 within the arms 38 and 40 of forward housing 22 in the manner illustrated in FIG. 10 and FIG. 11. This leaves a 0.4688 inch hole 73 (FIG. 17) in each arm 38 and 40 of the forward housing 22.

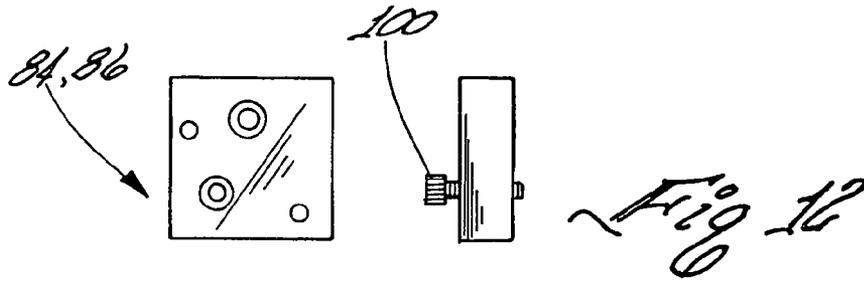
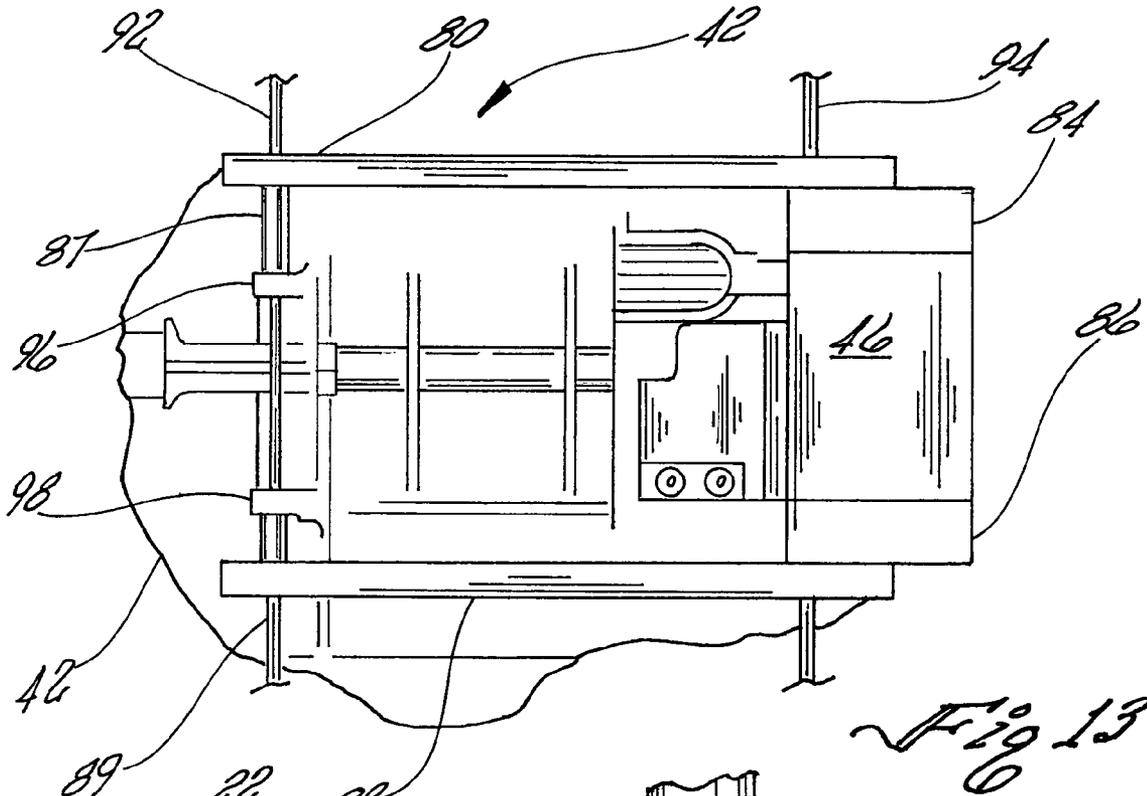
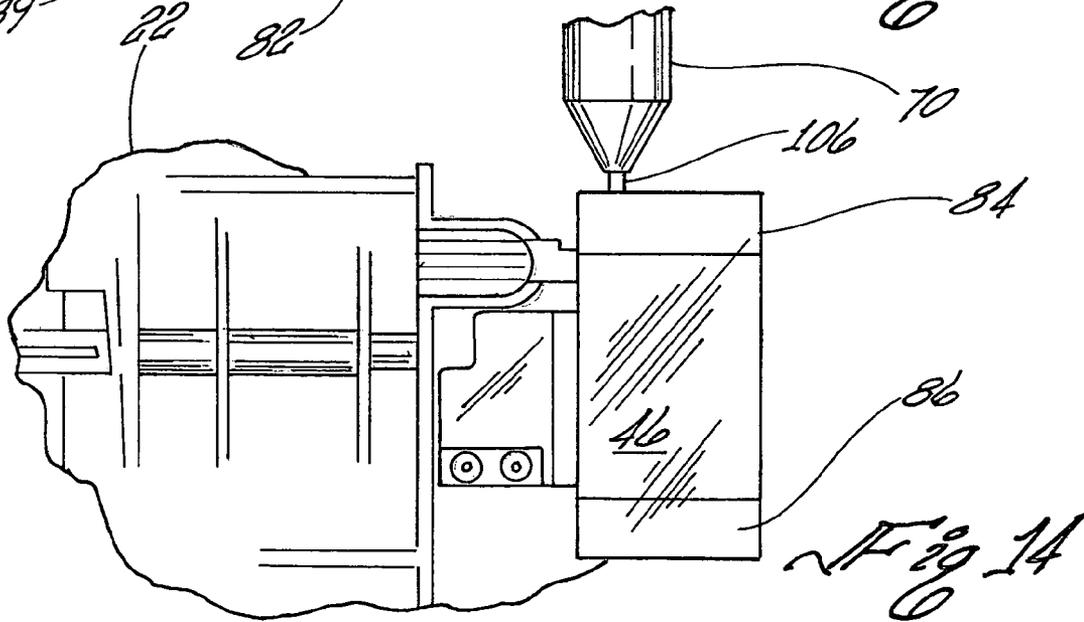
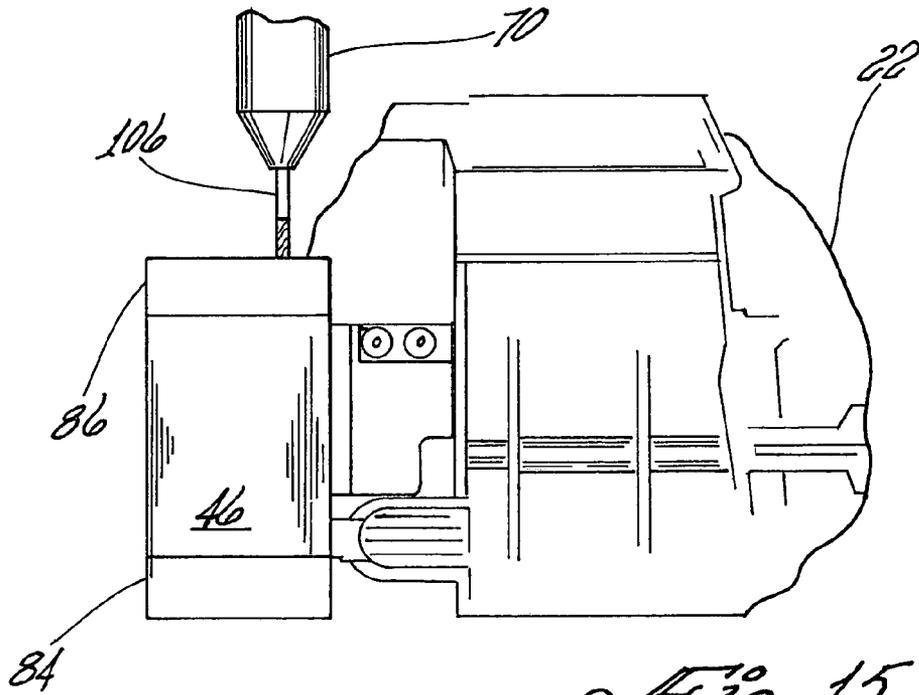
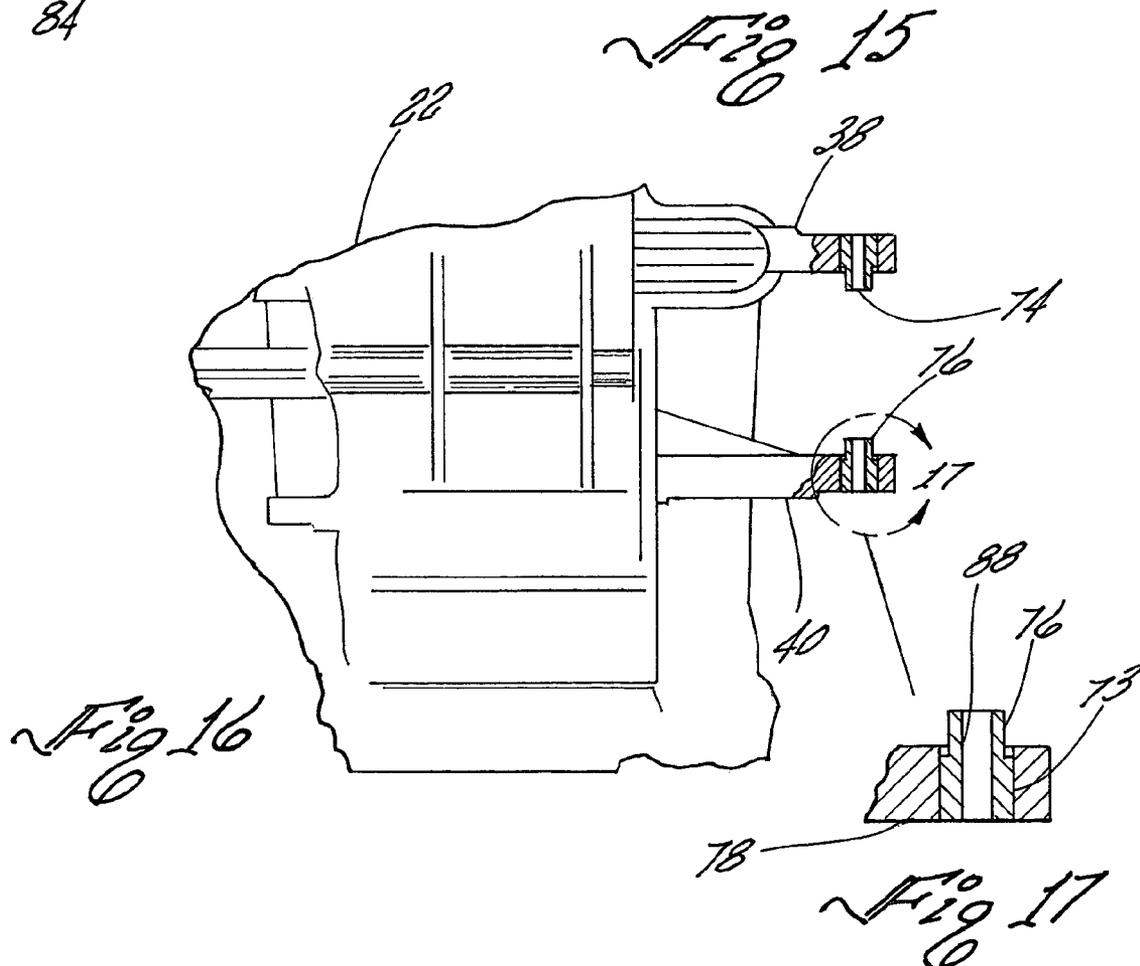
FIG. 12 illustrates the small drill plates for the bushing repair apparatus of FIG. 4;

FIG. 13 illustrate the locating plates for the bushing repair apparatus of FIG. 4 when attached to the forward housing of the ammo feeder; and

FIGS. 14-17 depict the mounting pin holes being drilled out of the replacement bushings on the ammo feeder for the M197 machine gun.

Referring to FIGS. 6 and 12-17, the user re-installs/attaches the central body 46 of bushing repair fixture 42 to the forward housing 22 using drill plates 84 and 86 as shown in FIG. 13. The screws 100 for each drill plate 84 and 86 are lightly tightened so that minor movement of the central body 46 of bushing repair fixture 42 is possible.

The user next installs to the two locating plates 80 and 82 to the central body 46 of bushing repair fixture 42. The user can use either a pair of 6.1 mm drill bits 92 and 94 (as shown in FIG. 13) or a pair of mounting pins 28 (as shown in FIG. 1) to fasten the locating plates 80 and 82 to the central body 46 and a pair of mounting pin holes within arms 96 and 98 of forward housing 22 on the opposite side of the feeder. Drill bit 92 passes through an opening within bushing 87 of locating plate 80, the mounting pin holes within arms 96 and 98 and an opening within bushing 89 of locating plate 82. Opening 102 in locating plate 80 and opening 104 in locating plate 82 receive drill bit 94 which secures the locating plates 80 and 82 to central body 46 of bushing repair fixture 42.

After the locating plates 80 and 82 are attached to the central body 46, the user sets the 9 inch nominal distance between mounting pin holes within arms 96 and 98 and the holes 88 to be drilled in each replacement bushing 74 and 76. The user tightens all screws securing the central body 46 of bushing repair fixture 42 to the forward housing 22 and removes the locating plates 80 and 82.

Referring to FIGS. 14, 15 and 16, the user first drills a 6.1 mm mounting pin hole through replacement bushing 74 (FIGS. 14 and 16) and replacement bushing 76 (FIGS. 15 and 16) using a 6.1 mm drill bit 106 and drill 70. The user then verifies the positioning of the mounting pin holes 88 in bushings 74 and 76 by attaching the feeder housing to the machine gun.
