(54) Titre : REPARATION D'ENVELOPPES DE TURBINES HAUTE PRESSION
 (54) Title: REPAIR OF HIGH PRESSURE TURBINE SHROUDS

REPAIR OF HIGH PRESSURE TURBINE SHROUDS

This invention relates to repair of high pressure turbine shrouds. More particularly, it relates to the method of repairing high pressure turbine shrouds utilizing a high velocity oxyfuel (HVOF) and materials used for such repairs.

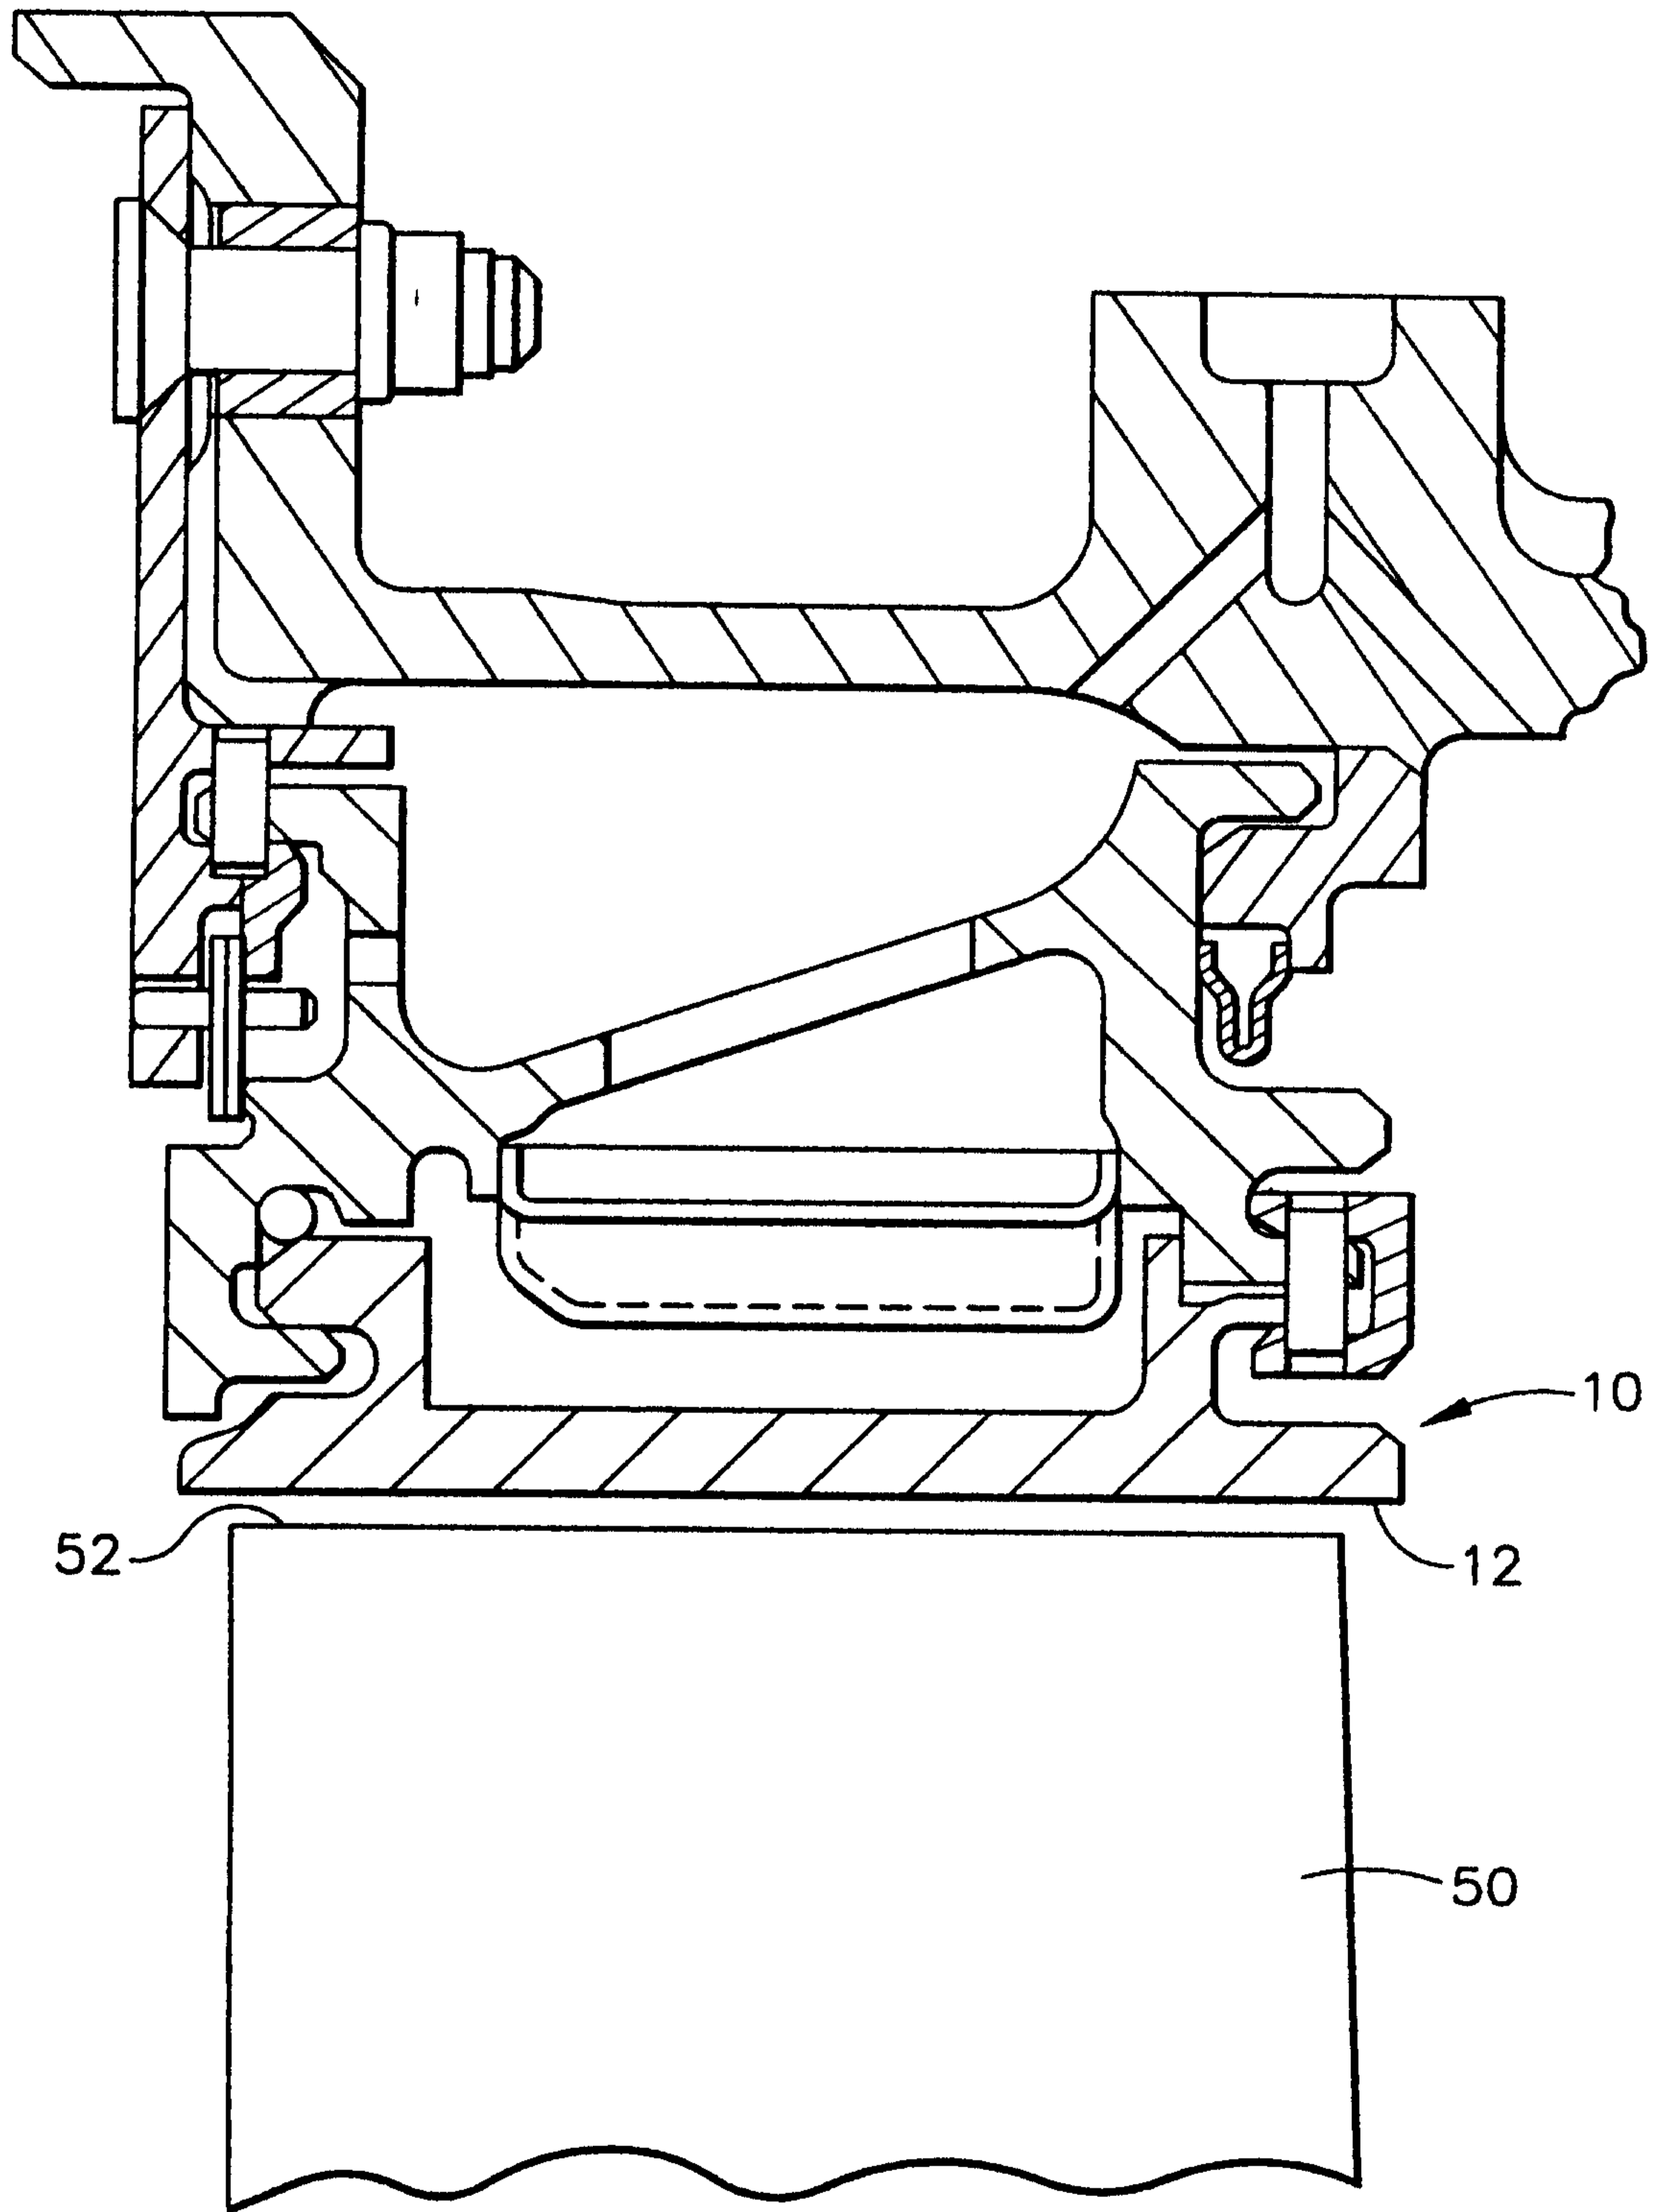
FIG. 1

Fig. 1 is a cross-sectional view of a shroud assembly, showing a shroud segment showing the shroud flow path surface adjacent to the tip of a turbine blade, the shroud support, the shroud hanger support and the support case;

Fig. 1 is a cross-sectional of a turbine engine shroud assembly, showing shroud segment 10. In this view, the shroud segment 10 has a flow path surface 12. Also shown for illustration purposes is a turbine blade 50 having a tip 52 immediately adjacent to the flow path surface 12 of the shroud segment. Fig. 2 is a perspective view of shroud segment 10 of Fig. 1. The shroud segment has a fore end 14 and an aft end 16. As shown in Fig. 3, a number of shroud segments having sides 18 are assembled together to form a shroud assembly that has the shape of a cylinder surrounding the turbine blades. As the hot gases of-combustion move rapidly from the combustors along the interior of the engine and across the shroud flow path surfaces 12 from the fore end 14 of the shroud segments to the aft end 16 of the shroud segments, the turbine blades are rotated. As can be seen, the tighter the tolerance between the shroud segments and the blades, the more efficient the engine will operate, since smaller volumes of gases will escape across the shroud flow path.

With reference to Fig. 1, turbine blades 50 are designed with tips 52 to cut into the flow path surface 12 of the shroud segments, which generally are comprised of a rub-compliant material. Of course, during the course of engine life, the clearance between the blade 50 and flow path surface 12 will gradually increase just from the operation of the rotating blades against the fixed shroud assemblies at various operating temperatures. Furthermore, as the hot gases of combustion pass along the engine interior across the shroud assembly from the fore rails to the aft rails, mechanical erosion of material from the shroud assemblies will also occur, thus increasing the clearance between the blades and the shroud assembly. Also, the hot gases of combustion contain a number of undesirable by-products which will cause not only oxidation, but also corrosion of the shroud assembly materials. Because the shroud assembly is comprised of a number of shroud segments assembled together to form a ring, as the shroud flow path material is removed, by whatever process described above, a gap develops along the shroud sides 18 between the shroud

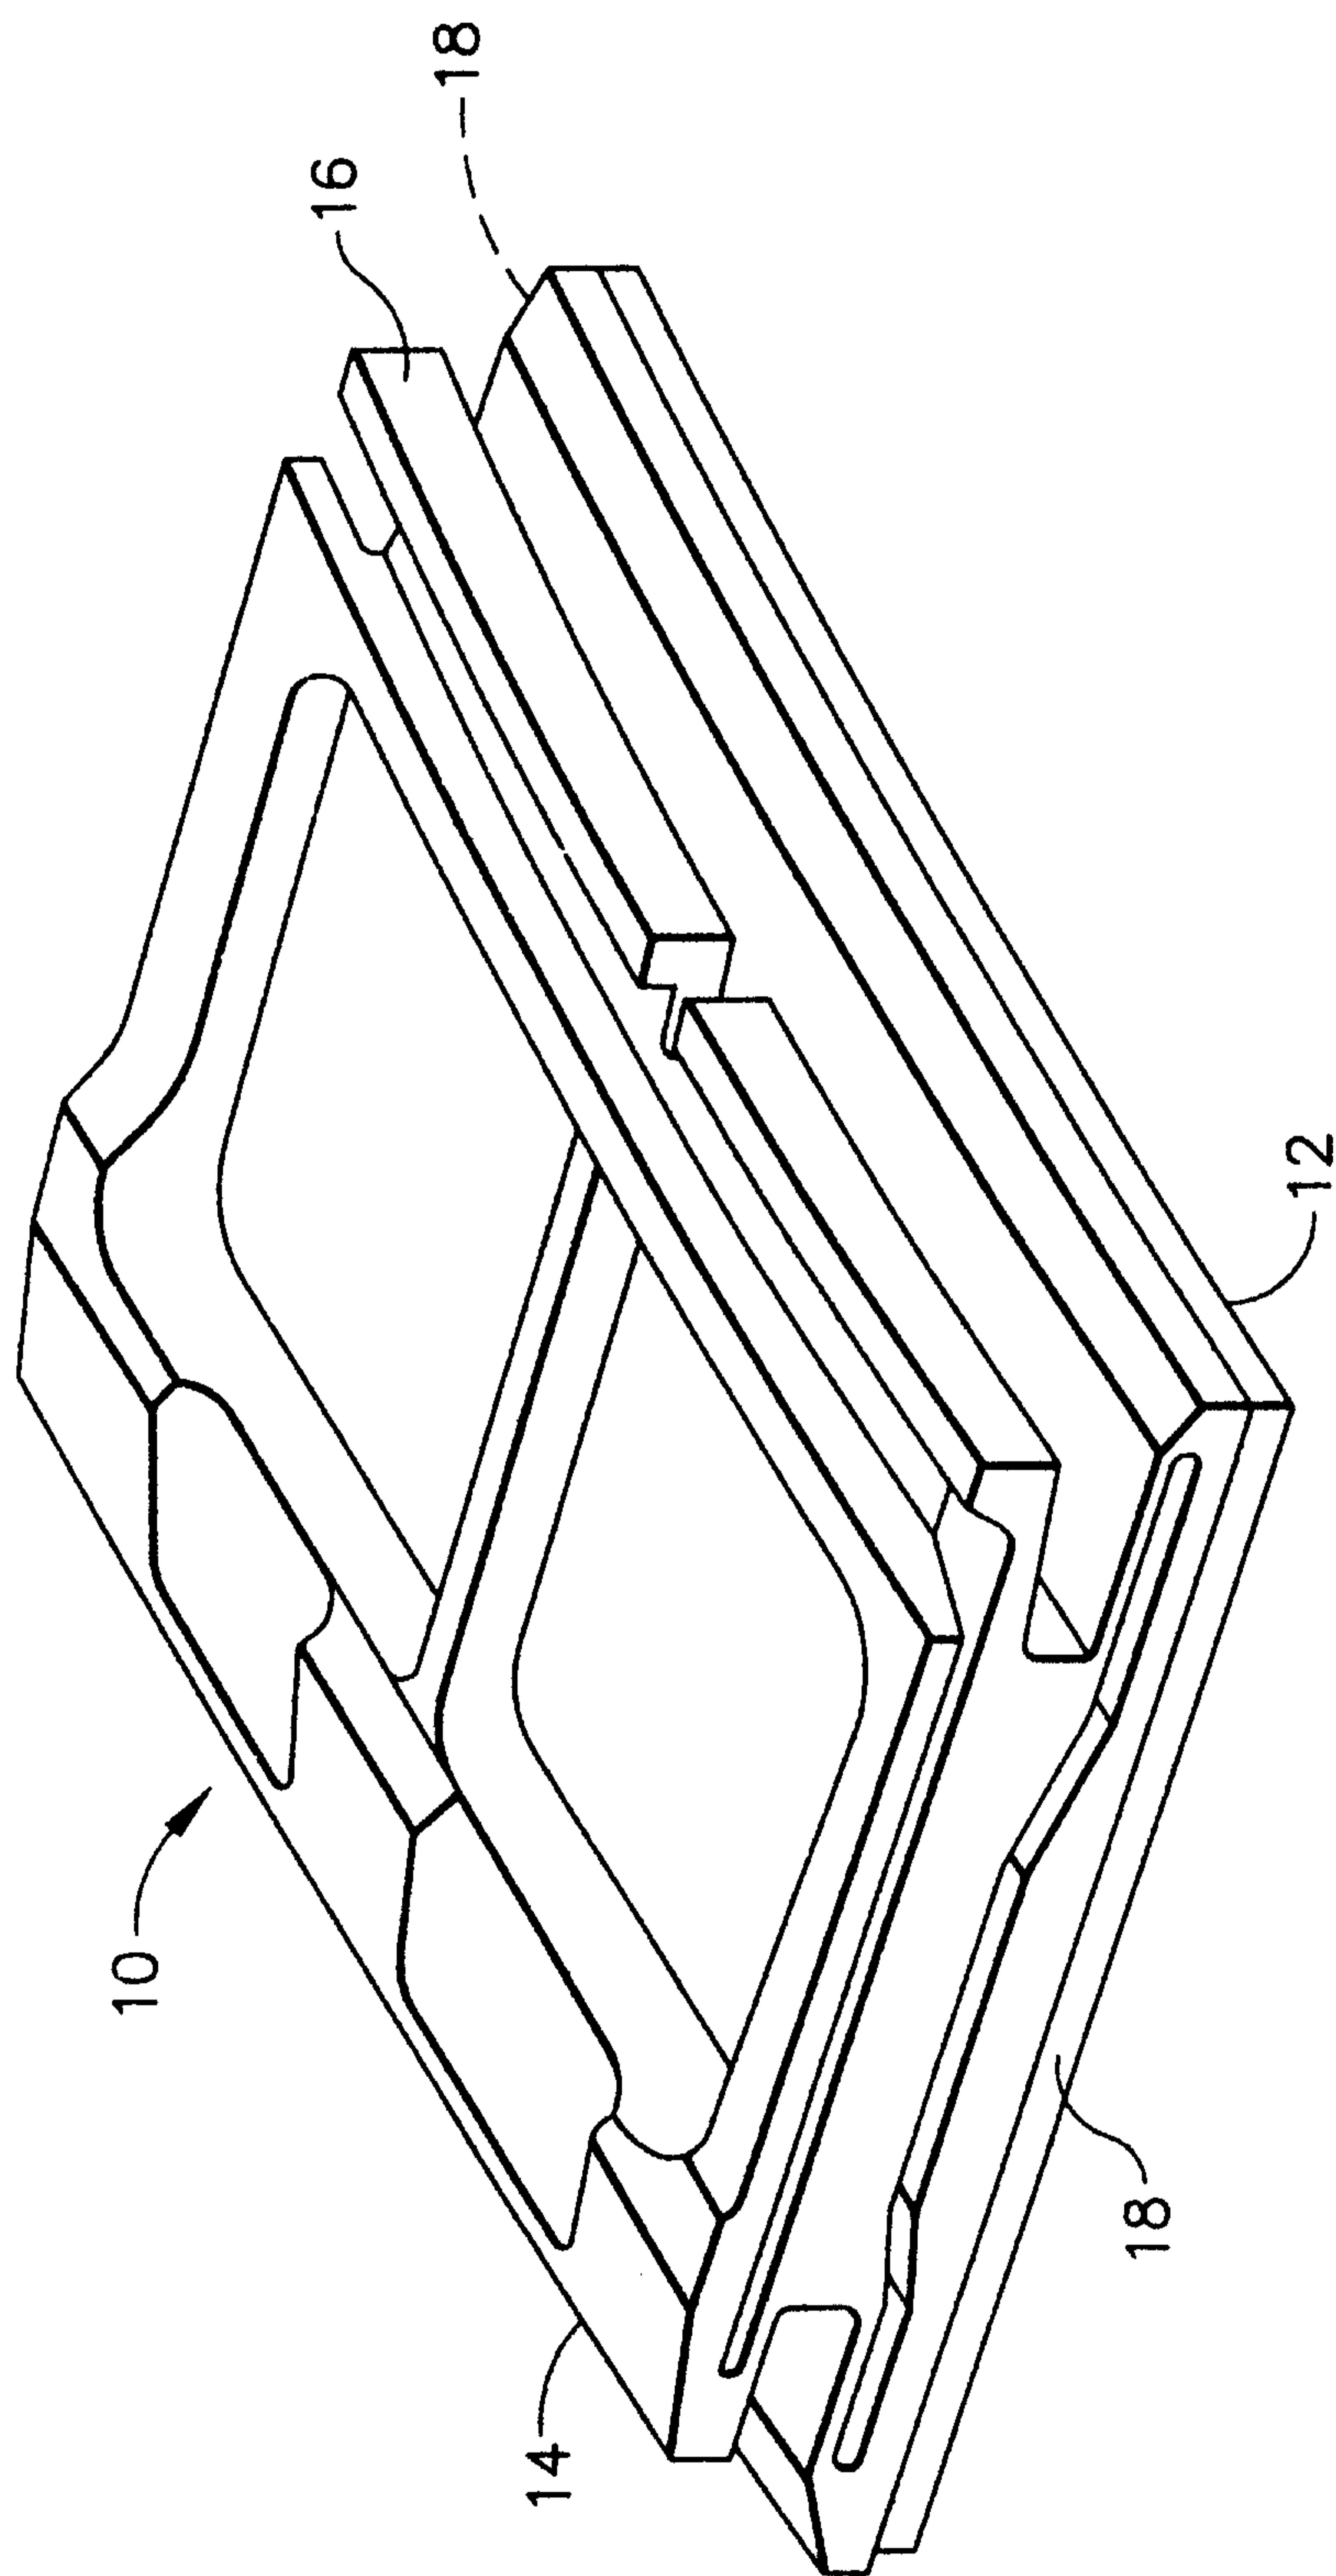
FIG. 2

Fig. 2 is a perspective view of a shroud segment; and

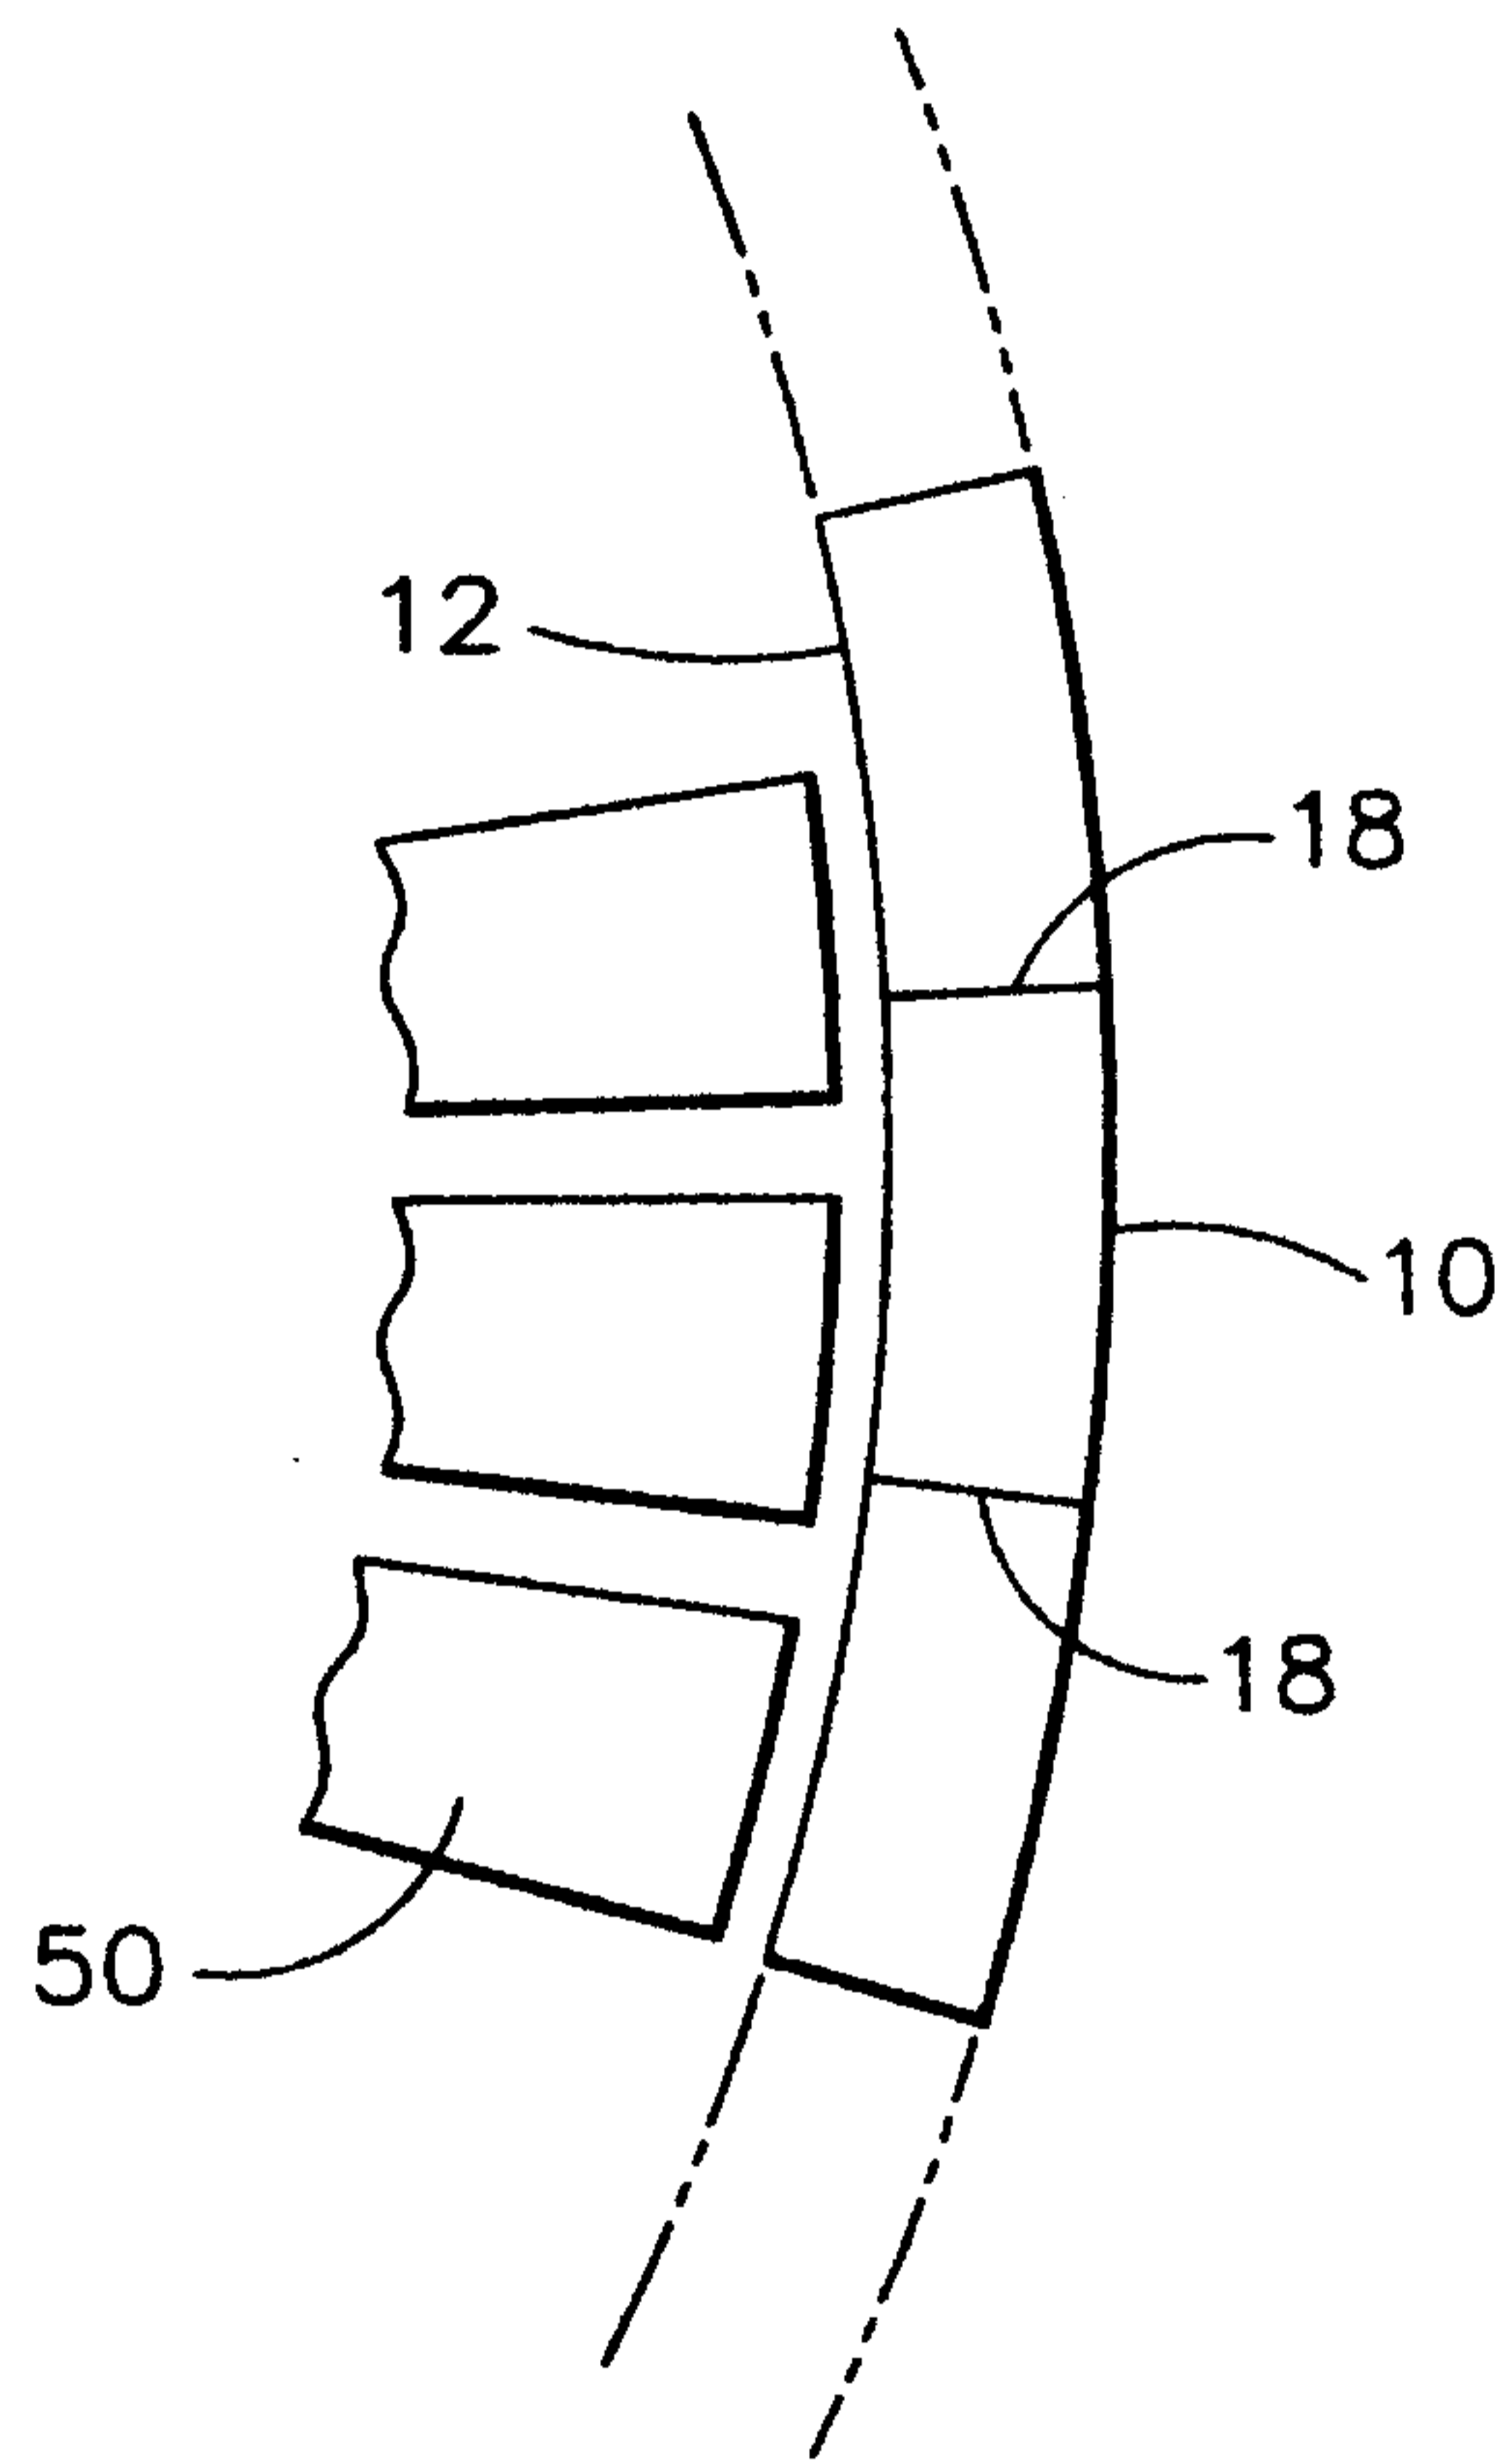
FIG. 3

Fig. 3 is a partial perspective view of a shroud assembly, comprised of a series of shroud segments assembled to form a portion of a cylinder around turbine blades.
