(11) **EP 2 151 543 A2**

(54) **Repair methods for turbines involving conductive heat resistance welding**

(57) Repair methods involving conductive heat resistance welding includes repairing a crack of a gas turbine engine component using (150) a conductive heat resistance welding technique and (146) a welding technique other than conductive heat resistance welding.

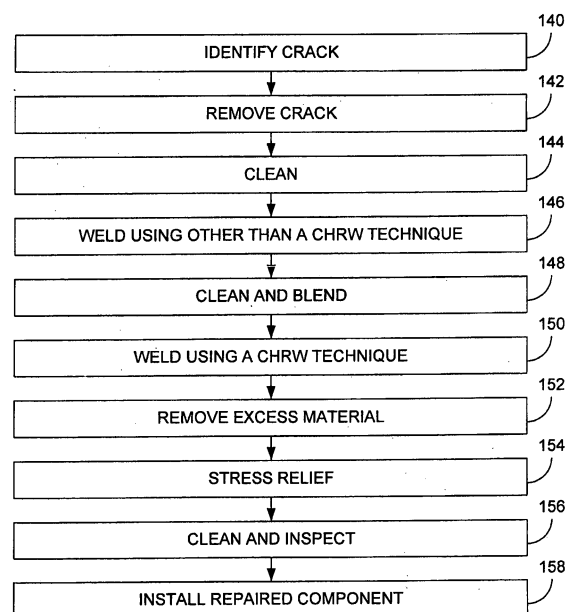
**FIG. 4**

FIG. 4 is a flowchart depicting another exemplary embodiment of a repair method involving conductive heat resistance welding.

**[0013]** FIG. 4 is a flowchart depicting another exemplary embodiment of a repair method involving conductive heat resistance welding (CHRW). As shown in FIG. 4, the method may be construed as beginning at block 140, in which a crack is identified on a gas turbine engine component. In some embodiments, this may involve identifying the crack while the component is still installed in the engine, while in others, the component is first removed. In block 142, the crack is removed such as by using a router to rout out material surrounding the crack. In block 144, the component is optionally cleaned. Then, as depicted in block 146, a first portion of the crack is welded using a welding technique other than conductive heat resistance welding. In some embodiments, such welding can be performed using a non-air environment about at least the first portion of the crack. Notably, the first portion of the crack may extend along a portion of the component surface that is non-planar, in some embodiments. In block 148, the component is optionally cleaned and the weld location is blended to remove excess material.

**[0014]** In block 150, a second portion of the crack is welded using conductive heat resistance welding. In particular, in some embodiments, such welding involves positioning a metal plug within the second portion of the crack, positioning a conductive plate adjacent to the second portion of the crack and the metal plug, and using the plate to melt the metal plug. Melting of the metal plug with the plate is accomplished by heating the plate via an electrical current. Notably, in some embodiments, care can be taken to reduce the opportunity for weld flash (i.e., liquid weld material produced by the metal plug) from seeping out of the weld location.

**[0015]** In block 152, any excess weld material can be removed from the component so that the component is finished to desired dimensions. Then, as depicted in block 154, stress relief can be performed in order to reduce the internal stresses of the component in a vicinity of the weld location. By way of example, if the component is formed of AA6061 aluminum (a common gas turbine component material), stress relief can be performed at approximately 325°F (163°C) for approximately 4 hours. In block 156, the component can be optionally cleaned and inspected to ensure adequate repair. In block 158, the component can be installed in a gas turbine engine, such as the engine from which the component was removed.

**[0016]** Conventionally, AA6061 aluminum is typically welded with non-parent metal filler alloy in order to reduce weld defects. Notably, conductive heat resistance welding utilizes a plug of parent metal composition. Therefore, using a method such as the exemplary method of FIG. 4, for example, a weld can be formed using parent metal, while alternative welding processes may be employed in lower stress regions that because of geometry do not lend themselves to a conductive heat resistance welding process.

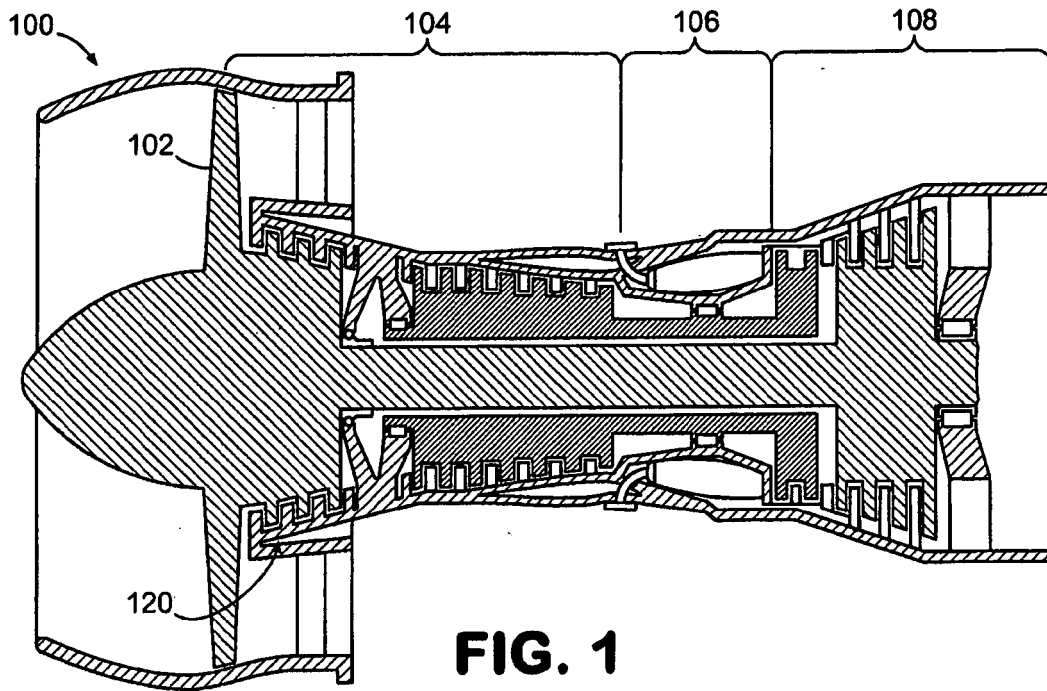
FIG. 1 is a schematic diagram depicting an exemplary embodiment of a gas turbine engine.

**[0009]** In this regard, reference is made to the schematic diagram of FIG. 1, which depicts an exemplary embodiment of a gas turbine engine. As shown in FIG. 1, engine 100 is depicted as a turbofan that incorporates a fan 102, a compressor section 104, a combustion section 106 and a turbine section 108. Although depicted as a turbofan gas turbine engine, it should be understood that the concepts described herein are not limited to use with turbofans as the teachings may be applied to other types of engines.

**[0010]** Also shown in FIG. 1 is a component 120 (in this case, a compressor stator flange located within the compressor section 104) that is in need of repair. Various components other than a compressor stator may be suited for repair by an embodiment of a repair method. By way of non-limiting example, fan cases, compressor cases and turbine cases also can be repaired. Notably, these components share the characteristic of including attach-
