(10) **Patent No.:** **US 7,646,446 B2**
(45) **Date of Patent:** **Jan. 12, 2010**

(54) **REPAIRING METHOD OF A THIN FILM TRANSISTOR ARRAY SUBSTRATE**

(73) Assignee: **Au Optronics Corporation**, Hsinchu (TW)

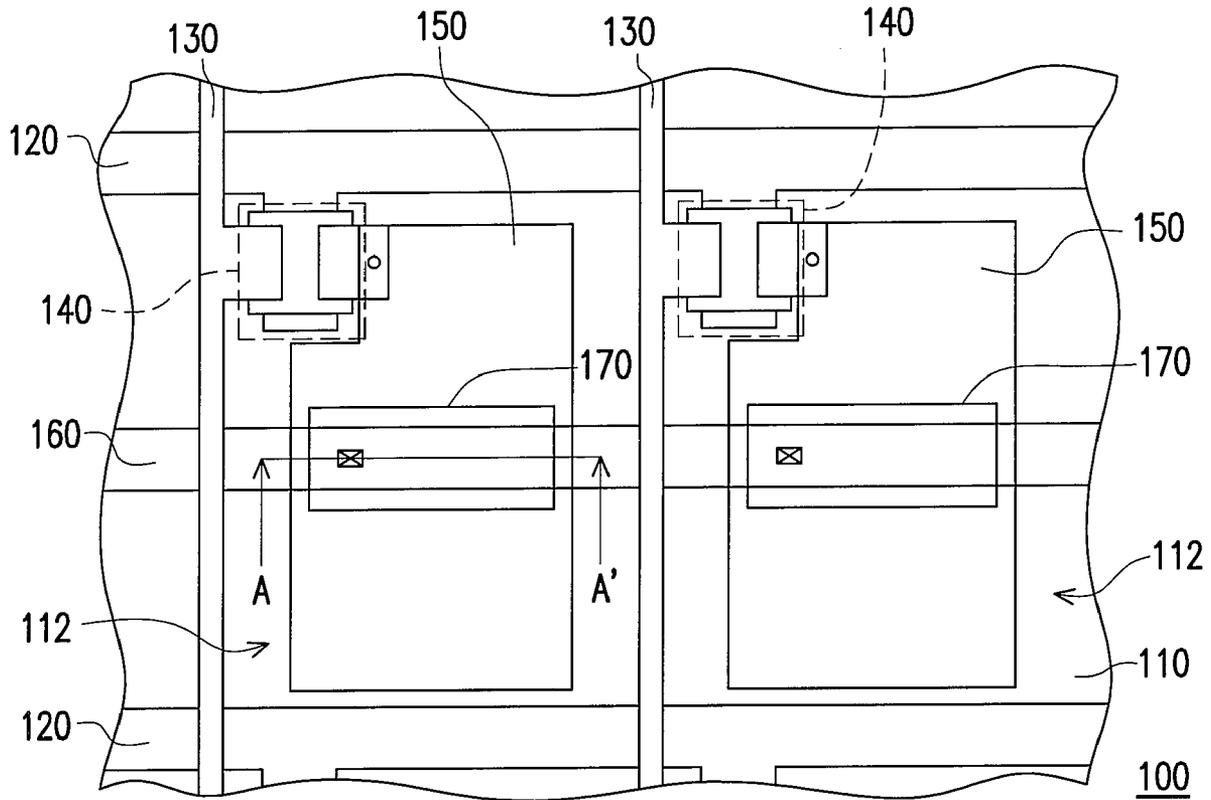
FIG. 1 (PRIOR ART)

FIG. 1 is a top view of a portion of a conventional thin film transistor array substrate. FIG. 2 is a schematic cross-sectional view along line A-A' of the thin film transistor array

FIG. 1 is a top view of a portion of a conventional thin film transistor array substrate.

substrate in FIG. 1. As shown in FIGS. 1 and 2, a conventional thin film transistor array substrate 100 mainly comprises a substrate 110, a plurality of scan lines 120, a plurality of data lines 130, a plurality of thin film transistors 140, a plurality of pixel electrodes 150, a plurality of common lines 160 (only one is shown) and a plurality of upper electrode 170.

The scan lines 120 and the data lines 130 are disposed over the substrate 110 to define a plurality of pixel areas 112. Each thin film transistor 140 is disposed inside one of the pixel areas 112 and is driven by one of the scan lines 120 and data lines 130. Each pixel electrode 150 is also disposed inside one of the pixel areas 112 and is electrically connected to one of the thin film transistors 140. The common line 160 is disposed over the substrate 110 such that a portion of the pixel electrode 150 is above one of the common lines 160.

In addition, an upper electrode 170 is disposed between each pixel electrode 150 and one of the common lines 160. Furthermore, a dielectric layer 180 is disposed between the upper electrode 170 and the corresponding common line 160 for isolating the upper electrode 170 and the common line 160. Another dielectric layer 190 is also disposed between the upper electrode 170 and one of the pixel electrodes 150. The dielectric layer 190 has a contact 192 for connecting the upper electrode 170 and the corresponding pixel electrode 150 electrically together.

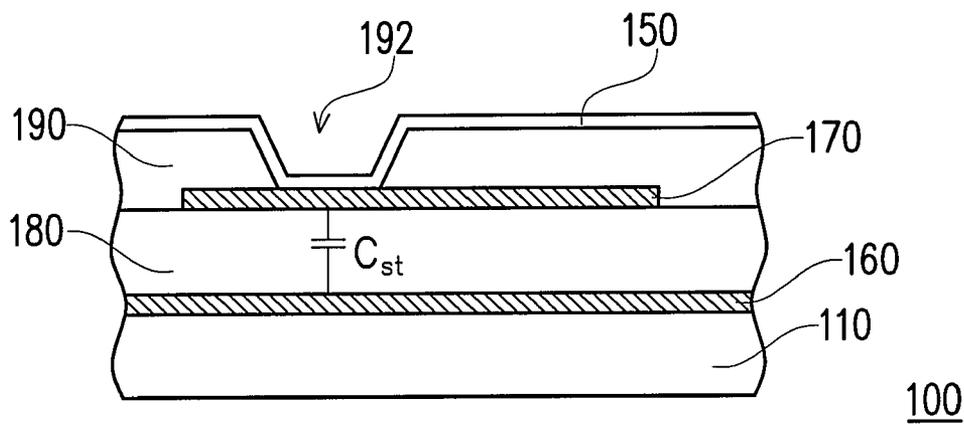
FIG. 2 (PRIOR ART)

FIG. 2 is a schematic cross-sectional view along line A-A' of the thin film transistor array substrate in FIG. 1.

As shown in FIG. 2, the upper electrode 170 and the corresponding common line 160 together form a storage capacitor (Cst) that smooth out the normal operation of various pixels within the thin film transistor liquid crystal display. However, any processing defect or other factors may lead to some particles falling into the dielectric layer 180 or trapped in the defects within the dielectric layer 180 and produce a leaky capacitor. Ultimately, the display quality of the pixel will be compromised.

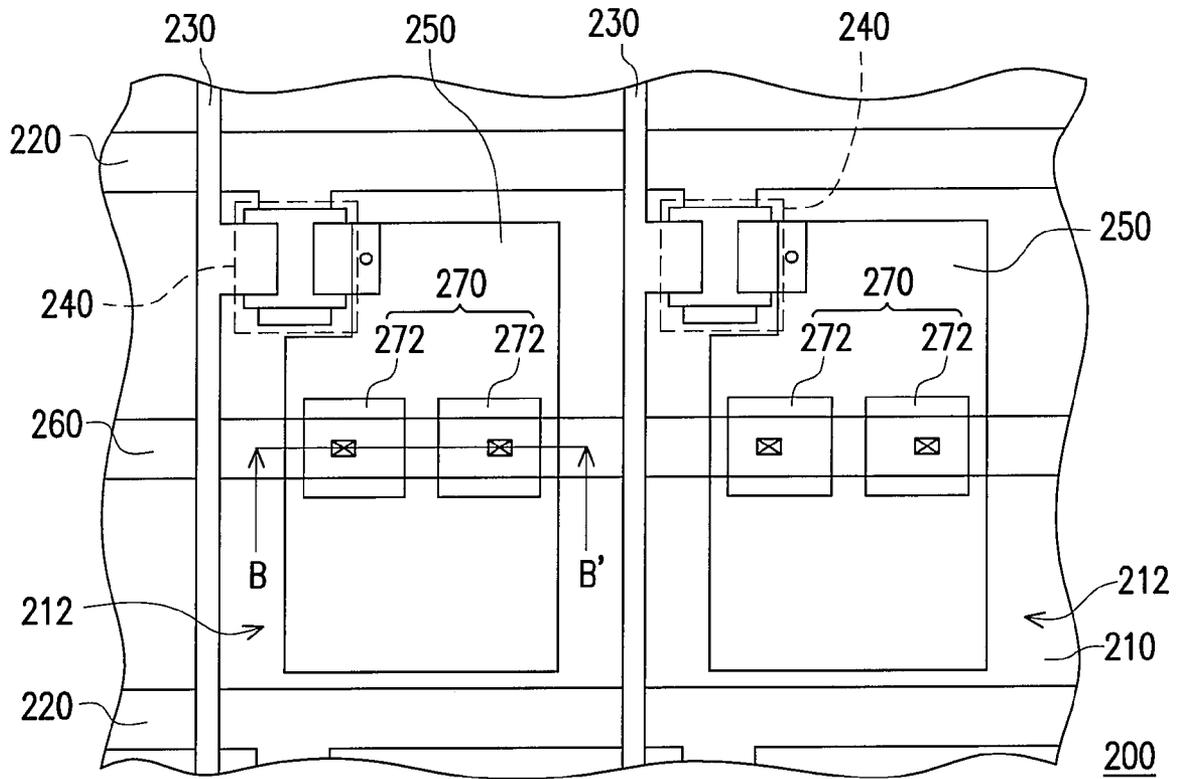
FIG. 3 is a top view of a thin film transistor array substrate according to one preferred embodiment of the present invention.

FIG. 3 is a top view of a thin film transistor array substrate according to one preferred embodiment of the present invention. FIG. 4 is a schematic cross-sectional view along line B-B' of the thin film transistor array substrate in FIG. 3. As shown in FIGS. 3 and 4, the thin film transistor array substrate 200 mainly comprises a substrate 210, a plurality of scan lines 220, a plurality of data lines 230, a plurality of thin film transistor 240, a plurality of pixel electrodes 250, a plurality of common lines 260 (only one is shown) and a patterned upper electrode 270.

The scan lines 220 and the data lines 230 are disposed over the substrate 210 to define a plurality of pixel areas 212. Each thin film transistors 240 is disposed inside one of the pixel areas 212 and driven by one of the scan lines 220 and one of the data lines 230. Each pixel electrode 250 is disposed inside one of the pixel areas 212 and electrically connected to one of the thin film transistors 240. The common line 260 is disposed over the substrate 210 such that a portion of each pixel electrode 250 is above one of the common lines 260.

The patterned upper electrode 270 is disposed between each pixel electrode 250 and the corresponding common line 260. A dielectric layer 280 is disposed between the patterned upper electrode 270 and the common line 260. Another dielectric layer 290 is disposed between the patterned upper electrode 270 and the pixel electrode 250. It should be noted that the patterned upper electrode 270 comprises a plurality of sub-upper electrodes 272 (only two of them are shown). A portion of each sub-upper electrode 272 is electrically connected to one of the pixel electrodes 250. For example, a contact 292 is formed in the dielectric layer 290 above each sub-upper electrode 272 so that each sub-upper electrode 272 is electrically connected to one of the pixel electrodes 250. Hence, the sub-upper electrode 272 and one of the common lines 260 together form a storage capacitor (Cst).

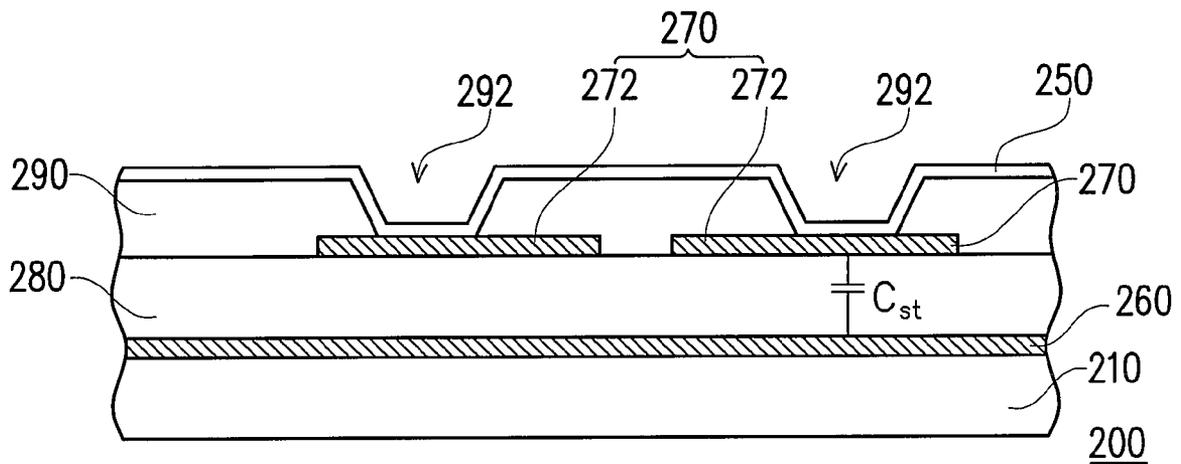
FIG. 4 is a schematic cross-sectional view along line B-B' of the thin film transistor array substrate in FIG. 3.

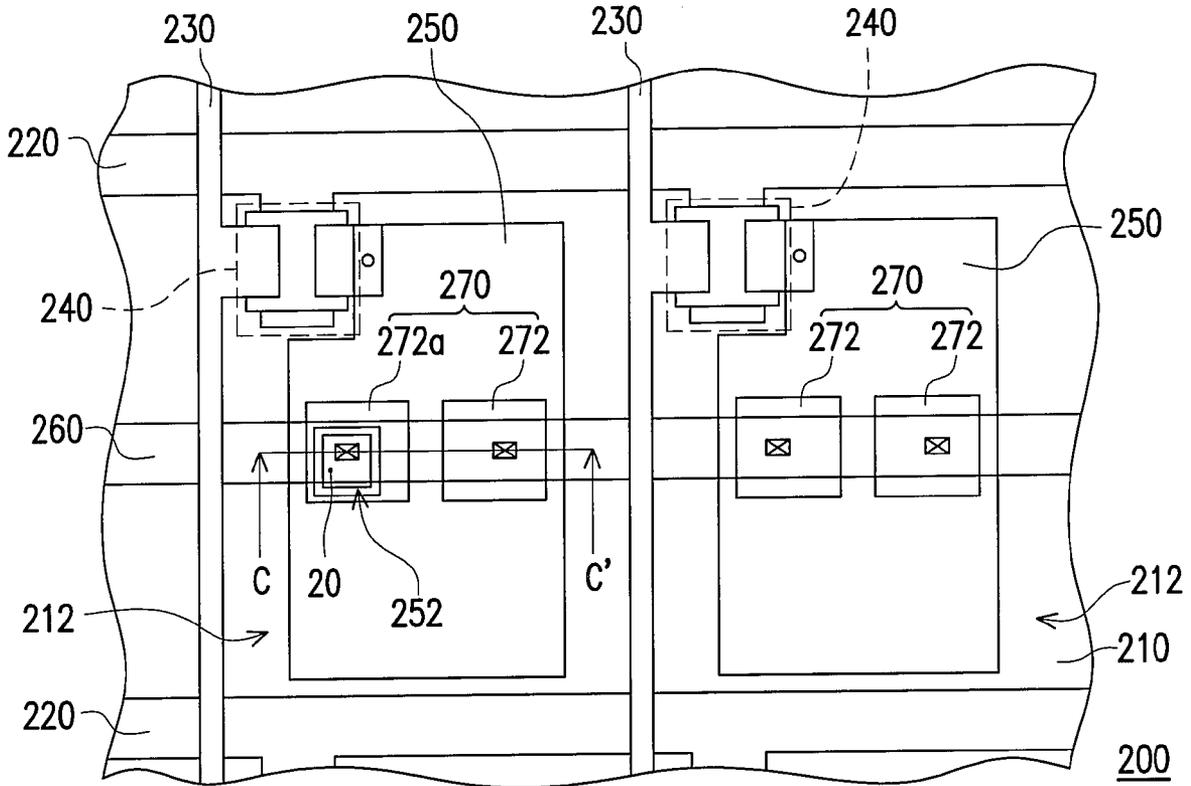
FIG. 5 is a top view of the thin film transistor array substrate in FIG. 3 after performing a laser repairing operation.

FIG. 5 is a top view of the thin film transistor array substrate in FIG. 3 after performing a laser repairing operation. FIG. 6 is a schematic cross-sectional view along C-C' of the thin film transistor array substrate shown in FIG. 5. As shown in FIGS. 5 and 6, if there is a particle (or defect) in the material between one of the sub-upper electrodes 272 and one of the common lines 260, leakage between the sub-upper electrode 272a and the common line 260 may occur. Thus, the pixel may display abnormally and need a repair. The method of repairing the pixel includes removing a portion of the pixel electrode 250 corresponding to the sub-upper electrode 272a of the defective capacitor so that the sub-upper electrode 272a and the corresponding pixel electrode 250 of the defective capacitor are electrically isolated.

In the present embodiment, a portion of the pixel electrode 250 above the sub-upper electrode 272a of the corresponding defective capacitor is removed to form an opening 252. The method of removing a portion of the pixel electrode 250 includes laser ablation, for example. The opening 252 is located around the contact area between the sub-upper electrode 272a and the corresponding pixel electrode 250 of the defective capacitor (that is, around the contact 292). By forming the opening 252, the sub-upper electrode 272a and the corresponding pixel electrode 250 of the defective capacitor

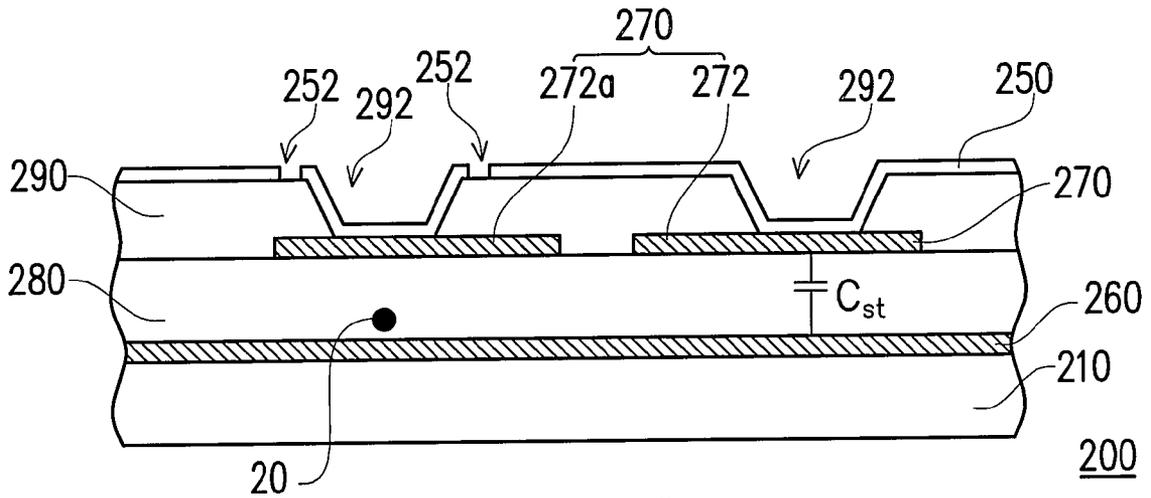
FIG. 6 is a schematic cross-sectional view along C-C' of the thin film transistor array substrate shown in FIG. 5.

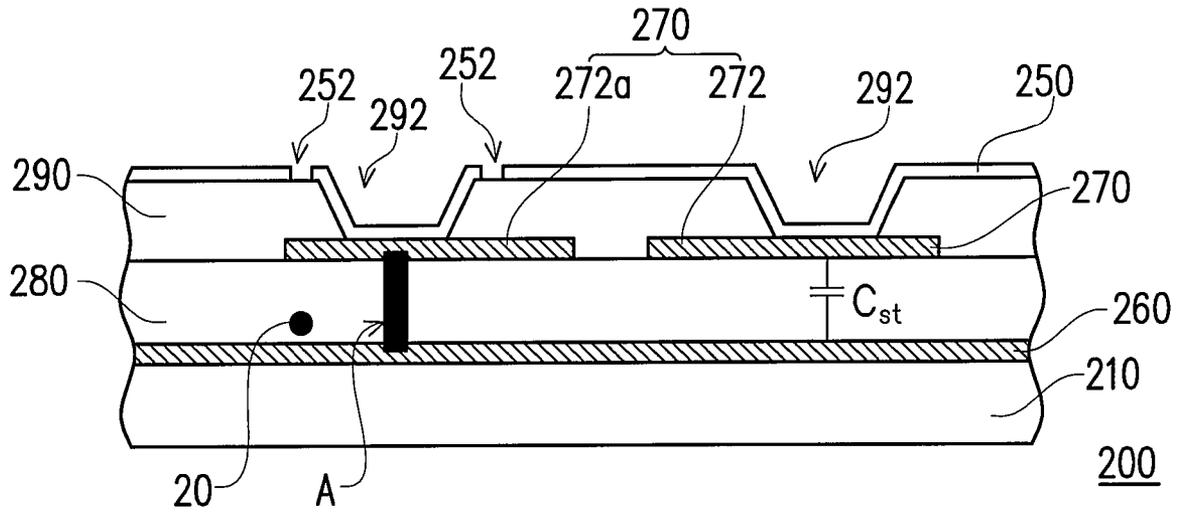
FIG. 7 is a schematic cross-sectional view showing the electrical connection between the common line and the sub-upper electrode in a defective capacitor for repairing a thin film transistor array substrate according to one preferred embodiment of the present invention.

FIG. **7** is a schematic cross-sectional view showing the electrical connection between the common line and the sub-upper electrode in a defective capacitor for repairing a thin film transistor array substrate according to one preferred embodiment of the present invention. After removing a portion of the pixel electrode **250** corresponding to the sub-upper electrode **272a** of the defective capacitor to isolate the sub-upper electrode **272a** and the pixel electrode **250** electrically, the sub-upper electrode **272a** and the corresponding common line **260** are welded together (labeled A). Hence, the sub-upper electrode **272a** and the common line **260** of the defective capacitor are configured at the same potential to prevent any leakage via the particles (or defects). The sub-upper electrode **272a** and the corresponding common line **260** are welded together by performing a laser welding process, for example.

In the present invention, the location at which the sub-upper electrode **272a** and the corresponding common line **260** of the defective capacitor weld together is underneath the contact **292**. However, anyone familiar with the technologies may choose other suitable locations convenient for welding the sub-upper electrode **272a** and the corresponding common line **260** of the defective capacitor together.

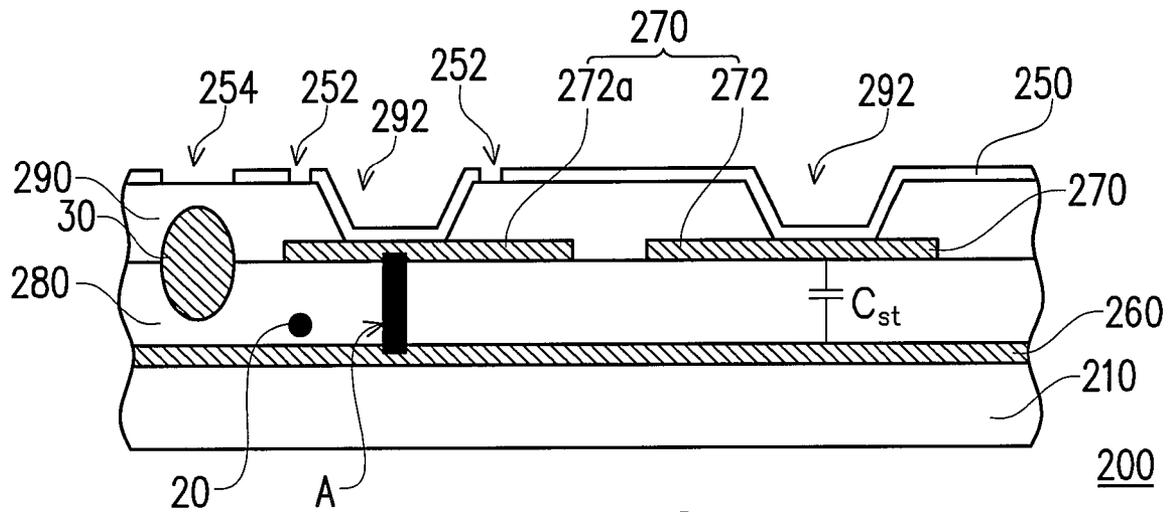
FIG. 8 is a schematic cross-sectional view showing the reparation of a thin film transistor array substrate when a particle is disposed between a pixel electrode and a common line.

FIG. **8** is a schematic cross-sectional view showing the reparation of a thin film transistor array substrate when a particle is disposed between a pixel electrode and a common line. When a particle **30** (or a defect) is formed inside the layers between the pixel electrode and one of the common lines, the repairing method of the present invention also permits the removal of a portion of the pixel electrode **250** above the particle **30** (or defect). For example, a portion of the pixel electrode **250** is removed to form an opening **254** that exposes the particle **30** (or defect) using a laser beam.

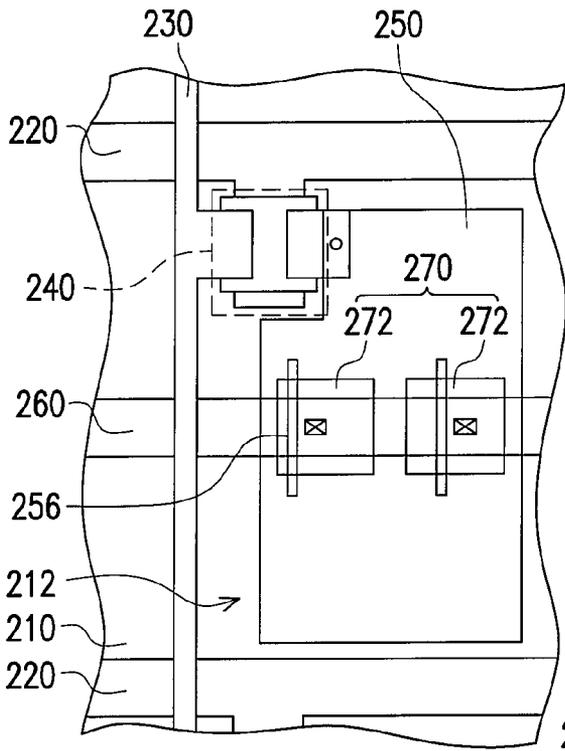
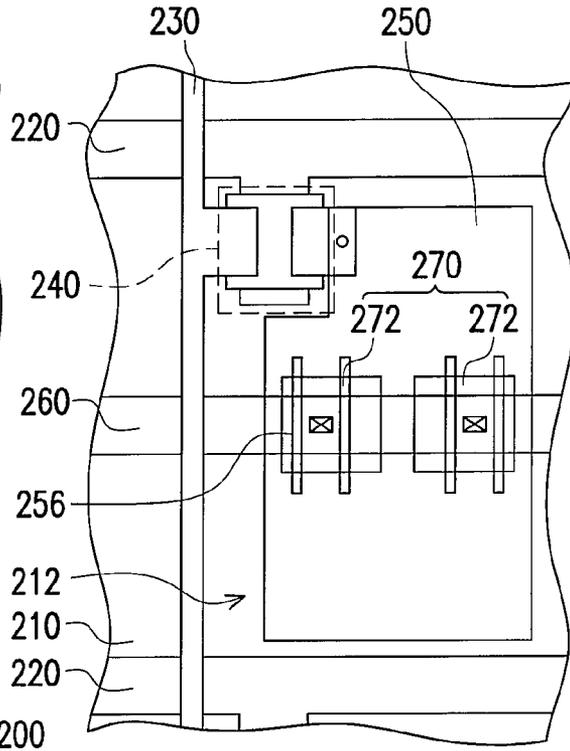
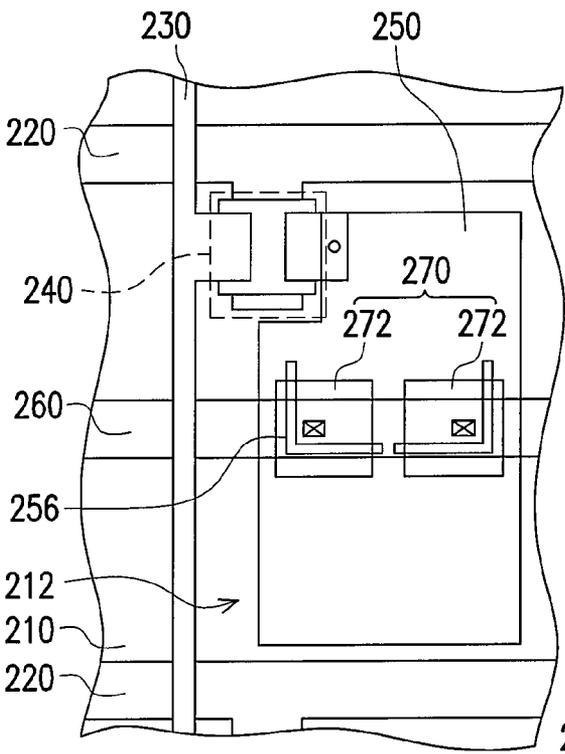
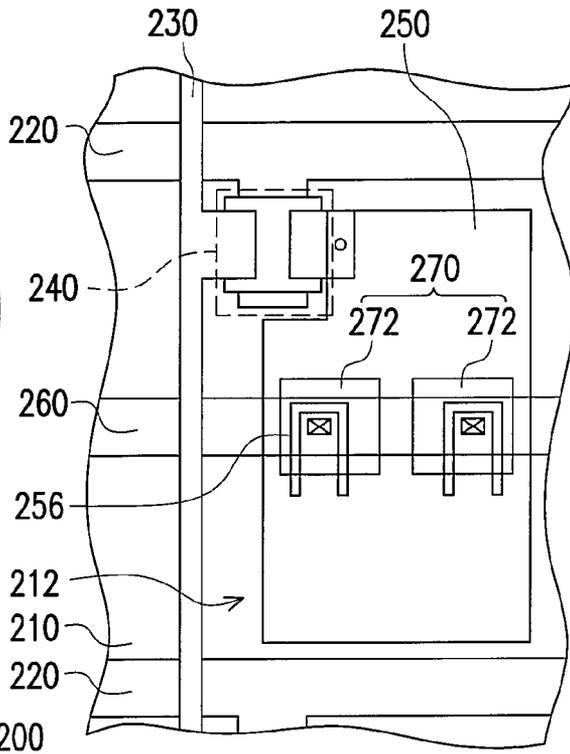
FIGS. 9A through 9D are top views showing different types of thin film transistor array substrates according to another preferred embodiment of the present invention.

FIGS. **9A** through **9D** are top views showing different types of thin film transistor array substrates according to another preferred embodiment of the present invention. The thin film transistor array substrate of the present embodiment is mostly identical to the one shown in FIG. **3**. One major difference is that one or more openings **256** are formed in each pixel electrode **250** when the pixel electrodes **250** are formed. The openings **256** are disposed around the contact region between each sub contact pad **272** and one of the pixel electrodes **250**. For example, a straight line opening **256** (shown in FIG. **9A**), two straight line openings **256** (shown in FIG. **9B**), an L-shaped opening (shown in FIG. **9C**) or a U-shaped opening **256** (shown in FIG. **9D**) is formed over the pixel electrode **250** corresponding to each sub contact pad **272**. With an opening **256** formed over the every pixel electrode **250**, a portion of any one pixel electrode **250** can be readily removed to connect the ends of the opening **256**. Hence, an opening similar to the opening **252** that encircles the contact **292** as shown in FIG. **5** can be produced when there is a particle (or defect) between a sub-upper electrode **272** and one of the common lines **260**. In the present embodiment, the method of removing a portion of the pixel electrode **250** includes performing a laser ablation process.

As shown in FIGS. **9A** through **9D**, a portion of the opening **256** is disposed above the area occupied by the sub-upper electrode **272** while the remaining portion of the opening **256** is disposed outside the area occupied by the sub-upper electrode **272**. In other words, the openings **256** also cover a region outside the upper electrode **272** to simplify and speed the repairing operation. In addition, anyone familiar with the

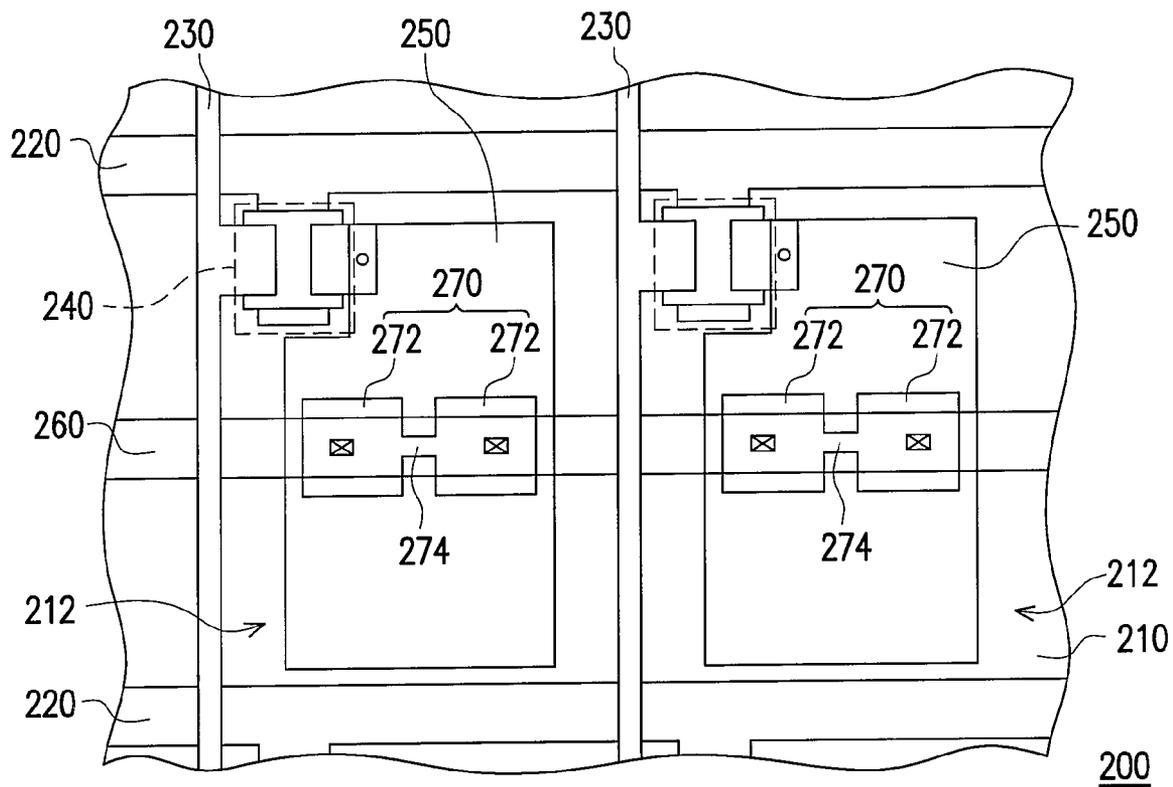
FIG. 10 is a top view of a thin film transistor array substrate according to another preferred embodiment of the present invention.

FIG. **10** is a top view of a thin film transistor array substrate according to another preferred embodiment of the present invention. FIG. **11** is a top view of the thin film transistor array substrate in FIG. **10** after a laser repairing operation. In the present embodiment, the thin film transistor array substrate has a structure mostly similar to the one shown in FIG. **3**. One major difference of the present embodiment is that the sub-upper electrodes **272** underneath each pixel electrode **250** are mutually connected through a neck portion **274** that can be severed in a repair operation.

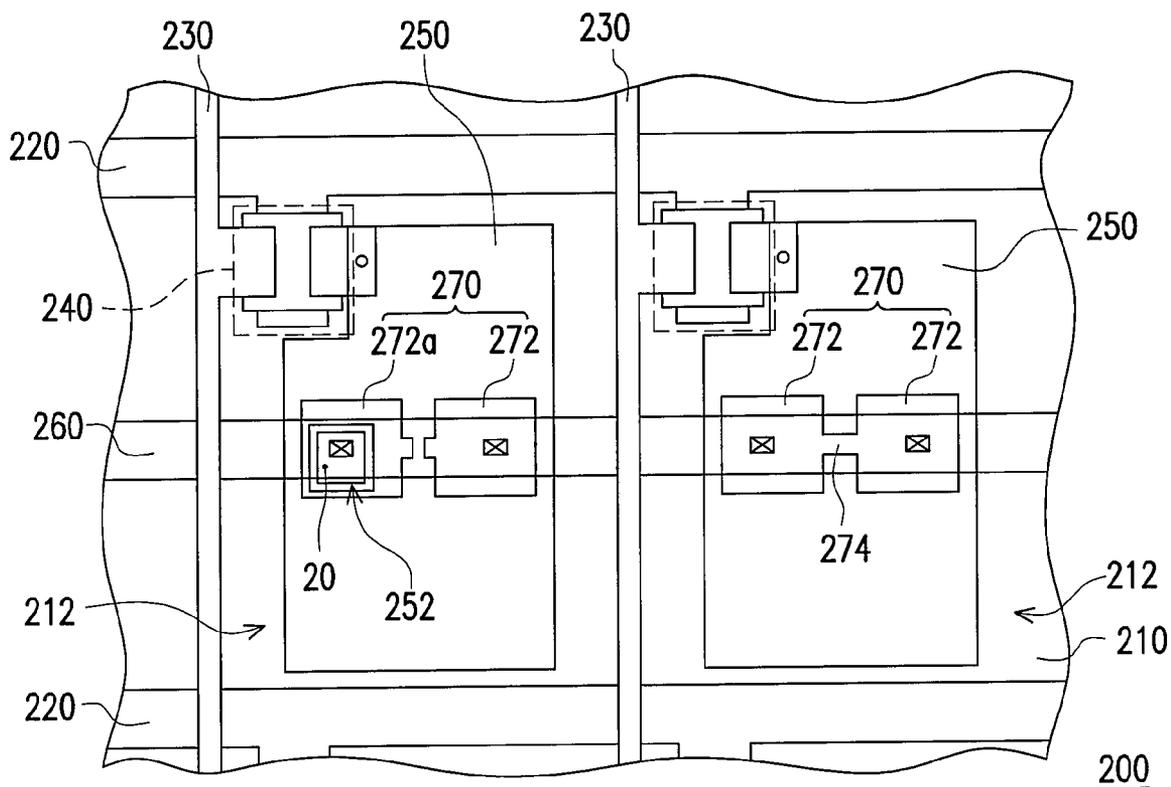
FIG. 11 is a top view of the thin film transistor array substrate in FIG. 10 after a laser repairing operation.

In the presence of a particle **20** (or defect) between one of the sub-upper electrode **270** and one of the common lines **260**, a leakage between the sub-upper electrode **272a** and the common line **260** may occur. To repair such defect, a portion of the pixel electrode **250** corresponding to the sub-upper electrode **272a** of the defective capacitor is removed. Thereafter, the neck portion **274** connecting with the sub-upper electrode **272a** of the defective capacitor **272a** is cut so that the sub-upper electrode **272a** and the corresponding pixel electrode **250** of the defective capacitor are electrically isolated. In the present embodiment, a portion of the pixel electrode **250** is removed to form an opening **252**. The opening **252** is located around the contact area between the sub-upper electrode **272a** and the corresponding pixel electrode of the defective capacitor. Furthermore, the method of removing a portion of the pixel electrode **250** includes performing a laser ablation and the method of cutting the neck portion **274** includes performing a laser cutting operation. After cutting the neck portion **274** connecting the sub-upper electrode **272a** of the defective capacitor, the sub-upper electrode **272a** and the corresponding pixel electrode **250** are electrically isolated to achieve the goal of repairing a thin film transistor array substrate.

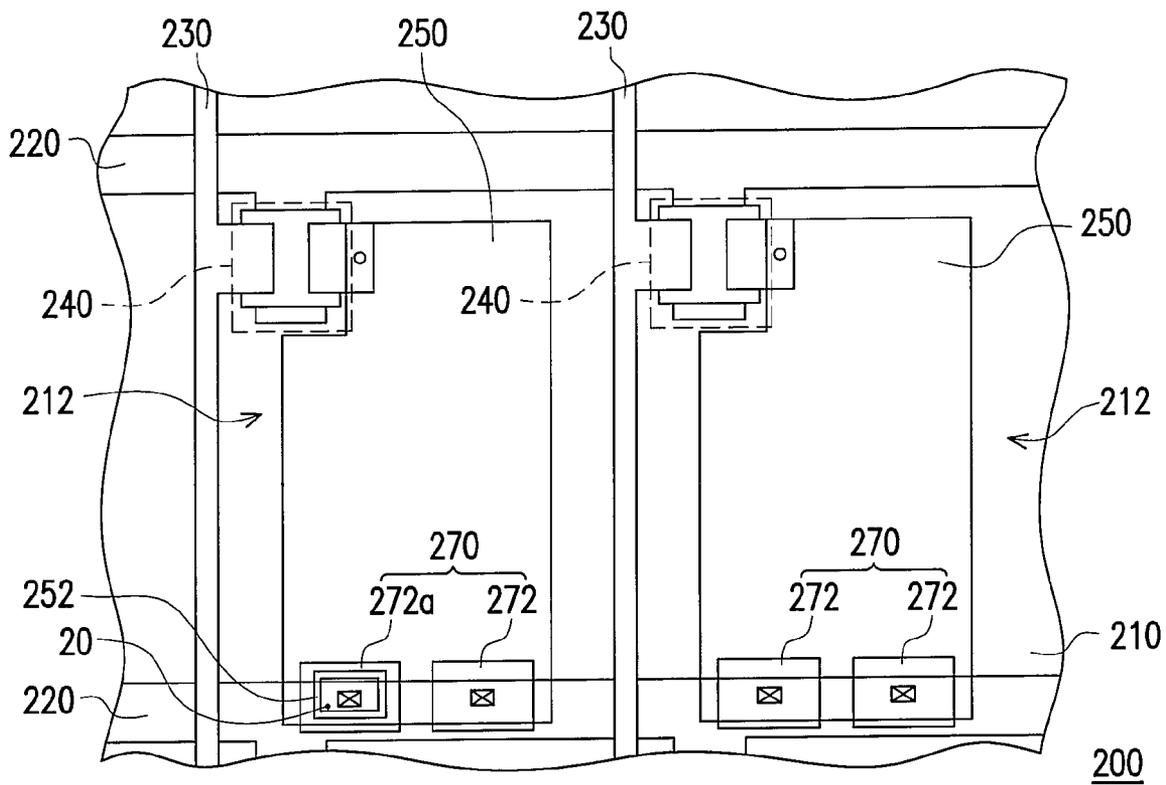
FIG. 12

FIGS. 12 and 13 are top views showing the method of repairing the scan line structure of the storage capacitor inside a thin film transistor array substrate according to the present invention.

As shown in FIG. **12**, a portion of each pixel electrode **250** extends into the area above one of the scan lines **220**. The patterned upper electrode **270** is disposed between the pixel electrode **250** and the corresponding scan line **220**. The patterned upper electrode **270** comprises a plurality of sub-upper electrodes **272**. The sub-upper electrode **272** and its underlying scan line **220** together form a storage capacitor inside each pixel.

As shown in FIG. 12, a portion of the pixel electrode **250** above the sub-upper electrode **272a** of the corresponding defective capacitor is removed to form an opening **252**. By forming the opening **252** in the pixel electrode **250**, the sub-upper electrode **272a** and the corresponding pixel electrode **250** of the defective capacitor are electrically isolated. The method of removing a portion of the pixel electrode **250** includes laser ablation, for example.

FIGS. **12** and **13** are top views showing the method of repairing the scan line structure of the storage capacitor inside a thin film transistor array substrate according to the present invention. As shown in FIGS. **12** and **13**, the thin film transistor array substrate has a capacitor on scan line structure (Cst on gate) similar to one shown in FIG. **5**.

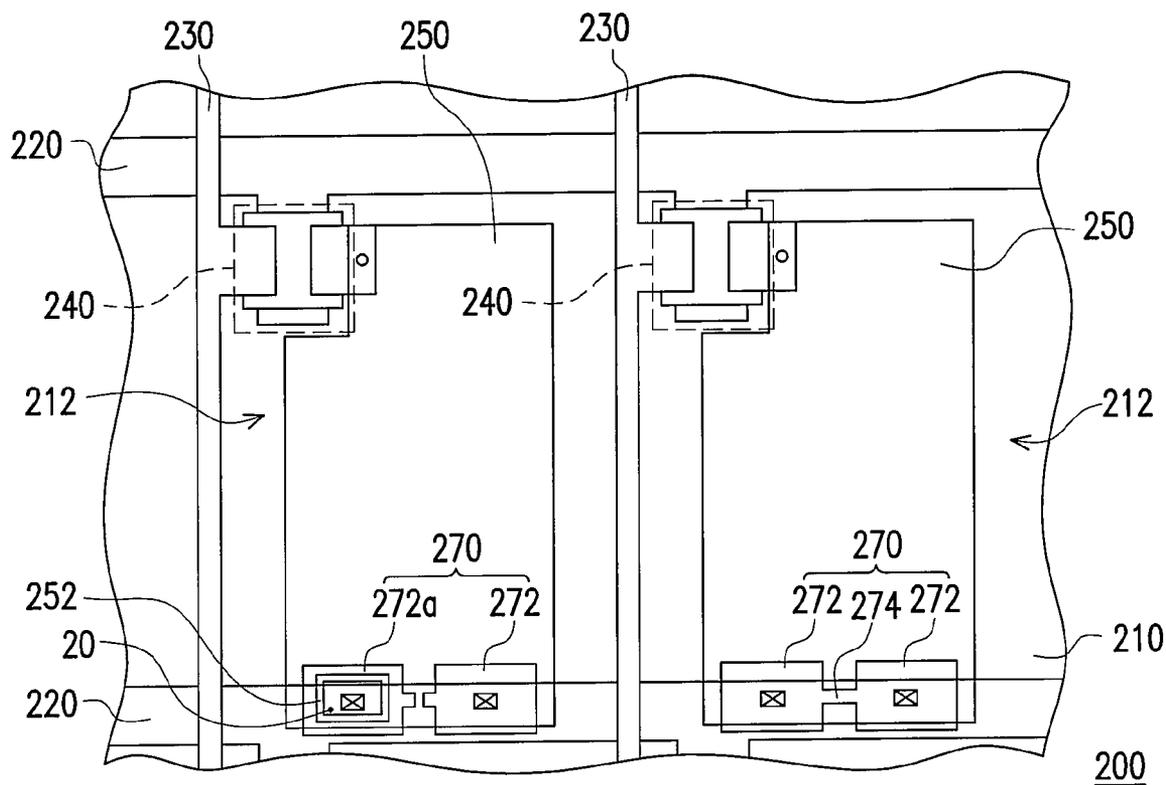
FIG. 13

As shown in FIG. **13**, the patterned upper electrode **270** is disposed **5** between each pixel electrode **250** and one of the scan lines **220**. The patterned upper electrode **270** comprises a plurality of sub-upper electrodes **272**. Furthermore, each sub-upper electrode **272** underneath the pixel electrode **250** has a neck portion **274** connecting with each other. The neck portion **274** serves as a cutting area in a repairing operation.

As shown in FIG. 13, the repairing method includes removing a portion of the pixel electrode corresponding to the sub-upper electrode **272a** of the defective capacitor to form an opening **252**. Furthermore, the neck portion **274** connecting with the sub-upper electrode **272a** of the defective capacitor is cut so that the sub-upper electrode **272a** of the defective capacitor and the corresponding pixel electrode **250** are electrically isolated. The method of removing a portion of the pixel electrode **250** includes a laser ablation process and the method of cutting the neck portion **274** includes a laser cutting operation.

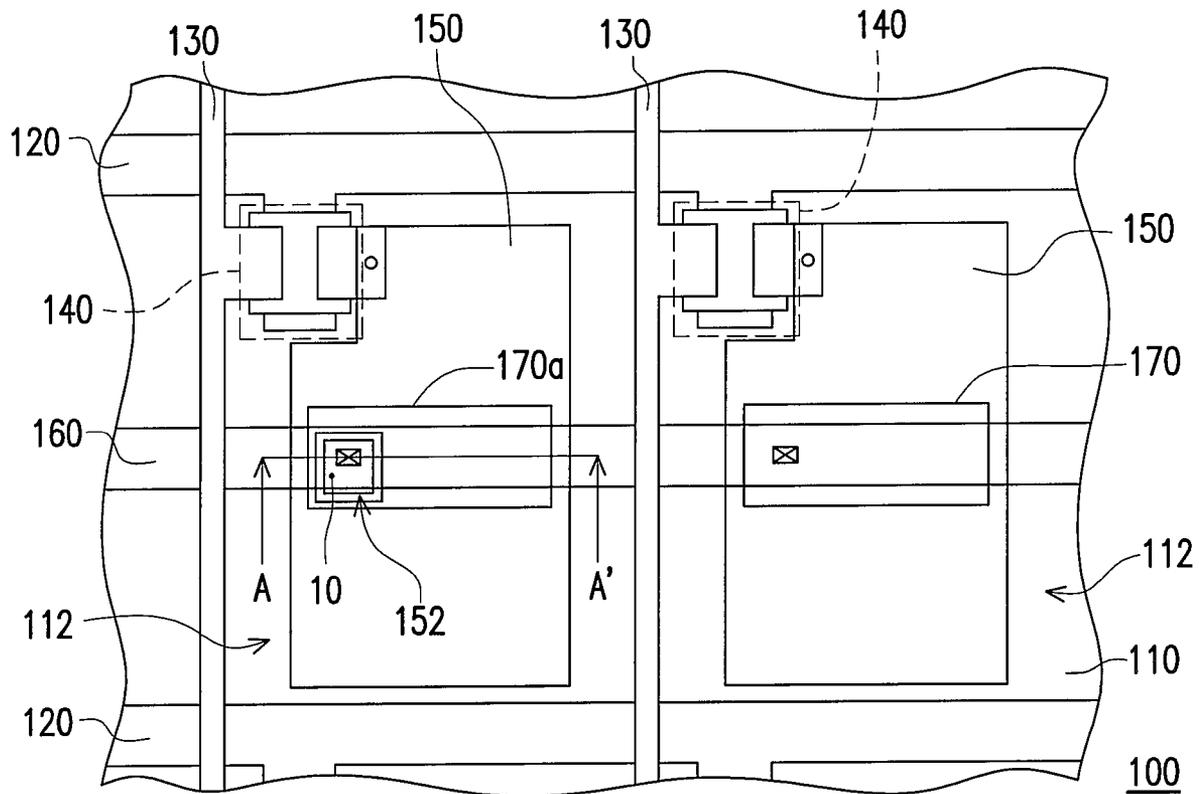
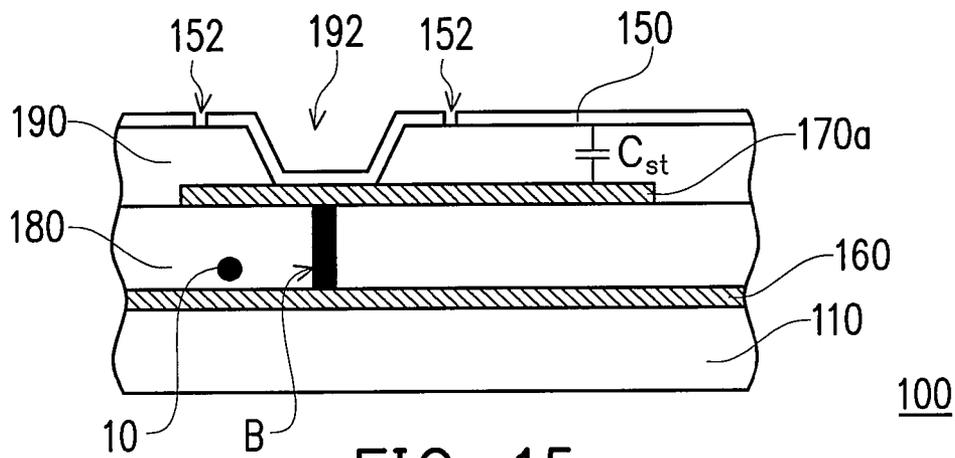
FIGS. 14 and 15 are top view and cross-sectional view showing the configuration after applying the method of the present invention to repair a conventional thin film transistor array substrate.

FIGS. 14 and 15 are top view and cross-sectional view showing the configuration after applying the method of the present invention to repair a conventional thin film transistor array substrate. As shown in FIGS. 14 and 15, a conventional thin film transistor array substrate **100** has an upper electrode **170** between every pixel electrode **150** and corresponding common line **160**. In the presence of a particle (or defect) **10** between any upper electrode **170** and the corresponding common line **160**, the repairing method of the present invention can be used to rectify the problem. The repairing method of the present embodiment includes removing a portion of the pixel electrode **150** corresponding to the upper electrode **170a** of the defective capacitor so that the upper electrode **170a** and the pixel electrode **150** of the defective capacitor is electrically isolated. Thereafter, the upper electrode **170a** and the corresponding common line **160** are welded together. Obviously, whether to weld the upper electrode **170a** and the common line **160** of the defective capacitor together can be determined by the amount of leakage in the defective capacitor.

In the present embodiment, a portion of the pixel electrode **150** above the upper electrode **170a** of the corresponding defective capacitor is removed to form an opening **152**. The method of removing a portion of the pixel electrode **150** includes laser ablation, for example. The opening **152** is located around the contact area between the upper electrode **170a** and the corresponding pixel electrode **150** of the defective capacitor (that is, around the contact **192**). By forming the

opening **152**, the upper electrode **170a** and the corresponding pixel electrode **150** of the defective capacitor are electrically isolated. Thereafter, the upper electrode **170a** and the corresponding common line **160** are welded together (as shown in label B), for example, by performing a laser welding process, so that the upper electrode **170a** and the common line **160** of the defective capacitor are configured at the same potential.

It should be noted that the thin film transistor array substrate **100** in FIGS. 14 and 15 has capacitor on common line (Cst on common) storage capacitor thereon. However, anyone familiar with the technology can apply the repairing method of the present invention to a substrate having a capacitor on gate (Cst on gate) storage capacitor thereon.

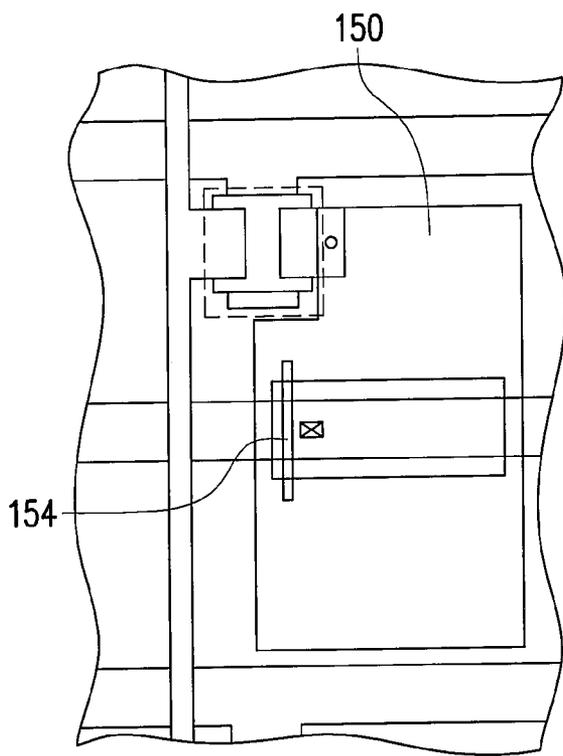
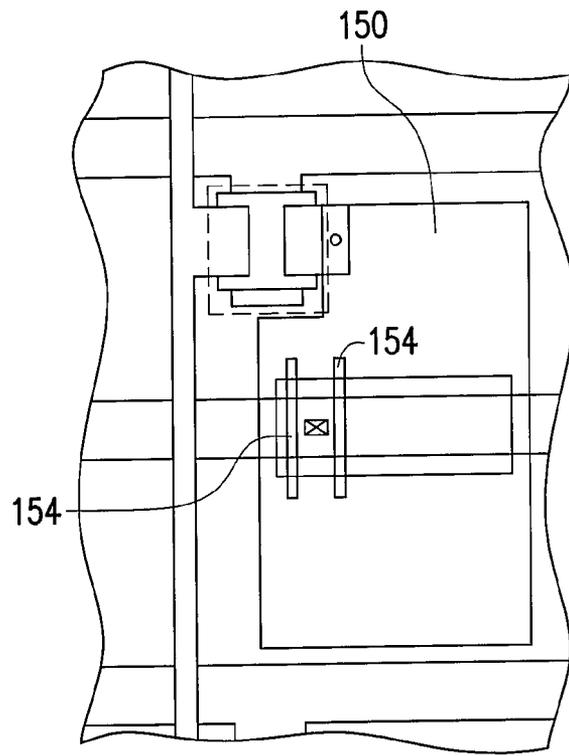
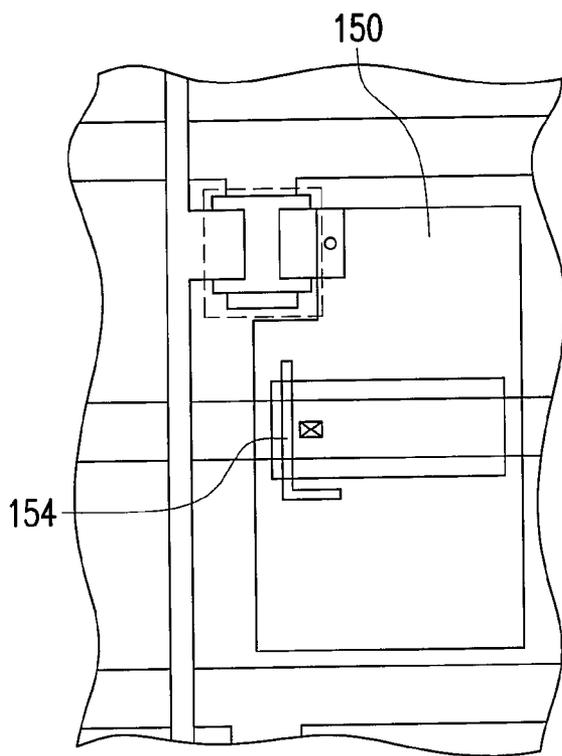
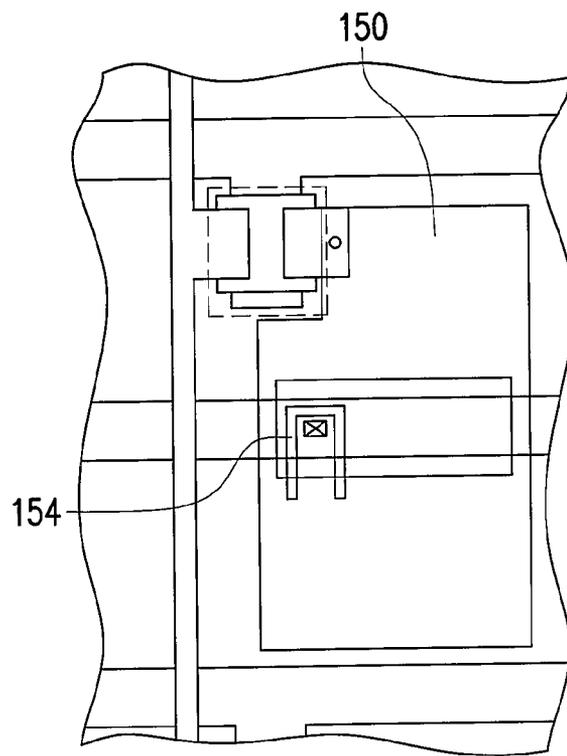
FIGS. 16A through 16D show the types of openings formed on the pixel electrode of a conventional thin film transistor array substrate.

FIGS. 16A through 16D show the types of openings formed on the pixel electrode of a conventional thin film transistor array substrate. To simplify and speed up the repairing process, one or more openings **154** are also formed over the thin film transistor array substrate in the process of fabricating the pixel electrode **150**. For example, a straight line opening **154** (as shown in FIG. 16A), a pair of straight line openings **154** (as shown in FIG. 16B), an L-shaped opening **154** (as shown in FIG. 16C) or a U-shaped opening **154** (as shown in FIG. 16D) are formed over the pixel electrode **150**. Since the openings **154** are similar to the openings disclosed in FIGS. 9A through 9D, detailed description is omitted.

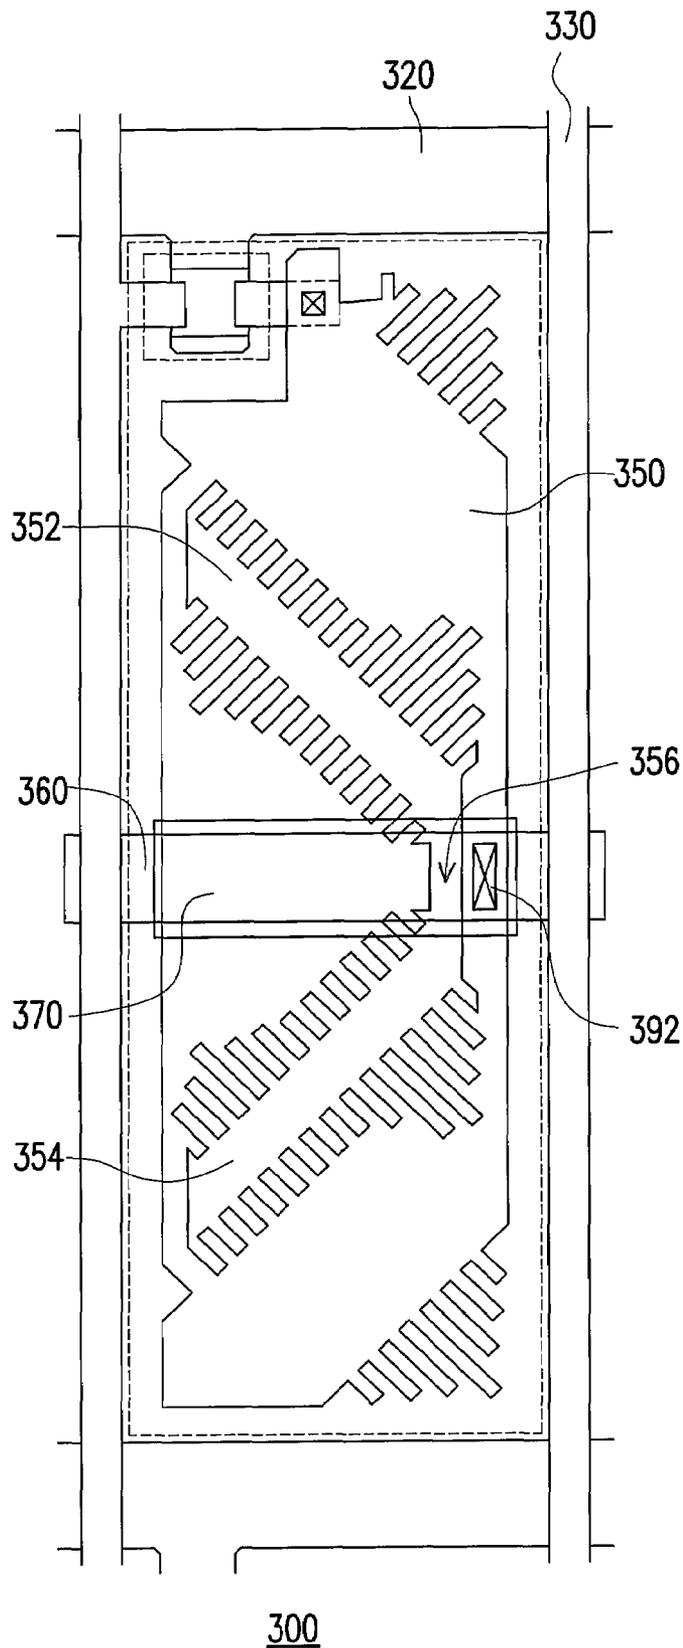
FIG. 17 is a top view showing a thin film transistor array substrate applied to a multi-domain vertical alignment liquid crystal display (MVA-LCD) according to yet another preferred embodiment of the present invention.

FIG. 17 is a top view showing a thin film transistor array substrate applied to a multi-domain vertical alignment liquid crystal display (MVA-LCD) according to yet another preferred embodiment of the present invention. The thin film transistor array substrate **300** in the present embodiment has a structure very similar to the thin film transistor array substrate disclosed in FIG. 1. Hence, only the dissimilar portions are described in the following.

The thin film transistor array substrate **300** has at least a first slit **352** and at last a second slit **354** disposed over each pixel electrode **350**. The first slit **352** extends in a direction different from the second slit **354** and the direction of exten-

sion of the first and the second slit **352**, **354** are different from the scan line **320**, the data line **330** or the common line **360**. In addition, a first slit **352** and one of the second slits **354** are connected together through a connecting area **356** when the first slits **352** and the second slits **354** are formed. The electrical contact area (the contact **392**) between the upper electrode **370** and the corresponding pixel electrode **350** are adjacent to the connecting area **356** between the first and the second slit. Furthermore, the upper electrode **370** and the corresponding common line **360** are coupled to form a capacitor.
