(10) **Patent No.:** **US 7,646,446 B2**
(45) **Date of Patent:** **Jan. 12, 2010**

(54) **REPAIRING METHOD OF A THIN FILM TRANSISTOR ARRAY SUBSTRATE**

(73) Assignee: **Au Optronics Corporation**, Hsinchu (TW)

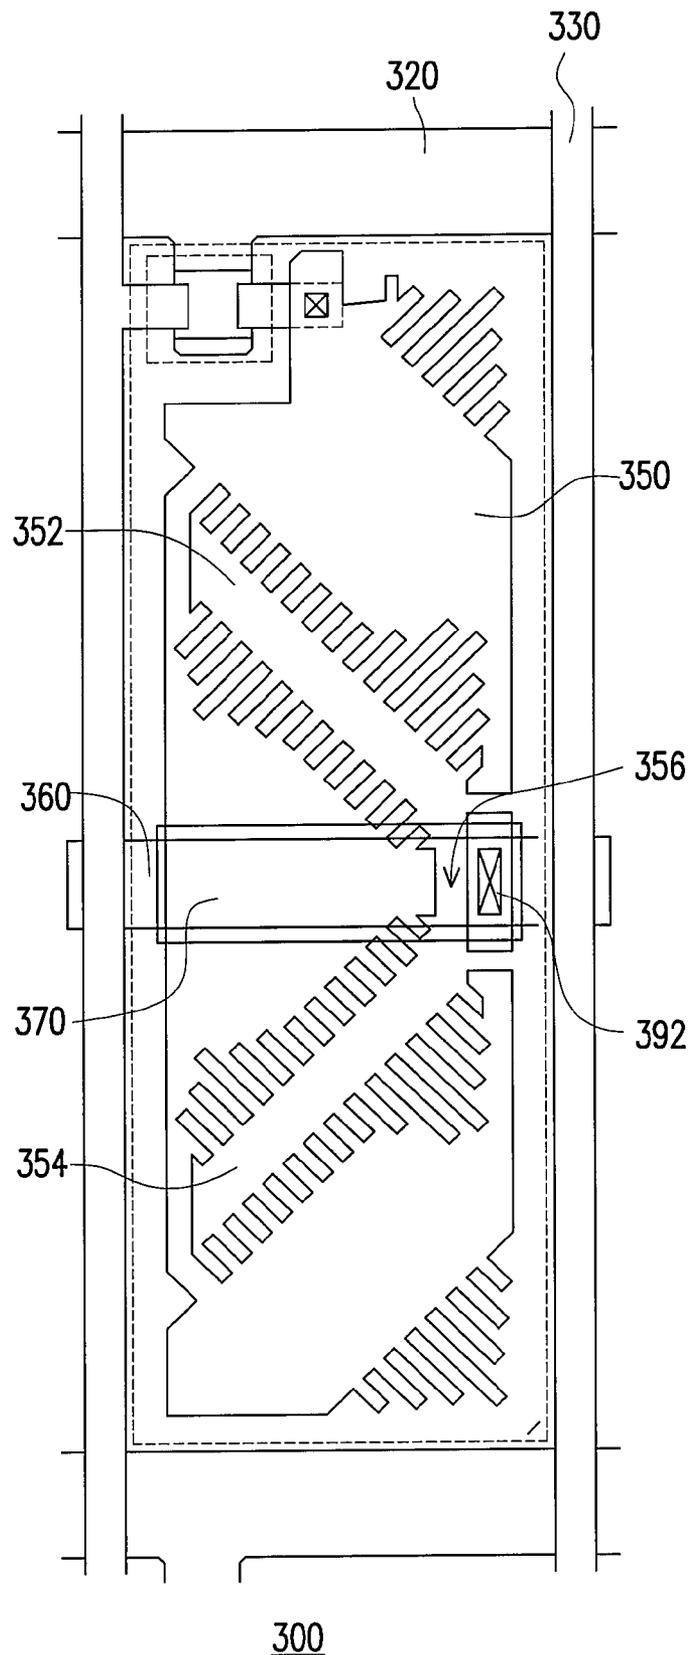
FIG. 18 is a top view of the thin film transistor array substrate of the MVA-LCD in FIG. 17 repaired according to the method of the present invention.

It should be noted a repair is required when a particle or defect is formed between the upper electrode **370** and one of the common lines **360** so that the upper electrode **370** and the common line **360** together form a defective capacitor. FIG. **18** is a top view of the thin film transistor array substrate of the MVA-LCD in FIG. **17** repaired according to the method of the present invention. The repairing method includes removing a portion of the pixel electrode **350** corresponding to the upper electrode of the defective capacitor. In the present embodiment, the portion of the pixel electrode **350** to be removed is the area around the electrical contact (the contact **392**) between the upper electrode **370** and the corresponding pixel electrode **350**. Thus, the upper electrode **370** of the defective capacitor and the corresponding pixel electrode **350** are electrically isolated. In other words, by removing a small portion of the pixel electrode **350** (a small area around contact **392**) covering the upper electrode **370**, the upper electrode **370** and the corresponding pixel electrode **350** of the defective capacitor are electrically isolated. Since only a small portion of the pixel electrode **350** covering the upper electrode **370** is removed in the present embodiment, a large capacitance can be maintained after the repair operation.

Thereafter, the upper electrode **370** and the corresponding common line **360** of the defective capacitor are welded together so that the upper electrode **370** and the corresponding common line **360** of the defective capacitor are at the same potential. Obviously, whether to weld the upper electrode **370** and the common line **360** of the defective capacitor together can be determined by the amount of leakage in the defective capacitor.
