(10) **Patent No.:** **US 9,194,843 B2**
(45) **Date of Patent:** **Nov. 24, 2015**

(54) **METHOD AND APPARATUS FOR MONITORING WIND TURBINE BLADES DURING OPERATION**

(71) Applicant: **Digital Wind Systems, Inc.**, West Conshohocken, PA (US)

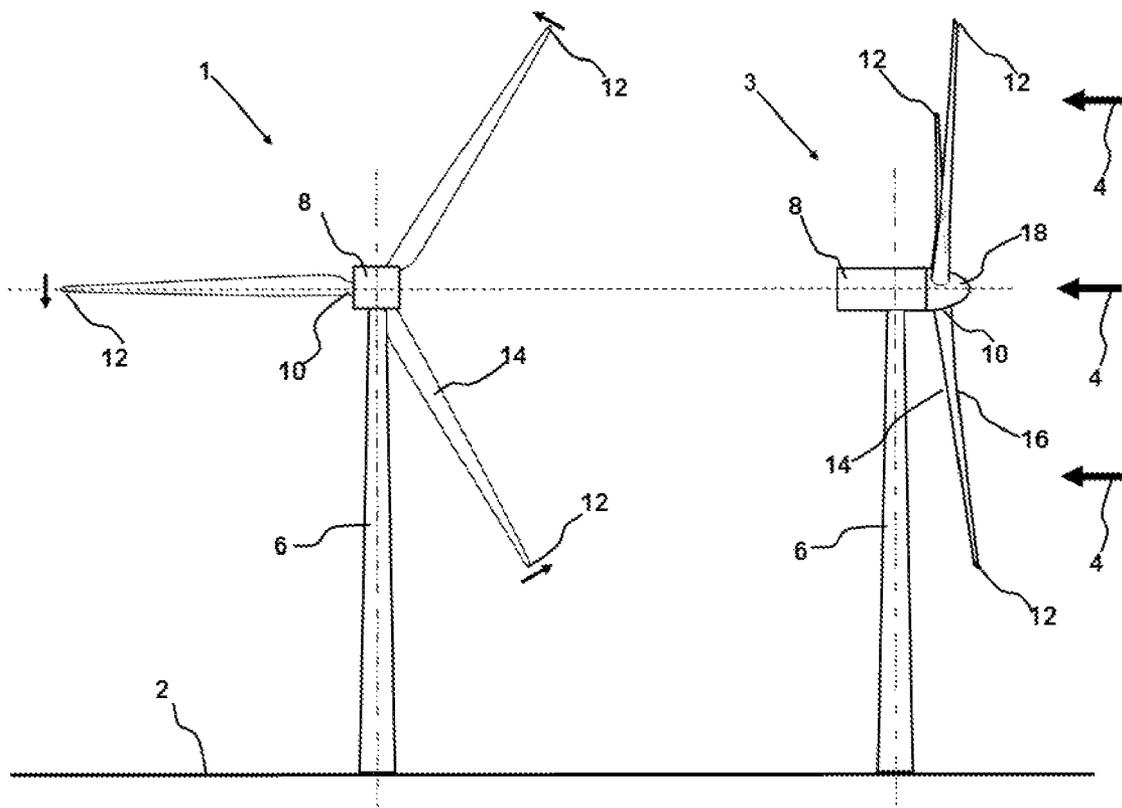
Fig. 1

FIG. 1 is a schematic representation of a utility scale, horizontal axis, wind turbine generator.

FIG. 1 is a schematic diagram of a HAWT that is typical of both land based and offshore turbine generators. The view 1 from behind the turbine facing the wind includes tower 6 extending up from the ground or ocean surface 2 to support the nacelle 8 which contains the generator and gear reducers, unless it is a direct drive generator. There are typically three blades on a utility scale wind turbine having root ends 10 and blade tips 21. As seen from the side view 2, the blade root ends attach to the rotatable hub 18. Blade side 16 facing the wind 4 is often referred to as the high pressure side. The blade side 14, facing away from the wind is referred to as the low pressure or suction side. As the blade speed increases the blade pitch is adjusted to the optimal angle of attack to the wind to create the maximum lift and torque required to drive the electricity generator.

Referring now to the drawings, wherein like reference numerals designate corresponding structure throughout the views, and referring in particular to FIG. 1, a wind turbine blade structural health monitoring system 1 according to a preferred embodiment of the invention is capable of continuously monitoring the structural health of both onshore and offshore power utility wind turbines for propagating defects or damage.

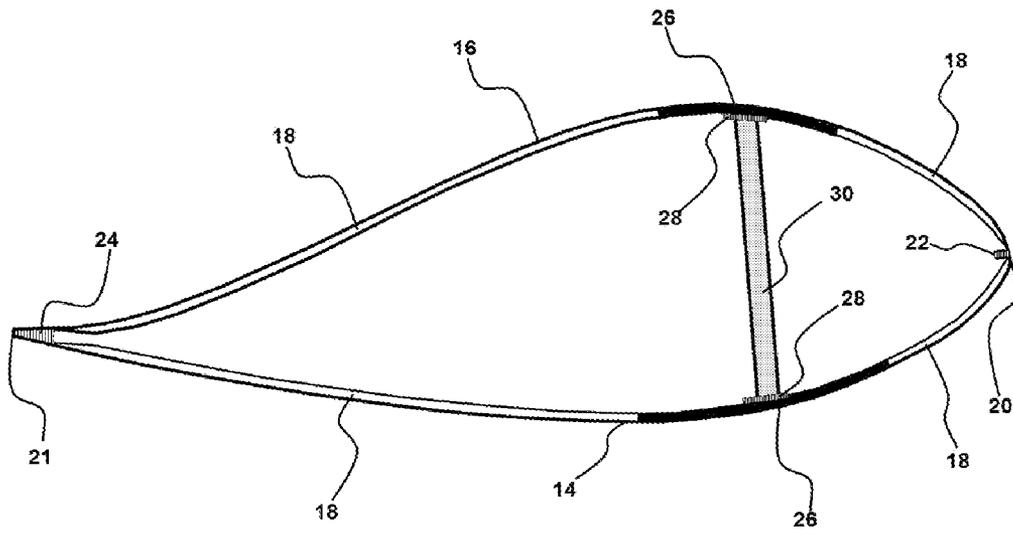
Fig. 2

FIG. 2 is a schematic representation of a wind turbine blade cross section.

FIG. 2 shows the construction cross section of a typical HAWT blade. Wind turbine blades are generally manufactured with adhesively bonded composite shells forming the high pressure side 16 and the low pressure side 14. The trailing edge 21 is adhesively bonded as is the leading edge 20, with adhesive bonding in some cases between two flanges 22 formed by the inner and outer fiberglass skins that make up sandwich panels 18. Two spar caps 26, which may be made from fiberglass or carbon fiber laminate are bonded to the edges of the sandwich panels 18. The blade spar web 30, which can be a solid fiberglass laminate or a sandwich construction with fiberglass or carbon fiber face sheets and a core material made with foam, balsa wood or other suitable material with high compressive strength. The spar web 30 is bonded with adhesive 28 to the spar caps 26 to form an I beam. Sometimes a second or even third spar web is present forming a box beam. Defects such as adhesive disbonds or unbonds present at the spar cap 26 to spar web 30 adhesive bond 28 may lead to catastrophic failure of the blade in service. Fiber waves in the solid spar cap 26 laminate can also lead to cracking and ultimately to blade failure. Further, trailing edge 21 splits or cracks in the high pressure 16 and low 14 pressure side shell adhesive bond 24 may be signs or excessive blade flex during operation. The trailing edge 21 adhesive bond 24, in the area of greatest blade chord width towards the root end 10 supports blade twist loads. Cracks and breaks in the adhesive bond 24 at these locations can also lead to blade failure unless detected in time and the turbine shut down and promptly repaired. When one of the reinforcing elements such as a glass or carbon fiber breaks, it makes a distinct sound, like a stick breaking. The sound propagates throughout the structure of the wind turbine blade, and throughout the enclosed space defined by the interior surface of the outer skin

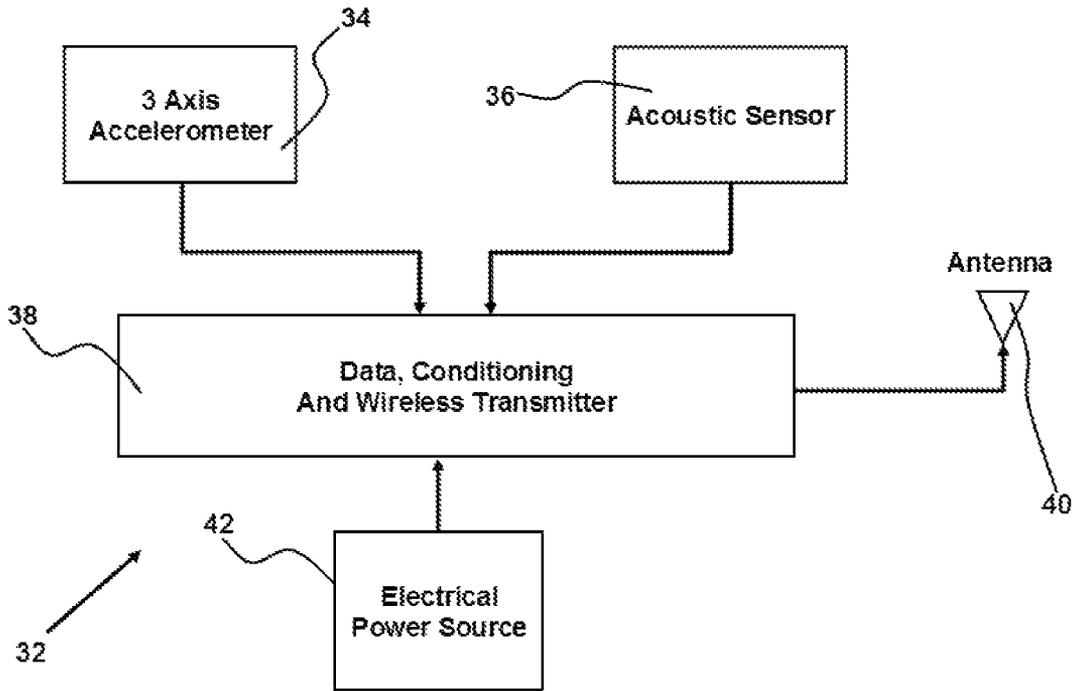
Fig. 3

FIG. 3 is a block diagram of the sensor package fitted to each blade bulkhead in accordance with an embodiment of the invention.

FIG. 3 is a block diagram of the blade mounted sensor device 32 that is installed in the root end 10 of each blade. The device 32 comprises a 3-axis accelerometer 34, an acoustic sensor 36, a data conditioning and formatting circuit 38 which includes a wireless transmitter with antenna 40. The acoustic sensor 36 is preferably coupled to the enclosed space defined within the wind turbine blade, and is preferably positioned at or proximate to the outermost end of the enclosed space. The device 32 is powered by a parasitic electricity generator and a rechargeable battery 42. The parasitic generator 42 extracts energy from the rotating turbine blade to which it is attached. The accelerometer 34, measures the angle of the blade it is attached to with respect to the gravity vector. When the blade is located at ninety degrees from the vertical, or $\pi/2$ radians, the force of gravity exerting torque on the blade is at its maximum, at 180 degrees, or π radians, the torque due to gravity is zero, and at 270 degrees, or $\pi/2$ radians, the torque is at its maximum negative value.

The position of each blade with respect to the gravity vector as determined by the accelerometer 34, may be used to correlate the position of the blade with the time when airborne acoustic emission signals are detected and to compare for each blade rotation phase angle when acoustic emission signals from each of the other two blades are detected. The blade data may be designed also that the serial number of each blade is encoded in the wireless data transmission allowing identification of the specific blade that producing signals that are out the acceptable range. The data in each sensor device may be transmitted continuously and simultaneously from each blade on different frequencies, in time sequential compressed packets or any other data transmission scheme designed to reduce both cost and power consumption requirements for power from generator 42.

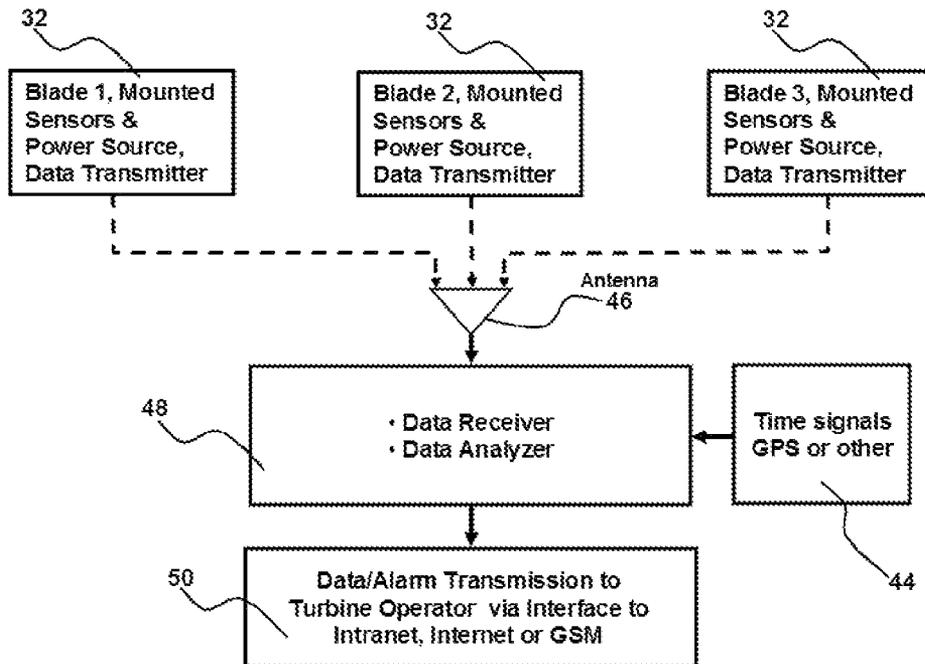
Fig. 4

FIG. 4 is a block diagram of the data receiver/analyzer mounted in the generator nacelle in accordance with an embodiment of the invention.

FIG. 4 is a block diagram of the tower or nacelle mounted data receiver and analyzer device 48. The purpose of this device is to receive data transmissions from the sensors 32 in each blade root end 10 by way of a wireless signal. Time signals provided by a GPS receiver or other source of accurate time signals, 44, are used to determine the timing of AE events and to allow comparison of acceleration signals from the 3 axis accelerometers 34, in each sensor package 32, to determine and compare the condition and performance each blade with respect to the others on the turbine. For example, continuously variable pitch blades have been recently introduced. The timing and amount of blade pitch changes for each blade can be measured during operation and anomalies detected. In addition, the data analyzer 48 use algorithms designed to detect the propagation of latent defects or damage to the blade and transmit the data to a central location, format and transmit an alarm or a report to the responsible entity by way of the intranet, the internet or by GSM cellular radio or other means of secure data transmission.

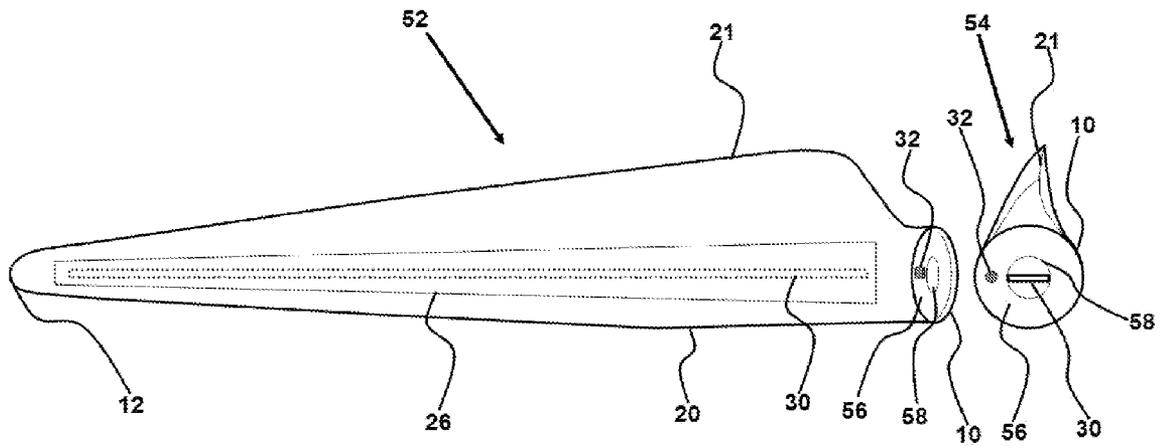
Fig. 5

FIG. 5 is an illustration of a wind turbine blade showing the sensor package mounting location on the root end bulkhead in accordance with an embodiment of the invention.

FIG. 5 shows the approximate location of the blade sensor device 32, mounted preferably on the end bulkhead 56, just inside the root end 10 of the blade 52. Usually this bulkhead 56 is plywood or fiberglass both of which are easy to drill and can be used to mount hardware using screws or other appropriate fasteners. The position of the sensor 32 should be medial with the spar web 30 to allow airborne acoustic emission signals from sources on both the leading edge 20 and trailing edge 21, to be received by the sensor 60 and on either side of the access hole 58 in bulkhead 56. To install the sensor,

a workman climbs into the turbine hub 18, a regular maintenance procedure to reach the blade pitch actuators for servicing. A hole is drilled through bulkhead 56 to allow the microphone components of the sensor package 32 to receive acoustic signals originating from inside the blade 52. In operation, sensor package 32 is powered by a small parasitic electricity generator using any one of a variety of technologies available including weighted piezoelectric generator, weighted pendulum on a small generator or alternator and a falling magnet and coil designed to extract energy from the rotating turbine using gravity.

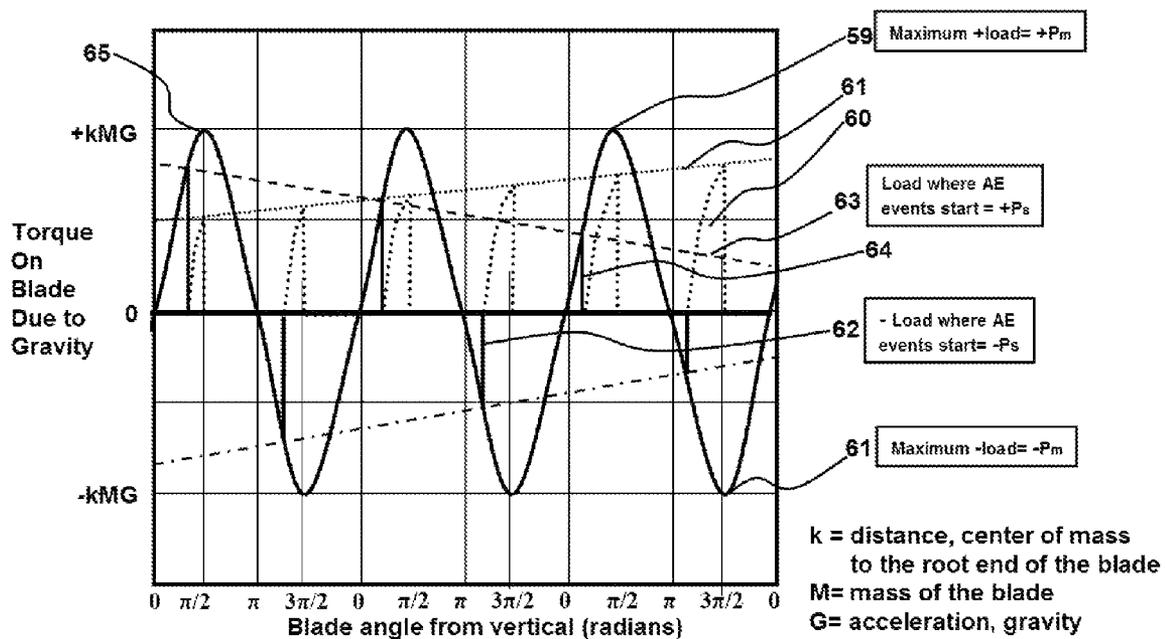
Fig. 6

FIG. 6 is graphical plot showing the relationship between blade angle, torque on the blade, the onset of acoustic emission signals and the increasing amount of AE signals and decreasing Felicity ratio expect of a blade with propagating defects.

FIG. 6 is a schematic diagram showing the relationship between the blade angle α from the vertical position, and the torque acting on the blade during rotation of the turbine. The output 60 of one channel of the 3 axis accelerometer sensor 34 in sensor package 32 which is detecting the gravity vector. The accelerometer detects the acceleration due to the gravity vector which, over time, is a sine wave varying in frequency with the period of the turbine. With the blade point straight up at a blade angle of 0 radians from the vertical, the torque load due to gravity on the blade is 0. The torque can be represented by the equation $T=kM \sin \alpha G$, where k is the distance from the center of mass of the blade to the blade root end, M is the mass of the blade, G is the acceleration due to gravity and α is the angle of the blade from the vertical position. The torque acting on the blade peaks at 90 degrees from the vertical or $\pi/2$ radians and again at 270 degrees from the vertical at $\pi/2$, 66 and 68. These peak loads are in the opposite direction, effectively imparting a reversing fatigue load on the blade. Acoustic emission signals may be generated as the positive and negative loads cycle during blade revolution.

Also shown is the increasing number 72 and 76, of acoustic emission events over time emanating from the propagation of defects within the blade. In addition, also shown is the decreasing load level or torque 70 and 74 acting on the blade where acoustic emission events begin as compared to previous loads in the turbine rotational cycle. This effect, known as the Felicity ratio is defined as $(F_R)=\text{Load}$ where AE start to occur on a successive stress cycle/Maximum Load during the previous stress cycle. As cracks begin to propagate over time due to the cyclic gravitational loading of the blade the number of acoustic emission events per blade revolution, 72 & 76 increases. Further, the stress or load level at which AE starts is slightly reduced for each revolution as the stress becomes concentrated in the crack tips. This reduction in the Felicity ratio over time, 78, as well as the increase in the number of AE events per revolution or during equal number of revolutions over time, 80, may be used as a trigger to alert signal to the wind generator owner/operator that a defect is growing and the blade requires attention. Comparison of the AE signal

rates between blades may also be used to detect an outlier blade with the onset of propagating damage prior to a catastrophic failure.

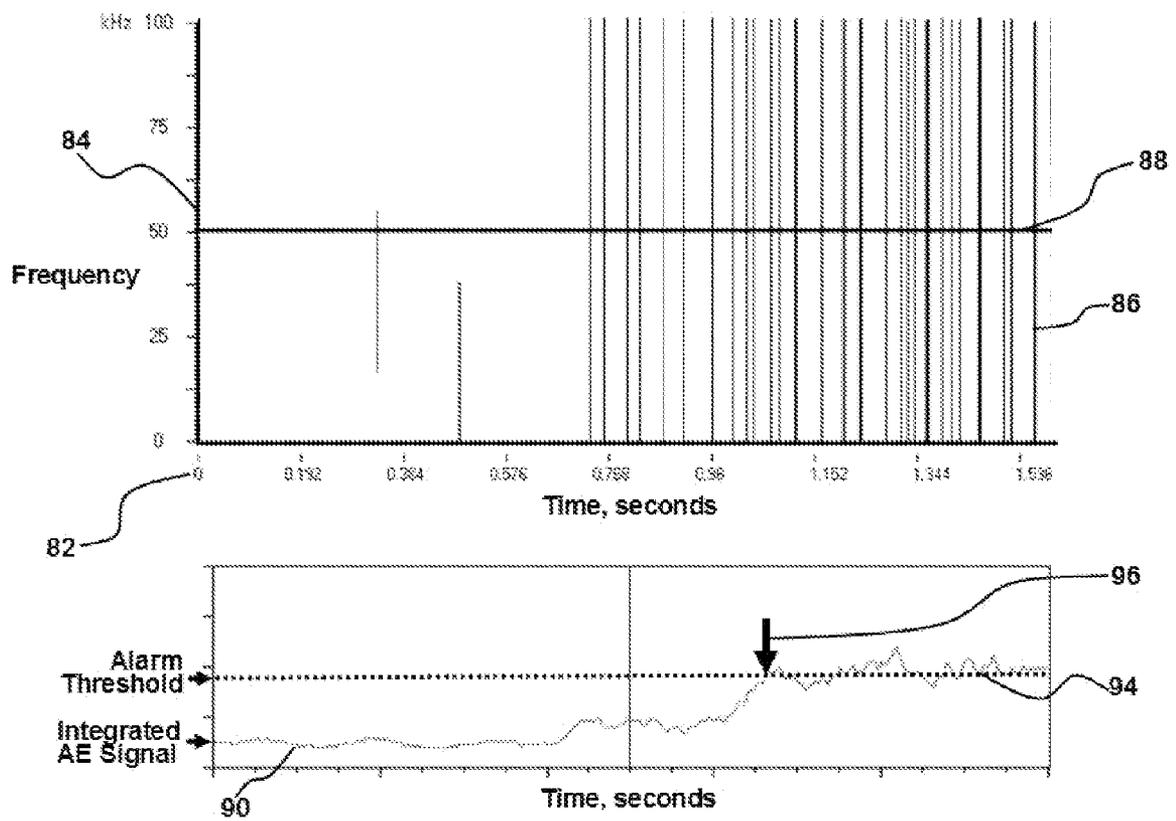
Fig. 7

FIG. 7 shows two graphical plots of acoustic emission signal increasing in time and an alarm threshold.

FIG. 7 shows a plot of airborne acoustic emission events **86**, recorded at the onset of loading a wind turbine blade section during a fatigue test. This plot may be similar to one showing AE signals emitted from a blade as it moves from a "no load" position at the 0 radian to the $\pi/2$ position where the blade experiences maximum load due to gravity. The signals can be filtered by frequency to eliminate sounds from actuators and machinery. As shown, a High Pass frequency filter **88**, is set to pass only signals above 50 kHz. The AE signals, while having a short duration measured in microseconds are representative of the release of energy. Summing the area under the signals waveform and plotting the resulting curve yields a representation of the strain energy release **90**, over time. An alarm threshold **94**, can be set which can be used to trigger an alarm **96**, or as a data point along with other measurements to trigger an alarm.

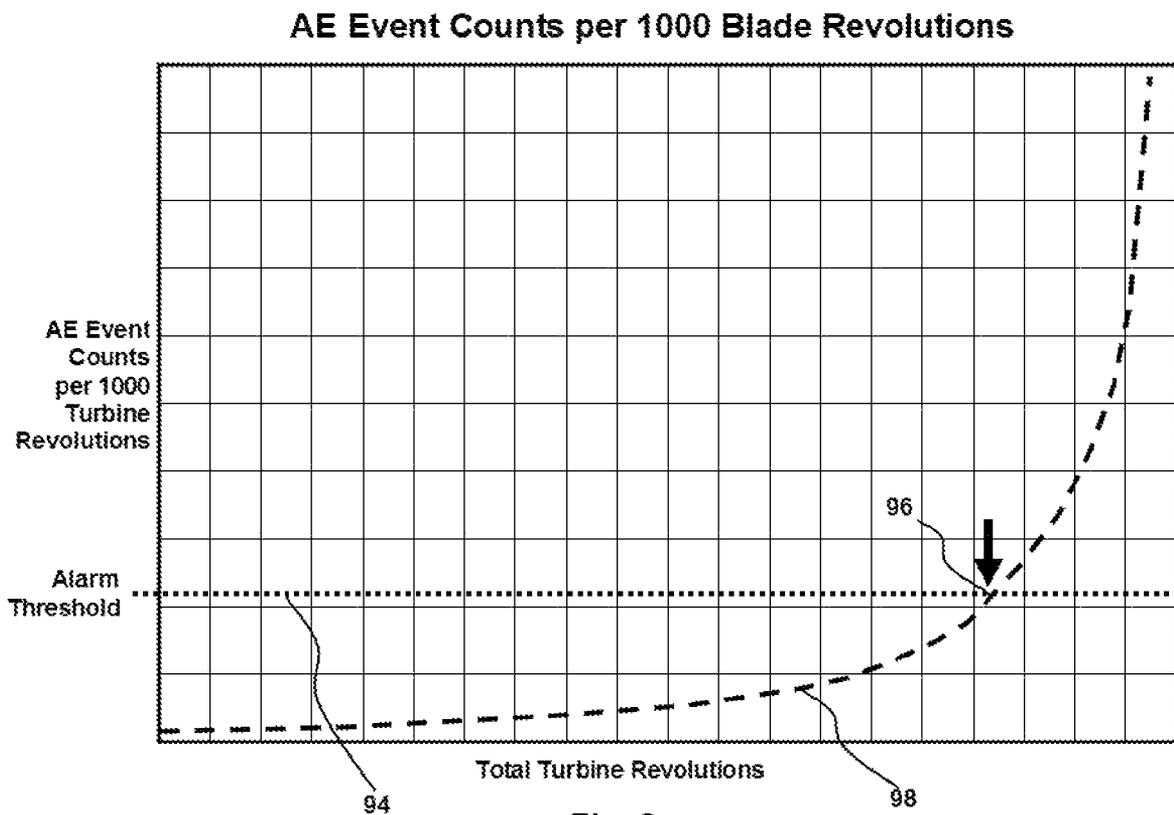
Fig. 8

FIG. 8 is a graphical plot showing the increasing acoustic emission event count per 1000 turbine revolutions as latent defects or damage propagate inside a blade. An alarm threshold is set to trigger an alert when the rate exceeds a threshold level.

FIG. 8 shows a second plot of AE events per 1000 blade rotations. If latent defects or damage to a blade is great enough, stress risers will cause the defect to grow and ultimately fail. The quantity of AE signals **98**, increases as the area of the defect(s) increases over time. Eventually the blade fails. An alarm level **96**, is set for a specific count/1000 revolutions.
