(54) **DISPLAY AND METHOD FOR REPAIRING DEFECTS THEREOF**

(73) Assignee: **Fujitsu Display Technologies Corporation**, Kawasaki (JP)

# DISPLAY AND METHOD FOR REPAIRING DEFECTS THEREOF

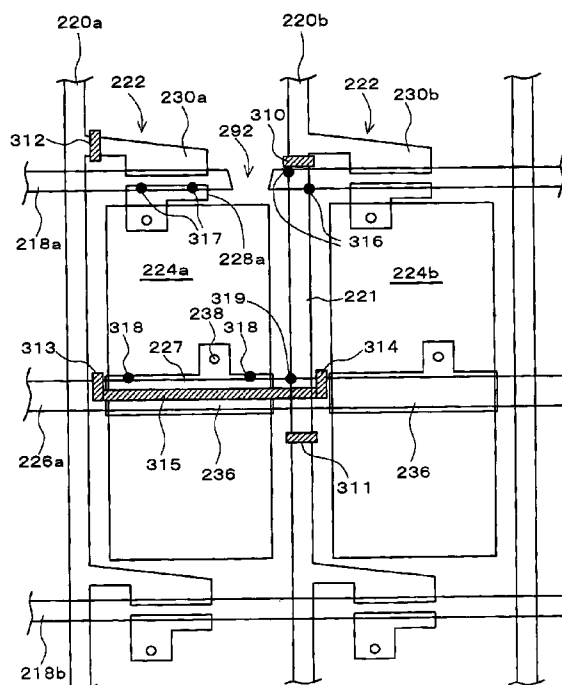
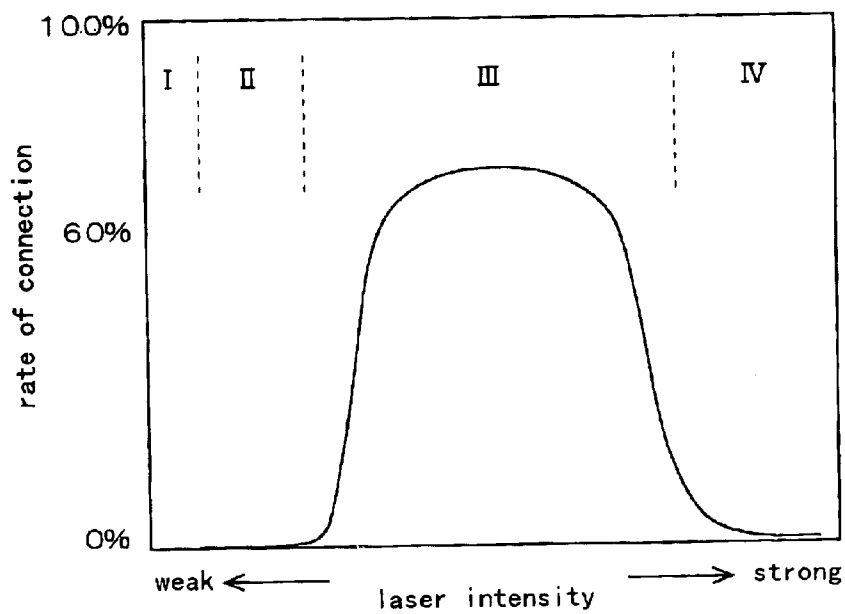
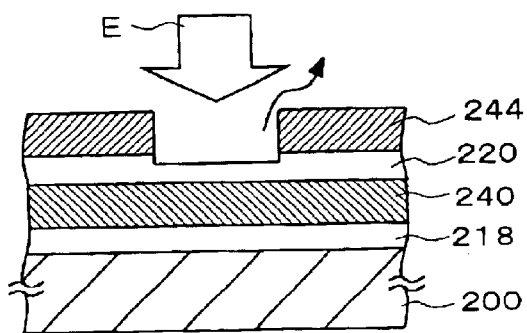
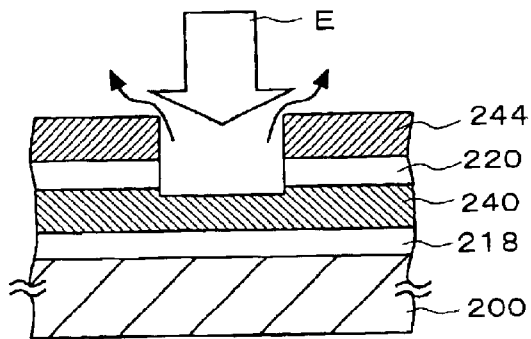
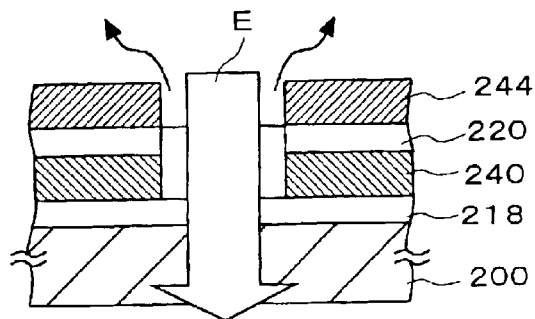
FIGS. 1a through 1e show the relationship between the output intensity of a YAG laser used for a repair and states of two metal layers vertically stacked with an insulation film interposed therebetween. FIG. 1a is a graph whose abscissa axis represents the output intensity of the laser and whose ordinate axis represents the rate of connection between the two metal layers. The output intensity of the laser is divided into four stages or ranges I through IV based on the rate of connection between the two metal layers. FIGS. 1b through 1e are sectional views of the substrate showing states of the two metal regions in the respective four stages or ranges I through IV of the output intensity of the laser divided based on the graph of FIG. 1a.

In the substrate to be repaired shown in FIGS. 1b through 1e, gate bus lines 218 (or storage capacitor bus lines 226) are formed as a first metal layer (conductive layer) on a TFT substrate 200 constituted by a 0.7 mm thick glass substrate,

When a defect attributable to an inter-layer short-circuit **290** occurs at a certain drain bus line **220**, a region **304** where the drain bus line **220** and the repair line **302** intersect with each other is irradiated with a laser beam to fuse those wiring metals together, which establishes connection and conduction. Referring to conditions for the laser irradiation at such a repair, the laser must have intensity as shown in FIG. **1d** which will be described later.

FIGS. **1a** through **1e** illustrate a method for repairing a defect in a display according to a first mode for carrying out the invention.

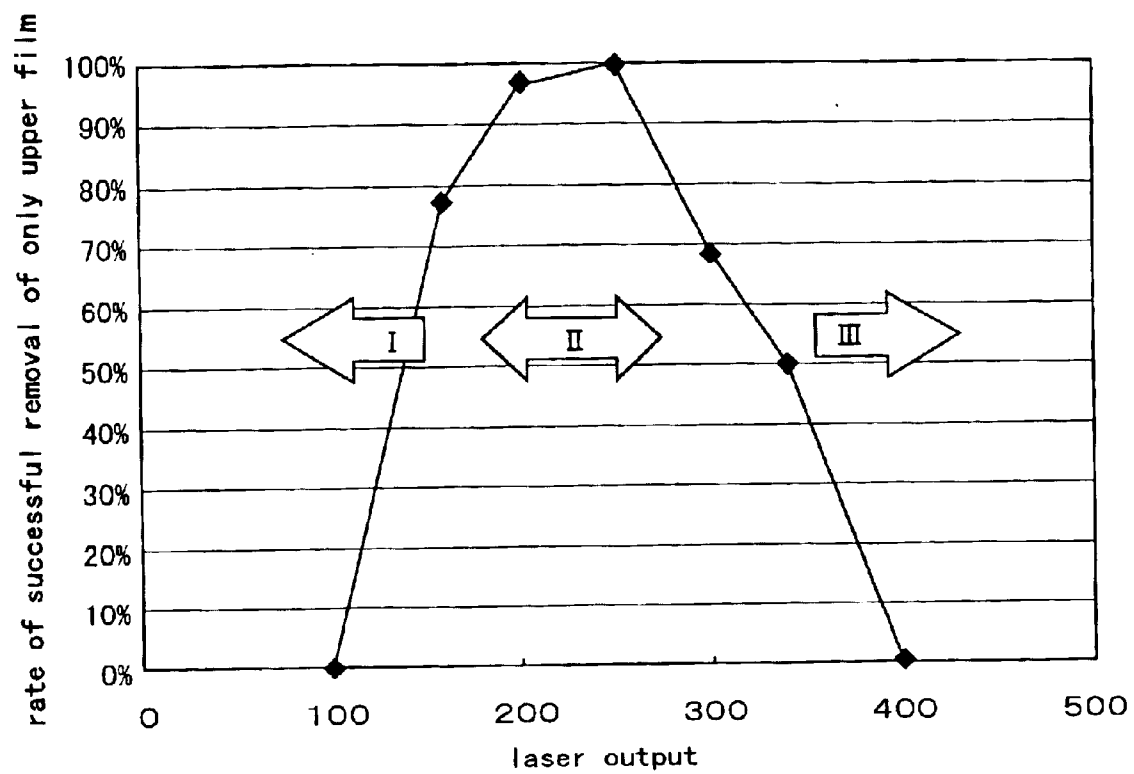
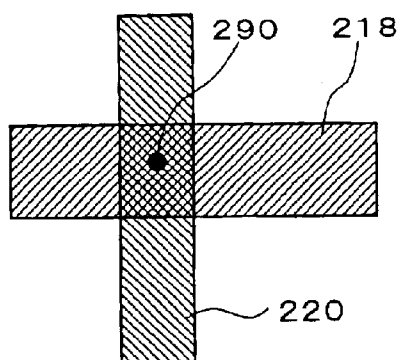
A description will now be made with reference to FIGS. **3a** and **3b** on an example in which an inter-layer short-circuit is repaired by performing irradiation with a laser using the range IV. FIG. **3a** shows a state of the surface of the TFT substrate **200** in which there is an inter-layer short-circuit **290** substantially in the middle of an intersection between a gate bus line **218** and a drain bus line **220**. In this case, the inter-layer short-circuit **290** is irradiated with a laser beam having output intensity within the range IV. In doing so, the laser beam is projected through a slit S for limiting the beam within a region to be irradiated that encloses only the inter-layer short-circuit **290** in order not to break the drain bus line **220** and gate bus line **218**. While the drain bus line **220** and gate bus line **218** are connected when the intensity of the laser beam is low and is actually at the level of the range III, the connection can be broken with an increased probability by performing irradiation again with the slit S adjusted to enlarge the irradiated region slightly. Further, the repair can be performed reliably and easily by repeating the irradiation with a laser beam until the resistance of the short-circuit sufficiently increases while measuring the resistance using a tester or the like. FIG. **3b** shows a state realized after the inter-layer short-circuit **290** is repaired. The inter-layer short-circuit **290** has been eliminated and replaced by a hole having a configuration substantially the same as the slit S which extends to the surface of the glass substrate, and no short-circuit has occurred between the drain bus line **220** and gate bus line **218**.

FIGS. **3a** and **3b** illustrate an example in which an inter-layer short-circuit is repaired by performing irradiation

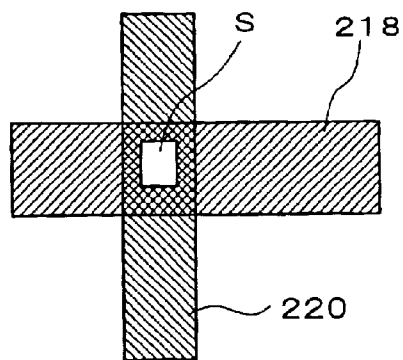
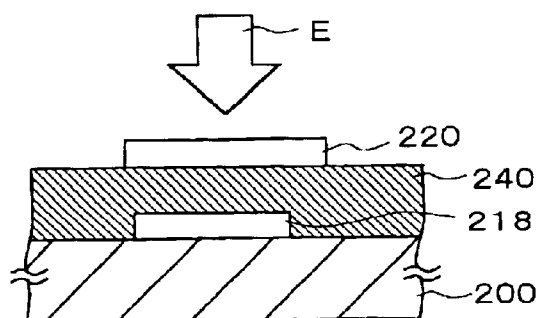
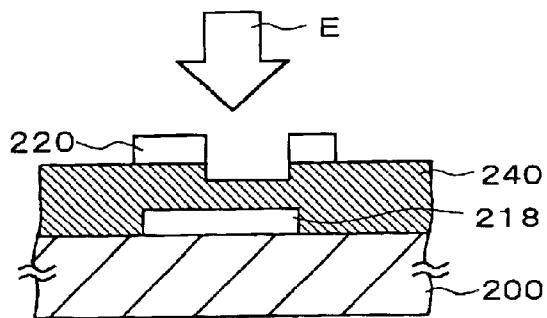
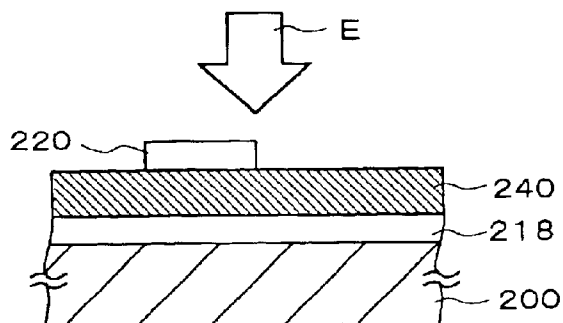
A description will now be made with reference to FIGS. **4a** through **4d** and FIGS. **5a** through **5c** on an example in which an inter-layer short-circuit is repaired by performing irradiation with a laser using the range II. FIGS. **4a** through **4d** are sectional views of the TFT substrate **200** showing states in which a gate bus line **218** is formed on the TFT substrate **200** and in which a drain bus line **220** intersects the same with a gate insulation film **240** interposed therebetween.

FIGS. **4a** and **4b** show proper laser irradiation using the range II according to the present mode for carrying out the invention, and FIGS. **4c** and **4d** show an example of improper laser irradiation which is not in accordance with the present mode for carrying out the invention.

FIGS. 4a through 4d illustrate an example in which an inter-layer short-circuit is repaired by performing irradiation with a laser using a range II according to the method for repairing a defect in a display in the first mode for carrying out the invention.

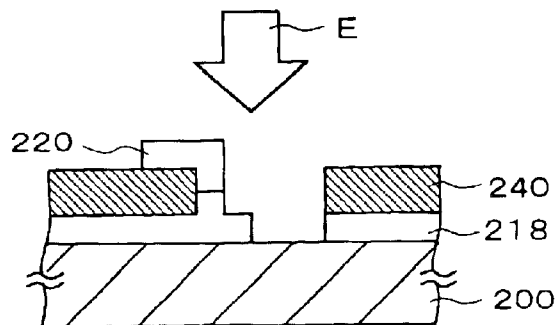
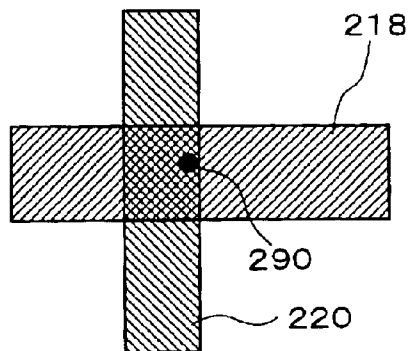
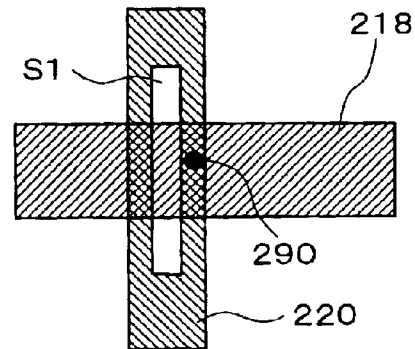
A description will now be made with reference to FIGS. 5a through 5c on an example in which an inter-layer short-circuit is repaired by performing irradiation with a laser using the range II. FIG. 5a shows a state of the surface of the TFT substrate 200 in which there is an inter-layer short-circuit 290 in the vicinity of an edge of a drain bus line 220 at an intersection between a gate bus line 218 and the drain bus line 220.

A laser beam irradiation apparatus for a repair according to the related art can irradiate an object by adjusting a slit S having a rectangular irradiating area to change the size of the irradiating area. Therefore, as described with reference to FIGS. 4a through 4d, laser irradiation having an output within the range II is carried out as a first cycle of laser irradiation by forming a slit S1 in a region where the drain bus line 220 completely covers the gate bus line 218. As a result of this laser irradiation, a cut portion longer than the width of the gate bus line 218 is formed adjacent to the inter-layer short-circuit 290 such that it splits the intersecting portion of the drain bus line 220 into two parts, as shown in FIG. 5b. Next, as shown in FIG. 5c, slits S2 and S3 are respectively used for second and third cycles of laser irradiation with an output within the range II to cut the drain bus line 220 at both ends of the cut portion (indicated by S1), thereby isolating the inter-layer short-circuit 290 of the drain bus line 220. The order of laser irradiation may be the reverse of that described above.

FIGS. 5a through 5c illustrate an example in which an inter-layer short-circuit is repaired by performing irradiation with a laser using a range II according to the method for repairing a defect in a display in the first mode for carrying out the invention.

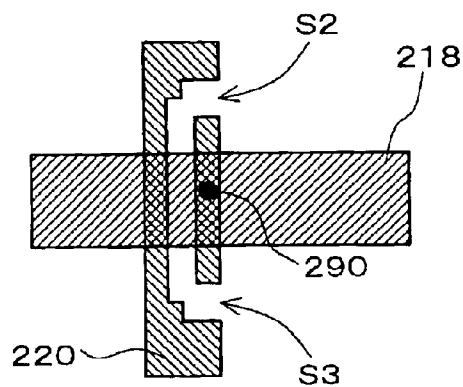
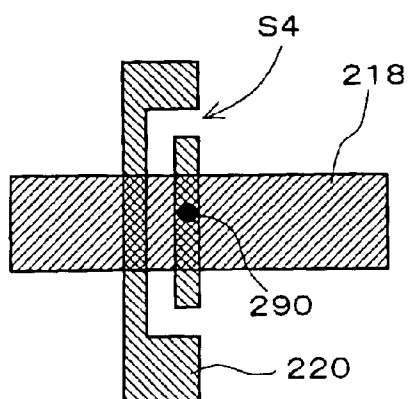
As shown in FIGS. 6a and 6b, the use of a U-shaped slit (see S4 in FIG. 6a), an arcuate slit (see S5 in FIG. 6b) or the like will make it possible to complete a repair of a defect in one cycle of laser beam irradiation.

FIGS. 6a and 6b illustrate a modification of the example of a repair of an inter-layer short-circuit by performing irradiation with a laser using a range II according to the method for repairing a defect in a display in the first mode for carrying out the invention.

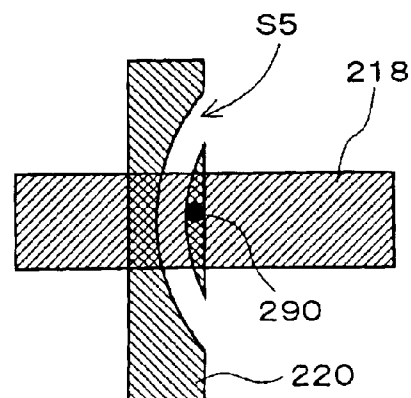
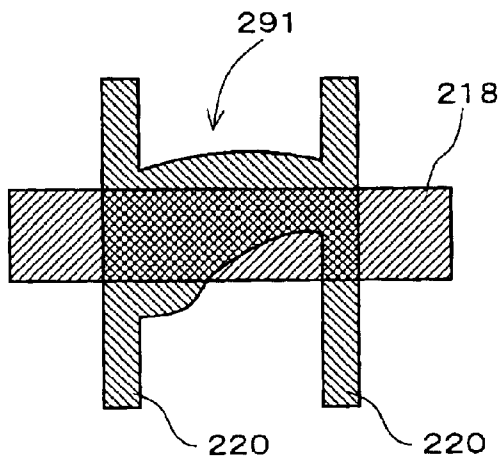
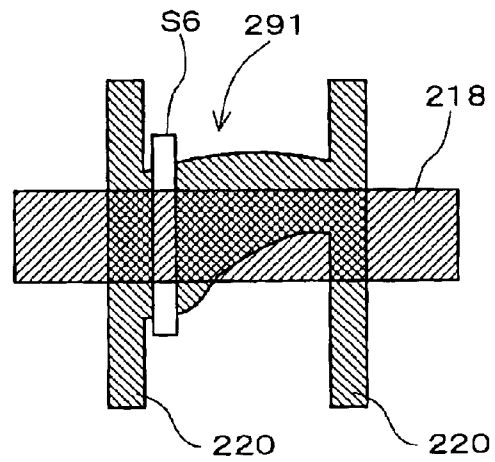
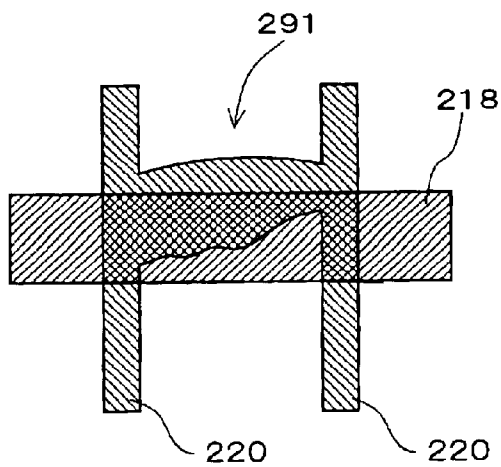
A description will now be made with reference to FIGS. 7a through 7d on examples in which a short-circuit in a single layer is repaired by performing irradiation with a laser using the range II. FIG. 7a shows a state of the surface of the TFT substrate 200 in which there is a short-circuit 291 between two drain bus lines 220 in the same layer in the vicinity of intersections between a gate bus line 218 and the drain bus lines 220. In the example shown in FIG. 7a, the short-circuit 291 in the same layer completely covers the gate bus line 218 in the vicinity of the region thereof connected to the drain bus line 220 on the left side. Therefore, a slit S is focused on the same region, and laser irradiation having an output within range II is performed with the shape of the slit S adjusted such that the short-circuit 291 in the same layer is cut along the drain bus line 220. As shown in FIG. 7b, this laser irradiation makes it possible to break the short-circuit 291 in the same layer in the region of a slit S6, thereby eliminating the short-circuit between the two drain bus lines 220 without irradiating the gate bus line 218 in the underlying layer with a laser beam.

FIGS. 7a through 7d illustrate an example in which a short-circuit in a single layer is repaired by performing irradiation with a laser using a range II according to the method for repairing a defect in a display in the first mode for carrying out the invention.

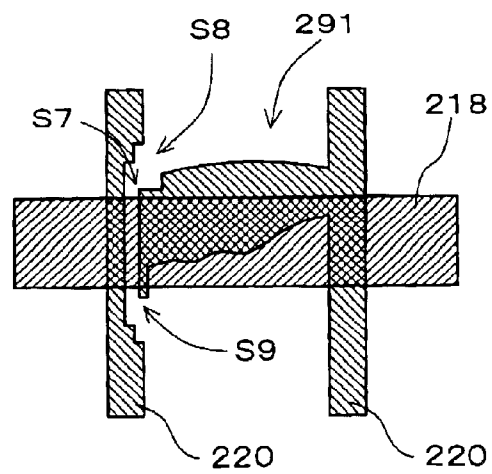
FIG. 8 shows a plurality of pixel regions as seen when the substrate surface is viewed from above, each of the pixels having the same structure as that shown in FIGS. 32a through 32c. In FIG. 8, a gate bus line 218a that horizontally extends substantially in the middle of the figure is broken at a broken portion 292.

This establishes electrical connection between the source electrode **228a**, pixel electrode **224a**, second isolated line **227** and first isolated line **221**. One end of the broken gate bus line **218a** is electrically connected to the source electrode **228a**, and the other end is electrically connected to the first isolated line **221**. Therefore, the gate bus line **218a** is capable of supplying a gate pulse to pixel regions other than the pixel region where the halved pixel electrode **224a** is located. The drain bus line **220b** broken to form the first isolated line **221** can be relieved using a repair line similar to that in the related art to drive all pixels connected to the drain bus line **220b** properly.

Thus, the present mode for carrying out the invention makes it possible to repair a breakage in a gate bus line at the sacrifice of only one pixel in total.

FIG. 8 schematically illustrates a first embodiment of a method for repairing a defect in a display in a second mode for carrying out the invention.

The present mode for carrying out the invention is characterized in that a bypass for a broken portion 292 of a gate bus line 218 is formed by separating or connecting it from or to a drain electrode 230 or a source electrode 228 of a TFT or a pixel electrode 224 or a storage capacitor bus line 226 which is formed above the gate bus line 218 with an insulation film 240 interposed through local irradiation with a laser beam, thereby allowing the broken portion 292 of the gate bus line 218 to be repaired.

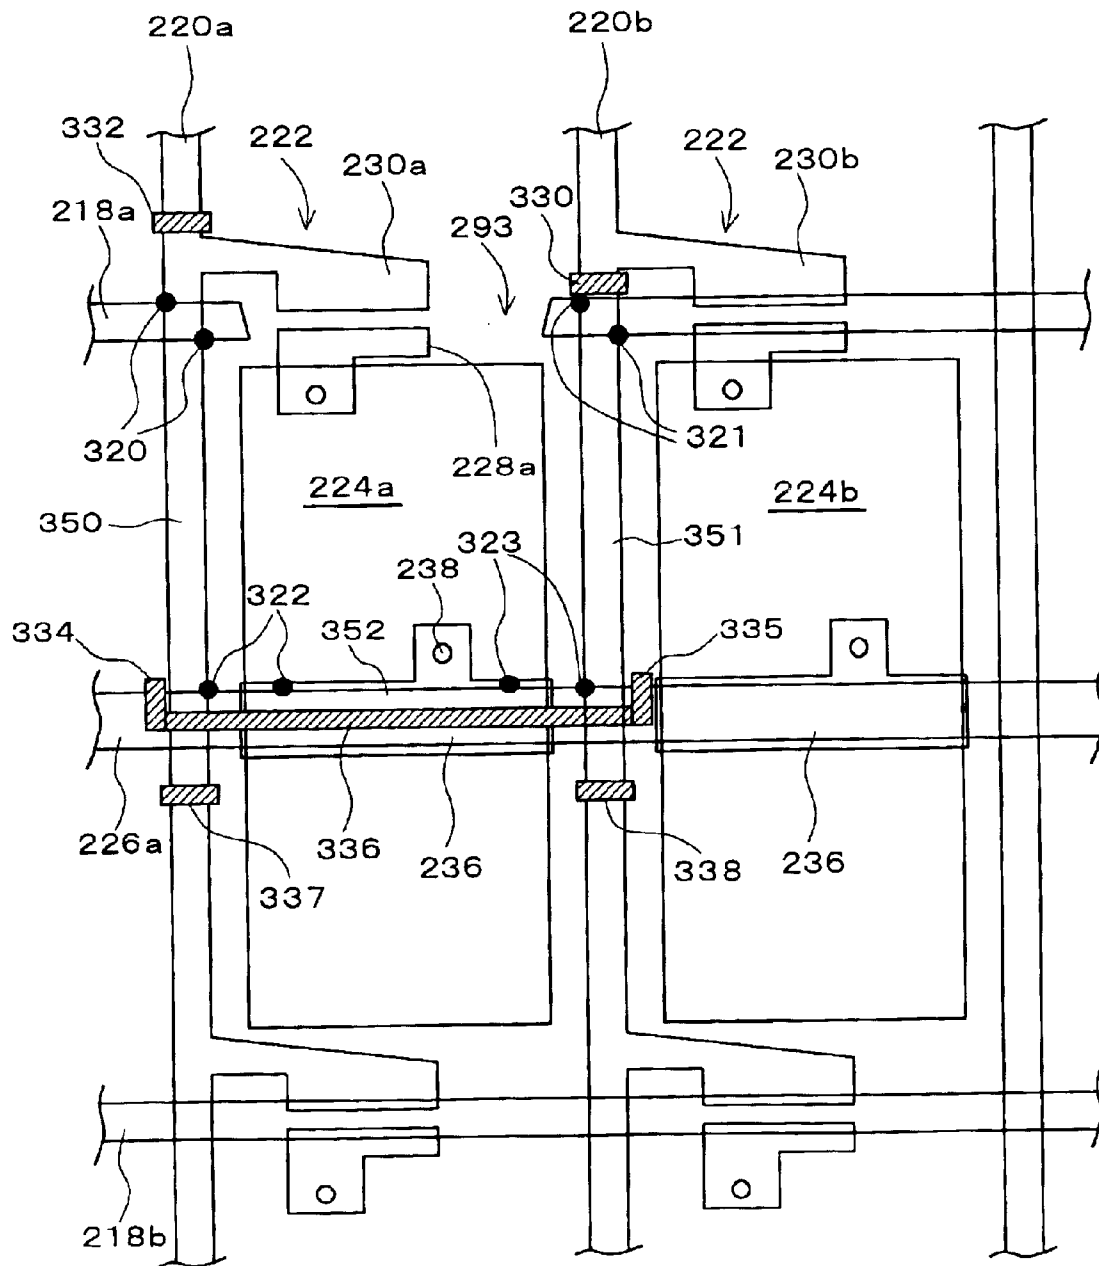
FIG. 10 shows a plurality of pixel regions as seen when the substrate surface is viewed from above, each of the pixel regions having the same structure as that shown in FIG. 8. In FIG. 10, a gate bus line 218a horizontally extending substantially in the middle of the figure is broken at a broken portion 293 under a drain bus line 220b.

This establishes electrical connection between the source electrode 228a, pixel electrode 224a, second isolated line 354 and first isolated line 352. One end of the broken gate bus line 218a is electrically connected to the source electrode 228a, and the other end is electrically connected to the drain electrode 230b which is connected to the first isolated line 352. Therefore, the gate bus line 218a is capable of supplying a gate pulse to pixel regions other than the pixel region where the halved pixel electrode 224a is located and the pixel region with the drain electrode 230b connected to the first isolated line 352. The drain bus line 220b broken to form the first isolated line 352 can be relieved using a repair line similar to that in the related art to properly drive pixels connected to the drain bus line 220b other than the pixel with the pixel electrode 224b.

Thus, the present mode for carrying out the invention makes it possible to repair a breakage in a gate bus line at the sacrifice of only two pixels in total.

FIG. 10 schematically illustrates a third embodiment of a method for repairing a defect in a display in the second mode for carrying out the invention.

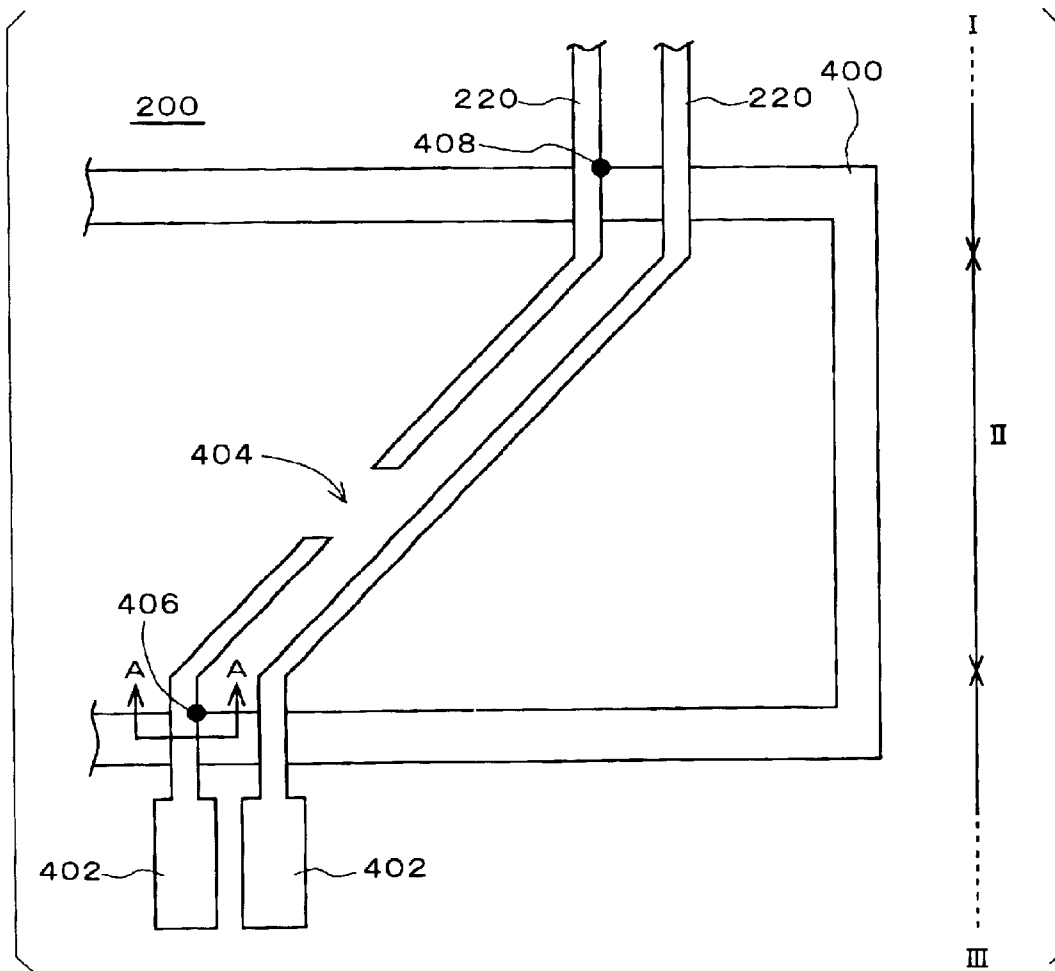
As shown in FIG. 12, the repair line 400 is formed from a metal that is used to form gate bus lines at the same time when the gate bus lines 218 are formed on the TFT substrate 200. The repair line 400 forms a multi-layer structure in combination with the drain bus lines 220 with a gate insulation film 240 interposed between them, and it is electrically insulated from the plurality of drain bus lines 220.

FIG. 12 schematically illustrates the first embodiment of a method for repairing a defect in a display in the third mode for carrying out the invention.

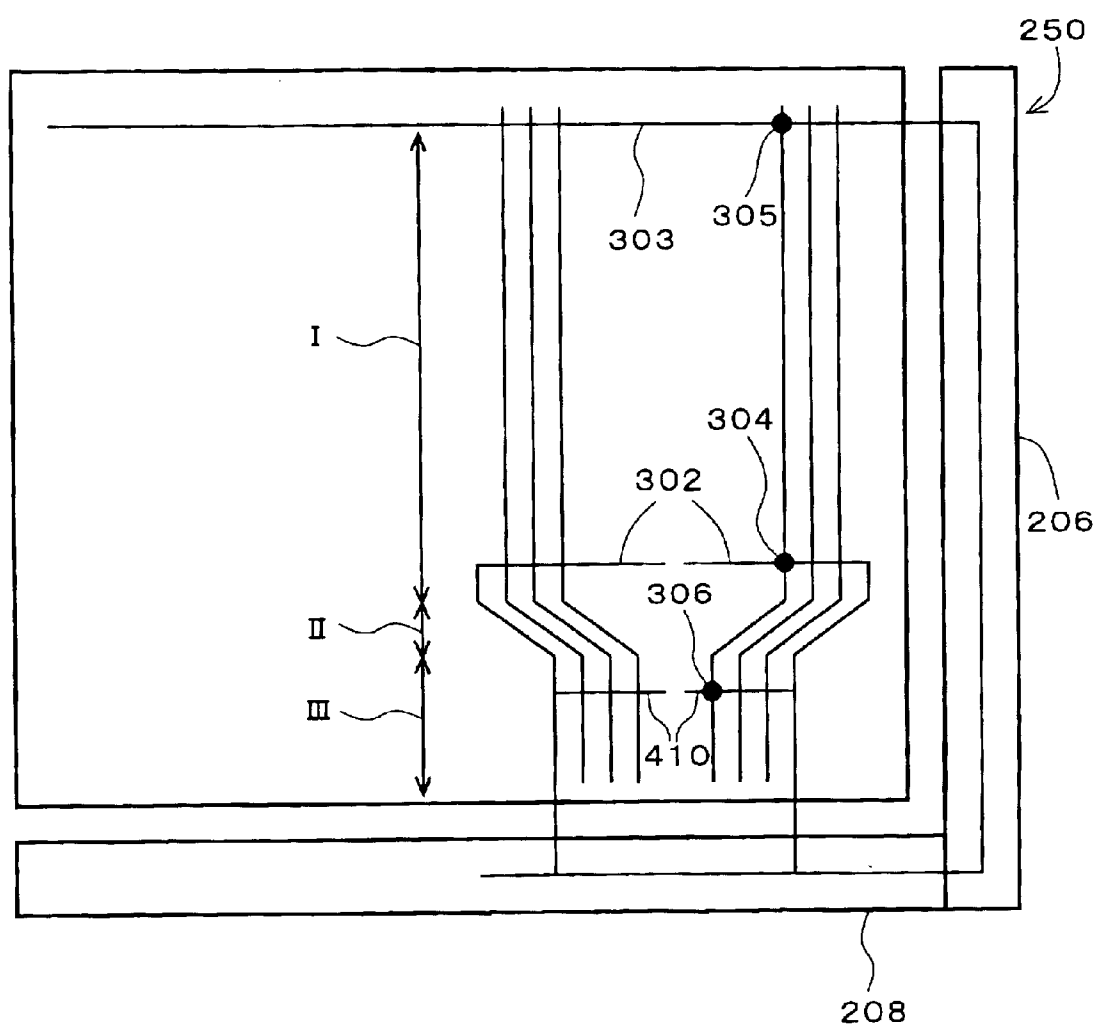
A description will now be made with reference to FIG. 14 on a repair of a short-circuit 412 in a single layer between adjoining drain bus lines 220 utilizing a repair line 400 according to the present embodiment. As shown in FIG. 14, when a short-circuit 412 in a single layer occurs at a location where a sealing material 418 is applied to put two substrates together, the sealing material 418 hinders the short-circuit 412 in the single layer from being cut as a result of direct irradiation with a laser beam. In this case, one of the drain bus lines 220 is cut at the cutting positions 414 and 416 which can be irradiated by a laser beam. Then, regions 406 and 408 where the drain bus line 220 intersects the repair line 400 are irradiated with a laser beam to fuse the drain bus line 220 and repair line 400 together, thereby shorting them. Thus, a short-circuit in a single layer between the drain bus lines 220 at the extraction wiring portion II can be easily repaired.

FIG. 14 schematically illustrates another modification of the first embodiment of a method for repairing a defect in a display in the third mode for carrying out the invention.

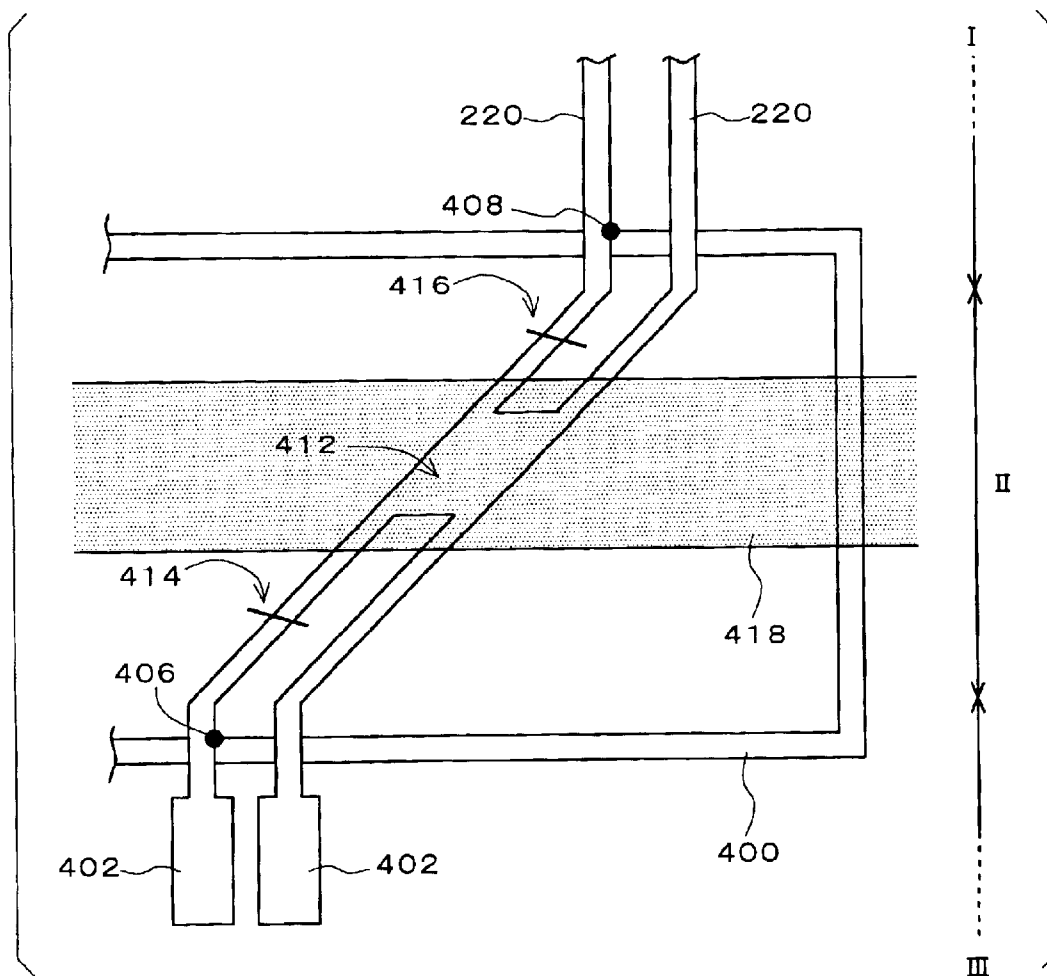
As shown in FIG. 15, the present embodiment is characterized in that defects at two locations in the extraction wiring portion II can be handled by providing a further repair line 420 outside the repair line 400 and by irradiating intersecting regions 422 and 424 with a laser beam to relieve the two drain bus lines 220. By providing a plurality of repair lines at the extraction wiring portion II, a plurality of defects in the extraction wiring portion II can be relieved.

FIG. 15 schematically illustrates a second embodiment of a method for repairing a defect in a display in the third mode for carrying out the invention.

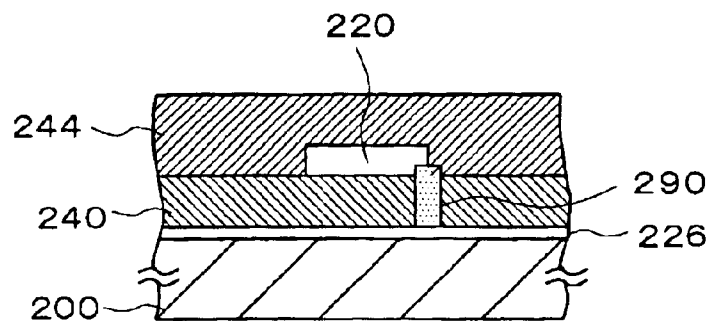
Third, as shown in FIG. **34**, spare lines (repair lines) **302** and **303** provided in advance for a repair on the TFT substrate **200** are used to apply a predetermined voltage to the drain bus line **220** thus cut from the drain driving circuit **208**.

The repair line **302** is formed such that it intersects the plurality of drain bus lines **220** with the insulation film interposed at the end of the display area I on the side of the drain driving circuit **208** and is extended along with the plurality of drain bus lines **220** through the extraction wiring portion II to be connected to the TCP at the terminal portion III. The repair line **302** is formed of the same metal as used to form the gate bus lines **218** and is normally insulated from the drain bus lines **220** by the insulation film **240**.

The repair line **302** extends from the gate driving circuit **206** through the printed circuit board **250** to the repair line **303** on the unloaded side of the driving circuit. The repair line **303** on the unloaded side of the driving circuit is also formed of the same metal as used for the formation of the gate bus lines **218** and is formed such that it intersects the plurality of drain bus lines **220** with the insulation film **240** interposed therebetween. During a repair, a region **304** where a drain bus line **220** having an inter-layer short-circuit **290** and the repair line **302**, intersect with each other is irradiated with a laser beam, and a region **305** where the drain bus line **220** and the repair line **303** intersect with each other is also irradiated with a laser beam to fuse both of the lines, which establishes connection and conduction. Thus, a predetermined voltage is applied to the drain bus line **220** from which the shorting portion of the inter-layer short-circuit **290** has been cut off also from the side opposite to the drain driving circuit **208** to perform a repair for preventing the occurrence of the line defect.

As described above, according to the related art, repair lines **302** and **303** are provided on an assumption that a line breakage or the like exists in a display area I as shown in FIG. **34**. Recent demands for panels with smaller frames have increased the possibility of defects such as breakage and shorting of a lines because such demands have necessitated a smaller line width and a smaller line interval at an extraction wiring portion II. This has resulted in a need for a repairing method which can cope with defects at an extraction wiring portion II.

FIG. 34 illustrates a method for repairing a liquid crystal display according to the related art.
