(10) **Patent No.:** **US 11,434,814 B2**

(54) **TURBOCHARGER SHAFT WOBBLE  
SENSOR**

(71) Applicant: **Caterpillar Inc.**, Deerfield, IL (US)

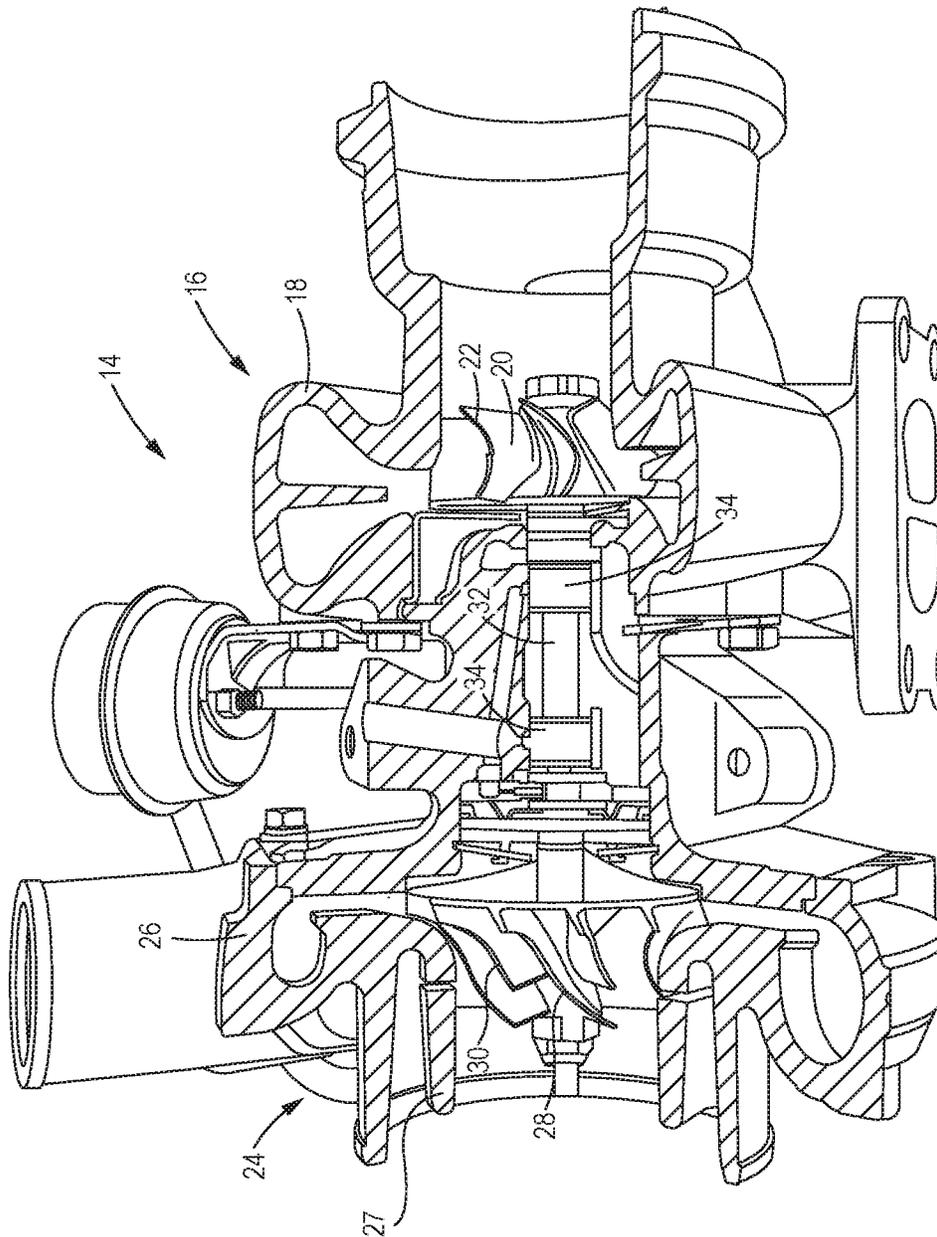
FIG. 2 is partial cross-sectional view of a turbocharger of the machine with a health sensor removed for clarity, constructed in accordance with the present disclosure.

Turning to FIG. 2, the turbocharger 14 of the machine 10 is shown in detail. The turbocharger 14 may include a turbine section 16 having a turbine housing 18 and a turbine wheel 20 with a plurality of blades 22, and a compressor section 24 having a compressor housing 26, a compressor inlet 27, and a compressor wheel 28 with a plurality of blades 30. A shaft 32, supported by one or more bearings 34, may rotatably couple the turbine wheel 20 and the compressor wheel 28. The flow of exhaust gas from the engine 12 through the turbine section 16 may cause the turbine wheel 20 to rotate, thereby driving the rotation of the compressor wheel 28 via the interconnecting shaft 32. The rotating compressor wheel 28 may pressurize the intake air that is supplied to the engine 12, allowing more fuel to be combusted and providing an increase in power.

With extended use of the turbocharger 14, the bearings 34 may wear and the clearance between the bearings 34 and the shaft 32 may increase. The increased clearance may allow the compressor wheel 28 and the turbine wheel 20 to wobble and impact their respective housings 26 and 18, causing damage to the walls of the housings 26 and 18. The wobbling of the compressor wheel 28 and the turbine wheel

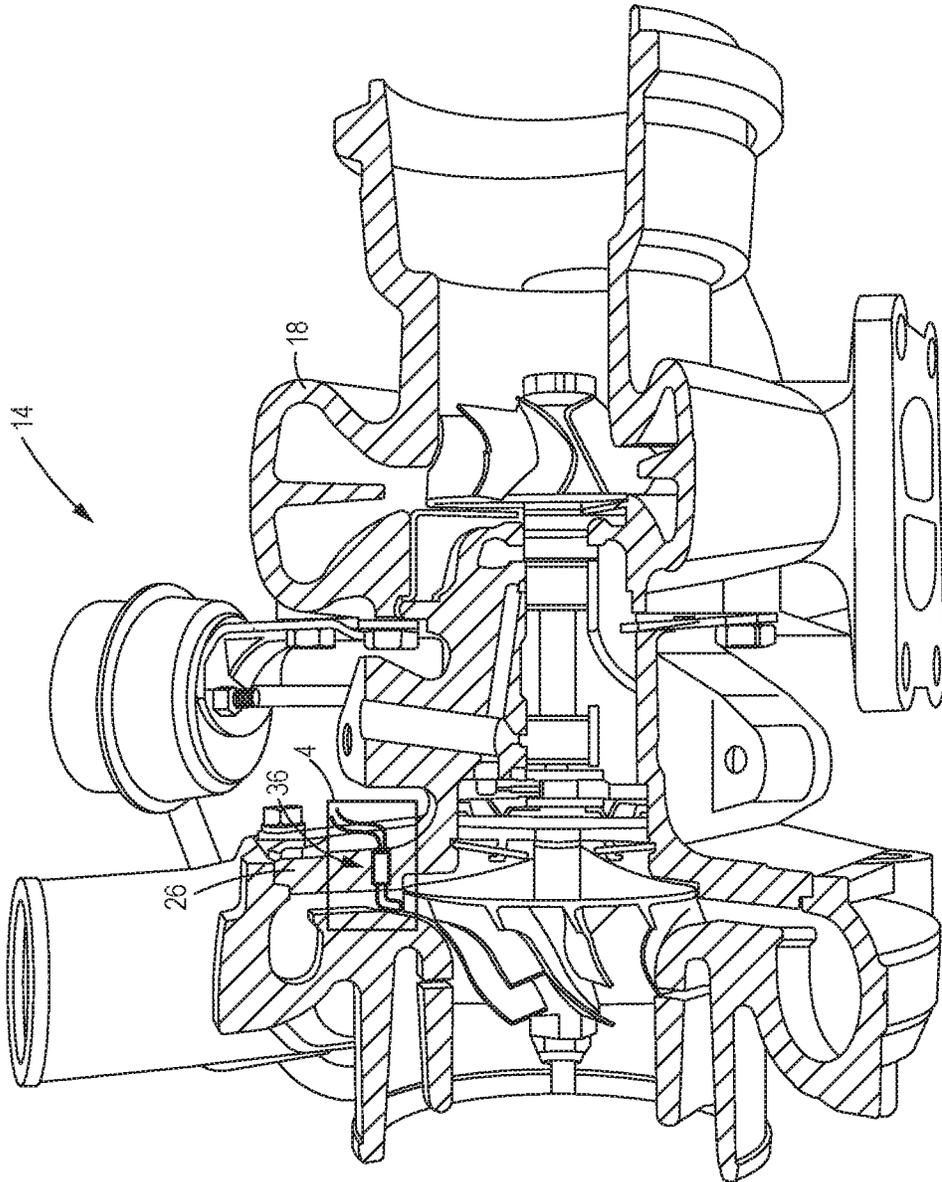
FIG. 3 is a partial cross-section view of the turbocharger of FIG. 2 with the health sensor, constructed in accordance with the present disclosure.

To detect the wobbling of the compressor wheel 28, the turbocharger 14 of the present disclosure may include a health sensor 36 mounted to the compressor housing 26 (see FIGS. 3-4). The position of the health sensor 36 on the compressor housing 26 shown in FIGS. 3-4 is merely exemplary, as the health sensor 36 may be mounted at other locations of the compressor housing 26 depending on a number of design considerations. The health sensor 36 may include a printed circuit board (PCB) 38 with a plurality of wire loops 40 attached thereto. The wire loops 40 may be integrated in the PCB 38 and/or may dangle from the PCB 38 over the blades 30 of the compressor wheel 28. For example, the wire loops 40 may be wire traces or a conductive feature on the PCB 38. In one example, the wire loops 40 may be positioned radially outward of the blades 30 in the compressor housing 26 and near enough to the blades 30 so that wobbling of the compressor wheel 28 causes the blades 30 to impact the wire loops 40. In other arrangements, the wire loops 40 may be positioned axially inward or axially outward of the compressor wheel 28. To facilitate breakage of the wire loops 40 by impact with the blades 30, the wire loops 40 may be coated with an abradable coating. In an alternative arrangement, the health sensor 36 may be mounted to the turbine housing 18 to detect wear of the turbocharger 14.

As the wear of the bearings 34 progresses and the degree of compressor wheel wobbling increases, the blades 30 may impact and break more of the wire loops 40 consecutively. The breakage of each of the wire loops 40 may be detected by the health sensor 36, and the health sensor 36 may transmit signals indicating breakage of the wire loops 40 to an electronic control module (ECM) 42 via electrical transmission through wires 44 or wireless transmission (also see FIG. 7). In particular, the signals transmitted to the ECM 42 from the health sensor 36 may indicate the number of wire loops 40 broken (or the wear condition of the turbocharger 14), and the ECM 42 may output a signal indicating a wear condition of the turbocharger 14 based on the number of wire loops 40 broken. Either the ECM 42 or the health sensor 36 may be configured to determine the wear condition of the turbocharger 14 based on the number of wire loops 40 that are broken. In response to receipt of the signals from the health sensor 36, the ECM 42 may output signals indicative of the wear condition for viewing at internal and external sites (see further details below). As the number of wire loops 40 broken increases, the urgency of the signal generated by the ECM 42 indicating that the turbocharger 14 should be replaced increases (see further details below).

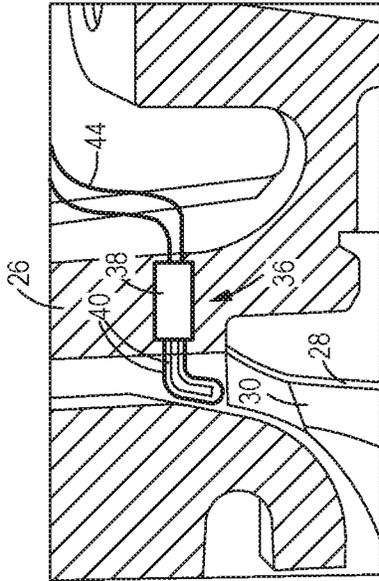
FIG. 4 is an expanded view of detail 4 of FIG. 3, constructed in accordance with the present disclosure.

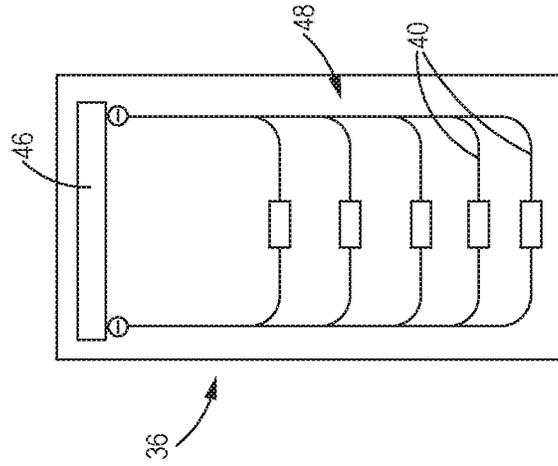
FIG. 6 is a plan view of the health sensor similar to FIG. 5 but with wire loops arranged in a resistive ladder, constructed in accordance with the present disclosure.

including wireless signals. Although FIGS. 5 and 6 show the health sensor 36 having three and five wire loops 40, respectively, it will be understood that the number of wire loops 40 shown is only exemplary and may vary in practice depending on various design considerations.

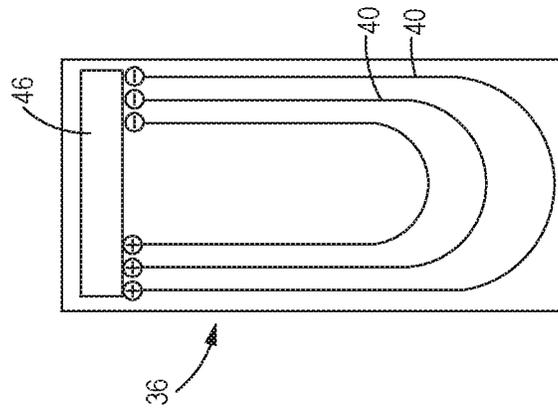
FIG. 5 is a plan view of the health sensor shown in isolation, constructed in accordance with the present disclosure.

As shown in FIG. 5, the health sensor 36 may include a microprocessor 46 connected to the wire loops 40 that monitors the voltage in each wire loop 40 and detects the breakage of the wire loops 40 by a voltage decrease. More specifically, the breakage of a wire loop 40 leads to an open circuit and the elimination of the voltage (voltage drop) in the broken wire loop 40. Alternatively, as shown in FIG. 6, the plurality of wire loops 40 may be arranged and connected in a resistive ladder 48, allowing the microprocessor 46 to detect breakage of each of the wire loops 40 by a decrease in resistance (see FIG. 6). In either arrangement, the microprocessor 46 may transmit signals to the ECM 42 indicative of the number of wire loops 40 broken or the wear condition of the turbocharger 14. The transmitted signals from the microprocessor 46 to the ECM 42 may be controller area network (CAN) signals, or other types of signals

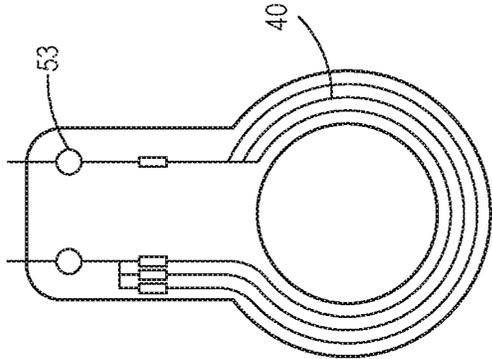
FIG. 8 is a plan view of the health sensor of FIG. 7 shown in isolation, constructed in accordance with the present disclosure.

In an alternative arrangement shown in FIGS. 7-9, a nut 50 may be assembled on a nose 52 of the compressor wheel 28 (and rotatably coupled to the compressor wheel 28) in proximity to the health sensor 36. As above, the health sensor 36 may include the PCB 38, the wire loops 40, and the microprocessor 46. As explained above, the wire loops 40 may be wires, wire traces, or conductive features on the PCB 38. The PCB 38 may have connection points 53 for connection to the ECM 42. As the compressor wheel 28 wobbles with wear over time, the wire loops 40 may be abraded by impact with the nut 50 or a special feature on the nut 50, leading to an open circuit detected by the microprocessor 46 and a change in voltage signal sent to the ECM 42. As in the arrangement of FIGS. 3-6 described above, the number of wire loops 42 broken may be correlated with the remaining service life or wear condition of the turbocharger. As shown in FIG. 7, the health sensor 36 may be mounted to wall of the compressor inlet 27 through one or more supporting structures 54, such as struts or panels.

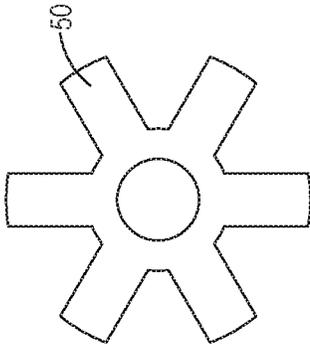
FIG. 9 is a plan view of the nut of FIG. 7 shown in isolation, constructed in accordance with the present disclosure.

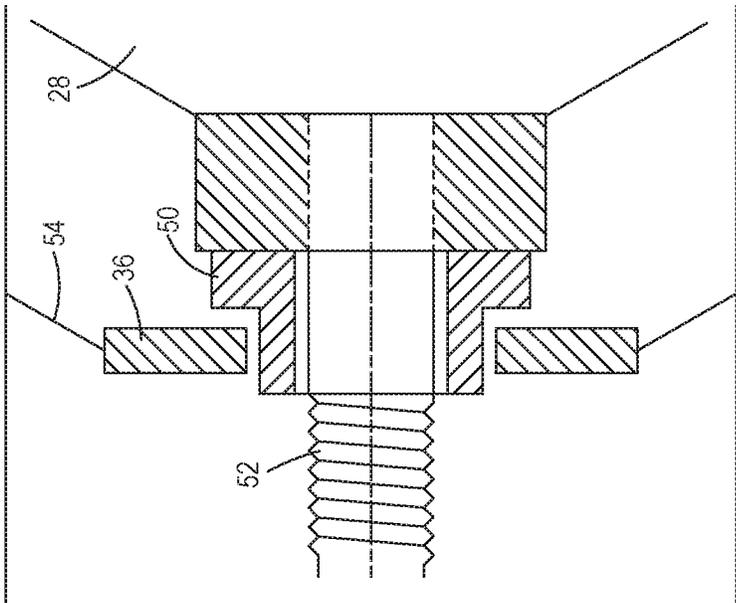
FIG. 7 is a cross-sectional view of a portion of the turbocharger with the health sensor mounted near a nut on a nose of the compressor wheel, constructed in accordance with the present disclosure.

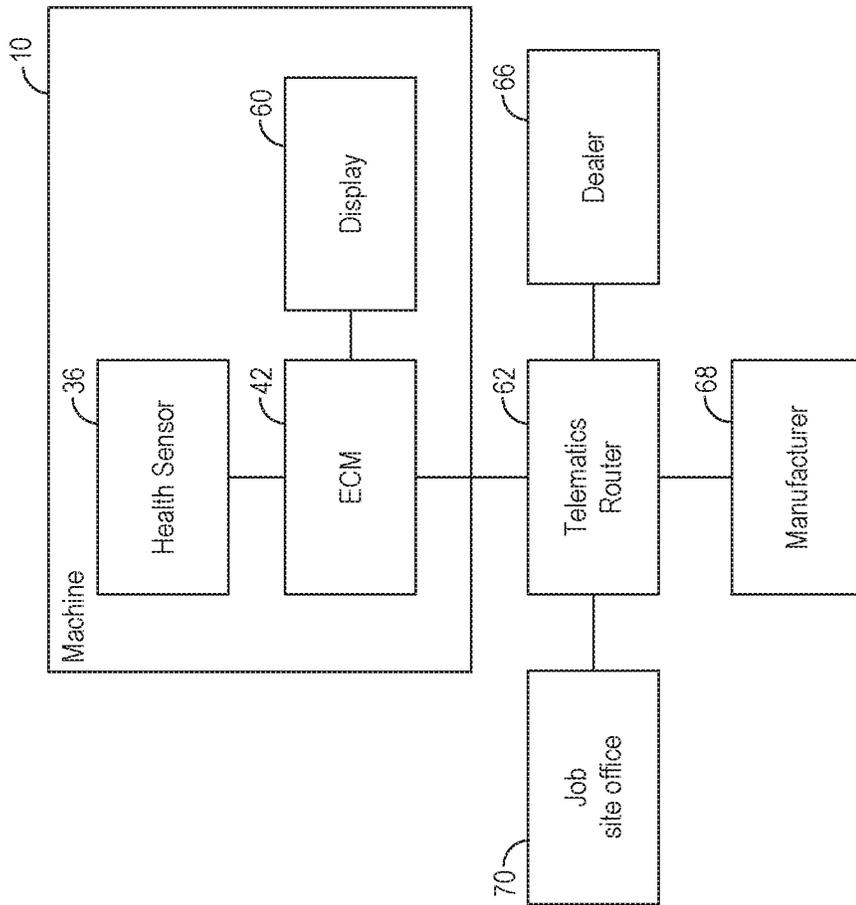
**FIG. 10**

FIG. 10 is a schematic representation illustrating how signals from the health sensor may be transmitted through the machine and to external electronic devices, constructed in accordance with the present disclosure.

FIG. 10 illustrates how the signals from the health sensor 36 may be transmitted through the machine 10 and to various external electronic devices. As discussed above, the health sensor 36 may transmit signals indicative of the number of wires loops broken (or the wear condition of the turbocharger 14) to the ECM 42. The ECM 42 may then output signals indicative of the wear condition of the turbocharger to an operator display 60 of the machine 10 to allow the operator to monitor the health status of the turbocharger 14. The operator display 60 may be a computer screen located in the machine 10, such as in the operator cabin, or it may be a hand-held or remote computerized device with a display. In addition, the signals from the ECM 42 may be output to various external electronic devices separate from the machine 10 via a telematics router 62. The telematics router 62 may include a cellular, Bluetooth®, and/or Wi-Fi modem such that the telematics router 62 may transmit cell phone, Bluetooth®, and/or Wi-Fi signals to the external electronic devices. The external electronic devices may include an electronic device 66 of a dealer (e.g., a service truck or back office) of the machine 10, an electronic device 68 of a manufacturer of the machine 10, and an electronic device 70 at a worksite office near the worksite of the machine 10. The electronic devices 66, 68, and 70 may be any type of electronic device (e.g., computer, cell phone, etc.) that includes a display for viewing the wear condition status transmitted from the ECM 42. If a wear condition signal is received at the electronic devices 66, 68, and 70 indicating that the turbocharger 14 is near the end of its service life, then replacement of the turbocharger 14 may be scheduled, avoiding costly machine downtime. Notifying the worksite office, the dealer of the machine, and the manufacturer of the machine 10 that the turbocharger 14 is near the end of its service life allows coordinated replacement of the worn turbocharger 14 prior to failure of the turbocharger 14.

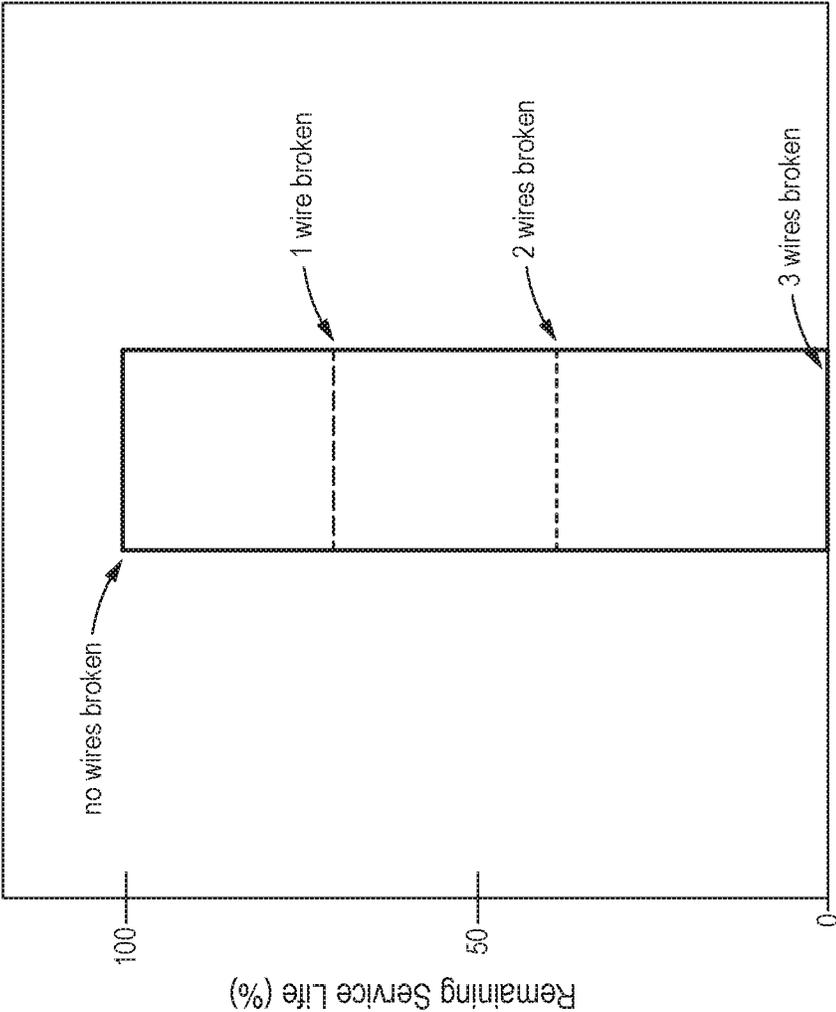
FIG. 11 is an exemplary display indicating a percent remaining service life of the turbocharger generated using the health sensor, constructed in accordance with the present disclosure.

FIG. 11 shows an exemplary output signal indicating the wear condition of the turbocharger 14 that may be viewable at the operator display 60 and at the electronic devices 66, 68, and 70. In this example, the output signal of the wear condition is a bar graph indicating the percent remaining service life of the turbocharger 14. For example, when no wire loops 40 are broken, the bar chart may indicate that the

turbocharger has 100% remaining service life. As each wire loop 40 is consecutively broken, the percent remaining service life may decrease, as shown, as the number of wire loops broken may be directly related to the remaining service life of the turbocharger 14. The determination of the percent remaining service life (wear condition) of the turbocharger 14 from the number of wire loops 40 broken may be performed by the health sensor 36 or by the ECM 42, as explained above. In other arrangements, the wear condition of the turbocharger 14 may be displayed as a graph of percent remaining service life that decreases over time, or simply as a number value indicating the percent remaining service life (e.g., 100%, 40%, etc.).

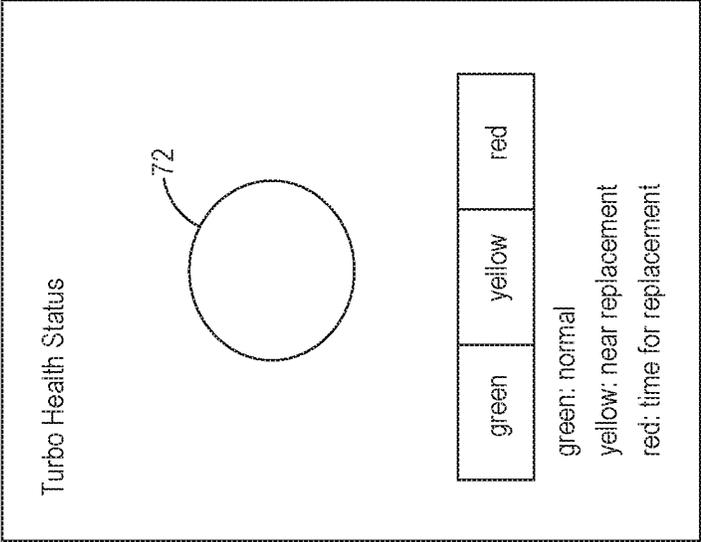
FIG. 12 is another exemplary display having a color signal indicating whether the turbocharger is ready for replacement, constructed in accordance with the present disclosure.

Alternatively, the wear condition of the turbocharger 14 may be displayed at the operator display 60 and at the electronic devices 66, 68, and 70 as a color signal 72 that indicates whether or not the turbocharger 14 should be replaced (see FIG. 12). For example, the color signal 72 may be green when the wear condition/health status of the turbocharger 14 is good or normal such that the turbocharger 14 does not need to be replaced, yellow when the turbocharger 14 is nearing the end of its service life and requires replacement soon, and red when the turbocharger 14 is at the end of its service life and requires immediate replacement. As a non-limiting example, a green signal may be generated when no wire loops 40 are broken, a yellow signal may be generated when one or two wire loops 40 are broken, and a red signal may be generated when all of the wire loops 40 are broken. Either the health sensor 36 or the ECM 42 may determine the color signal 72 that is displayed based on the number of wire loops 40 that are broken. It will be understood, however, that the colors and the number of colors for the color signal 72 may vary in practice and are not limited to green, yellow, and red. In other arrangements, other types of output signals such as audible signals or other types of visual signals may be generated to indicate the wear condition/health status of the turbocharger.

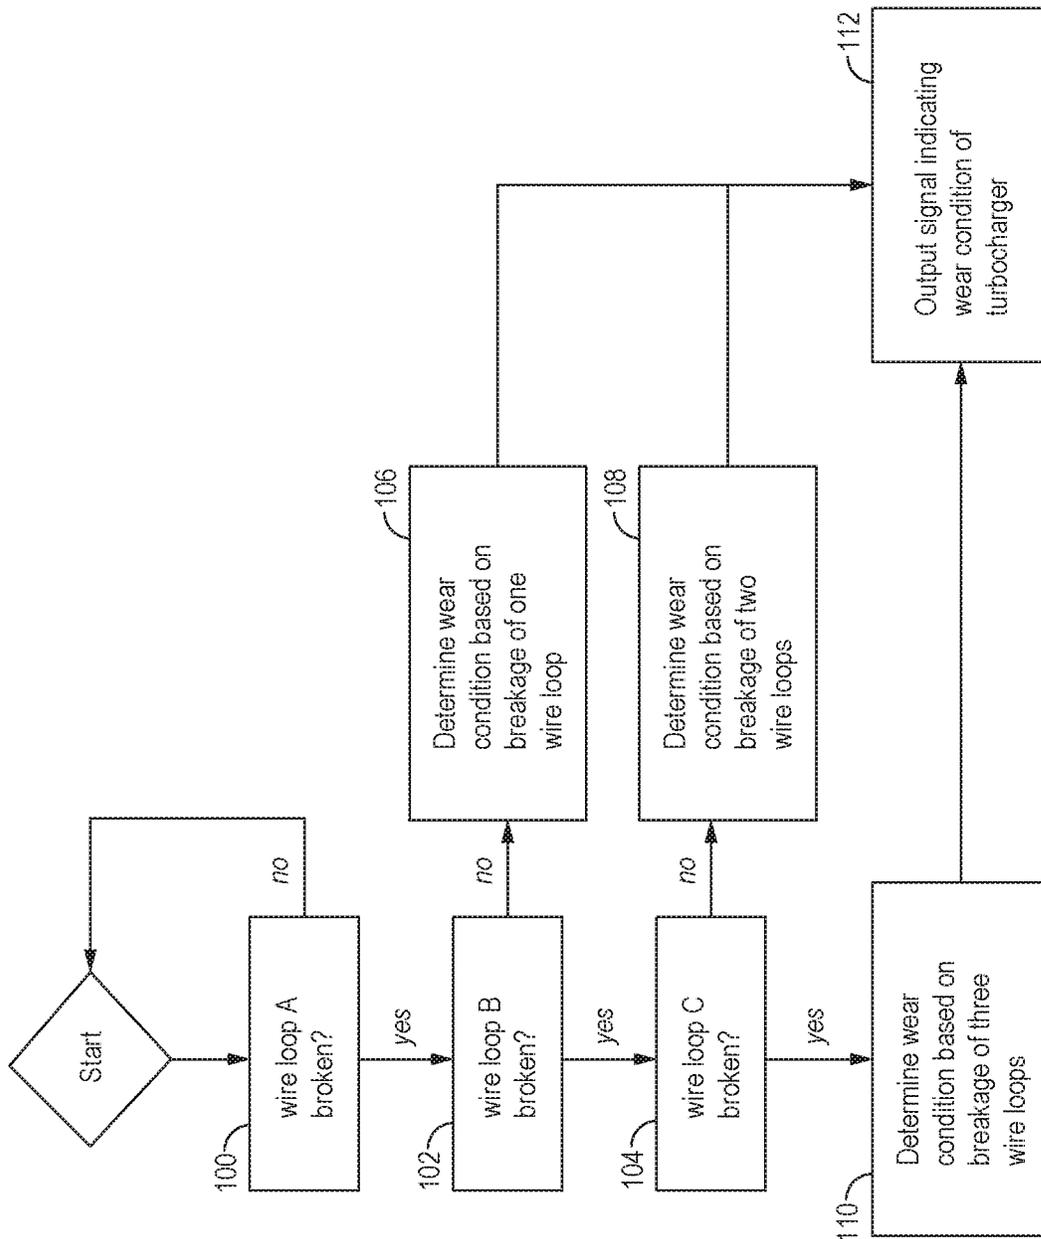
FIG. 13 is a flow chart of a series of steps that may be performed to determine a wear condition of the turbocharger using the health sensor, constructed in accordance with the present disclosure.

FIG. 13 shows a series of steps that may be performed to determine the wear condition of the turbocharger 14 as performed by the health sensor 36 and the ECM 42. According to exemplary blocks 100, 102, and 104, the health sensor 36 may determine the number of wire loops 40 that are broken using voltage or resistance measurements as discussed above. If only a first wire loop 40 is broken (wire loop A), then the health sensor 36 or the ECM 42 may determine the wear condition (remaining service life) of the turbocharger 14 based on the breakage of one wire loop 40 (block 106). If it is determined that the first wire loop 40 (wire loop A) and a second wire loop 40 (wire loop B) are broken, then the health sensor 36 or the ECM 42 may determine the wear condition of the turbocharger 14 based on the breakage of two wire loops 40 (block 108). If it is determined that the first wire loop 40 (wire loop A), the second wire loop 40 (wire loop B), and a third wire loop 40 (wire loop C) are broken, then the health sensor 36 or the ECM 42 may determine the wear condition of the turbocharger 14 based on the breakage of three wire loops 40 (block 110). It will be understood that the method of FIG. 10

is merely exemplary as the health sensor **36** may have less than or more than three wire loops **40**, and the wear condition of the turbocharger **14** may be assessed based on breakage more or fewer numbers of wire loops **40**. After determining the wear condition, the ECM **42** may output a signal indicating the wear condition of the turbocharger **14** to the operator display **60**, as well as to external electronic devices (the dealer's electronic device **66**, the manufacturer's electronic device **68**, and the worksite office electronic device **70**) via the telematics router **62**. As explained above, the wear condition may be output as the percent remaining service life of the turbocharger, as a color signal, or other readily interpreted signals.
