(10) **Patent No.:** **US 10,451,208 B1**  
(45) **Date of Patent:** **Oct. 22, 2019**

(54) **METHOD AND DEVICE FOR REPAIRING AN IRRIGATION SYSTEM**

The repair device secures to an irrigation conduit to seal any failures of the irrigation conduit. A patch body of the present invention is constructed from a plastic film, such as 15 mil polypropylene. The user installs a contact side of the patch body adjacent the irrigation conduit. A seal on the contact side of the repair device is located along the edges of the repair body. The seal encompasses the rupture. Fasteners located on the fastening edges of the patch body secure the repair body around the rupture. The seal and patch body compress the irrigation conduit to seal the failure in the conduit.

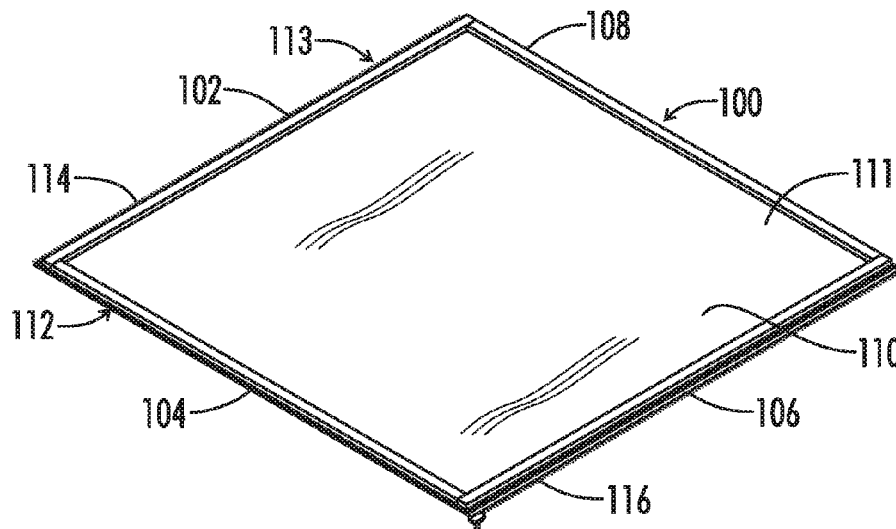
*FIG. 1*

FIG. 1 is a perspective view showing one embodiment of the present invention;

FIG. 1 shows a perspective view of one embodiment of the repair device generally shown as 100. The repair device 100 provides a patch body 110 with seal 112. The seal 112 is located on the contact side 111 of the patch body 110. The user places the contact side 111 of the patch body 110 adjacent the irrigation conduit. The user then attaches the attachment edges 102, 106 to each other around the irrigation conduit. Securing the attachment edges 102, 106 around the irrigation conduit secures the repair device to the irrigation conduit.

The irrigation conduit defines a longitudinal axis allowing the water to flow longitudinally through the irrigation conduit as shown in FIG. 6. Sealing edges 104, 108 as shown in FIG. 1 form the longitudinal edges of the repair device 100. Attachment edges 102, 106 form the lateral edges of the repair device 100.

FIG. 1 shows an embodiment utilizing a zipper and zipper track 114, 116. Such an embodiment utilizes a YKK zipper that has waterproof characteristics. Such a water proof zipper provides a more durable zipper that resists rusting and other water damage. The water proof zipper also provides another barrier to reduce the amount of water leaking from the repair device 100 at the fastener 113.

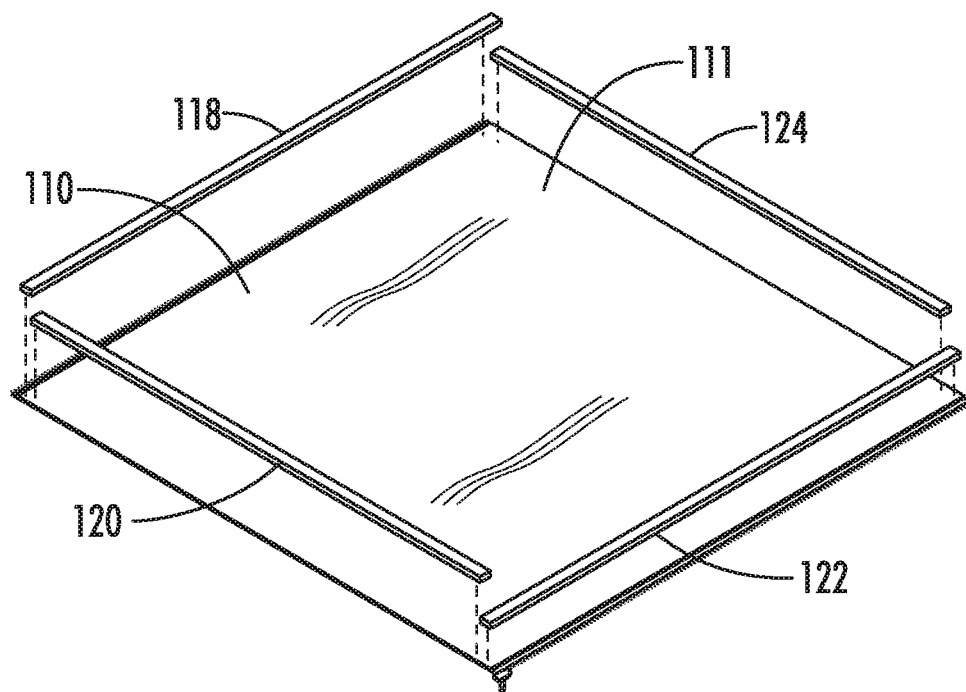
*FIG. 2*

FIG. 2 is an exploded view thereof;

FIGS. 2 and 4 show exploded views with the seal removed. Seal components 118, 120, 122, 124 attach to the contact side 111 of the patch body 110 as shown in FIGS. 1-4. The seal components of one embodiment are sewn to the patch body 110. The sewn attachment reduces the height of the seal to create two separate seals running along each edge.

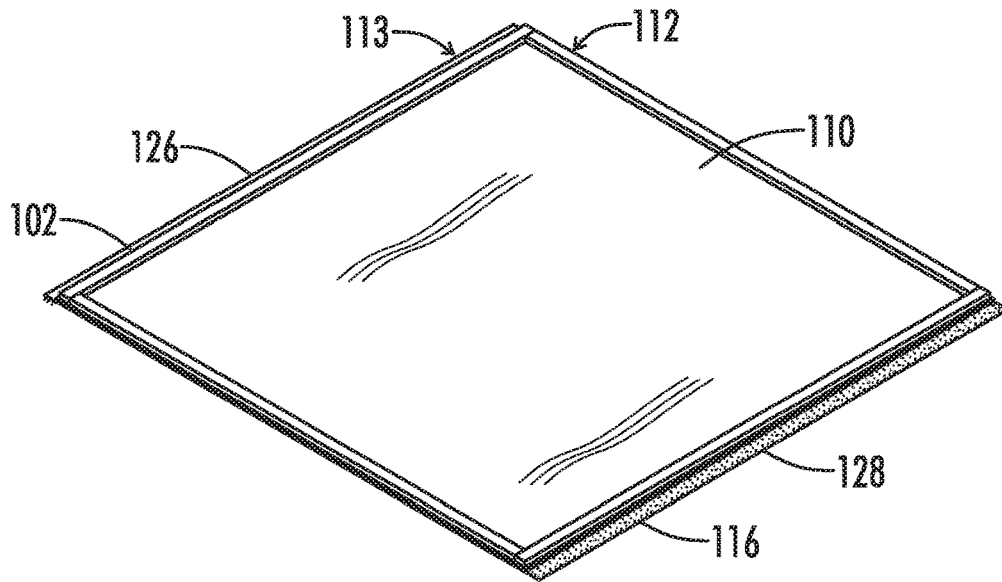
**FIG. 3**

FIG. 3 is a perspective view of one embodiment of the present invention;

FIG. 3 shows another embodiment of the repair device that utilizes a hook and loop fastener 126, 128 as fastener 113. The hook and loop fastener 126, 128 is located at attachment edges. The hook and loop fastener 126, 128 secures attachment edge 102 to attachment edge 106. Such attachment of attachment edges 102, 106 to each other secures the repair device to the irrigation conduit.

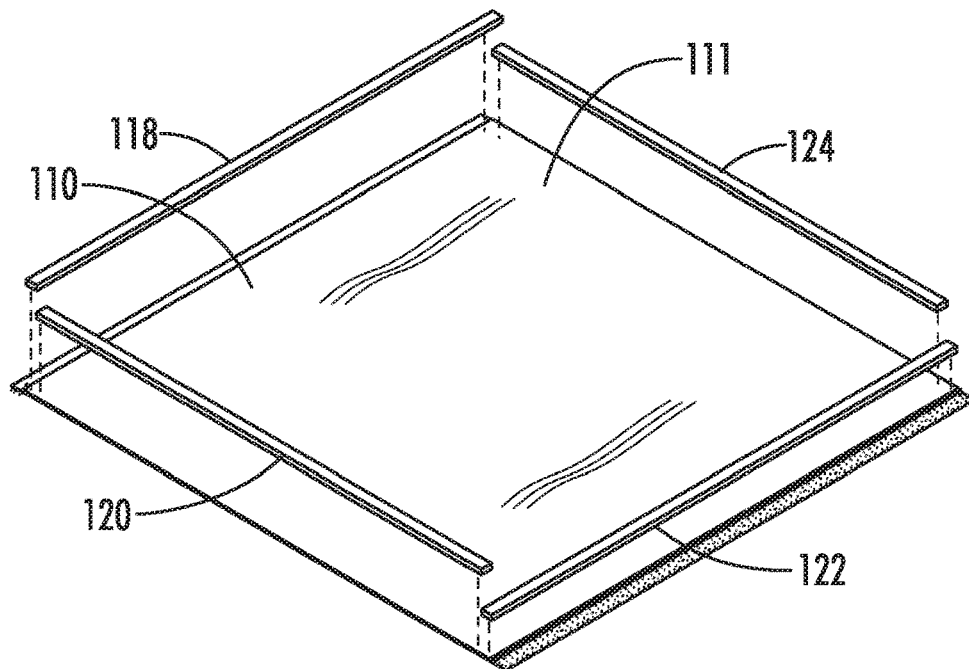
FIG. 4 is an exploded view thereof;

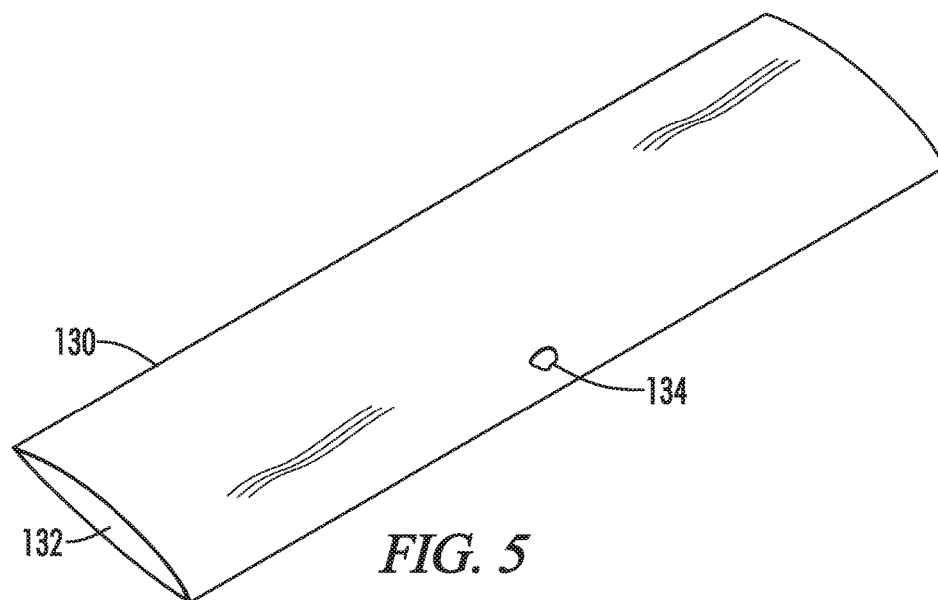
FIG. 5 is an environmental view of an irrigation conduit;

FIGS. 5 and 6 show a view of the irrigation conduit 130 and the repair of the irrigation conduit 130 with the repair device 100. The irrigation conduit 130 as discussed above is constructed from a plastic film. Such film may be packaged within a roll that the user lays out along the area to be irrigated. The irrigation conduit 130 will take the shape of the water as it flows through the irrigation conduit due to the thin film.

The user attaches a water source to opening 132. The water from water source 132 flows through the irrigation conduit 130. Failure 134 has formed in the irrigation conduit 130.

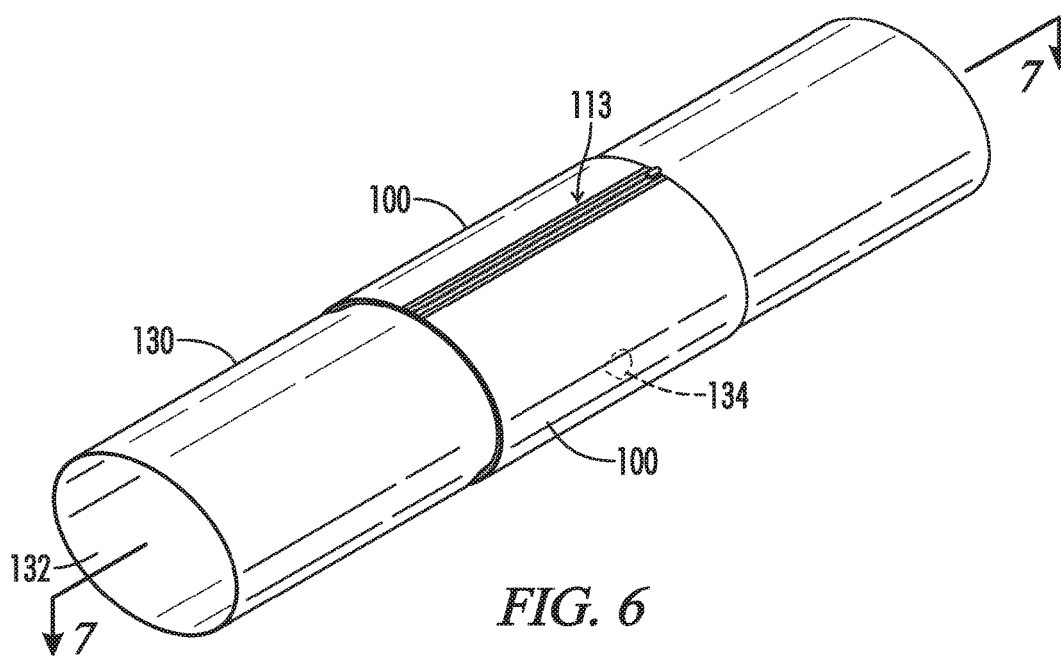
FIG. 6 is an environmental view of one embodiment of the present invention; and

FIGS. 6 and 7 show the repair of failure 134. The user applies the repair device 100 around the irrigation conduit 132 at failure 134. The seal 112 is located around the failure 134. Seal 112, patch body 110, and fastener 113, such as the

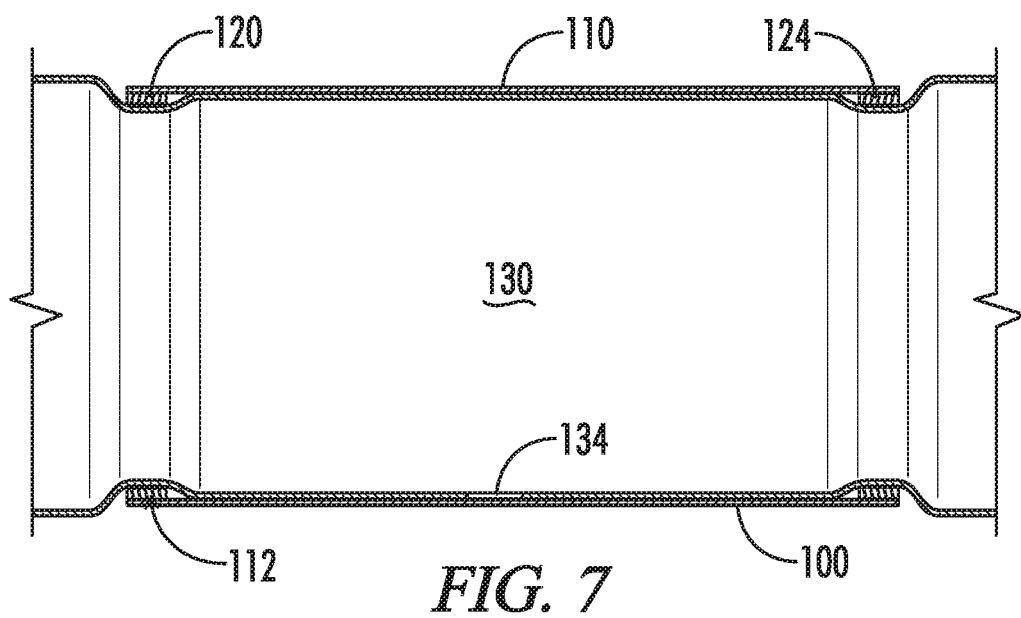
FIG. 7 is a sectional view thereof.

FIG. 7 shows a sectional view of the repair device 100 secured to the irrigation conduit 130. The seal 112 is positioned to encompass failure 134 such that the rupture 134 is located within the four corners of the seal 112. The repair body 100 compresses the irrigation conduit 130 to seal the failure. The opening of the repair body with the attachment edges attached is sized with a smaller cross section than the opening of the irrigation conduit. The opening enables the water to properly flow through the irrigation conduit and the repair device.

Sealing edges with sealing components 120, 124 are located longitudinally away from the rupture. Attachment edges with the sealing components 118, 122 are located laterally of the failure 134.

The seal 112 and patch body 110 seal the rupture by encompassing the rupture. The user then secures the attachment edges to each other with fastener 113. The user can then increase the water flow through the irrigation conduit 130. The increased water flow increases the size of the longitudinal cross section of the irrigation conduit in the opening. The cross section of the opening of the repair device 100 is sized smaller than the cross section of the opening of the irrigation conduit 130. Such difference in sizes of the openings through the irrigation conduit and the repair device enables the repair device to compress the irrigation conduit to seal the irrigation conduit as shown in FIG. 7.
