**EP 3 798 701 A1**

• **Castro, Jose M.****Naperville, Illinois 60565 (US)**(54) **FIBER OPTIC INSPECTION TOOL WITH INTEGRATED CLEANING MECHANISM**

(57) Various implementations of fiber optic inspection tools with integrated cleaning mechanisms are disclosed. The fiber optic inspection and cleaning tool includes a housing, a cleaning system and an imaging system. The cleaning system includes a pay-off reel, a take-up reel, a spindle and a cleaning tape that travels

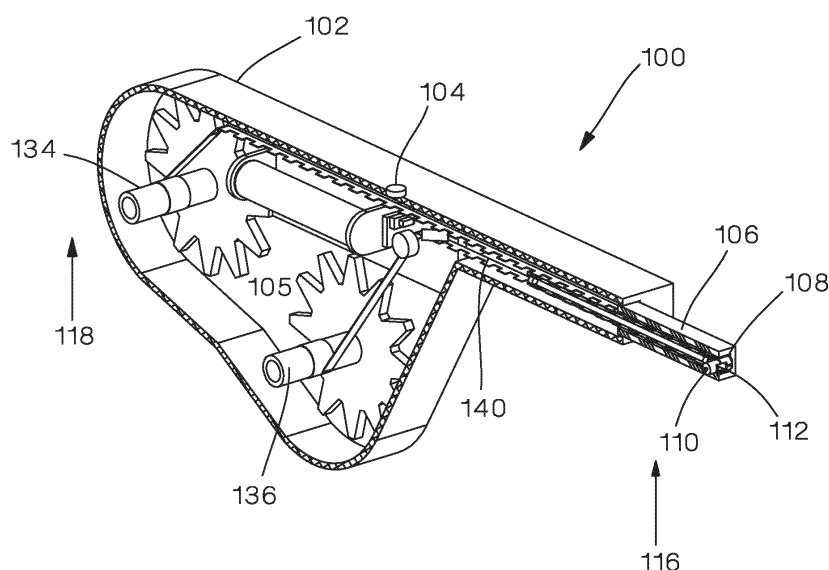
FIG. 2 is a perspective view of the fiber optic inspection and cleaning tool shown in FIG. 1 having a side cover removed to show at least some internal components included in the fiber optic inspection and cleaning tool;

**[0013]** FIG. 2 is a side view of the fiber optic inspection and cleaning tool 100 with the left side cover 101 removed to illustrate a view into the components and mechanisms within the housing 102. FIG. 3 is a side view of the fiber optic inspection and cleaning tool 100 with the left side cover 101 removed to illustrate a view into the components and mechanisms within the housing 102. FIGs. 2 and 3 depict the fiber optic inspection and cleaning tool 100 having a front end 116, a back end 118, and a probe head 132. Additionally, within the housing 102 is a pay-off reel 134, a take-up reel 136, a right-side cover 105, and an imaging system 160. The cleaning tape 140 travels off the pay-off reel 134, around the spindle 110 and onto the take-up reel 136. The imaging system 160 includes a battery 164, an imaging device 162, computing system 166, a light source 168, a first lens 170 and a second lens 172. The second lens 172 may be located towards the front end 116 of the fiber optic inspection and cleaning tool 100. The first lens 170 may be located between the second lens 172 and the imaging device 162. Although only two lenses are shown in the figure, one or more optical surfaces may be placed in between those lenses to correct for chromatic, spherical or other types of aberrations. The same set of lenses, namely the first lens 170 and the second lens 172, direct the light reflected from the connector 400 back to the imaging device 162. The imaging device 162 may include additional lenses or filters to improve the quality of the captured image.

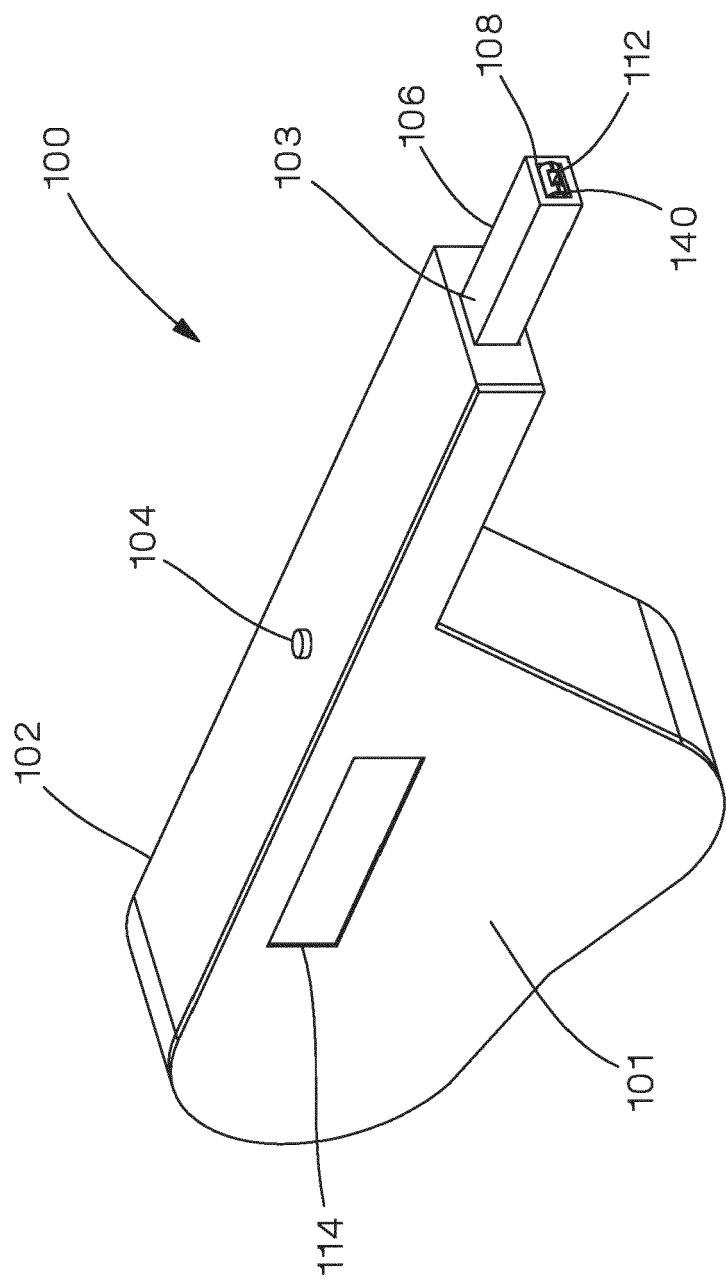
FIG. 1 is a perspective view of a fiber optic inspection and cleaning tool, according to an embodiment of the present disclosure;

**[0010]** FIGs. 1-11 disclose an exemplary fiber optic inspection and cleaning tool 100 according to an embodiment of the present disclosure. The fiber optic inspection and cleaning tool 100 is configured to clean and inspect adapters 402, or an end-face 401 to a connector 400 that is behind such adapter 402, such as those in optical cassettes used in data centers or network patch panels.

**[0011]** The fiber optic inspection and cleaning tool 100 includes a housing 102, a left side cover 101, an indicator 104, a probe 106, a first aperture 108, a cleaning tape 140 surrounding a spindle 110 (seen in FIG. 2), a second aperture 112, and a third aperture 103. Optionally, the left side cover 101 includes a window 114, made from a transparent material such as glass or transparent polymer, to see the internal components and mechanisms of the fiber optic inspection and cleaning tool 100. The fiber optic inspection and cleaning tool 100 may also optionally include a communication device for communicating with other devices wirelessly.

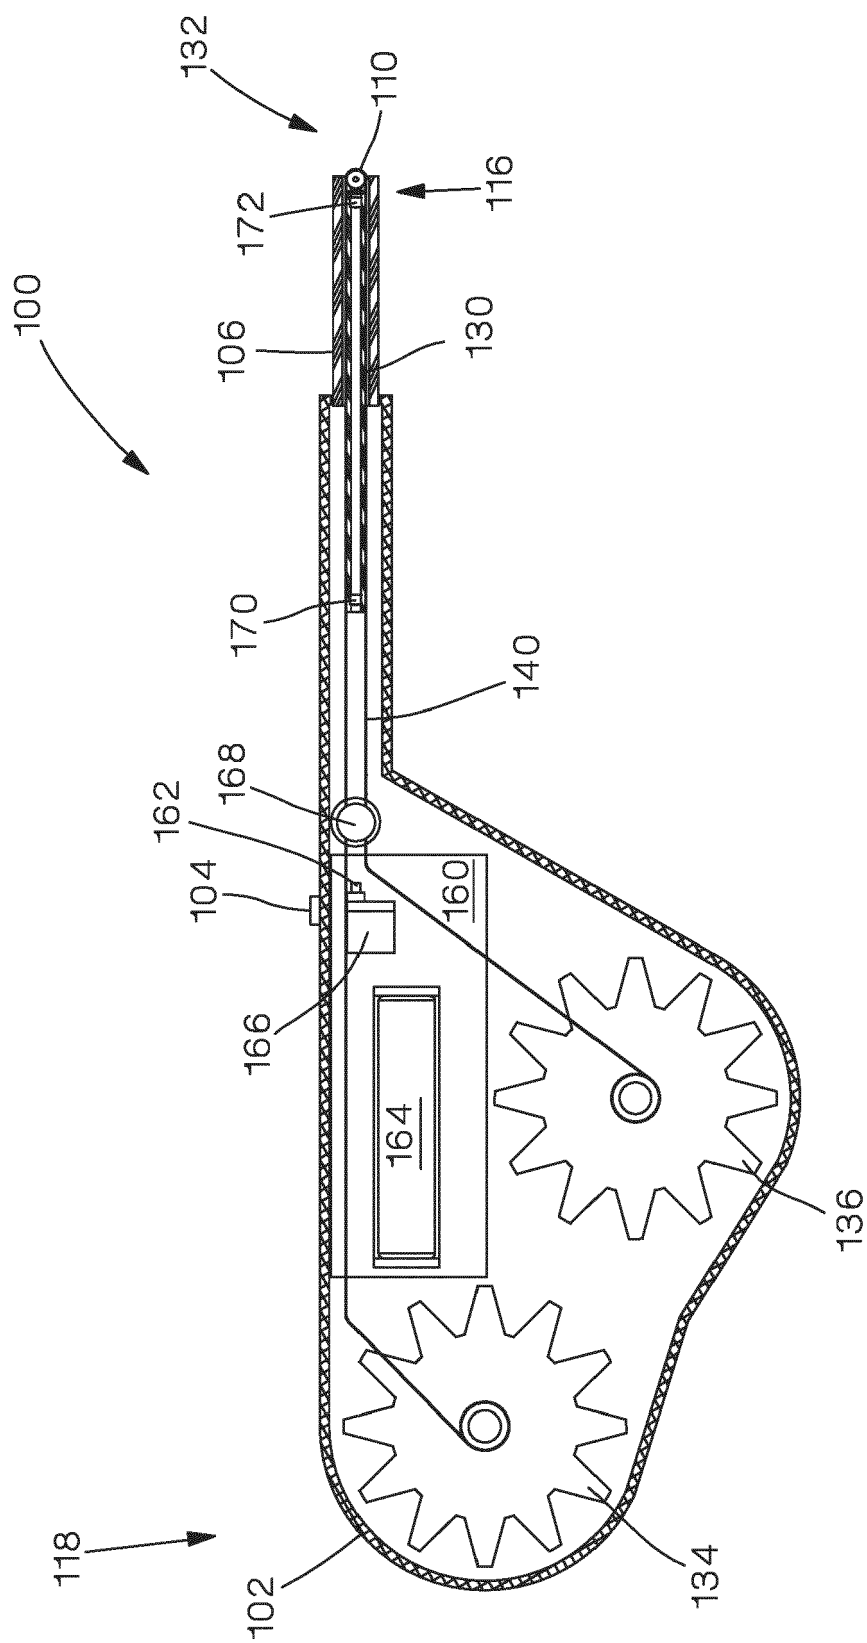
FIG. 3.

FIG. 3 is a side view of the fiber optic inspection and cleaning tool shown in FIG. 2 having the side cover removed to show at least some of the internal com-

ponents included in the fiber optic inspection and cleaning tool;

shown in FIGs. 2 and 3, are configured to direct light from the light source 168 to the end-face 401 of the connector 400 under inspection and/or cleaning. The same set of lenses (the first lens 170 and the second lens 172) are used to direct the light reflected from the end-face 401 of the connector 400 to the imaging device 162 (in UV, visible, or NIR light/image format). The set of lenses (the first lens 170 and the second lens 172) are designed to provide an optical magnification effect to detect debris or other contamination on the end-face 401 (e.g., equivalent magnification to an optical microscope, 100x, 200x, or 400x).

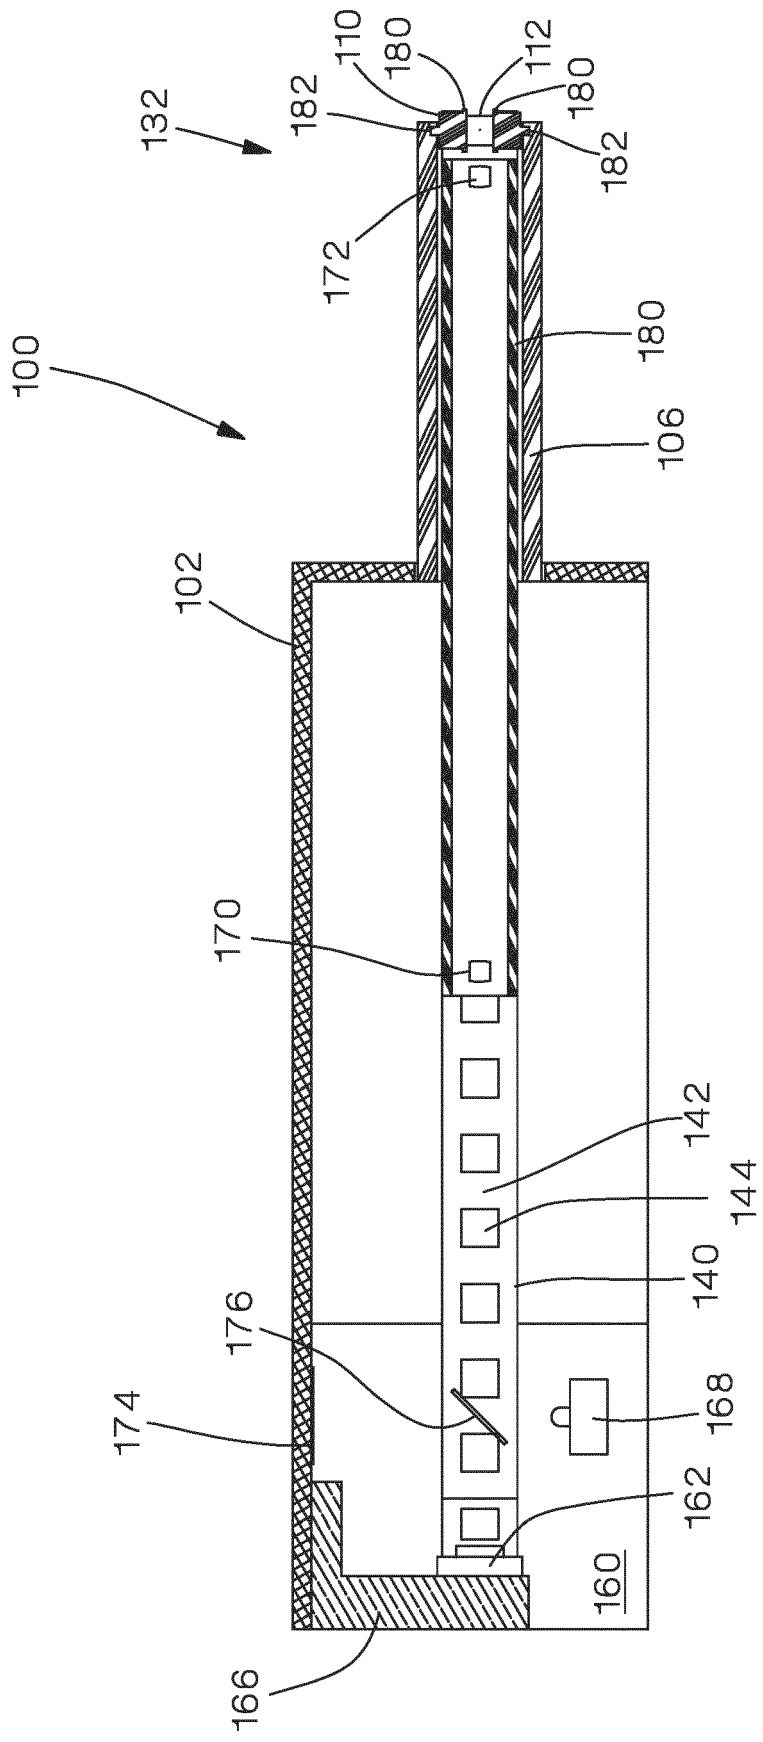
FIG.4

FIG. 4 is a top view of the fiber optic inspection and cleaning tool shown in FIG. 1 having at least a part of a top housing removed to show at least some of the internal components included in the fiber optic inspection and cleaning tool;

**[0019]** FIG. 4 is a top-down view of a portion of the example fiber optic inspection and cleaning tool 100. FIG. 4 shows the fiber optic inspection and cleaning tool 100 absent a top cover and the top portion of the cleaning tape 140 (the portion coming off pay-off reel 134). What is seen in FIG. 4 is the bottom portion of the cleaning tape 140 (after it come off spindle 110 and is on its way to take-up reel 136). FIG. 4 depicts the imaging system 160 including a beam splitter 176 and a light absorber 174. The light absorber 174 is positioned in line with the light source 168 in order to minimize spurious light and undesired reflections. The beam splitter 176 may be a partial mirror or a polarization beam splitter that helps convey light from the light source 168 to the end-face 401 of the connector 400.

**[0020]** FIG. 4 provides a detailed view of a portion of the cleaning tape 140. The cleaning tape 140 includes open sections or windows 144 and the cleaning portion 142. The windows 144 may be apertures (cut outs) or transparent sections. If transparent, the windows 144 may be a transparent tape or strength substrate such as mylar, or any optical material transparent to the wavelength utilized by the light source 168. In the embodiment of FIG. 4, the windows 144 are apertures within the cleaning tape 140. The cleaning portion 142 has a fabric, cloth, absorption or adhesive material that removes contamination from the end-face 401 of the connector 400.

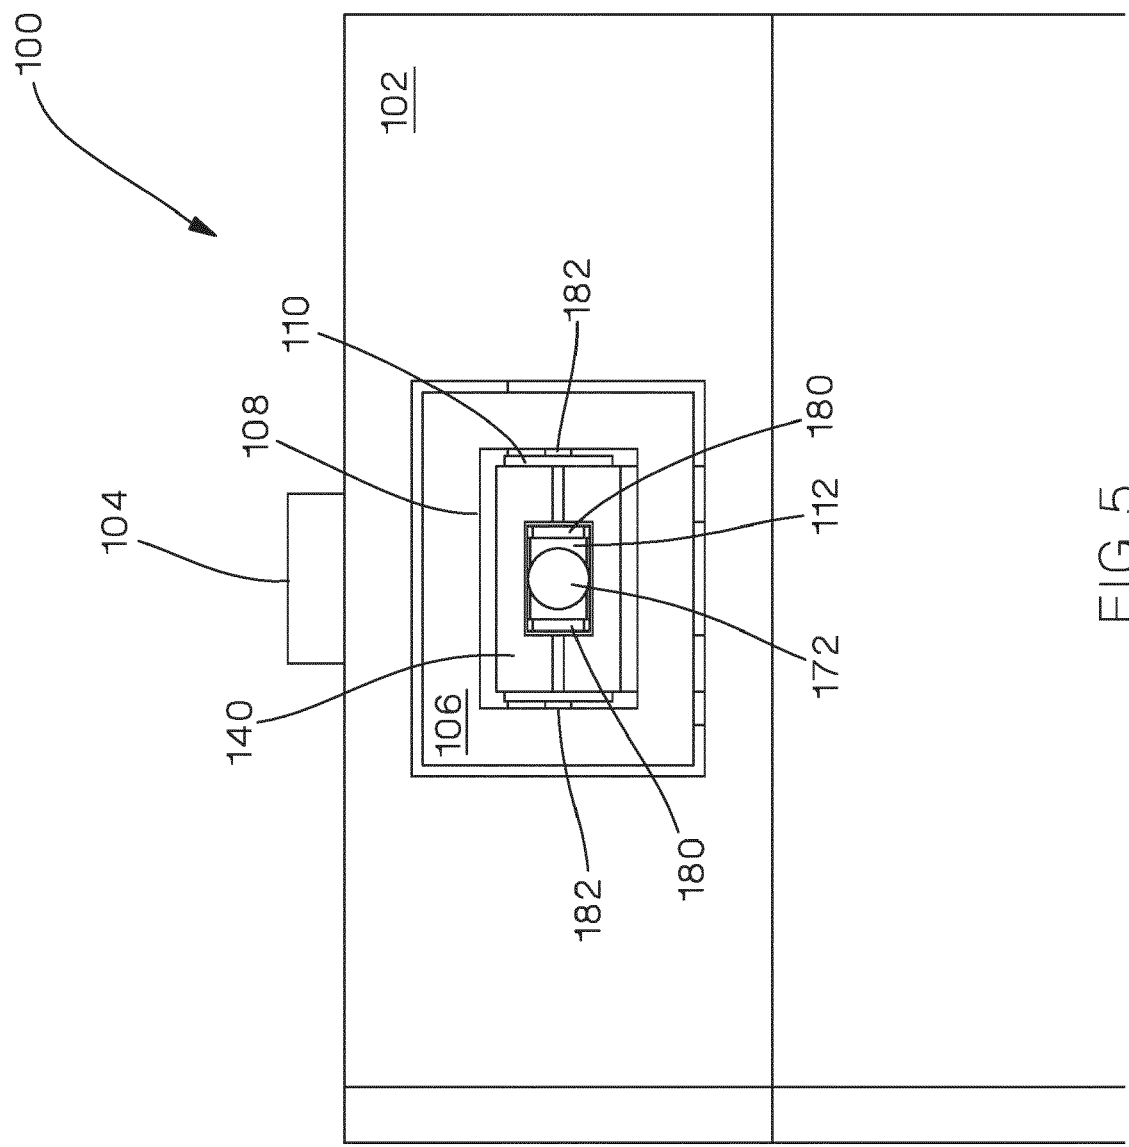
FIG. 5 is a front view of the fiber optic inspection and cleaning tool shown in FIG. 1 that shows a probe head included in the fiber optic inspection and cleaning tool;

**[0021]** FIG. 5 is a front view of the fiber optic inspection and cleaning tool 100 that better shows the probe head 132. From this front view, the probe 106 is shown to be protruding from the third aperture 103 in the housing 102. Within the first aperture 108, the cleaning tape 140 surrounds the spindle 110, a window 144 of cleaning tape 140 lines up with the second aperture 112. The spindle 110 includes spindle tabs 180 on either side of the second aperture 112. The spindle tabs 180 help to keep the cleaning tape 140 and the window 144 aligned precisely with the second aperture 112. The imaging device 162 may be synchronized with the movement of cleaning tape 140 to captures images of the connector end-face 401, or adaptor 402, under inspection when the window 144 is in front of the connector end-face 401, or adaptor 402, under inspection, not when the connector end-face 401 is being cleaned by the cleaning portion 142. The spindle 110 may also include support structures 182 to help keep the spindle 110 in place in the probe head 132. The second lens 172 is visible through the second aperture 112. The spindle 110 is cylindrical and provides a line of sight from the imaging device 162 to the connector end-face 401.

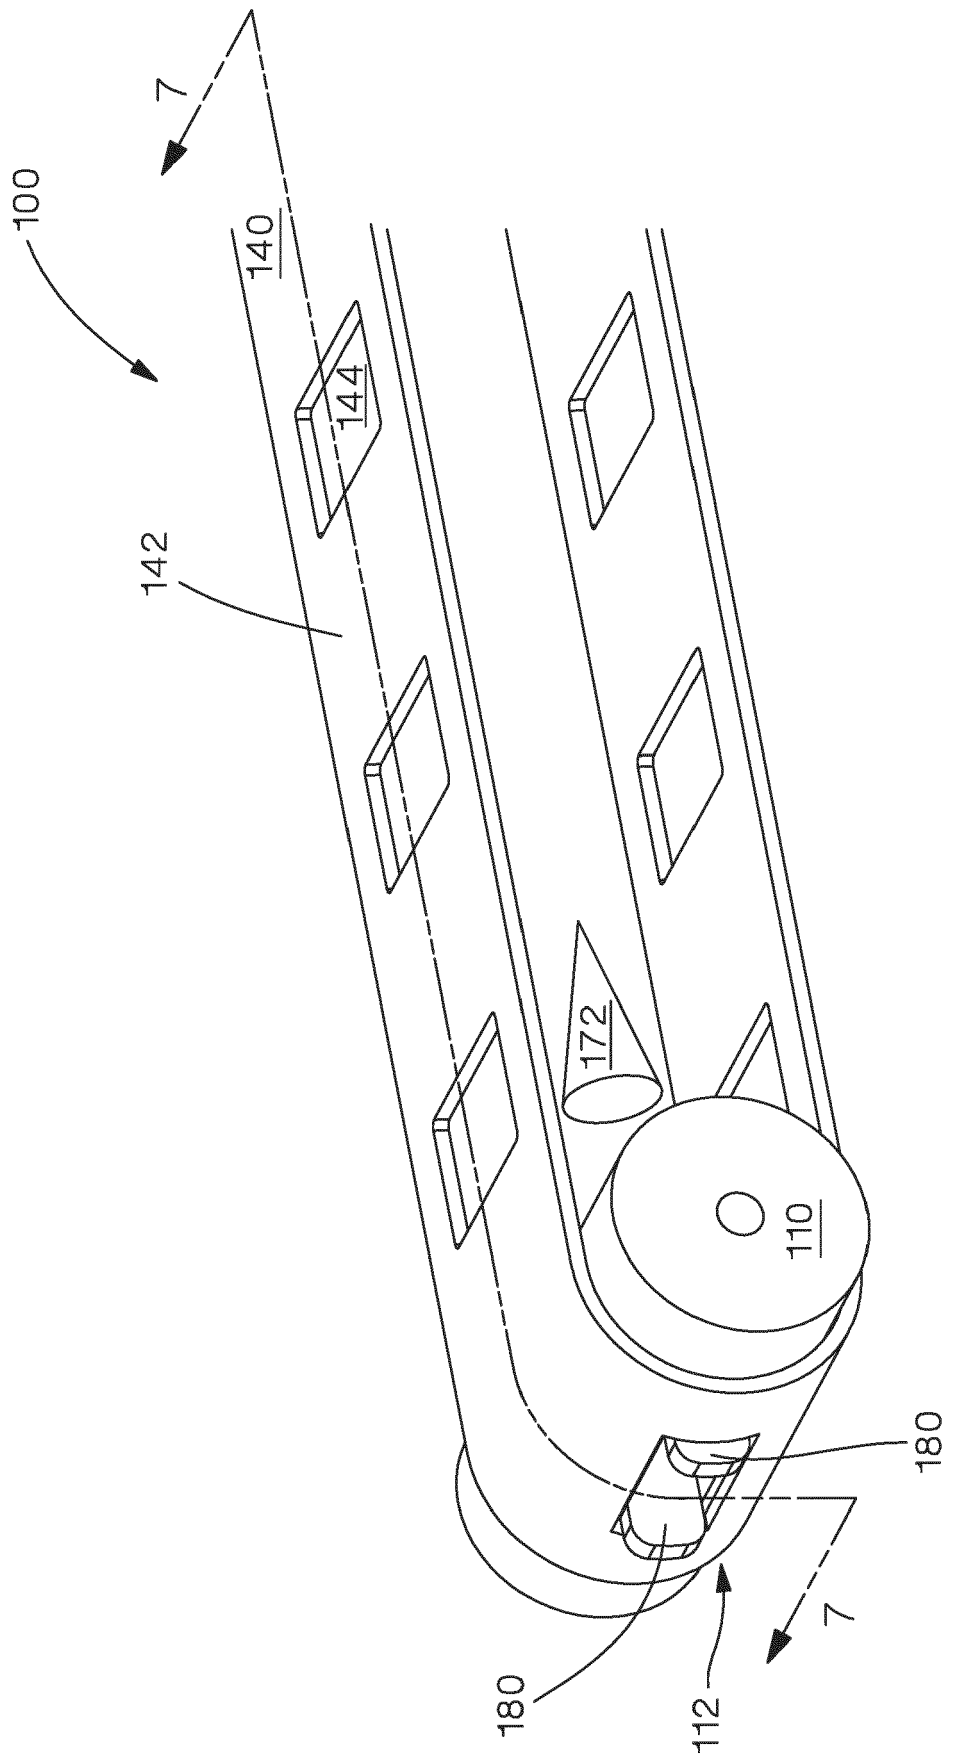
FIG. 6 is a perspective view of internal components of the fiber optic inspection and cleaning tool shown in FIG. 1 that illustrates an interaction of a spindle with a segmented tape;

**[0023]** FIGs. 6 and 7 show the interaction of the spindle 110 with the segmented cleaning tape 140 of the fiber optic inspection and cleaning tool 100, where FIG. 7 shows a cross-sectional view of the fiber optic inspection and cleaning tool 100 taken along line 7-7 from FIG. 6. As the cleaning tape 140 advances to rotate around the spindle 110, the spindle 110 correspondingly rotates so that the spindle tabs 180 catch the windows 144 of the cleaning tape 140.

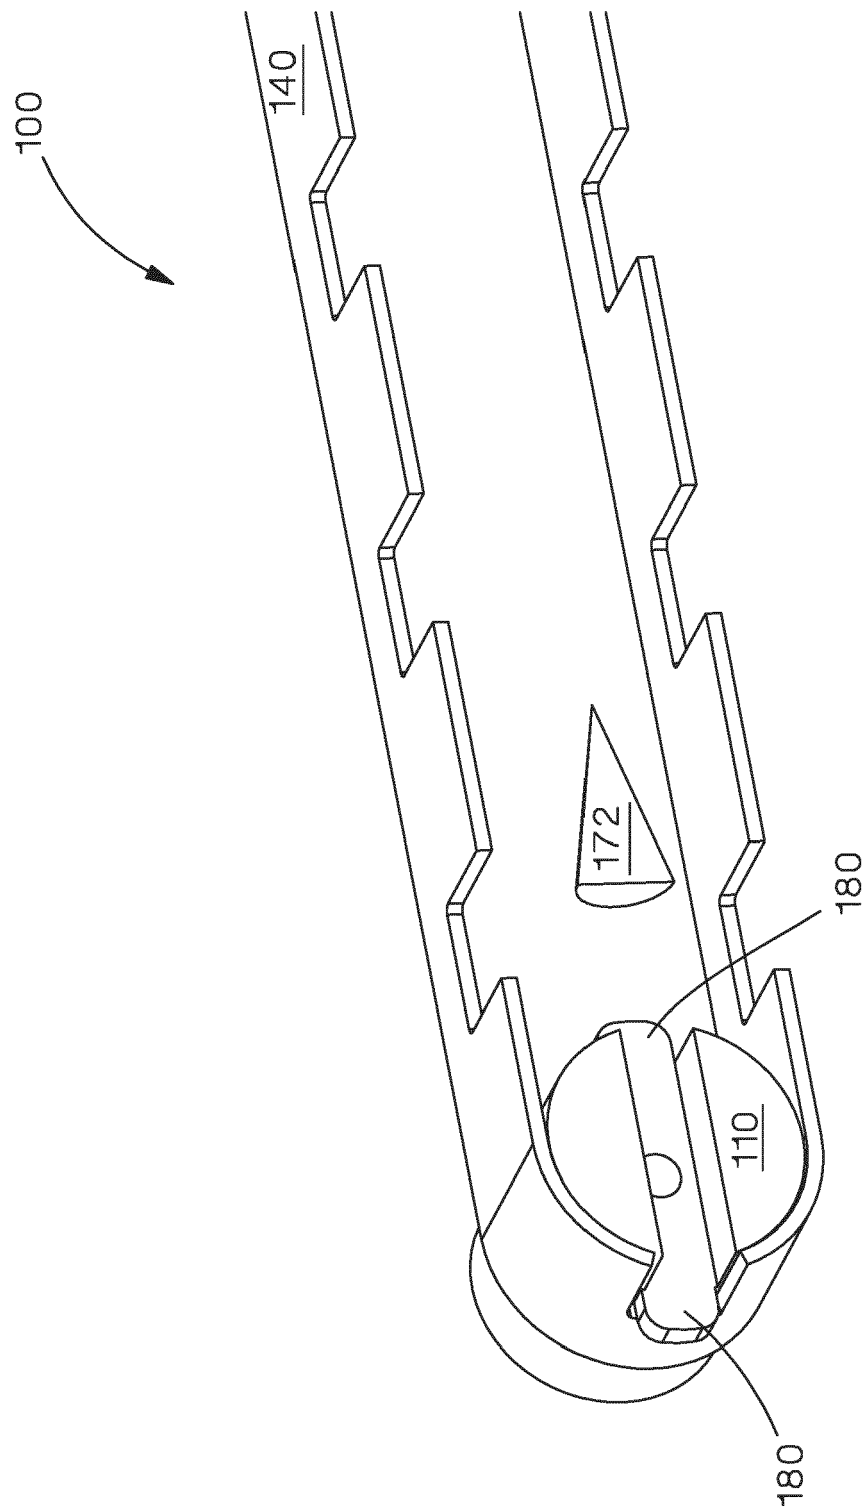
FIG. 7 is a sectional view of the internal components of the fiber optic inspection and cleaning tool taken along line 7-7 shown in FIG. 6.

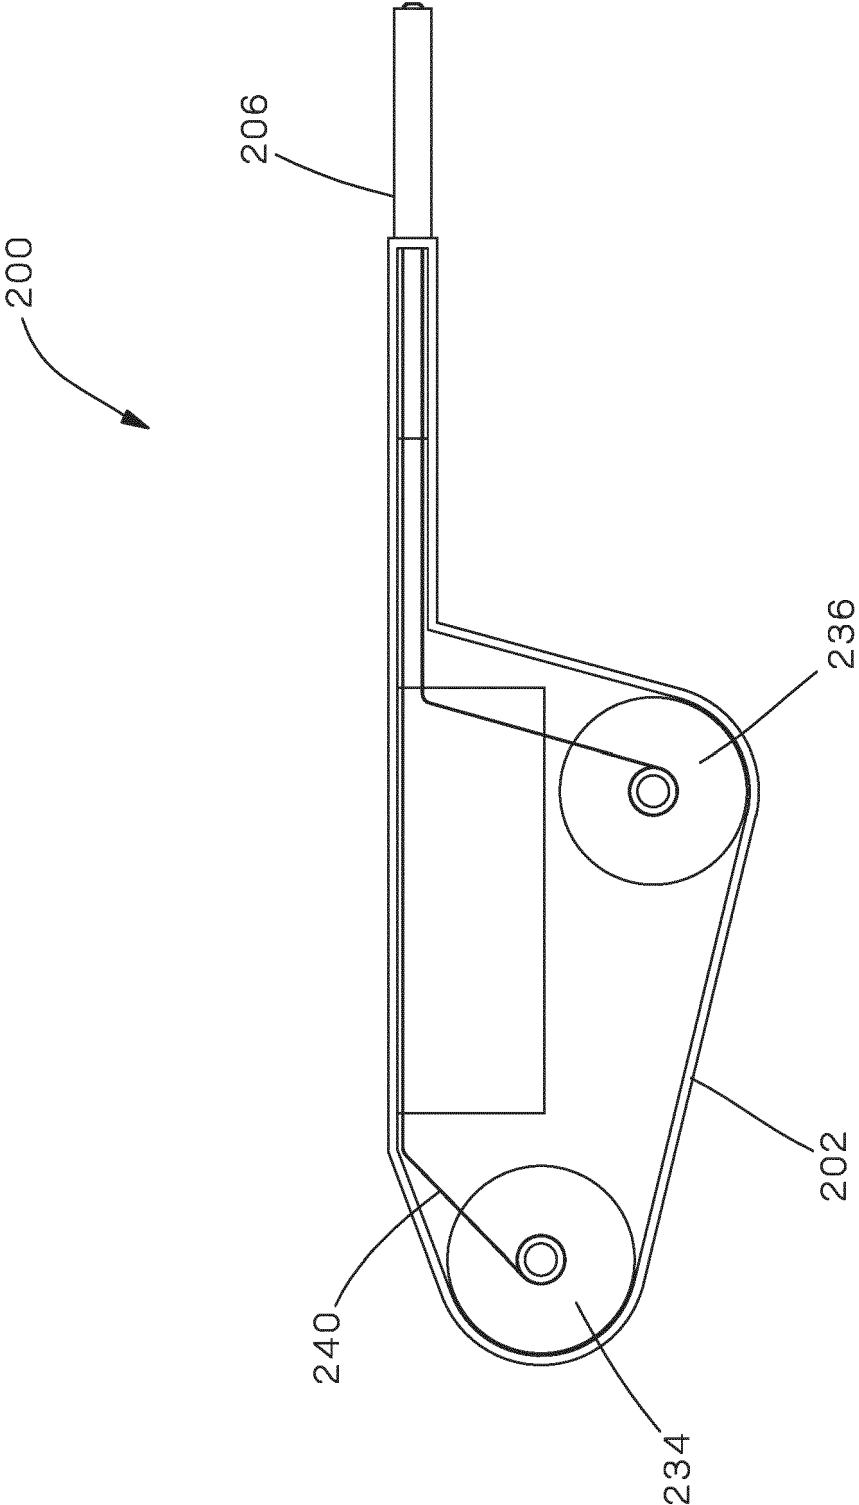
FIG. 8 is a side view of the fiber optic inspection and cleaning tool shown in FIG. 1 having an imaging system removed, according to an embodiment of the present disclosure;

**[0031]** FIGs. 8 and 9 depict an alternate embodiment where the most expensive components of a fiber optic inspection and cleaning tool 200 are detachable and reusable. FIG. 8 depicts all the components that may be discarded, such as a housing 202, a used tape 240, a pair of reels 234 and 236, and a probe 206. FIG. 9 depicts the reusable optical and electrical components. The reusable components include an imaging system 260, internal structure 230 (housing lenses that are not depicted in FIG. 9), light source 268, and indicator 204. The imaging system 260 includes a battery 264, electronics/processors 266, and imaging device 262.

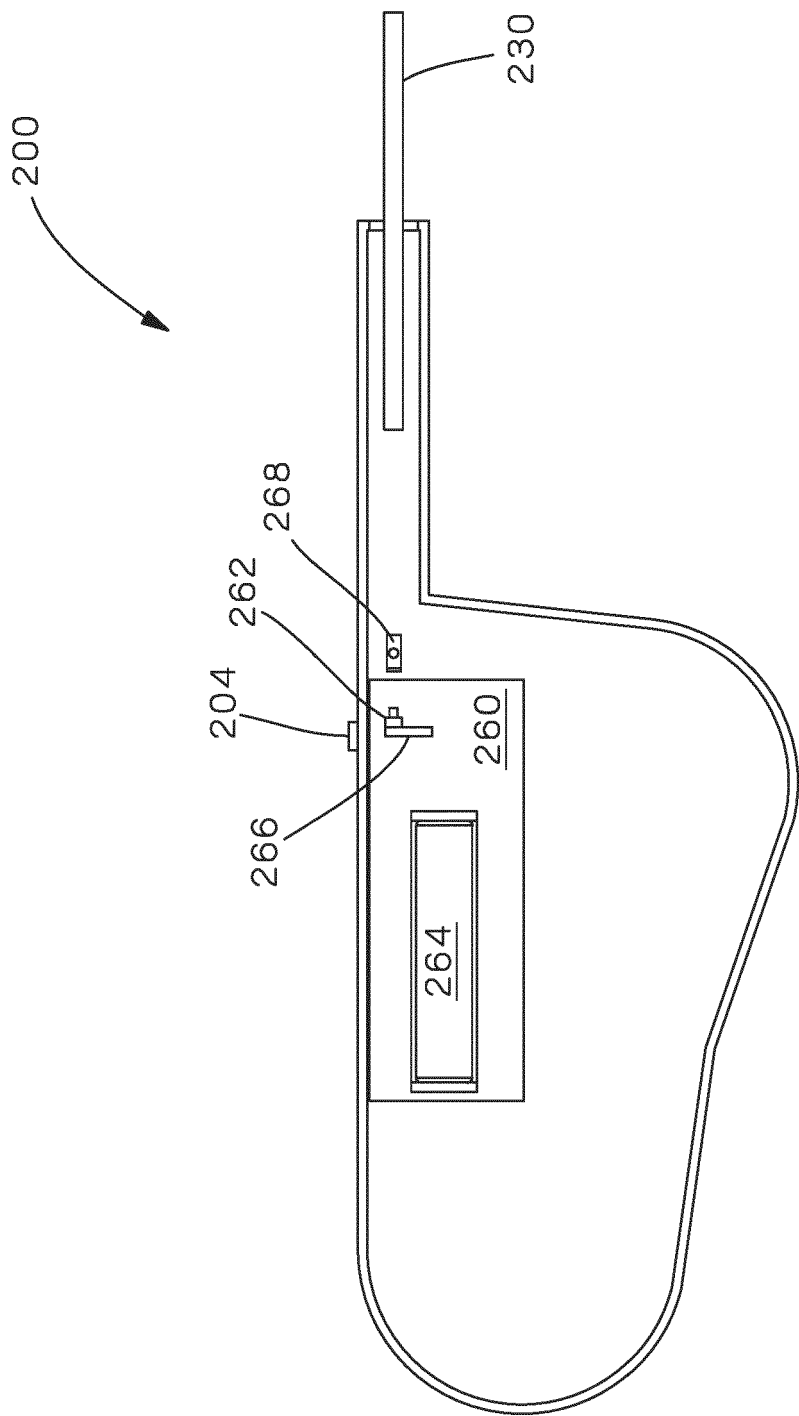
FIG. 9 is a side view of the fiber optic inspection and cleaning tool shown in FIG. 7 with the imaging system included;

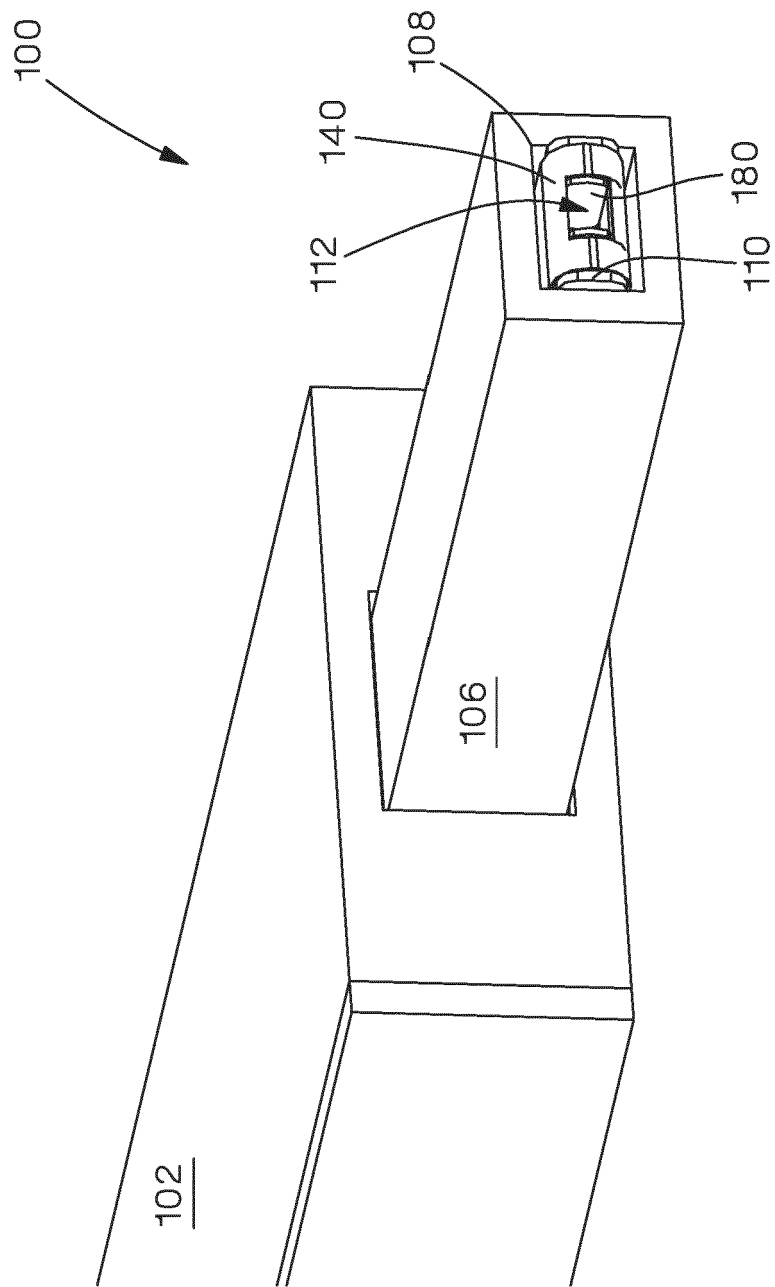
FIG.10

FIG. 10 is a front view of the fiber optic inspection and cleaning tool shown in FIG. 1 with a probe in an extended state;

**[0024]** In addition or alternatively, FIGs. 10 and 11 show a mechanism by which the cleaning tape 140 advances. FIG. 10 shows a perspective view of a portion of the front end 116 of the fiber optic inspection and cleaning tool 100 when the probe 106 is in an extended state. FIG. 11 shows a perspective view of a portion of the front end 116 of the fiber optic inspection and cleaning tool 100 when the probe 106 is in a retracted state. When the probe 106 is pressed against the adapter/connector under test, the probe 106 retreats into the housing 102, and causes the cleaning tape 140 to shift. The retreat of the probe 106 is shown in FIG. 11, however the movement of the cleaning tape 140 is not portrayed in FIG. 11.

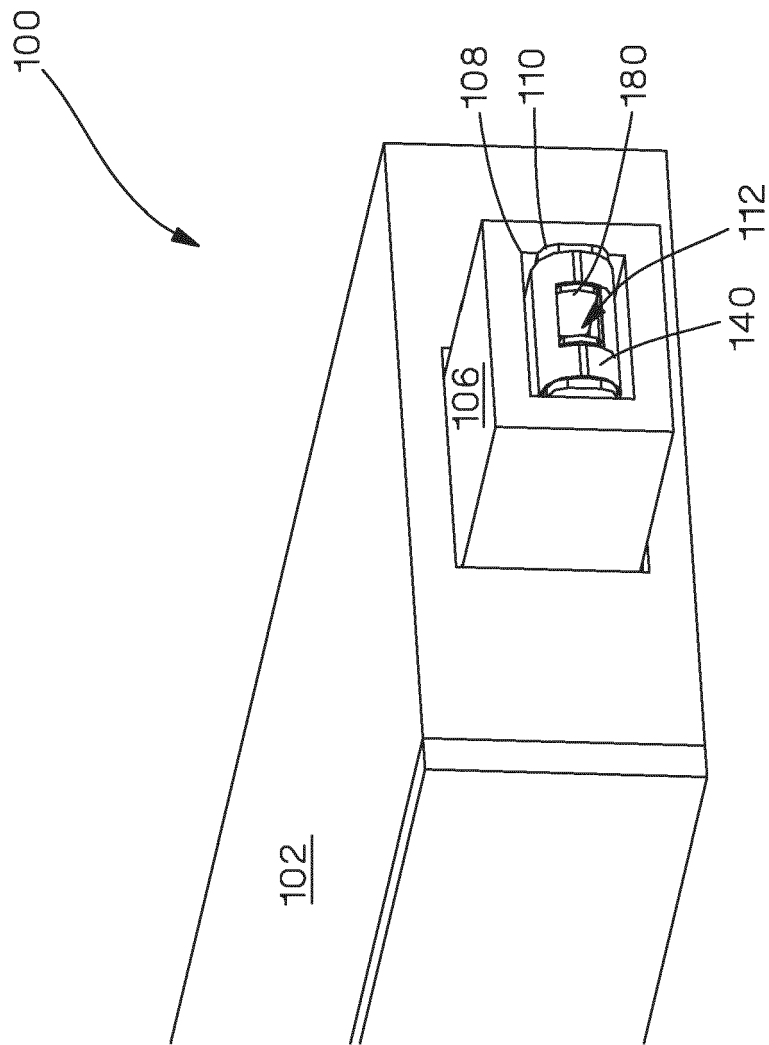
FIG.11

FIG. 11 is a front view of the fiber optic inspection and cleaning tool shown in FIG. 1 with the probe in a retracted state;

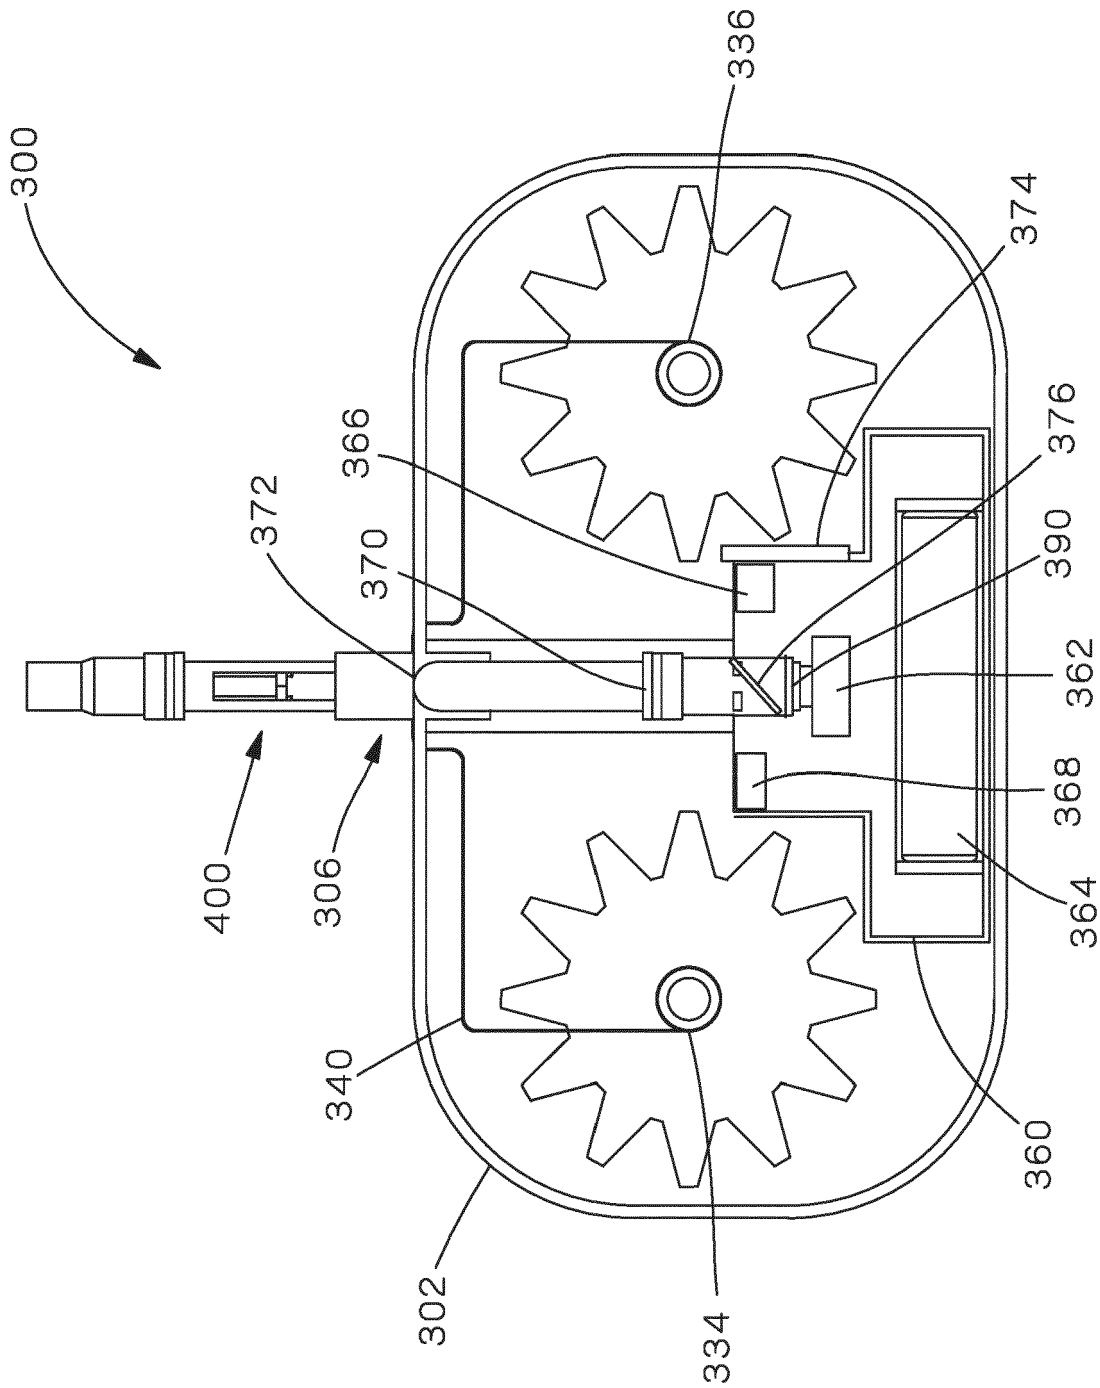
FIG.12

FIG. 12 is a top down view of a fiber optic inspection and cleaning tool having a top cover removed to show at least some internal components, according to an alternative embodiment of the present disclosure;

**[0032]** FIGs. 12 and 13 disclose another exemplary fiber optic inspection and cleaning tool 300 according to

**[0033]** The fiber optic inspection and cleaning tool 300 includes a housing 302, an adapter 306, an imaging system 360, a pay-off reel 334, a take-up reel 336, and a cleaning tape 340. The imaging system 360 includes a battery 364, a light source 368, an imaging device 362, a lens/filter 390, a first lens 370, a second lens 372, an absorber 374, electronics/processors 366, and a beam splitter 376. An adapter 306 is used in place of a probe in order to receive the connector 400. The cleaning tape 340 is similar to the cleaning tape 140 and includes windows to provide an opportunity for the camera to view the end face of the connector. A spindle 310 can be seen in FIG. 13 having a vertical configuration, rather than a horizontal configuration like spindle 110. Optionally, the fiber optic inspection and cleaning tool 300 may include an indicator (not shown). As noted above, the functionalities of each feature of the fiber optic inspection and cleaning tool 300 are similar to the functionalities of the features of the fiber optic inspection and cleaning tool 100.

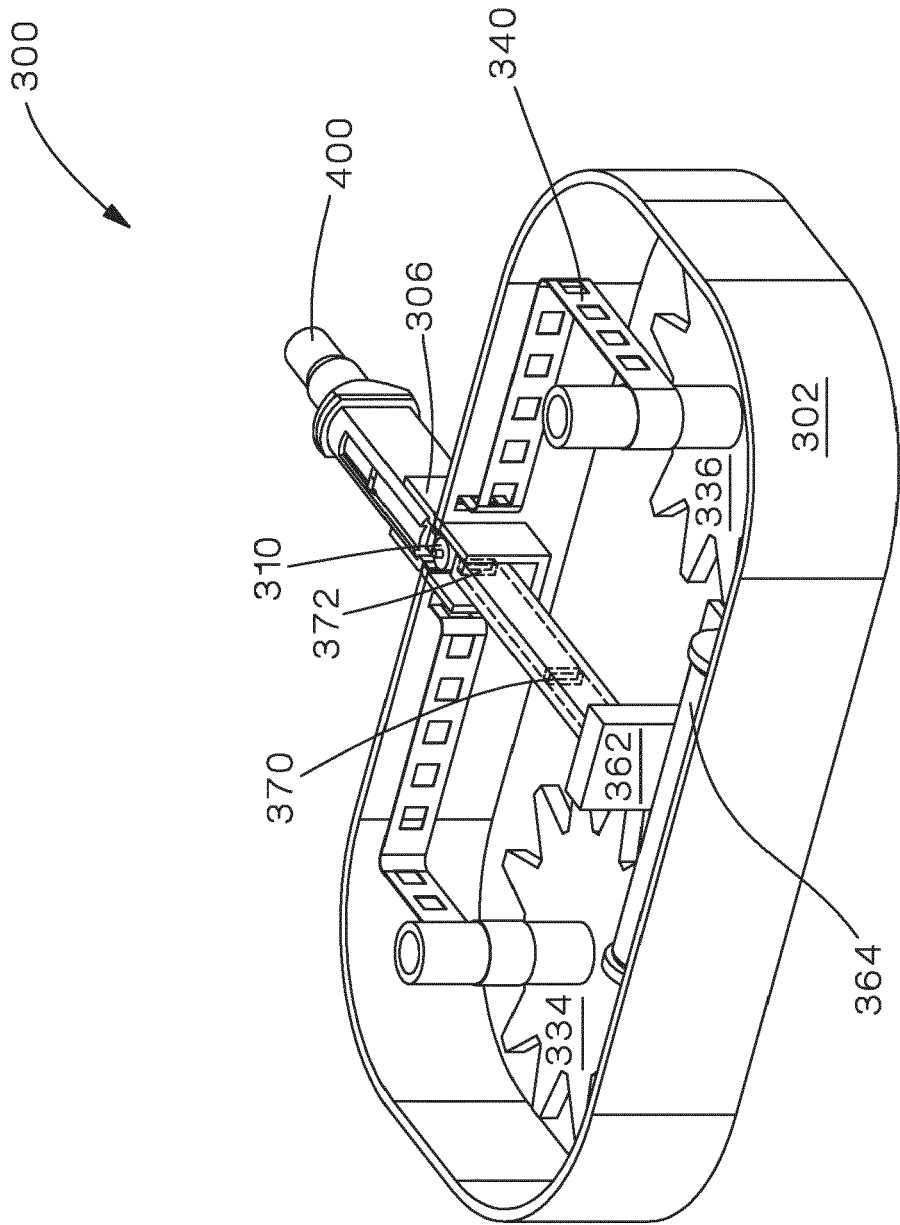
FIG.13

FIG. 13 is a perspective view of the fiber optic inspection and cleaning tool shown in FIG. 12;

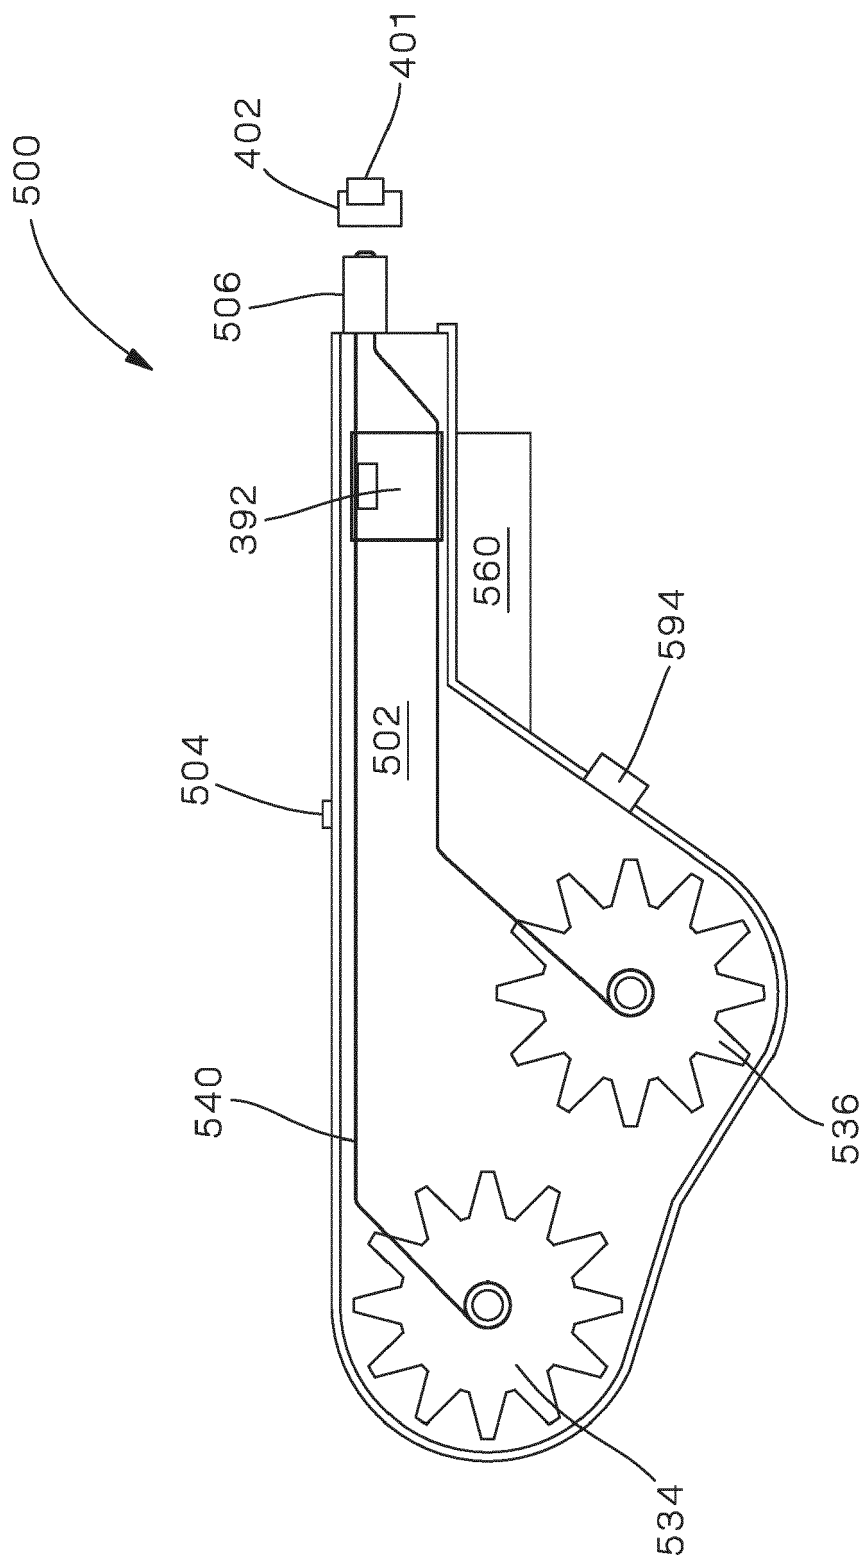
FIG.14

FIG. 14 is a side view of a fiber optic inspection and cleaning tool having a side housing removed to show at least some internal components, according to an alternative embodiment of the present disclosure;

**[0037]** FIGs. 14-17B disclose an exemplary fiber optic inspection and cleaning tool 500 according to another alternative embodiment of the present disclosure, where an imaging system 560 is located adjacent to a housing 502. The fiber optic inspection and cleaning tool 500 includes a housing 502, an indicator 504, an imaging system 560, a cleaning tape 540, an attachment section 592, a probe 506 to interface with an adapter 402 or connector end-face 401, a button, a pay-off reel 534, and a take-

**[0039]** The imaging system 560 can be attached or detached from the fiber optic inspection and cleaning tool 500 through the attachment section 592. Although seen in FIG. 14 as being visible on the opposite side of the housing 502, in an alternate embodiment as seen in FIGs. 15, the imaging system 560 may attach within the housing 502 and may not be visible on the opposite side of the housing 502. In some embodiments, the cleaning system and imaging system 560 may work independently from each other. The separation of the modules allows for re-using the optical module, which may be significantly more expensive than the cleaning module. The cleaning module (in housing 502) can provide several hundreds of cleaning instances, and then be discarded or recycled. The imaging system 560 may be attached to new cleaning modules when required.

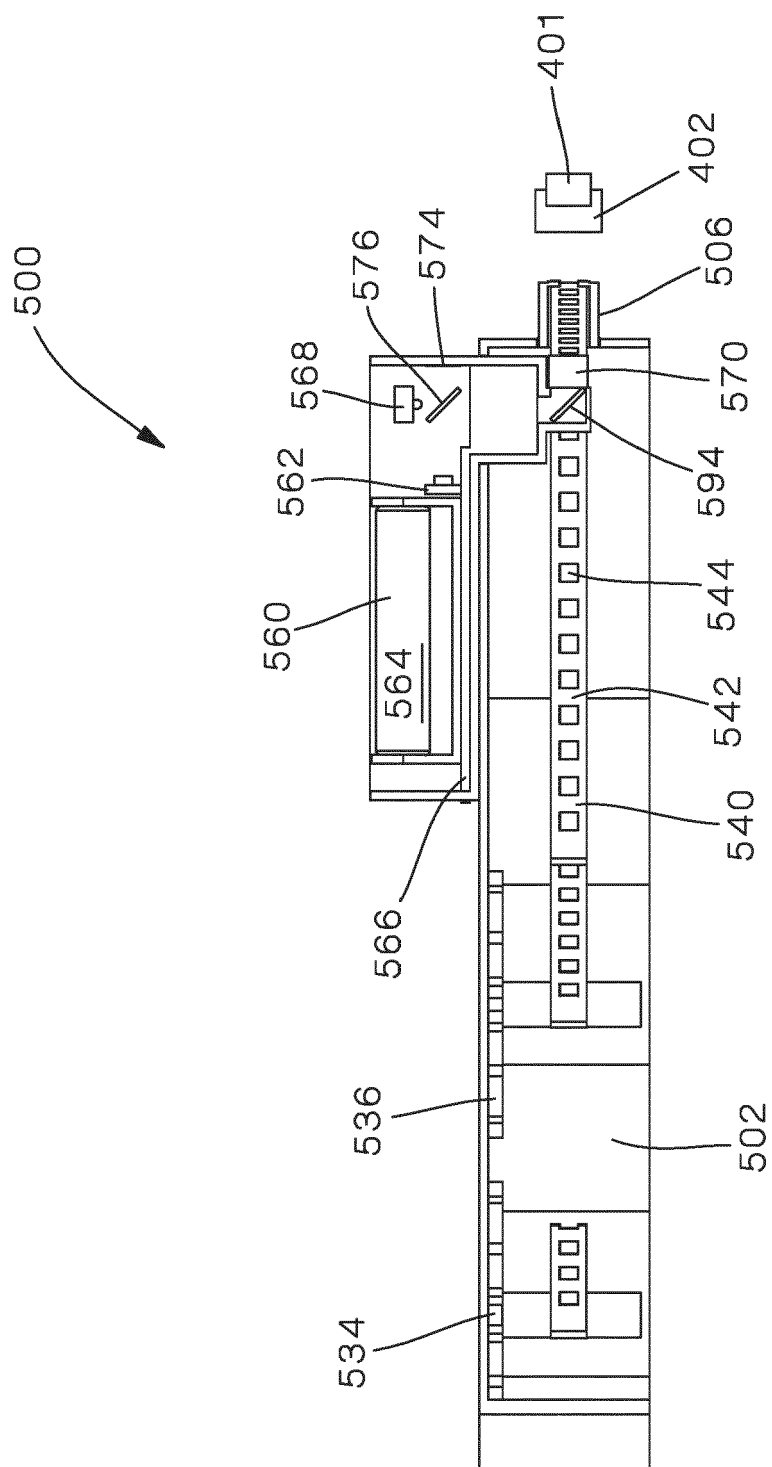
FIG. 15 is a top view of a portion of the fiber optic inspection and cleaning tool shown in FIG. 14

**[0040]** FIGs. 15 and 16 are top views of a portion of the example fiber optic inspection and cleaning tool 500 demonstrating the configuration of imaging system 560. FIG. 15 shows a view of the fiber optic inspection and cleaning tool 500 absent a top cover and the top portion of the cleaning tape 540 (the portion coming off pay-off reel 534). What is shown in FIG. 15 is the portion of the cleaning tape 540 after it come off spindle 510 (seen in FIG. 17A) and is on its way to take-up reel 536. FIG. 15 depicts the imaging system 560 connecting into the housing 502 between the probe 506 and the take-up reel 536. The imaging system 560 includes a battery 564, a light source 568, an imaging device 562, electronics/processors 566, a beam splitter 576, a light absorber 574, a mirror 594, and a lens 570. The lens 570 may include more than one lens. The battery 564 may be changed as needed. The cleaning tape 540 includes cleaning sections 542 and windows 544. FIG. 16 depicts an indicator 504 located toward the rear of the imaging system 560, located on top of the imaging system 560. Alternatively, the indicator 504 may be located directly on the housing 502.

**[0042]** As can be seen from FIGs. 15 and 16, when viewed from above the imaging system 560 forms an "L" shape. An attachment section 596 is a portion of the imaging system 560 furthest away from the light source 568 in the direction the light travels (towards the housing 502).
