**EP 3 798 701 A1**

• **Castro, Jose M.****Naperville, Illinois 60565 (US)**(54) **FIBER OPTIC INSPECTION TOOL WITH INTEGRATED CLEANING MECHANISM**

(57) Various implementations of fiber optic inspection tools with integrated cleaning mechanisms are disclosed. The fiber optic inspection and cleaning tool includes a housing, a cleaning system and an imaging system. The cleaning system includes a pay-off reel, a take-up reel, a spindle and a cleaning tape that travels

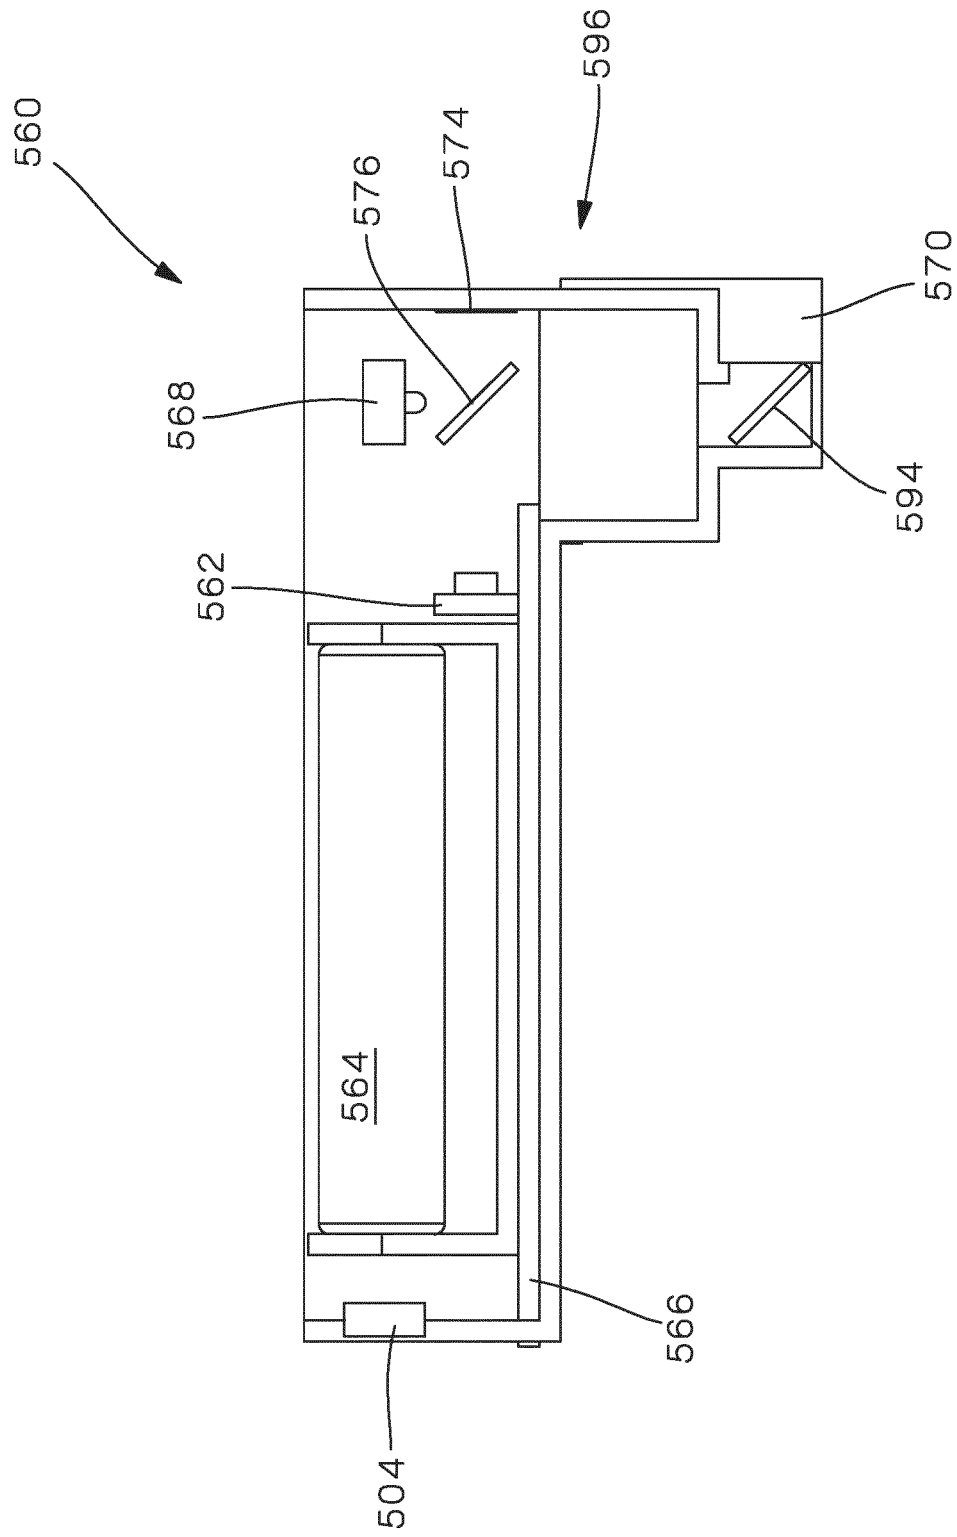
FIG. 16 is a top view of an imaging system component of the fiber optic inspection and cleaning tool shown in FIG. 15;

**[0040]** FIGs. 15 and 16 are top views of a portion of the example fiber optic inspection and cleaning tool 500 demonstrating the configuration of imaging system 560. FIG. 15 shows a view of the fiber optic inspection and cleaning tool 500 absent a top cover and the top portion of the cleaning tape 540 (the portion coming off pay-off reel 534). What is shown in FIG. 15 is the portion of the cleaning tape 540 after it come off spindle 510 (seen in FIG. 17A) and is on its way to take-up reel 536. FIG. 15 depicts the imaging system 560 connecting into the housing 502 between the probe 506 and the take-up reel 536. The imaging system 560 includes a battery 564, a light source 568, an imaging device 562, electronics/processors 566, a beam splitter 576, a light absorber 574, a mirror 594, and a lens 570. The lens 570 may include more than one lens. The battery 564 may be changed as needed. The cleaning tape 540 includes cleaning sections 542 and windows 544. FIG. 16 depicts an indicator 504 located toward the rear of the imaging system 560, located on top of the imaging system 560. Alternatively, the indicator 504 may be located directly on the housing 502.

**[0042]** As can be seen from FIGs. 15 and 16, when viewed from above the imaging system 560 forms an "L" shape. An attachment section 596 is a portion of the imaging system 560 furthest away from the light source 568 in the direction the light travels (towards the housing 502).

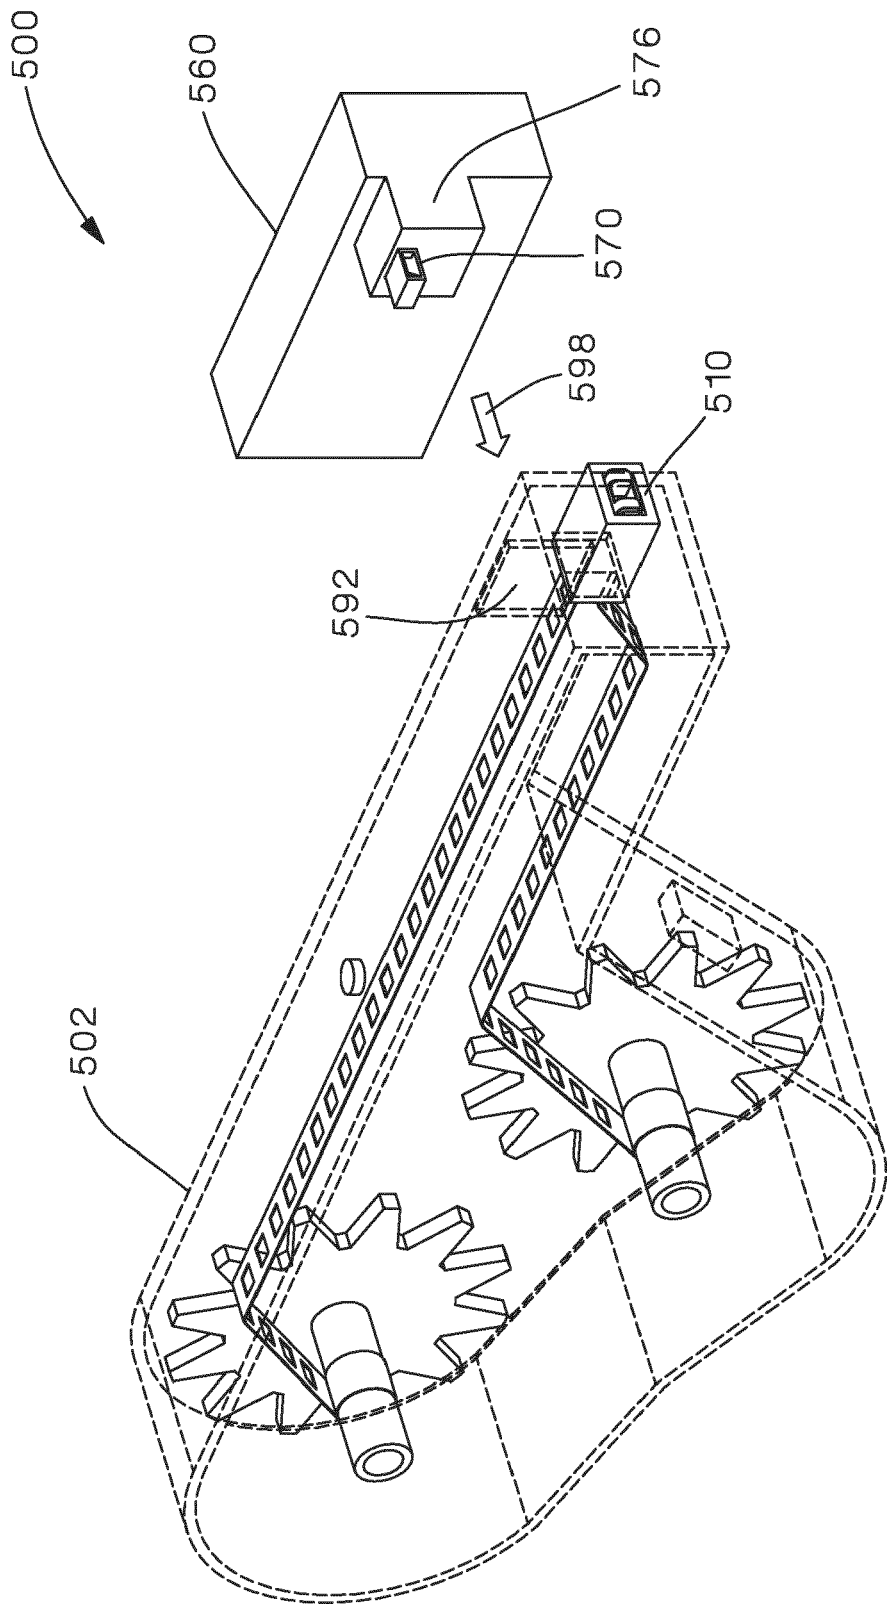
FIG. 17A is a view showing the imaging system and cleaning system separated of the example fiber optic inspection and cleaning tool shown in FIG. 14; and

**[0044]** FIG. 17A is a view showing the imaging system and cleaning system separated of the example fiber optic inspection and cleaning tool 500, and FIG. 17B is a view showing the integrated imaging system and cleaning system of the fiber optic inspection and cleaning tool 500. An arrow 598 in FIG. 17A shows the movement of the imaging system 560 in order to connect with the housing 502 of the cleaning portion of the fiber optic inspection and cleaning tool 500. As imaging system 560 connects with the housing 502, the attachment section 596 goes into attachment section 592, and lens 570 is in line with spindle 510 and tape 540.

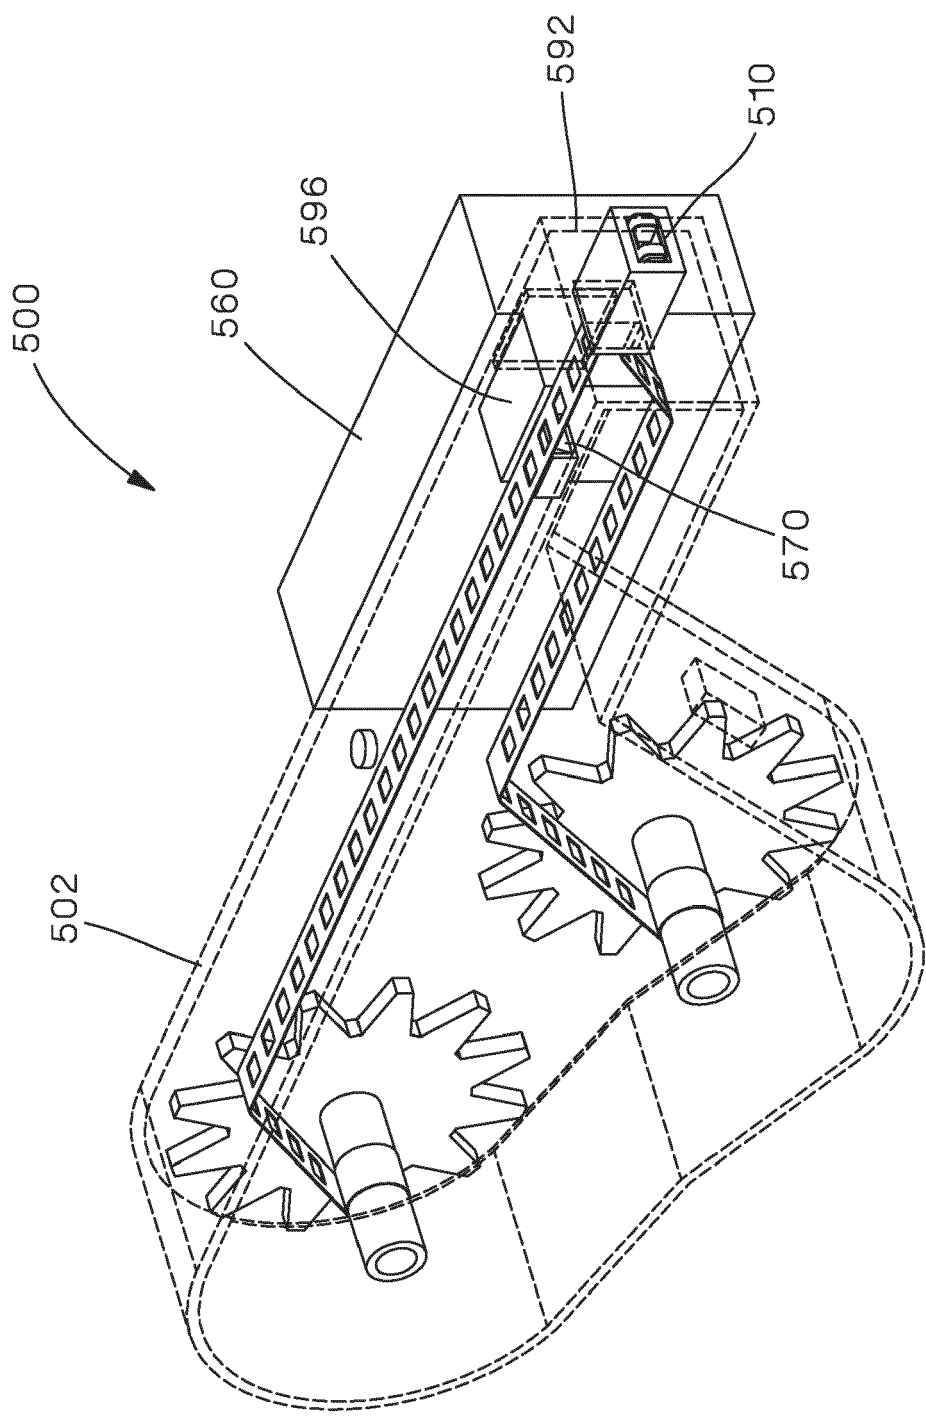
FIG.17B

FIG. 17B is a view showing the integrated imaging system and cleaning system of the example fiber optic inspection and cleaning tool shown in FIG. 14.
