[11] Patent Number: **5,813,118**

- [54] **METHOD FOR REPAIRING AN AIR COOLED TURBINE ENGINE AIRFOIL**
- [75] Inventors: **Lawrence J. Roedl**, West Chester;
Joseph H. Bowden, Jr., Mason, both of Ohio
- [73] Assignee: **General Electric Company**, Cincinnati, Ohio

METHOD FOR REPAIRING AN AIR COOLED TURBINE ENGINE AIRFOIL

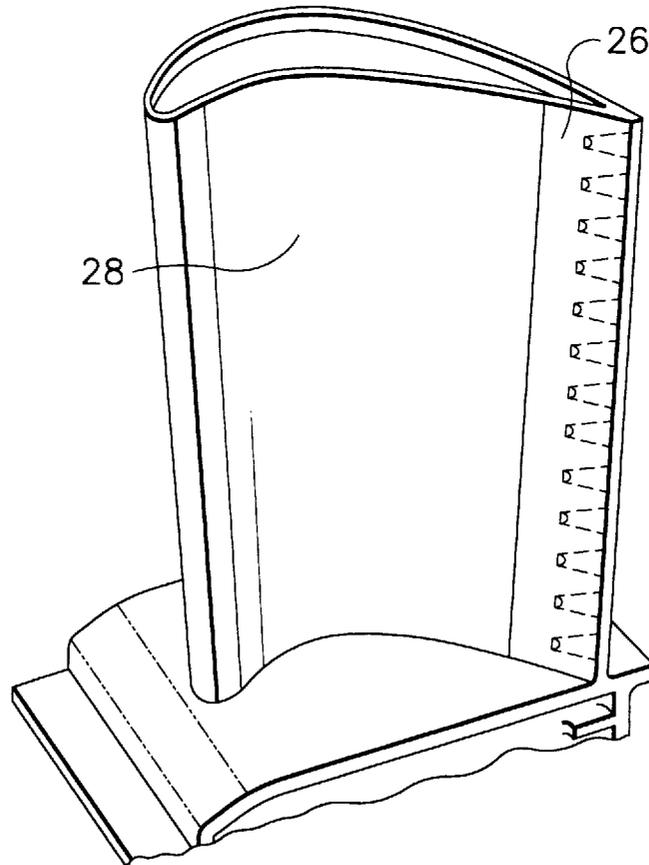
FIG. 1 is a perspective view of a gas turbine engine turbine rotor blade including trailing edge cooling air openings and associated cooling air discharge guide slots.

With reference to the drawing, a perspective view of an air cooled gas turbine engine turbine rotor blade is shown in FIG. 1. In that figure, the blade shown generally at 10 includes an airfoil 12 and a base 14. The airfoil leading edge is shown generally at 16 and the airfoil trailing edge is shown generally at 18. Cooling air discharge openings, such as holes 20 in a portion of trailing edge 18, communicate with the blade hollow interior to enable cooling air discharge from the blade interior and cooling of the blade outer wall 22, the discharge air being guided by air cooling slots or indentations 24 in outer wall 22. For high temperature environmental resistance during operation, outer wall 22 and generally at least the walls of openings 20 include a coating such as a commercially available aluminide coating. An example of such a coating is the above identified Codep aluminide coating. In some examples, a platinum aluminide combination coating is used, the platinum being first applied by electrodeposition, followed by Codep aluminide treatment of the platinum surface.

In one specific example of the practice of the present invention, an air cooled high pressure turbine blade from operation in a gas turbine engine was inspected for damage and serviceability. The blade was of the type described in connection with FIG. 1 and included trailing edge air cooling discharge openings and guide slots as shown. It was determined that a portion of the airfoil away from the trailing edge was damaged but could be repaired and made serviceable by welding. The blade had been cast from the above identified monocrystalline Rene' N5 Ni base superalloy. For environmental resistance during operation, the blade airfoil had been coated with the above described platinum aluminide combination coating. Included on inner walls of internal passages connected with the air cooling discharge openings was a coating of aluminide which had been deposited, as well known in the art, by a commercially available gas phase type of aluminiding.

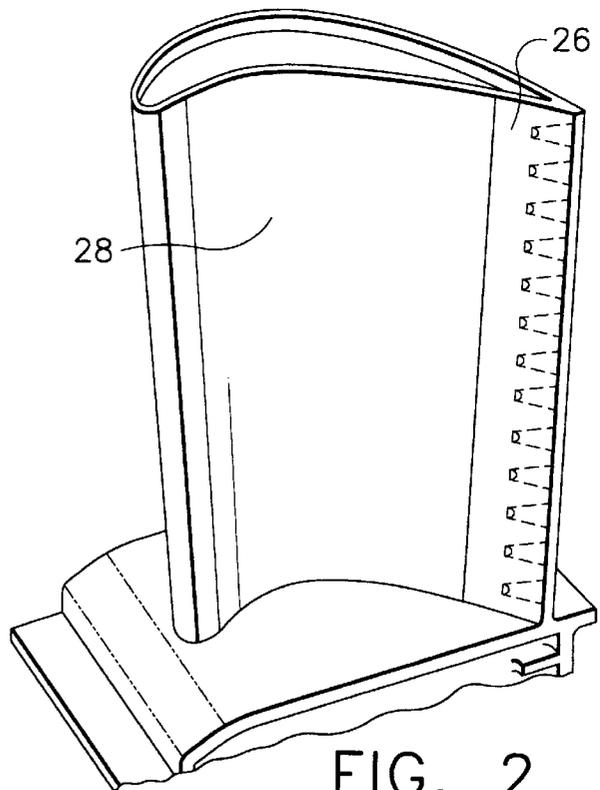
FIG. 2 is a fragmentary view of FIG. 1 with outer wall maskant on the trailing edge outer wall surface over cooling air openings and discharge guide slots.

One form of steps in the practice of the present invention is shown in FIG. 2 which is a fragmentary view of the blade of FIG. 1. The blade airfoil in FIG. 2 required repair in areas not including the trailing edge portion. In FIG. 2, a maskant was applied to the surface of the coating on outer wall 22 in the selected discrete trailing edge portion shown to provide a masked coated outer wall surface 26 and an unmasked coated outer wall surface 28. Then, to prepare the airfoil further for repair, coating was removed only from the unmasked surface 28. The coated surface beneath masked surface 26 thereby was preserved, without risk of wall thinning resulting from coating removal. After such selected coating removal, the maskant was removed and the airfoil was repaired. Generally, a replacement environmental resistant coating, which can be the same as or different from other coatings on or within the blade, is applied at least to the stripped, unmasked surface 28.

applied: to the selected discrete trailing edge portion over the openings and slots, as shown at 26 in FIG. 2; and within internal cavities to cover inner walls at least up to the openings in the outer wall. Masking of the internal cavities, as currently practiced in the art, was accomplished by injecting a commercial acid resistant resin maskant, sometimes called Plastisol material, into an opening through the blade base until the maskant was extruded through the air cooling discharge openings, thereby masking inner coated walls. In addition, according to the present invention, additional maskant was applied to the airfoil outer wall, limited to the selected trailing edge portion, by dipping that portion in Plastisol material. Any maskant which inadvertently was deposited, from the masking steps, on the outer wall other than on the selected outer wall surface in the trailing edge portion and within the air discharge openings, was removed by a light aluminum oxide grit blast. If desired, the removal of surface contaminants from engine operation and removal of undesired maskant on the outer wall surface can be combined in a single grit blast operation.

This provided the airfoil with a masked outer wall surface 26 and an unmasked outer wall surface 28. That maskant is typical of a variety of commercially available wax or curable resin maskants which are resistant to commercial acid based coating stripping solutions, for example the combination of acid solutions described above, and which can be removed substantially without residue by heating at a relatively low temperature, for example in the range of up to about 1100° F.
