(10) **Patent No.:** **US 8,904,635 B2**

(54) **METHOD FOR SERVICING A TURBINE PART**

(73) Assignee: **General Electric Company**, Schenectady, NY (US)

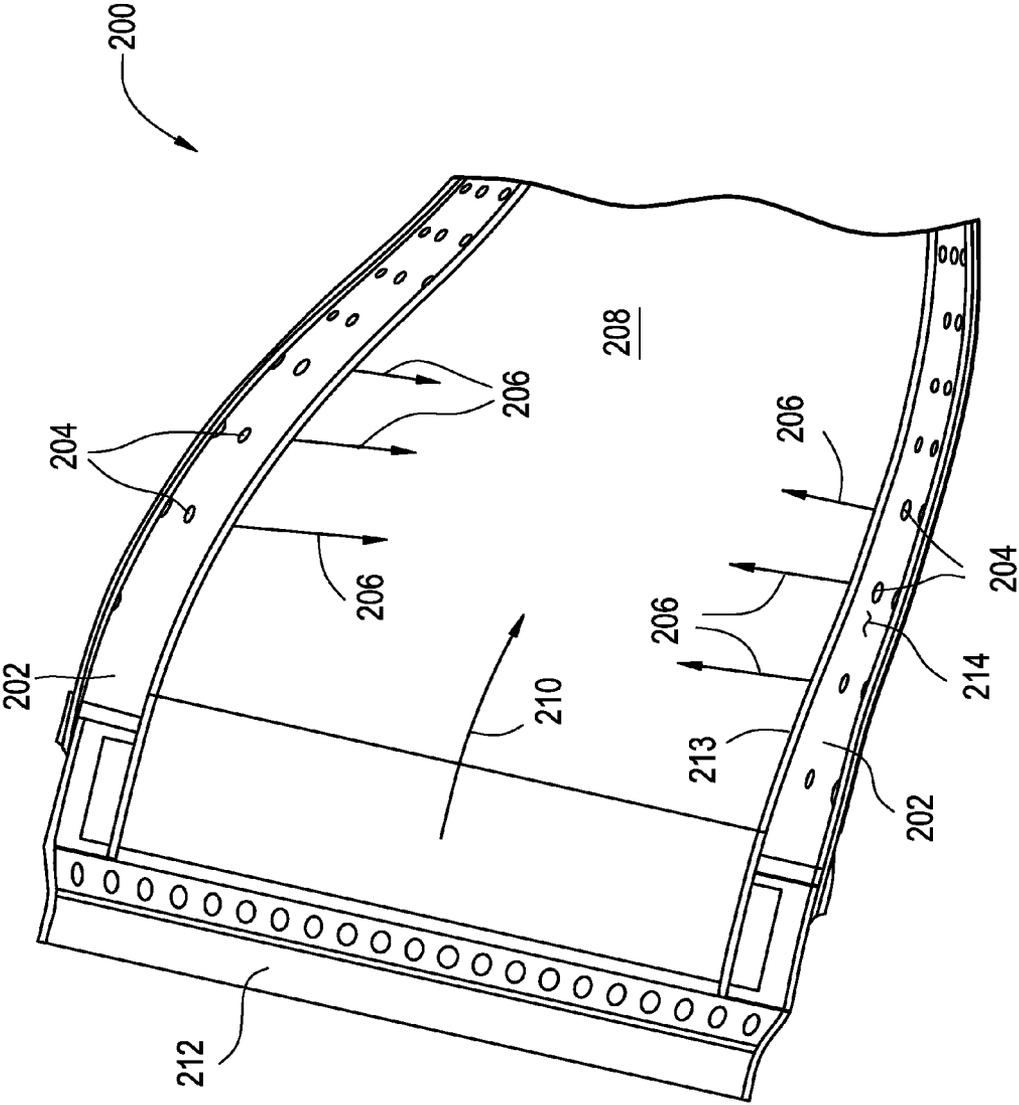
FIG. 2 is a sectional side view of an embodiment of a transition piece;

Referring now to FIG. 2, a sectional side view of an embodiment of a transition piece **200** is illustrated. The transition piece **200** includes a body **202** with holes **204** for flow of a cooling fluid **206** into a chamber **208**. The cooling fluid **206** is configured cool the body **202** as a hot gas flow **210** flows into the chamber **208** from a combustor coupled to transition piece end **212**. The holes **204** are a suitable structure or geometry, such as circles, hexagons or squares, to provide cooling fluid flow **206** that creates a film on body **202** to protect the body **202** as the hot gas **210** flows through the transition piece **200**. The shape and size of the holes **204** are designed to improve cooling of the body **202** (also referred to as impingement sleeve). In an embodiment, the holes **204** are a circular structure with a diameter of about 0.5 to 3 millimeters, wherein the size and shape of the structure causes the cooling fluid **206** to diffuse in the chamber **208**. In an embodiment, the body **202** comprises a steel alloy and the holes **204** are punched, drilled or otherwise formed in the body **202**. The pulsed laser weld repair near the holes **204** does not substantially change the diameter of the holes **204**, thereby enabling the cooling fluid to flow and produce the desired cooling in the turbine part, such as transition piece **200**.

In addition, an exemplary transition piece **200** includes a thermal barrier coating **213** wherein the thermal barrier coating **213** is configured to provide a layer of protection to the transition piece **200** from the high temperatures caused by hot gas flow **210** within the transition piece **200**. Further, thermal barrier coating **213** is disposed on a surface of the transition piece **200** wherein the thermal barrier coating **213** comprises a metal substrate, metallic bond coat, thermally grown oxide and ceramic topcoat. In embodiments, a structural flaw, such as a crack **214**, may develop near holes **204**. A pulsed laser welder may be used to fill the crack by precisely melting a filler material and the body **202** near the crack, wherein the pulsed laser weld repairs the crack **214** without affecting the nearby holes **204** and while maintaining the thermal barrier coating **213**. This is due to the precision and short pulse width of pulsed laser weld focused on the small area of the crack **214**. Thus, by intensely focusing short pulse width laser beams of the pulsed laser welder in a selected area, the pulsed laser welder provides a lower heat to the region of the body **202** near the crack **214**, thereby protecting the holes **204** and thermal barrier coating **213**. By precisely filling the crack **214**

using the pulsed laser welder, the repair of the transition piece **200** is simplified and shortened due to the weld not affecting the structure of holes **204** and thermal barrier coating **213**.

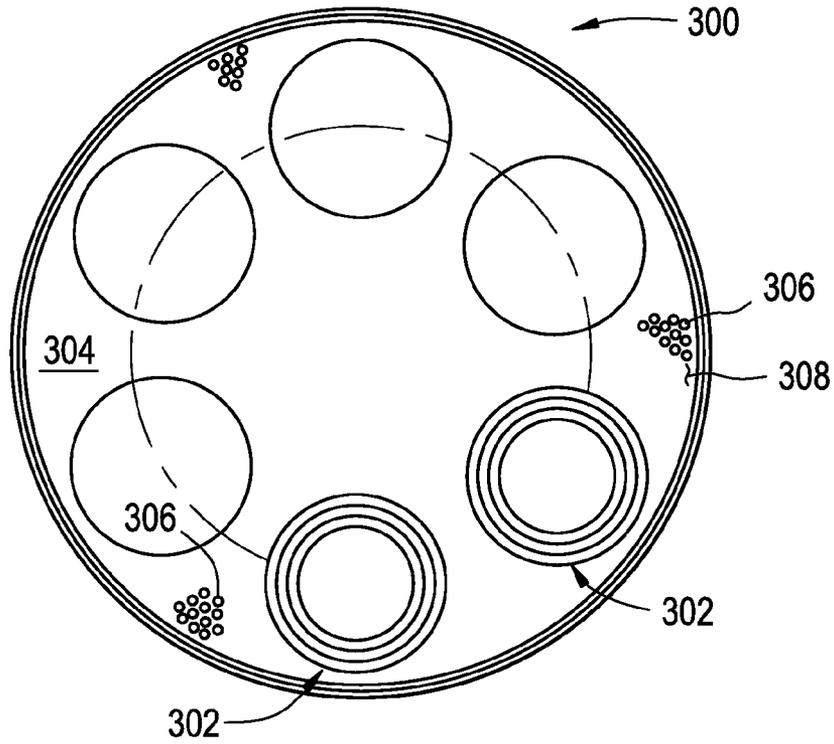
FIG. 3 is a top view of an embodiment of an effusion plate; and

FIG. 3 is a top view of an embodiment of an effusion plate **300**. In one embodiment, the effusion plate **300** is proximate to a downstream end of one or more fuel nozzles **302**. The effusion plate **300** includes a body **304** with a plurality of holes **306** for a flow of cooling fluid. In an aspect, the holes **306** are circular holes configured to enable a fluid flow through the holes **306** and causing a film of cooling fluid to develop on the body **304**, thereby cooling the body from the hot gas flow within the turbine. In aspects, the holes **306** may be any suitable structure, including but not limited to, circles, hexagons and squares. Over time, wear and tear may cause flaws, such as a crack **308**, to develop on the body **304** near the holes **306**. As discussed above, the crack **308** is repaired by a pulsed laser welder without affecting the structure of the holes. In an example, the effusion plate **300** is removed from the turbine and the crack **308** is pulsed laser welded while still attached to adjacent components, such as nozzles **302**, thereby eliminating disassembly and assembly steps of the repair process. The pulsed laser weld provides a precise and focused weld to fill the crack **308** without affecting regions near the weld. Specifically, the precise laser weld of the crack **308** does not affect a structure of the cooling fluid holes **306** and is performed while attached to fuel nozzles **302**. Thus, the crack **308** is repaired and operational without brazing or machining the body **304** or the holes **306** following the pulsed laser welding process. Accordingly, the repair process is simplified and shortened by utilizing pulsed laser welding to avoid several steps that are used in other repair processes.

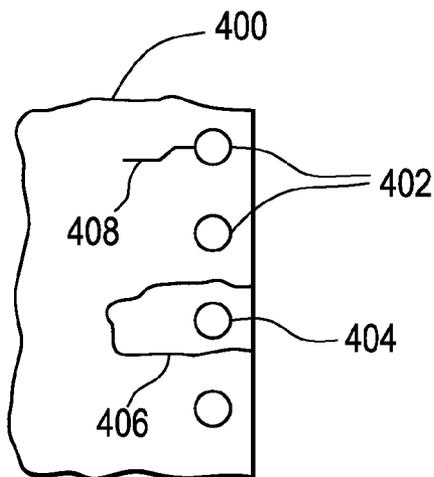
FIG. 4 is a top view of an embodiment of a combustion part that has been repaired.

FIG. 4 is a top view of an embodiment of a combustion part **400** that has been repaired using a pulsed laser welder. The combustion part **400** includes holes **402**, repaired hole **404**, weld area **406** and crack **408**. The repaired hole **404** shows the structure of the hole **404** that has been maintained after a pulsed laser weld has repaired a crack filled by the weld area **406**. The depicted weld area **406** shows the area after pulsed laser welding, where the weld forms a small pool, but does not fill hole **404**. Therefore, the hole **404** is capable of fluid flow without machining or drilling the hole before reinstalling in the turbine. Element **408** depicts an example of a crack that may be repaired by the pulsed laser welding method discussed above.
