[11] **Patent Number:** 5,703,816[45] **Date of Patent:** Dec. 30, 1997[54] **FAILED MEMORY CELL REPAIR CIRCUIT OF SEMICONDUCTOR MEMORY**[75] Inventors: **Hyo-Yun Nam; Young-Ho Suh**, both of Kyungki-do, Rep. of Korea[73] Assignee: **Samsung Electronics Co., Ltd.**, Suwon, Rep. of Korea

# **FAILED MEMORY CELL REPAIR CIRCUIT OF SEMICONDUCTOR MEMORY**

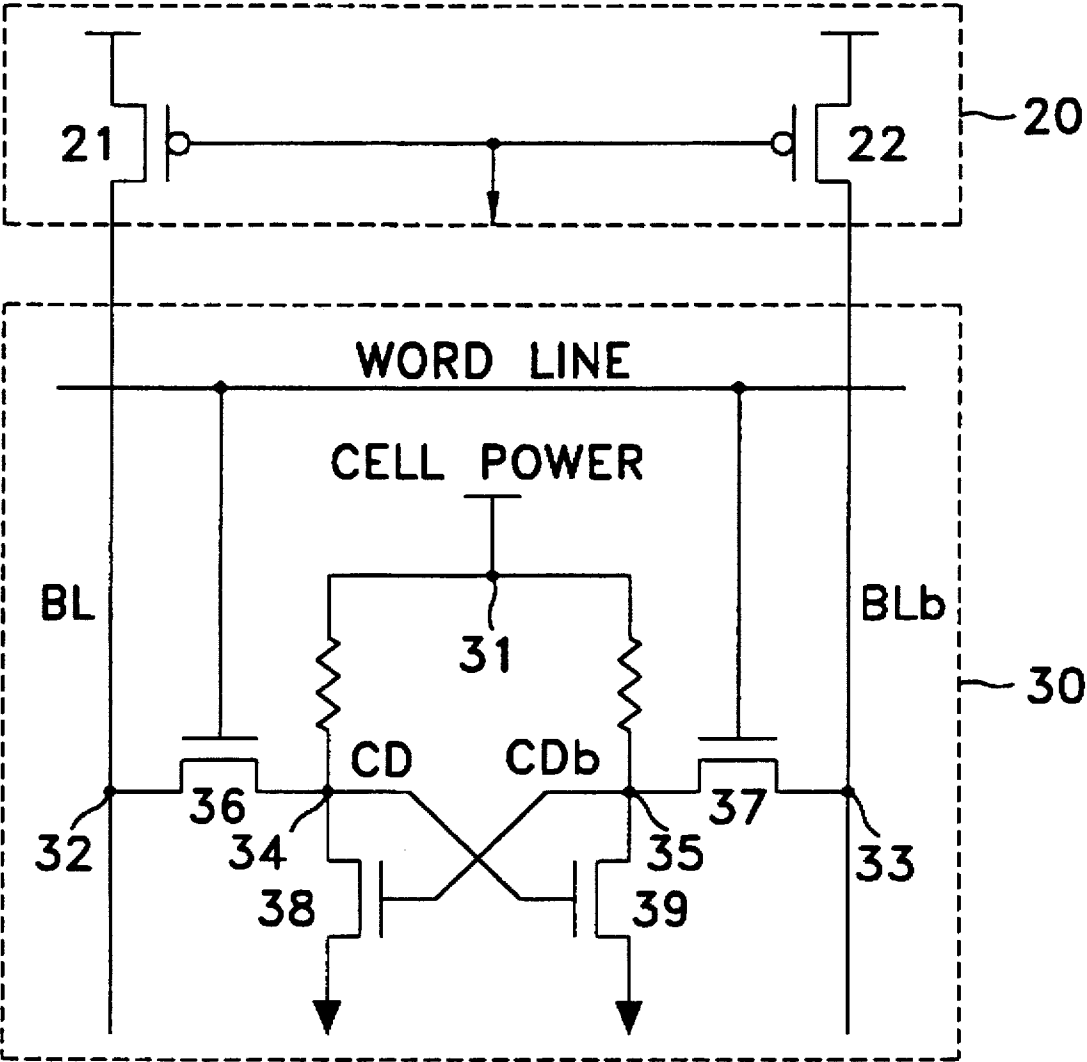
(PRIOR ART)  
FIG. 1

Second, the case where the standby current failure occurs within the memory cell array will be explained with reference to FIG. 1. FIG. 1 is a circuit diagram illustrating a memory cell structure in a typical static random access memory. In a memory cell 30, nodes connected to current sources which may generate the standby current failure are bit line pair BL and BLb (nodes 32 and 33, respectively) and a cell power node 31. Since the node 31 receiving the cell power is connected to a high resistance load or a current limit means, an extremely limited data maintaining current is supplied to cell nodes CD and CDb (34 and 35 appearing at the drain terminals of access transistors 36 and 37, respectively.) Moreover, the current sources connected to the bit line pair BL and BLb nodes 32 and 33 are supplied to the bit lines by the precharge circuit 20 for maintaining the bit lines at a given voltage in a standby state. Where the current source flowing to the bit lines causes the standby current failure, a circuit diagram for repairing the standby current failure is shown in FIG. 2, which is disclosed in U.S. Pat. No. 4,587,639.

FIG. 1 is a circuit diagram illustrating a structure of a memory cell in a typical static random access memory;

However, while the circuit of FIG. 2 prohibits the operation of the bit line precharge circuit 20 in the failed column, there remains a problem in that a standby current failure occurring at an individual cell power node (31 of FIG. 1) can continue to draw current. Therefore, in order to solve this problem, another prior art standby current cell repair circuit 60 is shown in FIG. 3, and disclosed in U.S. Pat. No. 4,639,895. Referring now to FIG. 3, another standby current failed cell repair circuit 60 includes a series of transmission transistors, each of which transmits a supply voltage in response to a common control signal Pb of a logic "low" state, and a series of fuses, e.g. fuse F21, each connected in series between a respective one of the transmission transistors and a corresponding one of the cell power lines. Each transmission transistor provides supply power to the corresponding row of memory cells as long as the corresponding fuse remains in met. Repair circuit 60 thus separates cell power lines within the memory cell array by individual rows, or by a specific number of rows, and connects the cell power lines together along each such row. When cell power supplied to a standby current failed memory cell (or the row having the cell) is cut off, the cell(s) no longer draw current at the cell power node. For example, when the row 21 is determined to have a standby current failure, the supply of cell power connected to the memory cells along the row is stopped by blowing open the corresponding fuse F21.

Referring first to FIG. 4, the cell power supplied to each memory cell 30 in a column of the memory array is connected to a fuse circuit 400 through a common cell power line. (The cell power node internal connection is shown in FIG. 1.) The fuse circuit 400 implements a current cutoff device as follows. The fuse circuit 400 includes a resistor 401 and a fuse F31 connected in series between a cell power

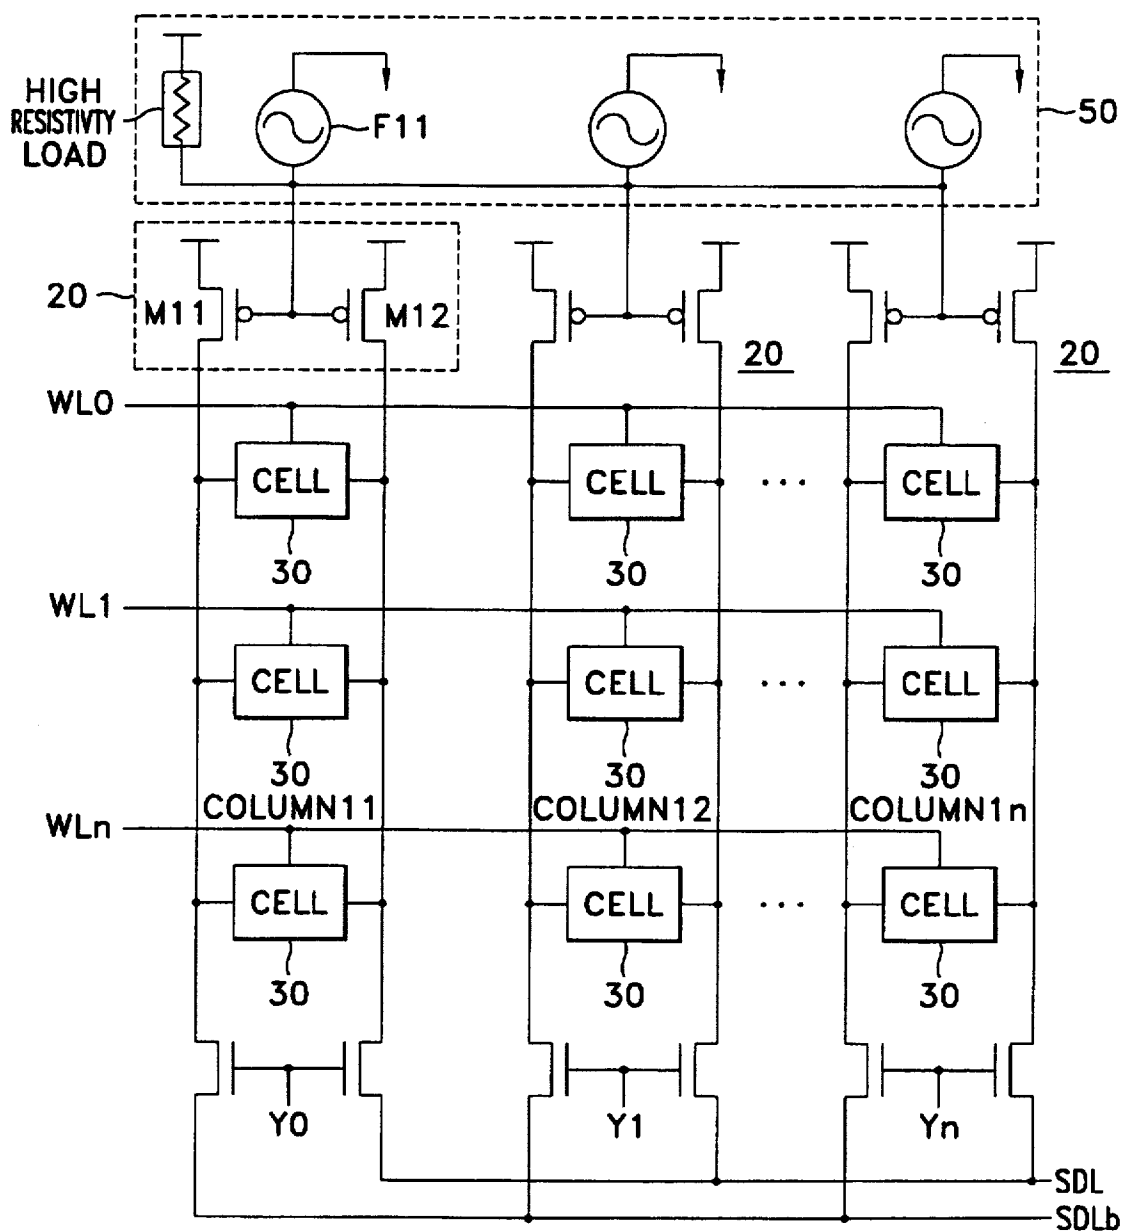
(PRIOR ART)  
FIG. 2

FIG. 2 is a circuit diagram illustrating a standby current failure memory cell repair circuit, which is useful where the current sources connected to the bit lines (i.e., the bit line precharge circuit 20) causes the standby current failure. A repair circuit 50 includes a series of fuses, e.g. FI 1, each connected between one terminal of a high resistivity load and a ground potential. Each fuse is connected to a corre-

sponding column in the precharge circuit 20. The repair circuit 50 selectively disables the current sources supplying current to memory cells 30. Specifically, the repair circuit disables the current sources, e.g. M11, M12 that supply current to the column of the array in which a standby current failure occurs. Shutting off the precharge current source prevents abnormal standby current from flowing through the failed column. Of course, the failed column can be replaced by an available redundant column. The circuit in FIG. 2 is different from the typical failed cell repair circuit in that the bit line precharge circuit 20 positioned in the failed column is turned off by the circuit 50.

To illustrate, if the column 11 is determined to have a standby current failure, the fuse F11 connected to the gates of transistors M11 and M12 within the precharge circuit 20 of the column 11 is blown open. This results in a logic "high" level applied to the gates of the bit line precharge circuit 20 corresponding to the failed column, so transistors M11 and M12 are turned off. Accordingly, the current supply to the bit lines of column 11 is stopped.

FIG. 2 is a circuit diagram illustrating a standby current failed cell repair circuit in a conventional memory device;

The circuits of FIGS. 2 and 3, however, do not entirely resolve the standby current failure problem. The repairing operation of FIG. 2 is executed by columns, and addresses only excessive bit line precharge current. The repairing operation of FIG. 3, on the other hand, is executed by row and remedies only excessive cell power node current. Neither approach ensures that all standby current failures are resolved. Moreover, if repairing operations are simultaneously executed in both row and column directions, double repairing operations are required and double fuses and repairing circuits must be provided in the memory device. Such a design of a memory device results in unduly complicated structure and the product yield therefore may be accordingly reduced.

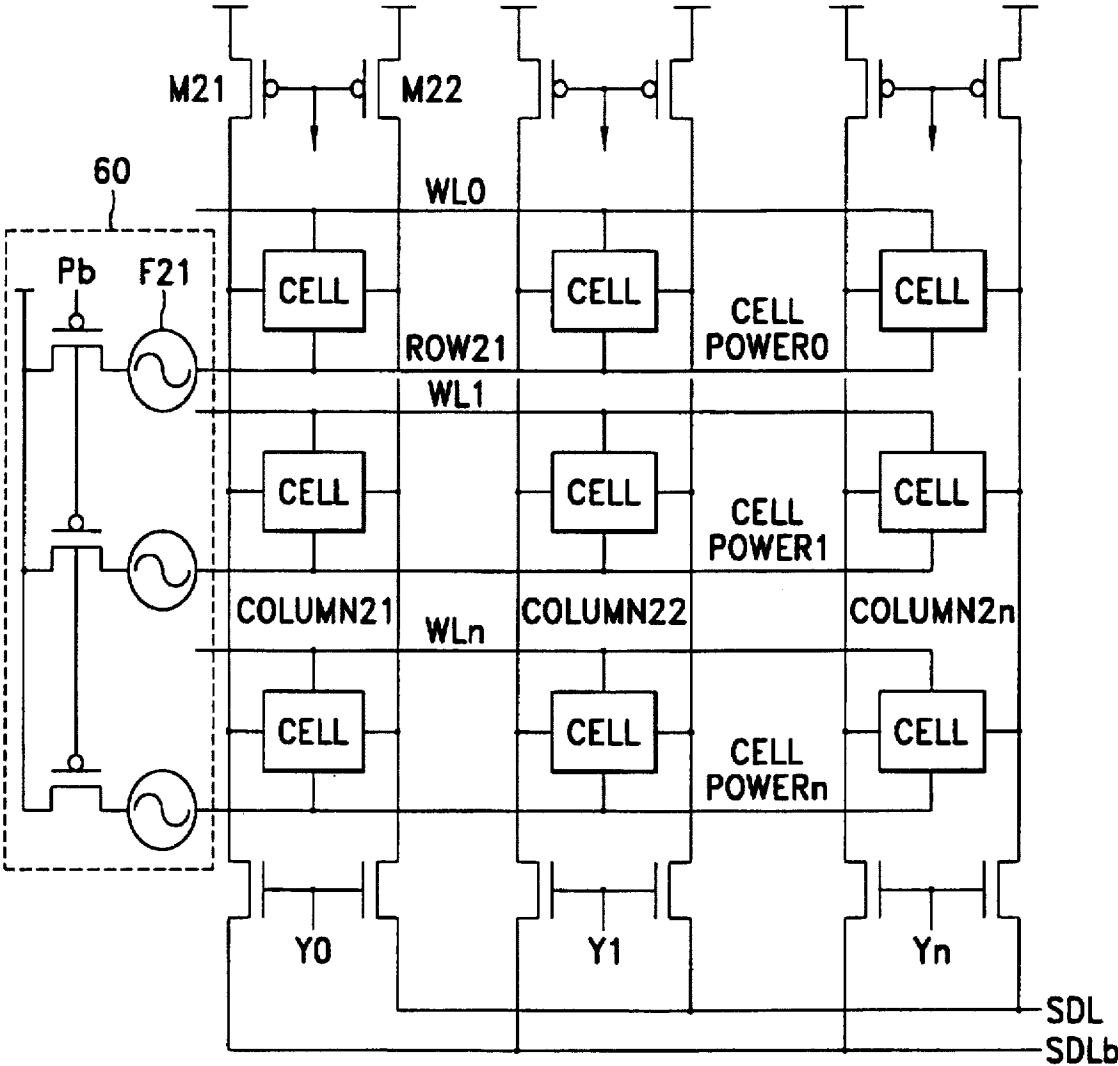
(PRIOR ART)  
FIG. 3

FIG. 3 is a circuit diagram illustrating a standby current failed cell repair circuit in another conventional memory device;

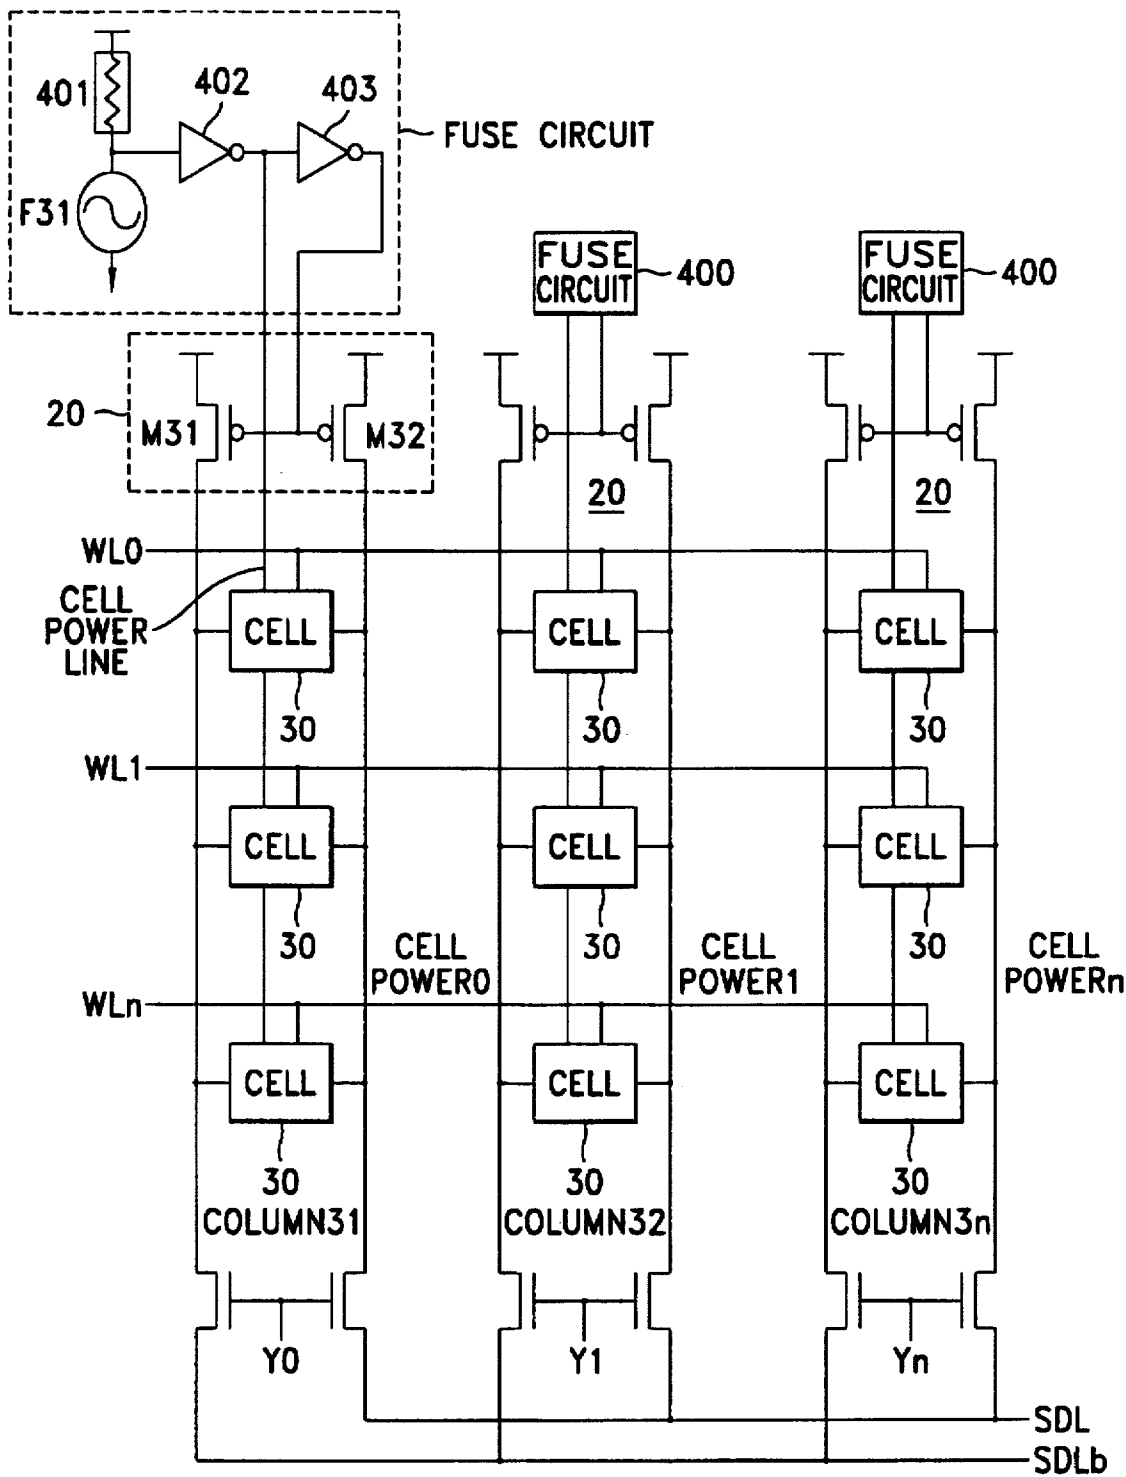
FIG. 4 is a circuit diagram illustrating a standby current failed cell repair circuit according to one embodiment of the present invention; and

supply source and a ground potential. A first inverter 402 has an input terminal connected to the common node intermediate the resistor 402 and the fuse F31. In operation, while the fuse is in tact, the common node is pulled down to ground, and the inverter 402 outputs a high signal providing cell power to the cell power line. If and when a standby current failure is detected, the fuse F31 is blown open, and the common node is pulled high, so that the inverter 402 outputs a logic low or ground potential to the cell power nodes, i.e. the cell resistor load terminals. A second inverter 403 has an input connected to the output terminal of the first inverter 402. The second inverter output terminal is connected to the column precharge circuit 20, i.e. to the gates of transistors M31 and M32, so as to turn off the transistors when inverter 402 goes low. Thus the fuse circuit rams cuts off the cell power line current, and cuts off the precharge circuit as well, of a column in which a standby current failure has been detected. Similar fuse circuits 400 are provided for each column of the array as indicated in FIG. 4.

Consequently, the column of the array in which the standby current failure occurs is electrically isolated from the current source and hence no longer exhibits excessive standby current drain. The isolated column is replaced by a redundant column. The particulars of such replacement are known to those skilled in the art, and hence are omitted here.

FIG. 4 is a circuit diagram illustrating a standby current failed cell repair circuit according to one embodiment of the present invention, and FIG. 5 is a circuit diagram illustrating a standby current failed cell repair circuit according to another embodiment of the present invention.

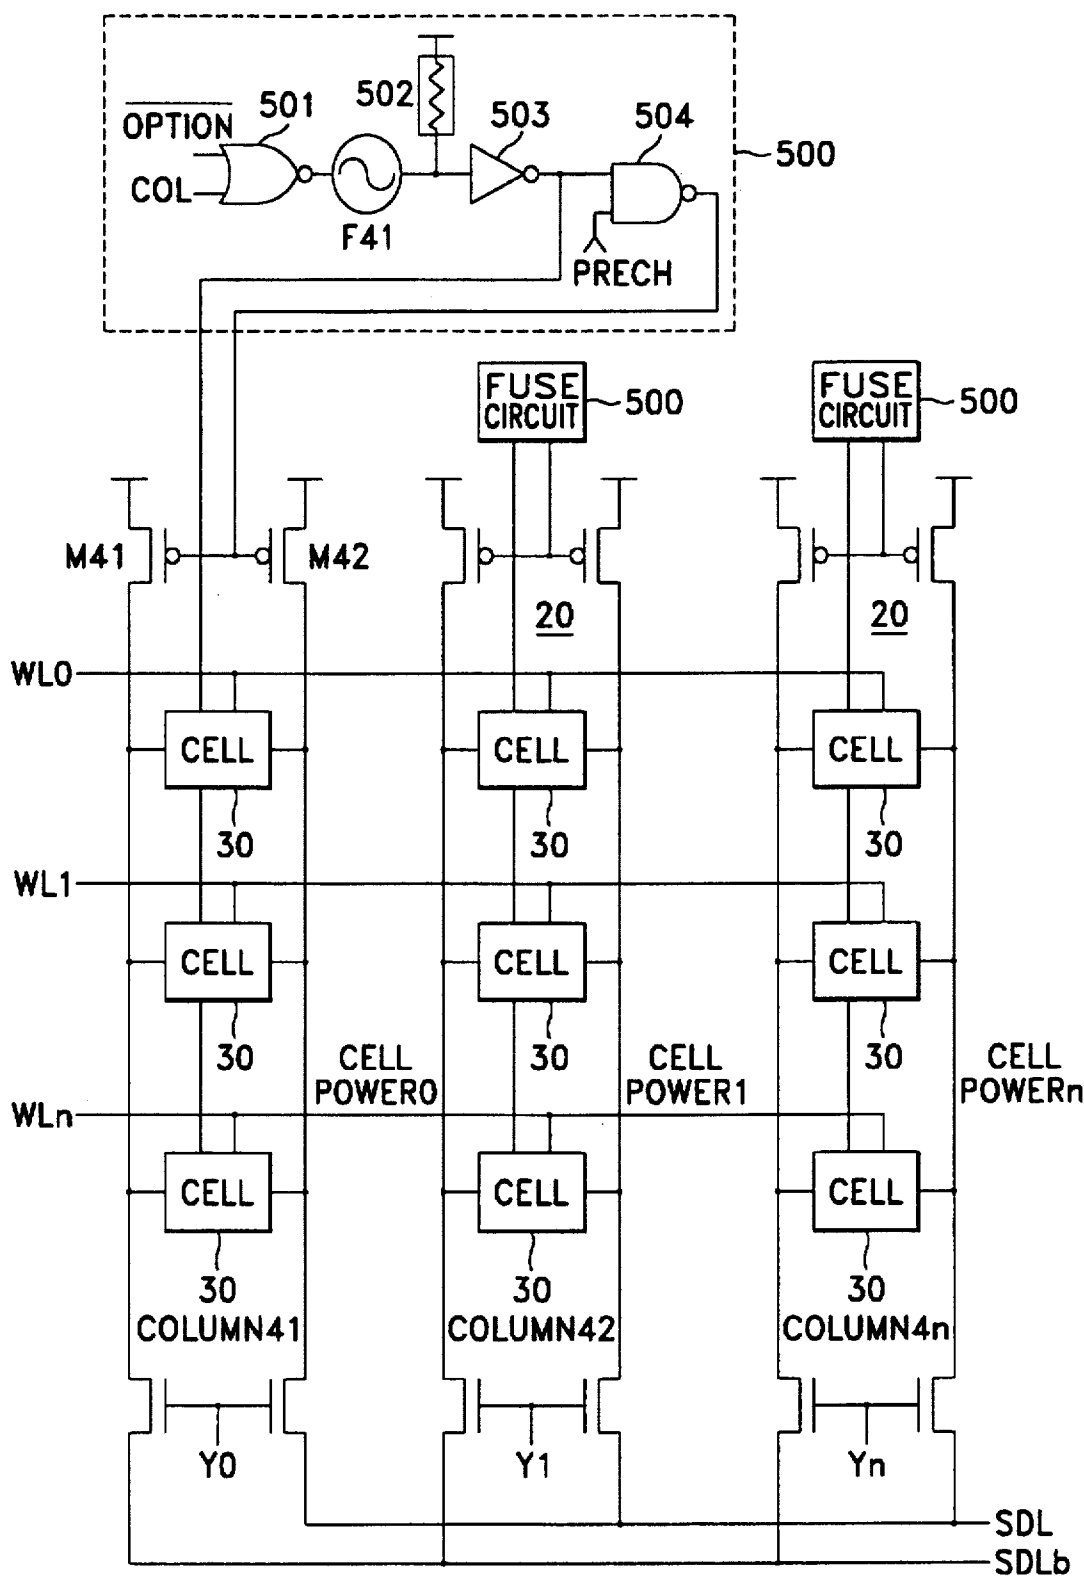
FIG. 5 is a circuit diagram illustrating a standby current failed cell repair circuit according to another embodiment of the present invention.

Referring next to FIG. 5, an alternative fuse circuit 500 includes a resistor 502 and a fuse F41 connected to each other at a common node. The resistor is arranged to pull up the common node to a cell power supply node. A NOR logic gate 501 has an output terminal connected to the fuse F41, one input terminal connected to an external selection signal COL, and the other terminal connected to a first internal selection signal/OPTION. Thus, when either selection signal goes high, the NOR output goes low, pulling the common node down substantially to ground, provided the fuse is in tact (conductive). An inverter 503 has an input terminal connected to the common node between the resistor 502 and the fuse F41, and has its output connected to the corresponding column cell power line. When the fuse F41 is open, the common node goes high, and the output of inverter 503 goes low, thus providing substantially a ground potential to the resistor load terminals—i.e. the cell power nodes—by the blowing of the fuse F41, in the case where the memory cells are identified as standby current failed cells; and a NAND gate 504 having one input terminal connected to an output terminal of the inverter 503 and the other input terminal connected to an internal selection signal, for providing the cell power to the gate terminals of the precharge transistor pair M41 and M42, in the case where the inverter 503 outputs the ground potential and for providing a given voltage to the gate terminals of the precharge transistor pair M41 and M42 in response to the second internal selection signal, in the case where the inverter 503 outputs the cell power.

In FIG. 5, the column is electrically cut from the current source by the external selection signal as well as the fuse device. Further, an arbitrary column is electrically connected to the current source by the internal selection signal COL regardless of the external selection signal state. The external selection signal is a mode selection signal for implementing a specific test. The internal selection signal COL can use a column address decoding signal. In other words, when the

external selection signal and the internal selection signal COL are at ground potential levels, all of the columns are then electrically cut from the current source. Then, the cell power is applied to the signal COL of a selected column and only the selected column is connected to the current source. In this way, the column select circuitry (not shown) can be used to survey the device to locate a column that exhibits excessive standby current—i.e. a failed column—simply by stepping through all of the array column addresses so that the COL internal selection signals are asserted one at a time. As discussed in the above, the present invention is advantageous in that a standby current failure attributable to a cell power node is avoided, and operation of the failed cell is terminated as to the bit line current source as well.
