(10) **Patent No.:** **US 6,489,659 B2**  
(45) **Date of Patent:** **Dec. 3, 2002**

(54) **NON-HERMETIC APD**

(73) Assignee: **Agere Systems Inc.**, Allentown, PA (US)

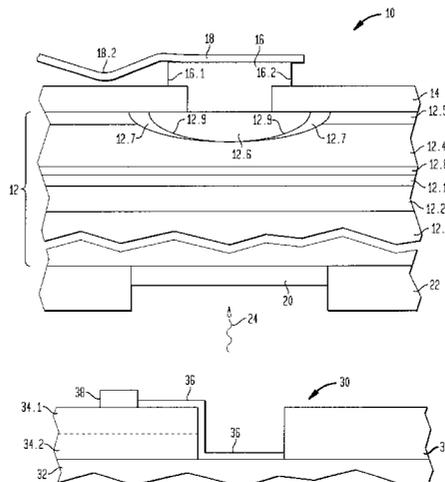
FIG. 1 is a schematic, cross-sectional view of an APD;

With reference now to FIG. 1, an APD 10 comprises a semiconductor body 12 that includes a light absorption region 12.1 buried beneath the top surface of the body, and a p-n junction 12.9 near to and typically intersecting the top surface. Electrodes 18 and 22 are disposed on opposite sides of the device for two purposes: first to apply a reverse bias voltage across the body 12 and hence the junction 12.9, and second to collect the photocurrent that flows when a light (or radiation) signal 24 is absorbed in the region 12.1. The absorbed light generates photocarriers (i.e., electron-hole pairs) in region 12.1. Under the influence of the electric field across the body 12, one carrier type drifts toward the junction 12.9, where avalanche multiplication takes place, whereas the other carrier type drifts toward the opposite side of the device. Thus, the photocurrent is amplified, making the APD particularly suited to detecting low intensity light signals.

The APD illustrated in FIG. 1 is known as a back-illuminated device; that is, the light signal 24 enters the device through the substrate (or bottom) side of the device. In this regard, the bottom electrode 22, which is typically annular, has an opening in which an anti-reflection (AR) coating 20 is disposed. The light signal 24 made incident on the AR coating propagates into the body 12 and is absorbed by the light absorption region 12.1. To this end, the wavelength corresponding to the bandgap of the absorption region 12.1 should be higher than the wavelength of the light signal 24.

In the interest of clarity and simplicity, the FIGS. 1, 2 and 6 have not been drawn to scale. In addition, when describing physical or optical dimensions, the symbol A stands for Angstroms, whereas when describing electric current, it stands for Amperes.

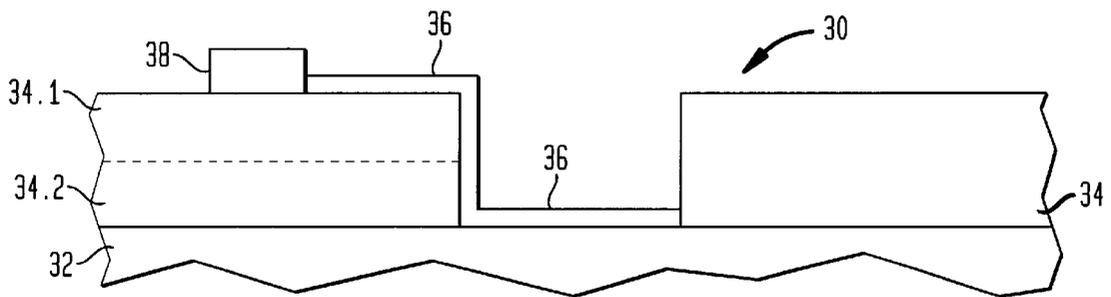
FIG. 2 is a schematic, cross-sectional view of the top portion of an APD in accordance with one embodiment of our invention;

In accordance with one aspect of our invention, a non-hermetic, back-illuminated APD **30** (e.g., FIG. **2**) includes a patterned, dielectric passivation layer **34** on its front surface that is sufficiently thick to reduce the leakage current there-through to less than about 1 nA for voltages in the range of about 20–100 V. In a preferred embodiment, the passivation layer is a nitride layer that is at least 2  $\mu\text{m}$  thick, and typically 2–5  $\mu\text{m}$  thick. The increased thickness of the nitride layer reduces the electric field in and around the area where the p-n junction (not shown in FIG. **2**, but similar to that of FIG. **1**) intersects the top surface of the semiconductor body **32**. Given that the current flowing through the nitride layer increases exponentially with the square root of the electric field, the increased thickness of the nitride layer **34** substantially reduces the leakage current flowing through it. Since the corrosion rate of the nitride layer is proportional to the current flowing through it when exposed to a MCA, the increased thickness of the nitride substantially decreases the oxidation rate of the nitride. Therefore, the lifetime and reliability of our non-hermetic APDs are expected to be increased in a MCA.

The general configuration of our APD may follow the design of FIG. **1** provided that accommodation is made, if necessary, for the increased thickness of the nitride layer. In addition, care should be exercised to provide a relatively large gap between the wire **18** in the region **18.2** and the underlying nitride layer. In addition, it would be prudent to avoid any mechanical damage to the nitride layer during the wire bonding process or any other assembly and handling process for that matter. Alternatively, if the thickness of the nitride layer makes it too difficult to form the electrode (bonding pad) **16** in the shape of a plug as shown in FIG. **1**, then, as shown in FIG. **2**, the metalization **36** may be deposited only at the bottom of the opening in the nitride layer **34** and then run up onto the top surface of the layer **34** to a bonding pad **38**.

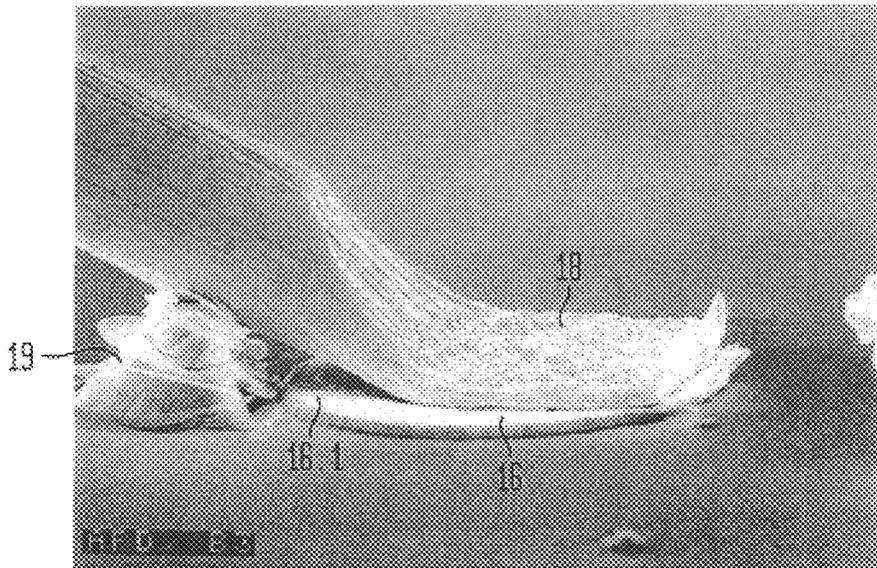
FIG. 3 is a scanning electron micrograph (SEM) of an APD that was tested at 60° C., 85% RH and 70 V. Corrosion is seen at the heel of the wire bond. The device failed after 149 hr. of operation; and

More specifically, FIG. **3** is an SEM of an APD that failed after 149 hours of aging at 60° C., 85% RH and 70 V. The SEM shows a relatively large area of heel corrosion product **19** that grew from the surface of semiconductor body **12** toward the wire **18**. When the growing corrosion product **19** contacted the wire **18**, a short circuit occurred and the device failed. Circular sections of what appears to be silicon nitride were embedded in the corrosion product. We believe that as the corrosion product grew, it fractured the sections of the nitride layer and lifted the sections up. Note, although the slope of wire **18** in the schematic of FIG. **1** seems to be opposite to that in the SEM of FIG. **3**, in reality they would

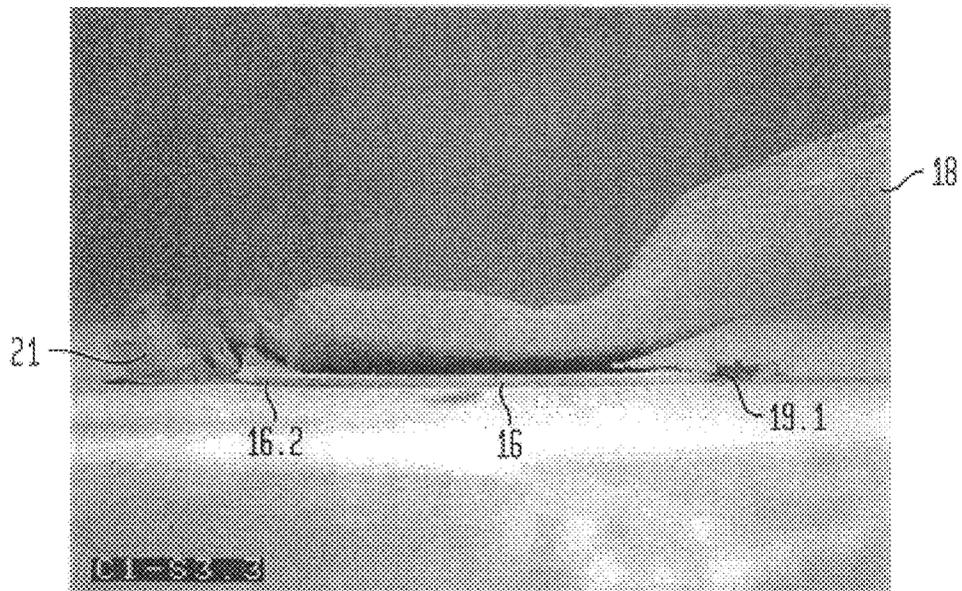
FIG. 4 is an SEM of an APD that was tested at 60° C., 60% RH and 70 V. Corrosion is seen at the toe of the wire bond. The device failed after 456 hr. of operation;

Similarly, FIG. **4** is an SEM of an APD that failed after 456 hours of aging at 60° C., 85% RH and 70 V. The SEM shows some heel corrosion product **19.1** and a much larger area of toe corrosion product **21**. The heel corrosion product **19.1** was spaced from the bond pad **16**, as in the device of FIG. **3**, but the toe corrosion product **21** was not. That is, the latter grew over the edge **16.2** of the bond pad, thereby producing a short circuit.

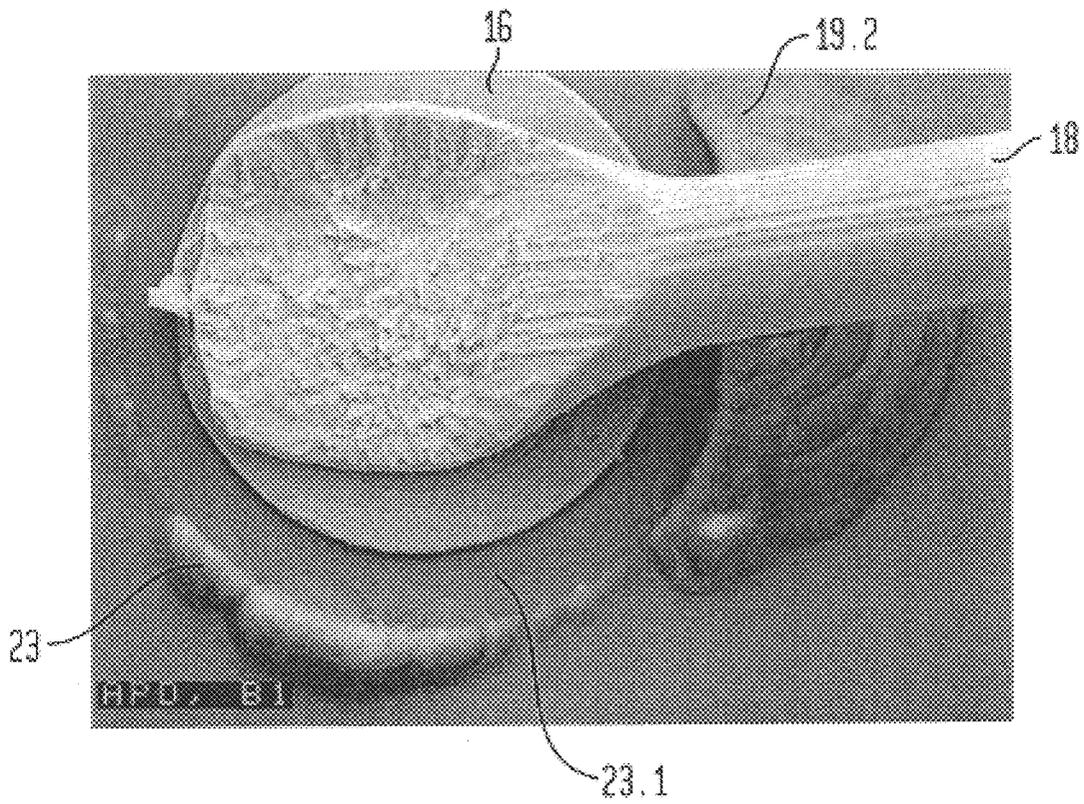
FIG. 5 is an SEM of an APD that was tested at 60° C., 85% RH and 70 V. The SEM shows both halo and heel corrosion near the wire bond. The device failed after 53 hr. of operation; and

Finally, FIG. **5** is an SEM of an APD that failed after 53 hours of aging at 60° C., 85% RH and 70 V. The SEM shows pronounced toe corrosion product **23** as well as some heel corrosion product **19.2**. Measurement of the diameter of the halo shows that it coincides with the location of the circular p-n junction. Examination of all devices aged at 60% RH or greater revealed that the halo effect was present in all cases. On the other hand, devices aged at 25% and 40% RH exhibited heel and toe corrosion, but no halo corrosion. In many cases at 25% and 40% RH we observed mechanical damage to the bond pad.

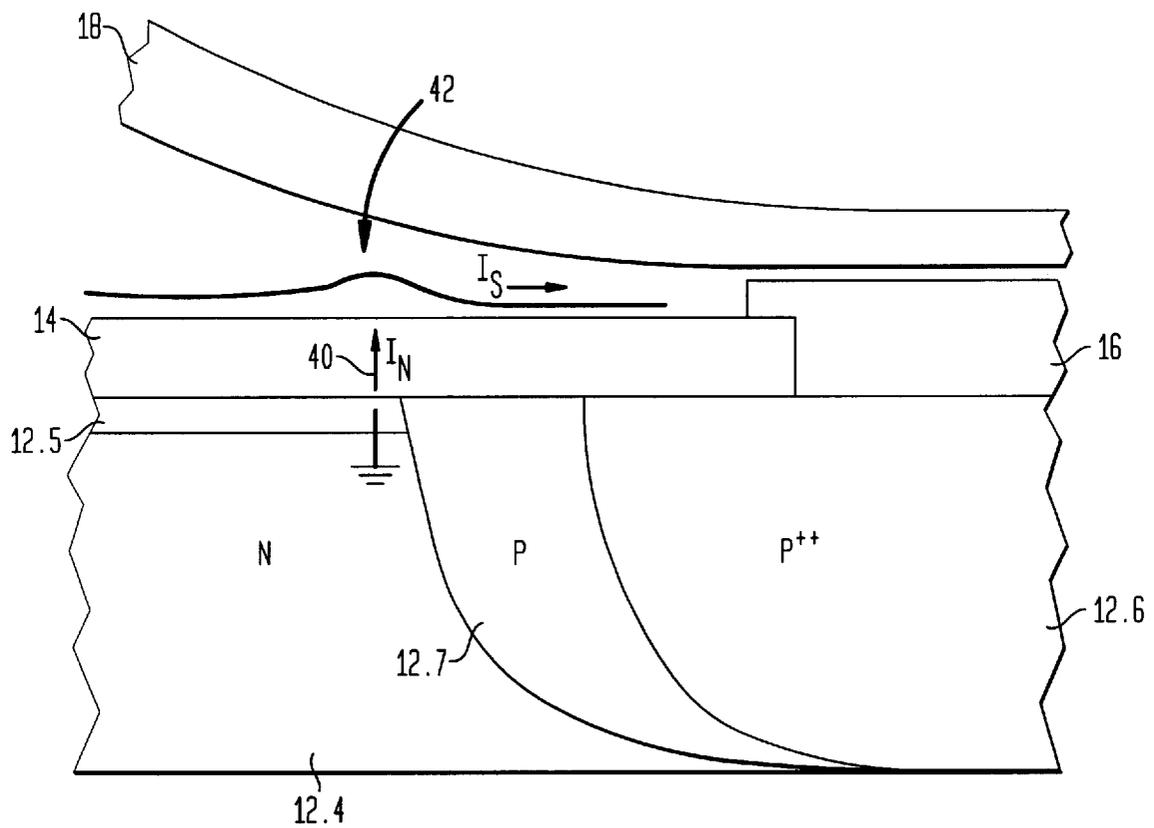
FIG. 6 is a schematic of an APD showing a bulge produced in an adsorbed water film by electrostriction.

During the incubation stage the nitride layer is being oxidized at the location where leakage current  $I_N$  (in excess of about 1 nA) flows from the n-type cap layer **12.5** to the surface of the nitride layer, as indicated by the upward arrow **40** in FIG. **6**. This initial stage of the failure process takes much longer than the later stage, which coincides with the corrosion process. The nitride oxidation takes longer because the nitride is a good insulator, which limits the current needed for the oxidation. A substantial fraction of the voltage drop is across the thickness of the nitride layer, especially at relatively high RH values that tend to reduce the surface resistance of the nitride. During oxidation of the nitride, the chemical structure of the layer is drastically altered so that it cracks locally at the point where oxidation is taking place. This disruption of the nitride layer exposes more nitride to oxidation, and gradually the disrupted region penetrates to the top surface of the n-type cap layer **12.5**. At this time the semiconductor begins to corrode, a process that is much more rapid than the nitride oxidation since there is no insulator to impede current flow. When this breach of the nitride-semiconductor interface occurs, a much larger current  $I_s$  flows (e.g., more than an order of magnitude larger than 1 nA) from the semiconductor across the unoxidized portion of the top surface of nitride to the bond pad **16**. Most of the voltage in this case is along the top surface of the nitride layer. When the corrosion product resulting from the semiconductor corrosion contacts the wire **18**, a short circuit results. Disruption of the p-n junction by the corrosion process (i.e., a corroded region that bridges the junction) may also cause high leakage currents. In addition, if the corrosion products of the semiconductor involve oxides of phosphorus, which are highly hygroscopic even at relatively

In a relatively high electric field polar molecules, such as water molecules on the surface of the nitride layer, can be displaced by electrostrictive forces. This force results in a pressure on the liquid that is proportional to the square of the average electric field at the point of interest. For a gap of 2  $\mu\text{m}$  between the wire and the top surface of the nitride layer, the pressure in the water due to electrostriction is approximately 5 N/cm<sup>2</sup> (N=Newtons) or about 0.5 atmospheres. We believe that a force of this magnitude is sufficient to cause local accumulation of additional water under the wire **18**, as shown in region **42** of FIG. **6**. This accumulation is in addition to the water present in equilibrium with the ambient RH. The increased thickness of the water in region **42** results in higher leakage current  $I_s$  on the top surface of the nitride layer **14**, thereby increasing the corrosion rate. Moreover, if the increased thickness is sufficient that the water approaches bulk properties, then chemical dissolution of the nitride can occur. As discussed by J. W.; Osenbach in J. Electrochem. Soc., Vol. 140, p. 3667 (1993), this effect would increase the corrosion rate in two ways: by reducing the nitride thickness to be oxidized, and by increasing the electric field in the nitride layer, and hence the current flow through that layer. These mechanisms appear to explain the presence of heel corrosion, but may also underlie the occurrence of toe corrosion. If the bonded end of the wire **18** is smeared right up to or beyond the edge of the bond pad, then the metal is effectively thicker at that location. The greater height of the metal will result in increased electric field via fringing effects, and this increased field may locally increase the thickness of the water film by electrostriction. In addition, any smearing of the wire material beyond the bond pad will decrease the surface path length for current between the metal edge and the edge of the p-type diffused regions **12.6–12.7**, thereby reducing the voltage drop on the surface path and increasing the voltage drop across the nitride layer. Either mechanism will result in increased corrosion rate near the toe.
