US008300171B2

# (54) REPAIRING STRUCTURE OF LIQUID CRYSTAL DISPLAY AND REPAIRING METHOD THEREOF

- (75) Inventors: **Dian-Gan Liao**, Keelung (TW); **Han-Tung Hsu**, Taoyuan County (TW)
- (73) Assignee: Chunghwa Picture Tubes, Ltd.,

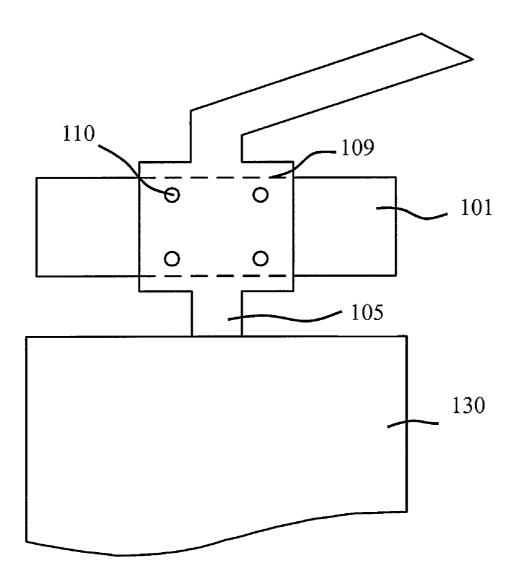
FIG .1 (RELATED ART)

FIG. 1 is a schematic structural view of a repairing method of a data line of a display in the prior art.

In order to solve the above problems, in a structure layout 50 of a current TFT LCD, a plurality of annular repairing line structures is usually disposed around the array, which achieves a repairing effect through a laser welding manner, thereby increasing the yield of the panels and saving the fabrication cost. Referring to FIG. 1, when a data line 105 in 55 a pixel region 130 is broken, a crossing region 109 between the data line 105 to be repaired and the repairing line 101 is dotted and welded by using the laser, so as to enable the data line 105 to be electrically connected to the repairing line 101, such that an electrical signal is delivered between the two 60 wires. Particularly, during the repairing process, 4 welding points 110 around the crossing region 109 are selected to be repaired by using the laser, and a diameter range of the welding points 110 is approximately 3 μm-5 μm. However, the repairing method of the line defect still has disadvantages, for 65 example, too many welding points exist, such that a repairing time is too long, and the welding points are too small, so that

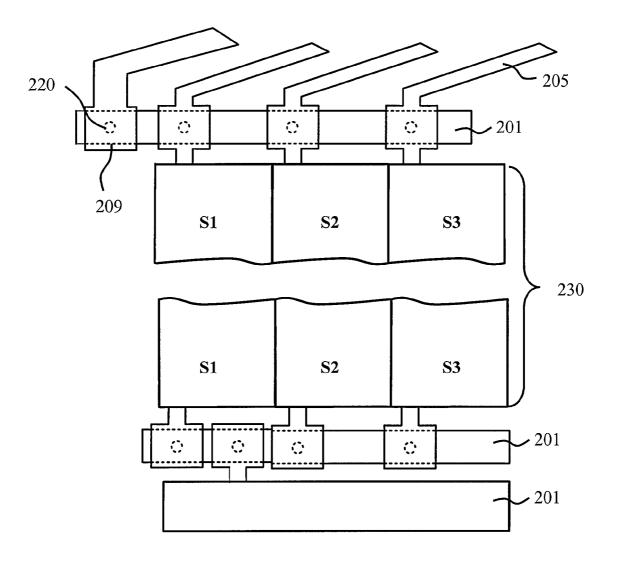
FIG .2

FIG. 2 is a schematic structural view of a repairing method 15 of a data line of a display according to an embodiment of the present invention.

In the repairing method of an LCD, when a first conductive layer is a repairing line, and a second conductive layer is a data line, the method may be applied to repairing the defective data line. FIG. 2 is a schematic structural view of a repairing method of a data line of an LCD according to an embodiment 40 of the present invention. Referring to FIG. 2, a display panel includes a plurality of data lines 205 and a plurality of repairing lines 201. The data lines 205 are connected to a pixel region 230. Each of the repairing lines 201 spans across at least one data line 205. The data line 205 and the corresponding repairing line 201 have a crossing region 209 where they are overlapped with each other, and a round opening 220 is designed at a central position of the repairing line 201.

If the data line **205** in the pixel region **230** has certain 65 defects, the data line **205** may be repaired by using the repairing structure. A laser power is provided, and at the crossing

regions 209 between the defective data line 205 and the repairing lines 201 located on two ends thereof, the insulating layer 203 above the opening 220 of each repairing line 201 is penetrated by the laser power, such that the defective data line 205 is electrically connected to the repairing lines 201, and the electrical signal is delivered between the two conductive layers. Any defective data line 205 spans across at least two repairing lines 201, and the welding area is larger than that of the prior art, such that an impedance value at the position is reduced, and it is not necessary to weld four points at each repairing region, thereby greatly reducing the repairing time.

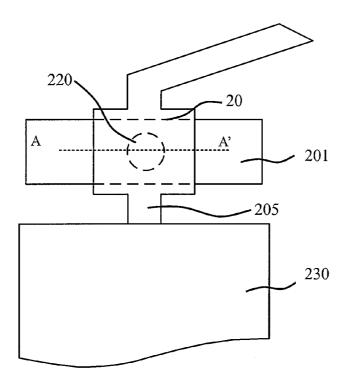
FIG .3A

FIG. 3A is a partially enlarged view of a repairing structure of a data line of FIG. 2.

FIG. 3A is a partially enlarged view of a repairing structure of a data line according to the above embodiment, and FIG. 50 3B is a schematic cross-sectional view of FIG. 3A, taken along a section line of A-A'. Referring to FIGS. 3A and 3B, the repairing structure of the data line includes: a repairing line 201 with an opening 220, an insulating layer 203 located on the repairing line 201 and covering the opening 220, a data 55 line 205 located on the insulating layer 203, a protective layer 207 located on the data line 205, and a crossing region 209 located at a position where the repairing line 201 and the data line 205 are overlapped, in which the opening 220 is located on the crossing region 209 of the repairing line 201. When the 60 insulating layer 203 above the opening 220 is penetrated, the repairing line 201 is electrically connected to the data line 205, such that an electrical signal is delivered between the two wire layers.

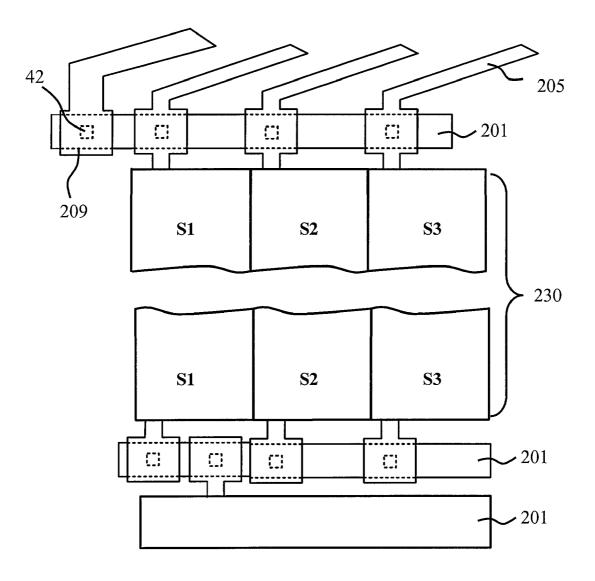
FIG .4

FIG. 4 is a schematic structural view of a repairing method of a data line of a display according to another embodiment of the present invention.

FIG. 4 is a schematic structural view of a repairing method of a data line of a display according to another embodiment of the present invention. Referring to FIG. 4, a display panel includes a plurality of data lines 205 and a plurality of repairing lines 201. The data lines 205 are connected to a pixel region 230. Each of the repairing lines 201 spans across at least one data line 205. The data line 205 and the corresponding repairing line 201 have a crossing region 209 where they are overlapped with each other. A square opening 420 is designed at a central position of the repairing line 201, which is used for laser melting when the defective data line 205 is repaired subsequently. Referring to FIGS. 3A and 3B, in the repairing structure, various patterns of the opening may be designed according to users' different demands.

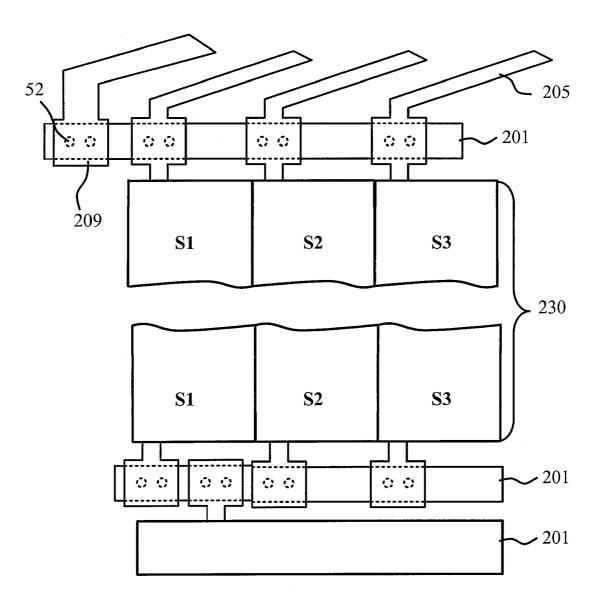
FIG.5

FIG. **5** is a schematic structural view of a repairing method 25 of a data line of a display according to another embodiment of the present invention.

FIG. 5 is a schematic structural view of a repairing method of a data line of a display according to another embodiment of the present invention. Referring to FIG. 5, a display panel includes a plurality of data lines 205 and a plurality of repairing lines 201. The data lines 205 are connected to a pixel region 230. Each of the repairing lines 201 spans across at least one data line 205. The data line 205 and the corresponding repairing line 201 have a crossing region 209 where they are overlapped with each other. Two round openings 520 are 35 designed at a central position of the repairing line 201, which are used for laser melting when the defective data line 205 is repaired subsequently. Referring to FIGS. 3A and 3B, such repairing structure mainly aims at preventing a repairing failure. If the welding fails for the first time, the remaining opening 520 can be still used for welding, thereby increasing the yield and lowering the cost.
