**EP 0 780 720 A1**

**EUROPEAN PATENT APPLICATION**

(54) **Method for repairing low noise metal lines in thin film imagers**

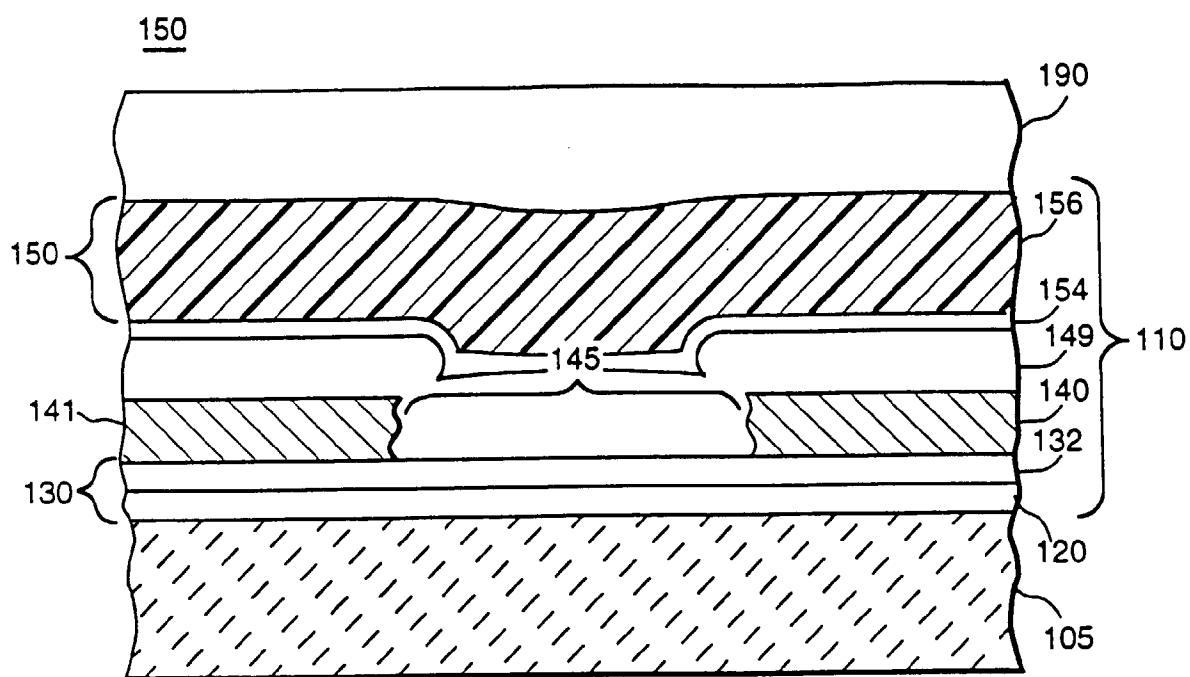
FIG. 1

Figure 1 is a cross-sectional view of an imager device having a defective first conductive component and illustrated at a point in the fabrication process prior to deposition of an overlying second conductive component.

A thin film electronic imager device 100, such as a solid state radiation imager, typically comprises respective layers of conductive, semiconductive, and dielectric material that are disposed on a substrate 105 and that are patterned in the fabrication process to form a photosensor array 110, a portion of which is illustrated in cross-section in Figure 1 at a point in the fabrication process prior to deposition of a common electrode over

In the fabrication of the photosensor array in a typical imager device, scan lines are formed on substrate 105 (not shown in the cross-sectional portion illustrated in the Figures); a gate dielectric layer 120 (so named as it is disposed over the scan lines with the gate electrodes for the switching transistors formed thereon from overlying components) comprising silicon nitride ( $\text{SiN}_x$ ), silicon dioxide ( $\text{SiO}_2$ ), or the like, is deposited over the scan line array; a semiconductive layer 132 comprising silicon or the like is deposited over dielectric layer 120. Semiconductive layer 132 may further comprise a doped semiconductive layer (not shown) comprising silicon doped to exhibit n type conductivity or the like is deposited over the semiconductive silicon. Semiconductive layer 132 is patterned to form the bodies of switching devices (not shown), such as a field effect transistor (FET) (also referred to as a thin film transistor (TFT)) associated with each pixel. The combined layers of semiconductive layer 132 (with the doped semiconductive layer thereon) and underlying dielectric material layer 120 are typically referred to collectively as a FET sandwich 130. Conductive material, such as molybdenum, titanium, aluminum, chromium, or the like, is deposited and patterned to form source and drain electrodes (not shown) for each TFT and this layer of conductive material is also patterned to form data lines 140 (a representative one of which is shown in cross section in Figure 1) in the array.

Additional fabrication steps include the formation of the photodiodes, including the deposition and patterning of semiconductive material, typically silicon, to form the photodiode body (not shown in the cross-sectional portion of the imager illustrated in Figure 1). A photosensor barrier layer 150 is then formed over the array; barrier layer 150 typically comprises a first protective layer 154 comprising an inorganic dielectric material such as silicon nitride ( $\text{SiN}_x$ ) or the like. In the portion of the array illustrated in cross section in Figure 1, first protective layer 154 is disposed over FET passivation layer 149. First protective layer 154 of silicon nitride typically has a thickness in the range between about 0.04  $\mu\text{m}$  and 0.5

Figure 1 illustrates an imager device at a first stage in the repair process of the present invention; at this point in the fabrication process, the FETs have been formed and FET passivation layer 149 and barrier layer 150 have been deposited. At this stage the electrical integrity of the address lines can be tested; for purposes of illustrating the process of this invention, a defect 145 is shown disposed in data line 140 such that an open circuit condition exists between a first portion 141 and a second portion 142 of data line 140. Defect 145 comprises a break in the conductive material of data line 140 in which non-conductive material is disposed between respective portions 141, 142, of the data line. The non-conductive material typically comprises dielectric material from FET passivation layer 149, but further may comprise other non-conductive material that has been used in the array fabrication process. As used herein, "non-conductive" refers to both dielectric and semiconductive material that may be disposed in defect 145 so as to create the open circuit condition (the term also implies a non-gaseous material, such as solid or fluid that reposes in the defect region). Defect 145 results from damaged or missing metal for data line 140 such as might occur when there is a defect in the mask used for the deposition or patterning of the conductive material comprising data line 140, or from damage to the conductive line in processing. Alternatively, the defect may have been made with a laser, such as in an attempt to cut the line in order to isolate a portion of data line 140 shorted to an underlying conductive component. e.g., a scan line, such as at a crossover point between the two types of address lines. The open circuit condition of the data line is typically determined and recorded during inspection of the imager device following formation of the data lines.

In accordance with this invention, prior to removal of portions of barrier layer 150 to expose defect 145 in address line 140, a layer of photoresist 190 is deposited in a spin process, a meniscus process, or the like, over the organic dielectric material comprising second protective layer 156 across the array. Photoresist layer 190 typically has a thickness in the range between about 1  $\mu\text{m}$  and 3  $\mu\text{m}$ .

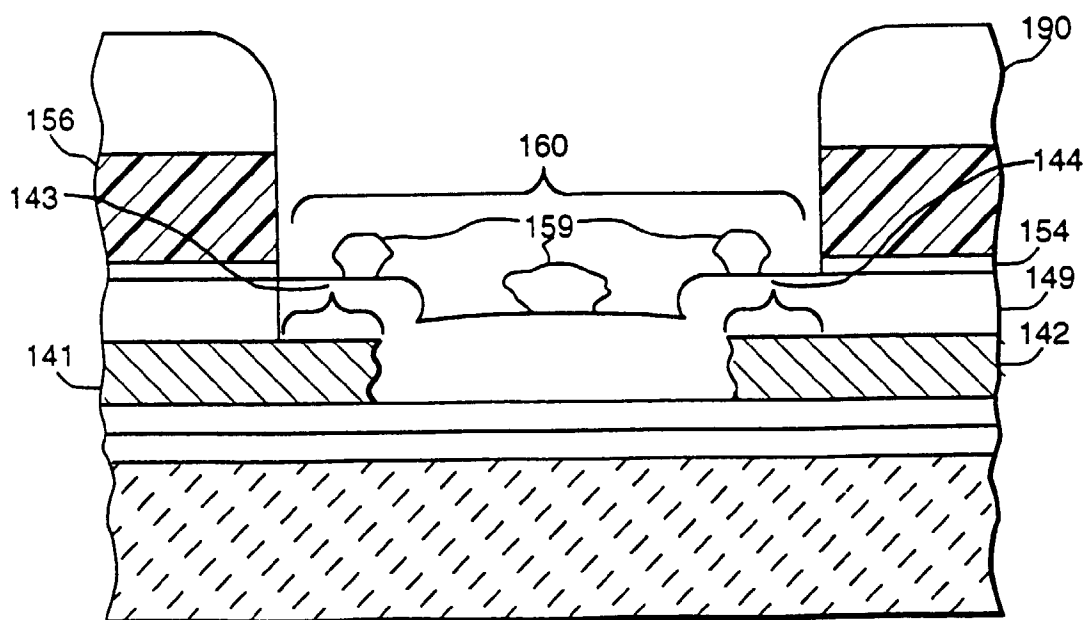
FIG. 2

Figure 2 is a cross-sectional view of an imager device in which ablation has been used to begin the formation of a repair area over the defect in the first conductive component in accordance with the present invention.

circuit defect 145 in data line 140 is repaired with the use of a procedure that opens a repair area 160 (Figure 2) around defect 145 that exposes address line 140 while maintaining the low noise characteristics of the address line. In particular, the process of exposing the conductive material comprising the component being repaired, e.g., address line 140, is such that the conductive material is not contaminated. As used herein, "not contaminated," "uncontaminated" or the like refers to the conductive component to be repaired being fully exposed (that is, about 90% or more of the surface conductive component in repair area 145 is exposed with few, if any, residual materials from other components in the device are left on the surface of the conductive component in the repair area); and the condition of the conductive component (data line 140) is substantially the same as it was when the data line was formed (that is, after deposition of the conductive material, patterning, and cleaning of the surface to complete the formation process of the conductive component during the fabrication process, which typically does not damage the conductive material but may result in some oxidation of the conductive material on the surface of the address line). The address line being in substantially the same condition further implies that the line is substantially geometrically the same shape as when formed, with the surface of the conductive material being relatively smooth without notches, depressions, or the like. One manifestation of the process of the present invention providing an uncontaminated address line 140 in the repair area is that, when repaired, the address line exhibits noise characteristics that are typically not greater than about 10% more noise than an undamaged and unrepaired address line. Such noise measurements are typically obtained by reading out the imager in the dark and calculating the standard deviation of each pixel from a set of the dark images.

Repair area 160 (Figure 2) is formed by removing portions of photoresist layer 190 and underlying portions of protective layer 150 to expose defect 145 and selected adjoining portions of data line 140. Typically laser ab-

lation is used to remove the portions of photoresist layer 190, second protective layer 156, and first protective layer 154 from selected repair area 160. In particular, a xenon-chloride type excimer laser provides a finely-focused beam (e.g., in the range between about  $1\mu\text{m}^2$  to  $20\mu\text{m}^2$ ) that is very effective in ablating the above-mentioned non-conductive material with the ability to maintain precise boundaries around repair area 160. Laser ablation is not, however, as effective in removing FET passivation layer 154 as that layer comprises silicon oxide, which exhibits poor energy absorption in the visible and near ultraviolet (UV) wavelength range. It has been found that the poor energy absorption of the silicon oxide requires lengthy efforts at ablation to remove the material, and typically such an ablation effort results in a contaminated surface of first conductive component 140 underlying the silicon oxide ablated. Thus, laser ablation is stopped following removal of photoresist layer 190, the organic dielectric of second protective layer 156, and the silicon nitride of first protective layer 154 in repair region 160. Typically the ablation process results in some residual particles 159 remaining from portions of FET passivation layer 150 ablated away remaining in repair area 160, as illustrated in Figure 2.

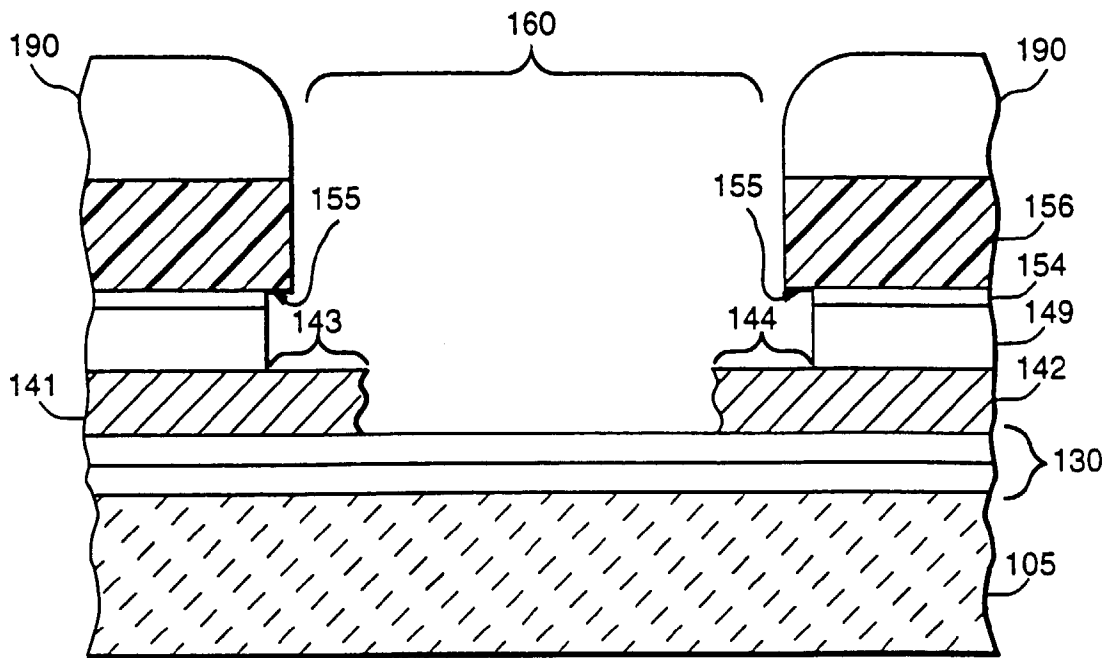
FIG. 3

Figure 3 is a cross-sectional view of an imager device in which the repair areas has been formed over the defect in the first conductive component following an etching step in accordance with the present invention.

Formation of repair area 160 is then completed by etching the residual dielectric material in repair area 160 so as to remove residual dielectric material in the repair area to expose defect 145 and adjoining portions of address line 140, as illustrated in Figure 3, the etching step further providing that the exposed surfaces of the address line 140 remain uncontaminated. The adjoining portions of data line 140 include a first segment 143 of first address line portion 141 and a second segment 144 of second address line portion 142 of address line 140, the adjoining portions collectively comprising areas on each portion of the data line adjoining open circuit defect 145. Segments 143 and 144 are sufficiently large to allow the subsequently deposited conductive material to make satisfactory electrical contact to data line 140 and to form a stable structure. In a typical imager in which address line 140 has a width of about  $7\mu\text{m}$ , segments 143 and 144 each have a length of about  $10\mu\text{m}$ . Additionally, the sidewalls of photoresist layer 190 and the portion of barrier layer 150 where the non-conductive

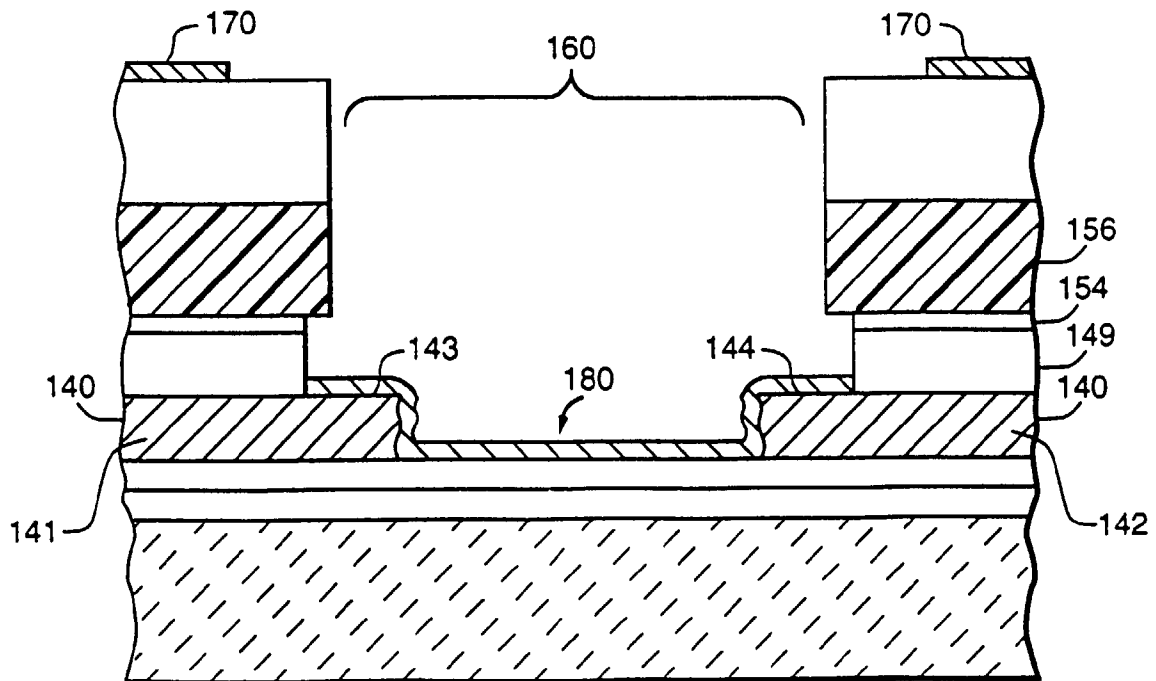
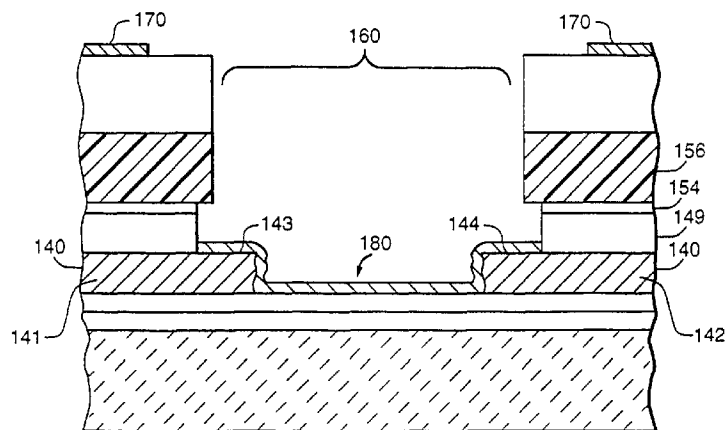
FIG. 4

Figure 4 is a cross-sectional view of an imager device after deposition of the repair shunt and second conductive component in accordance with the present invention.

Following the formation of repair area 160 such that uncontaminated portions of address line 140 are exposed around defect 145, as described further below, conductive material is deposited to form a second conductive component 170 (Figure 4) on a succeeding level of the device. As used herein, "succeeding level of the device" refers to a conductive component that is formed in the fabrication process following the formation of address line 140, and thus is typically disposed on a different level of the sandwich of materials that are deposited to fabricate the components for the imager device. No restriction on the orientation of the device is to be implied by the terminology relating to levels of the components. As set out above, in the repair of a data line in an imager, the next conductive component to be deposited in the fabrication process is typically the common electrode of the photosensor array.

(Figure 4) is formed in imager device 100 by depositing a conductive material (for imager devices, this material is deposited to form a substantially optically transparent layer) such as indium tin oxide, or the like, using, for example, a sputter process. Alternatively, conductive materials such as aluminum, chromium, or the like can be used to form the common electrode; if such non-optically transparent material is used, however, additional process steps are required to pattern the common electrode so that it does not prevent light from reaching large portions of the photodiode surface. Coincidentally with the deposition of common electrode 170, a repair shunt 180 is formed in selected repair area 160 as the same conductive material that is used to form common electrode 170 is deposited over defect 145 and on segments 143 and 144 of data line 140. As illustrated in Figure 4, repair shunt 180 thus comprises the same conductive material as common electrode 170 and is disposed so as to electrically bridge defect 145 such that first portion 141 and second portion 142 of data line 140 are electrically coupled together. Similarly, the thickness of repair shunt 180 corresponds with the thickness of common electrode 170 as the two components are formed in the same deposition process. Alternatively, dependent on the component being repaired, the conductive material deposited to form the repair shunt may be the same as the conductive material of the underlying component in which the defect exists.

As illustrated in Figure 4, repair shunt 180 extends over all surfaces of address line 140 that are exposed in repair area 160, which coverage is desirable from the standpoint of structural integrity when using a conductive material such as indium tin oxide or the like. Alternatively, repair shunt 180 can be disposed in-between first portion 141 and second portion 142 of data line 140 in lieu of being disposed on the upper surfaces of segments 143 and 144, so long as adequate electrical contact is made to bridge the open circuit between first and second data line portions 141, 142.
