US012145893B2

(54) COATING REPAIR FOR CERAMIC MATRIX COMPOSITE (CMC) SUBSTRATES

(57) ABSTRACT

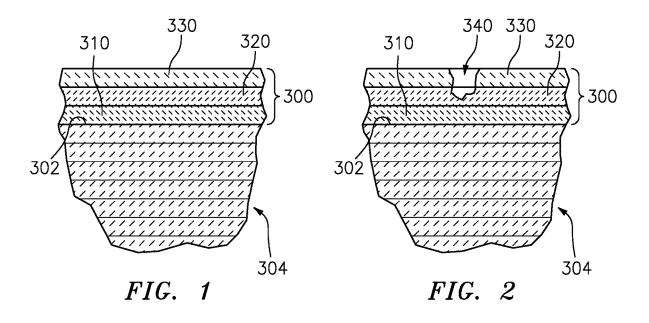
FIG. 1 is a partial schematic cross-sectional view of a

FIG. 1 shows an exemplary coating system (coating) 300 of a part such as a blade, vane, BOAS, or the like). The exemplary coating system is a three-layer system. A first

layer 310 is formed by applying a mixture of silicon oxycarbide (SiOC) and silicon dioxide (SiO $_2$). Exemplary silicon oxycarbide is relatively fine (e.g., particle size in the range of 0.10 micrometer to 45.0 micrometers (e.g., -325 mesh which would limit to below 45.0 micrometers), more 5 narrowly 1 micrometer to 25 micrometers). The majority by mass may be in the higher end of the range. For example, the mass median particle may be equal to or above 10 micrometers or equal to or above 20 micrometers (while still equal to or lower than the 45.0 micrometers or 25.0 micrometers 10 alternate upper ends of that range).

A second layer **320** is formed by applying a combination of silicon oxycarbide and an additional particulate for assisting in formation of a sealing layer. Exemplary additional particulates are aluminosilicates (namely one or more of BMAS (barium magnesium aluminosilicate), BAS (barium aluminosilicate), BSAS, (barium strontium aluminosilicate) 65 SAS (strontium aluminosilicate), and/or silicon dioxide. In this layer, the silicon oxycarbide particles may be relatively

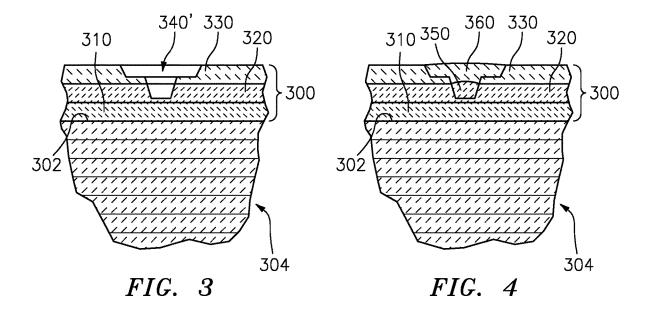
FIG. 2 is a partial schematic cross-sectional view of the article with a damage site.

FIG. 2 shows a damage site in the form of a penetration 340 penetrating the outermost layer 330 and intermediate layer 320. An exemplary first repair process for this damage site generally preserves the layers. There may be an initial cleaning of the site prior to repair. This cleaning may include a chemical cleaning, may include a grit blasting, or may include machining (e.g., using a drill or milling bit to provide a clean even surface of cleaned penetration 340' for spray deposition of repair material) (FIG. 3).

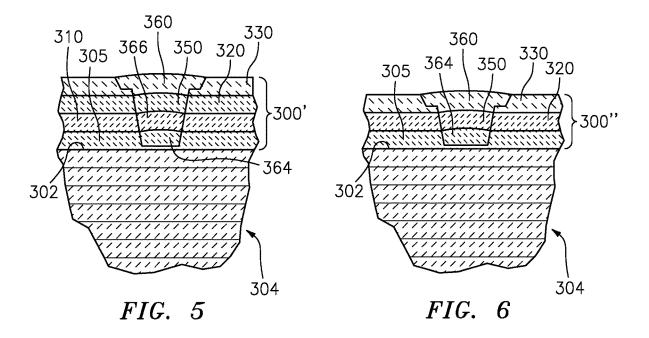
FIG. 3 is a partial schematic sectional view of the article with the damage site cleaned.

The exemplary cleaned penetration 340 is left with a stepped shape akin to a counterbore that provides enhanced surface area for bonding between repair material and the original/prior material.

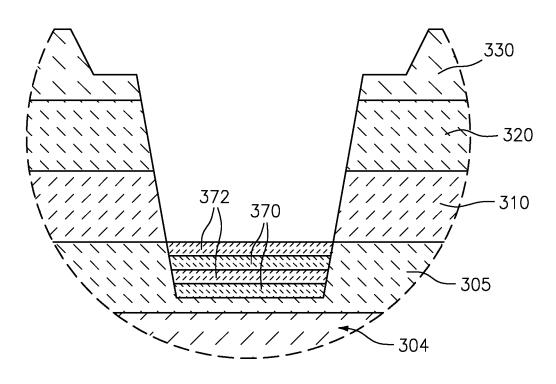
FIGS. 8 and 9 are partial schematic sectional views of two stages of an alternate repair to the first alternate coated

Alternating layers/continuous sublayers of silicon and hafnium oxide may be applied to grade the composition and make the repaired layers more compatible. FIG. 8 shows such sublayers of silicon (or silicon dioxide) 370 and hafnium oxide 372 (e.g., both microplasma sprayed, or optionally slurry application of layer 372 such as noted above). FIG. 8 shows four total such layers 370, 372 within the depth of repair of the layer 305. A broader range of number of such layers is two to twenty or two to ten or four

to ten. Heat treatment of such layers in an oxidizing environment between 1000 C-1450 C results in a final layered structure. One example of such final layered structure has each layer 370, 372 diffusing to essentially hafnium silicate but with a compositional gradient within/between such layers (FIG. 9). The illustrated FIG. 8 example has the material 350 repairing both the layers 310 and 320. Alternatively, the sublayering 370, 372 may extend further outward replacing some or all of the material 350 or other layerings may replace some or all of the material 350.
