(10) **Pub. No.: US 2007/0202269 A1**

(54) **LOCAL REPAIR PROCESS OF THERMAL  
BARRIER COATINGS IN TURBINE ENGINE  
COMPONENTS**

## LOCAL REPAIR PROCESS OF THERMAL BARRIER COATINGS IN TURBINE ENGINE COMPONENTS

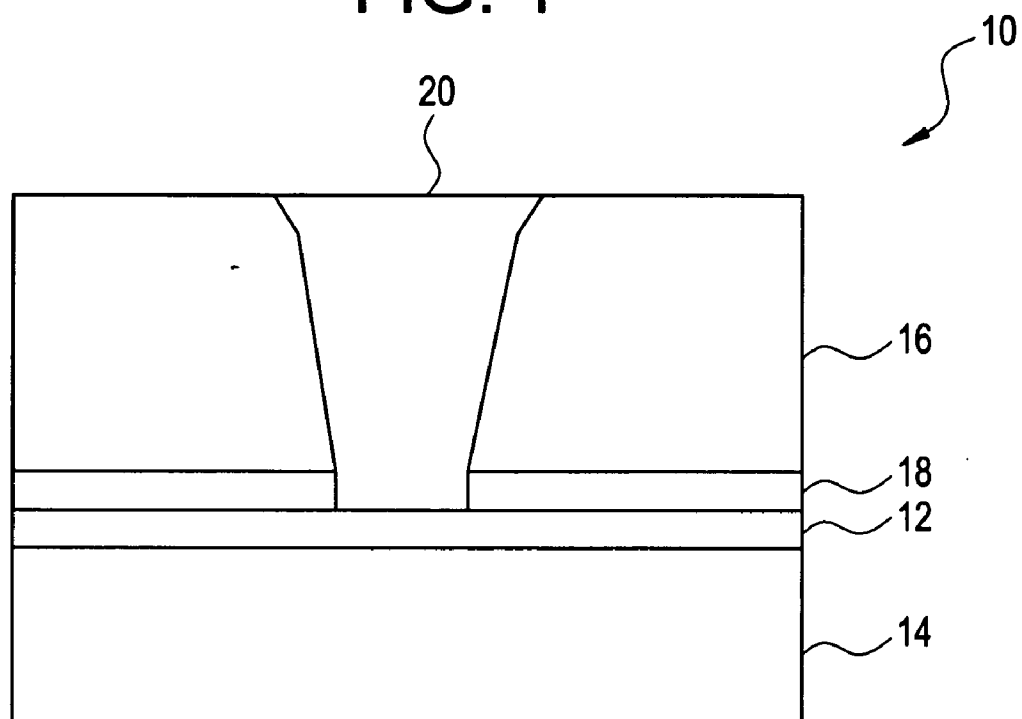
[0012] FIG. 1 is a cross sectional view illustrating a typical thermal barrier coating system deposited onto a turbine component, wherein the illustrated thermal barrier coating system includes a locally spalled region;

[0017] Referring now to FIG. 1, there is illustrated a typical thermal barrier coating system, generally designated by reference numeral 10, having a locally spalled region 20. The system generally includes a bond coat 12 deposited on the surface of a turbine engine component 14 and a ceramic layer 16 disposed thereon. The form of the turbine engine component varies among combustor liners, combustor domes, shrouds, buckets or blades, nozzles or vanes. The component is most typically an airfoil, including stationary airfoils such as nozzles or vanes, and rotating airfoils including blades and buckets. Blades and buckets are used herein interchangeably; typically a blade is a rotating airfoil of an aircraft turbine engine, and a bucket is a rotating airfoil of a land-based power generation turbine engine. In the case of a blade or bucket, typically the region under repair is the tip region that is subject to wear due to rubbing contact with a surrounding shroud, and to oxidation in the high-temperature environment. In the case of a nozzle or vane, typically the area under repair is the leading edge, which is subject to wear due to exposure of the highest velocity gases in the engine at elevated temperature. The component may be formed from a nickel, cobalt or iron-based superalloys, or the like. The alloys may be cast or wrought superalloys. Examples of such substrates are GTD-111, GTD-222, Ren 80, Ren 41, Ren 125, Ren 77, Ren N4, Ren N5, Ren N6, 4th generation single crystal superalloy MX-4, Hastelloy X, cobalt-based HS-188, and MAR-M509.

[0018] The ceramic layer (top coat) 16, also sometimes referred to as a topcoat, is deposited on the surface of the bond coat 12. The bond coating 12 is typically in the form of an overlay coating such as MCrAlX (where M is iron, cobalt and/or nickel, and X is yttrium or another rare earth element), or diffusion aluminide coatings. The bond coating 12 protects the underlying component 14 from oxidation and enables the ceramic layer 16 to more effectively adhere to the component 14. During the deposition of the ceramic top coat layer and subsequent exposures to high temperatures, such as during engine operation, these bond coats form an oxide scale 18, e.g., a tightly adherent alumina ( $\text{Al}_2\text{O}_3$ ) layer, that adheres the top coat to the bond coat.

[0020] In an operating turbine, the surfaces of the component 14 are subjected to hot combustion gasses, and are therefore subjected to attack by oxidation, corrosion and erosion. Accordingly, the component 14 must remain protected from this hostile operating environment by the TBC system 10. Loss of the ceramic layer 16 and possibly the bond coat 12, due to spallation brought on by thermal fatigue may lead to premature, and often rapid deterioration of the component 14. A localized spalled region 20 of the ceramic layer 16 is illustrated in FIG. 1.

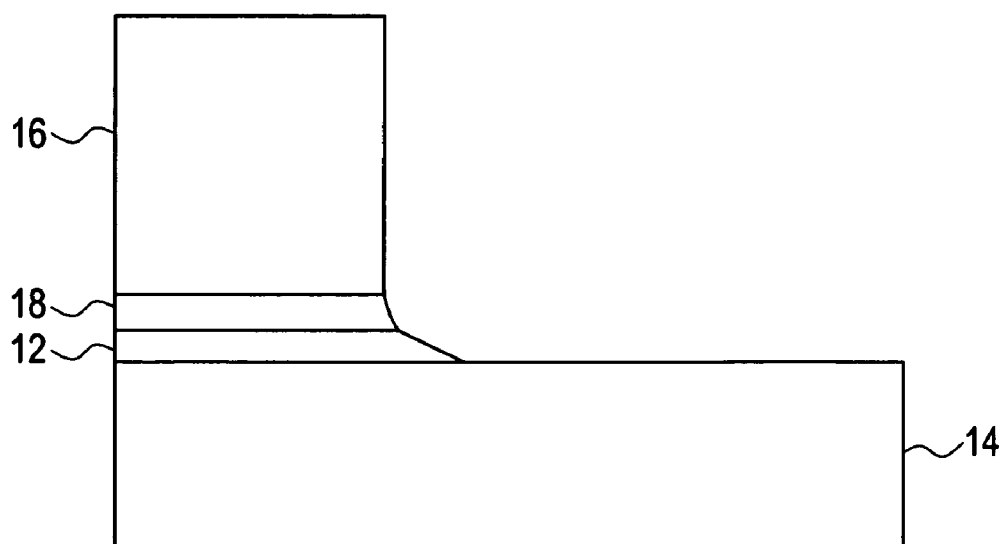
[0013] FIG. 2 is a cross sectional view illustrating the thermal barrier coating system after locally cleaning and stripping the locally spalled region, wherein the cleaning process provides a tapered profile to the existing thermal barrier coating;

[0021] In the repair process, the component 14 is first removed from the turbine and the surface including the localized spalled region 20 is cleaned and stripped so as to remove loose oxides and contaminants, such as grease, oils and soot. While various techniques may be used, one embodiment includes removing the loose material from the spalled region 20 and cleaning the surface with water using a waterjet. The waterjet is programmed to specifically target the spalled region 20 and form a tapered profile to the various layers defining the particular TBC system 10 as shown in FIG. 2. This step may be selectively performed to ensure that the surrounding undamaged TBC is not subjected to this procedure. Following cleaning, the spalled region 20 is locally recoated using a thermal spray process.

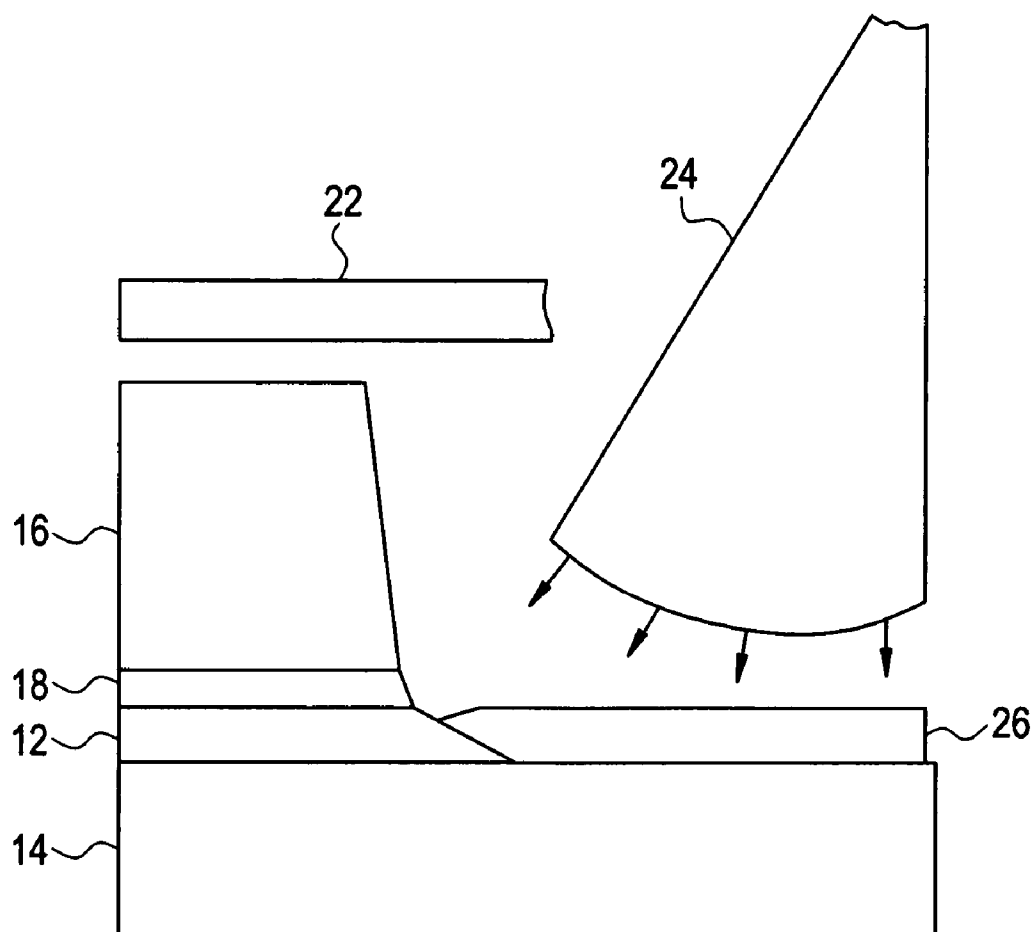
[0014] FIG. 3 is a cross sectional view illustrating local recoating of the thermal barrier coating using a thermal spray process; and

[0028] FIG. 3 schematically illustrates an exemplary locally repaired TBC system. After cleaning the locally spalled region 20 to impart a tapered profile, a mask 22 is employed in combination with the thermal spray process. By using the mask 22, the thermal spray 24 specifically targets and recoats the damaged region. By careful selection of powder used in thermal spray process, the repaired TBC region 26 can be substantially reproduced to match the coating composition of the existing TBC surrounding the spalled region 20. In this manner, the recoated TBC can be thermally deposited such that there is no overlap of the bond coat 12 onto the topcoat 16 can be effected. Moreover, by using a tapered profile, gaps are eliminated and/or substan-

tially minimized, thereby providing the repaired region with coating properties similar to the existing TBC.

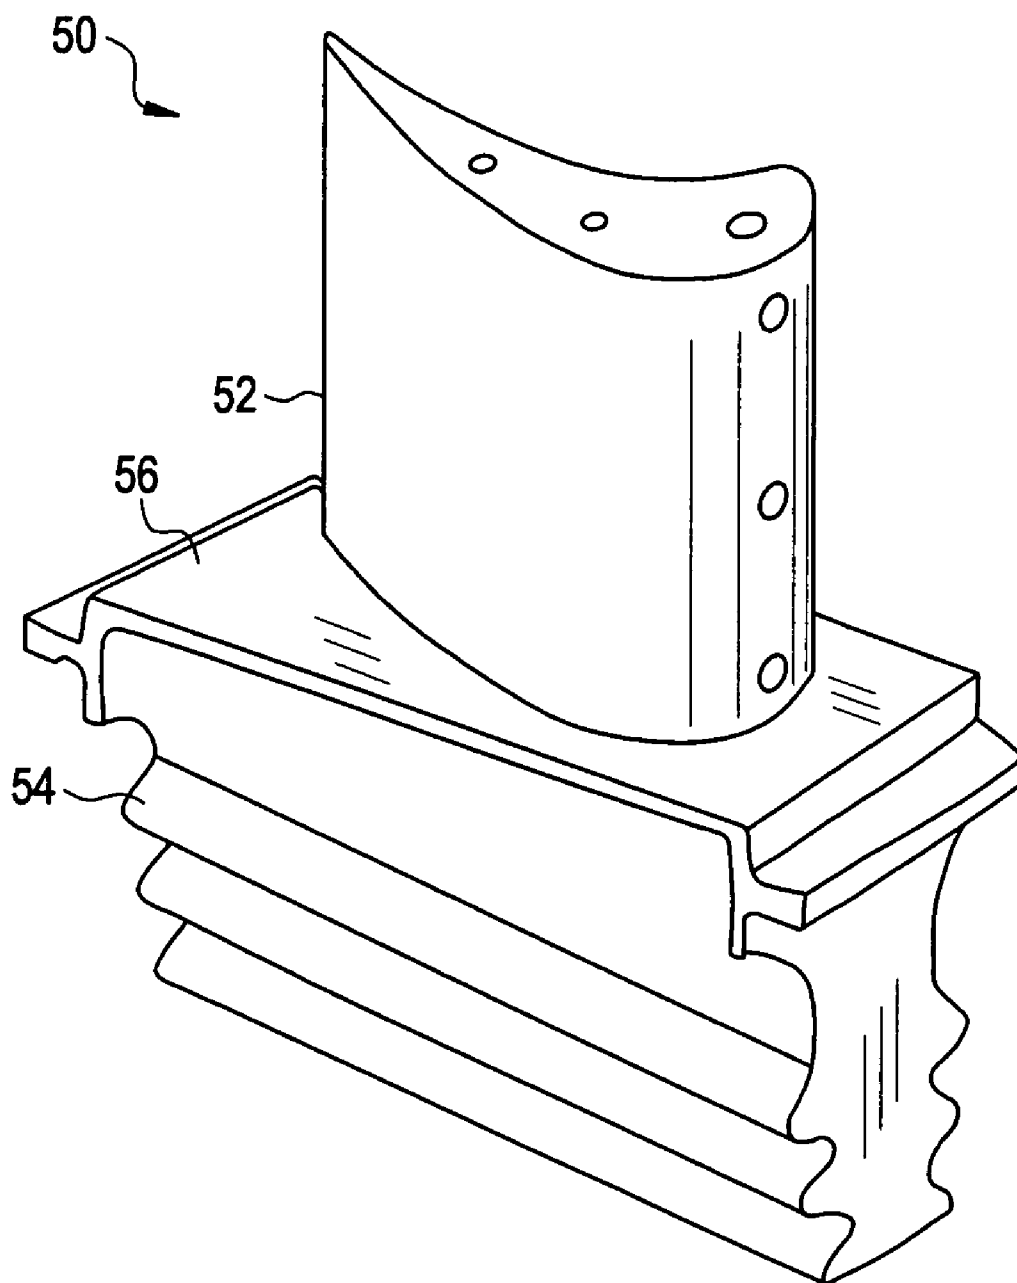
[0015] FIG. 4 illustrates a perspective view of a bucket turbine engine component.

[0029] FIG. 4 illustrates a bucket turbine engine component generally designated by reference numeral 50. The bucket 50 includes an airfoil portion 52 and a dovetail portion 54. The airfoil portion 52 is seated on a platform 56. All of the surfaces are coated with a thermal barrier coating system, an example of which has been shown with reference to FIG. 1. During repeated operation, the platform 56 can undergo spallation as previously described. Advantageously, the above noted repair process can be used to repair the platform. The repair process, since it is locally applied, does not expose the airfoil to the thermal conditions employed during thermal spraying to effect the repair. As is known in the art, during operation the thermal barrier coating system about the airfoil can crack as a result of the stresses applied to the airfoil during operation. Although cracking may occur, the presence of cracks generally does not warrant immediate repair. Prior art thermal spraying processes would require stripping all of the thermal barrier coating system from all surfaces because thermal exposure would cause additional damage, e.g., corrosion, oxidation and the like, to the cracked coating of the airfoil.
