US007925454B1

(54) **PROCESS FOR DETERMINING A
REMAINING LIFE OF A DETERIORATED
TURBINE COMPONENT**

(73) Assignee: **Florida Turbine Technologies, Inc.**,
Jupiter, FL (US)

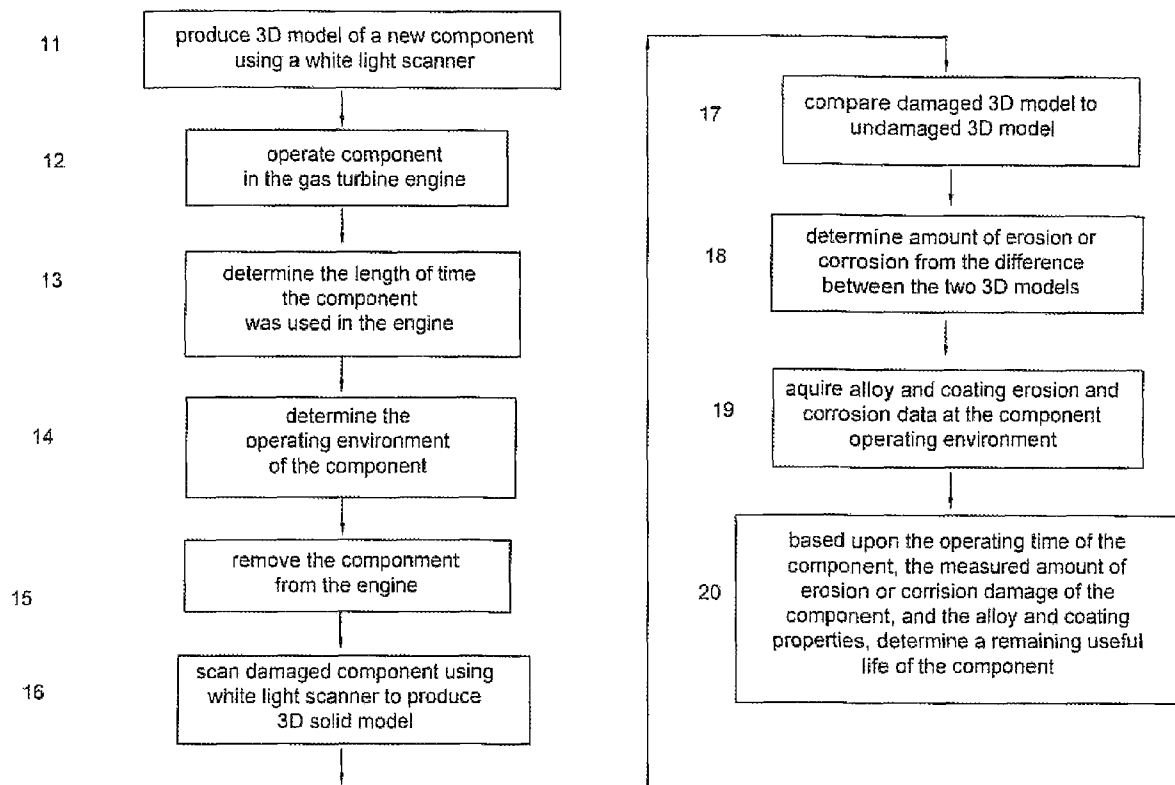
Fig 1

The FIGURE shows a flowchart for the process of determining a remaining useful life for a damaged airfoil.

After the component has undergone exposure in the engine to the high temperature environment that will cause the erosion or corrosion damage, the engine is shut down (step 21) and the component is removed from the engine (step 15) and scanned again to produce a 3D model of the damaged component (step 16). An optical scanner such as a white light scanner is used to produce the 3D model because it can reproduce on the model the amount of erosion or corrosion occurring. A thermal analysis and a structural analysis of the

damaged component 3D model are performed (step 22). From the thermal analysis and a structural analysis of the scanned solid model, the depth of erosion or corrosion can be determined by comparing the original undamaged solid model of the component with the solid model showing the damage (step 17).

When the undamaged solid model is compared to the damaged solid model, the differences can be determined that will represent the amount of damage occurred on the component (step 18). During the component's use—when the damage was done—the length of time (step 13) and the operating conditions of the component (step 14) such as the temperature is noted for use in determining the component's remaining life. For example, the length of time that the component was exposed in the engine is noted. With the length of time that the component was undergoing the erosion or corrosion damage, and the amount of damage done on the component for that length of time, the amount of remaining useful life for that component can then be determined (step 20). Material property tables or previous experiences with the particular material can be used to aid in this determination. If the remaining life of a damaged component is found to be longer than a certain time period, the damaged component is then reused in the engine (step 23). If the time period is less than the certain time period, then the damaged component is discarded and a new component is placed in the engine.
