(10) **Patent No.:** **US 10,919,180 B2**  
(45) **Date of Patent:** **Feb. 16, 2021**

(54) **REPAIR PROCESS USING NETWORKED CERAMIC NANOFIBERS**

(71) Applicant: **United Technologies Corporation**,  
Farmington, CT (US)

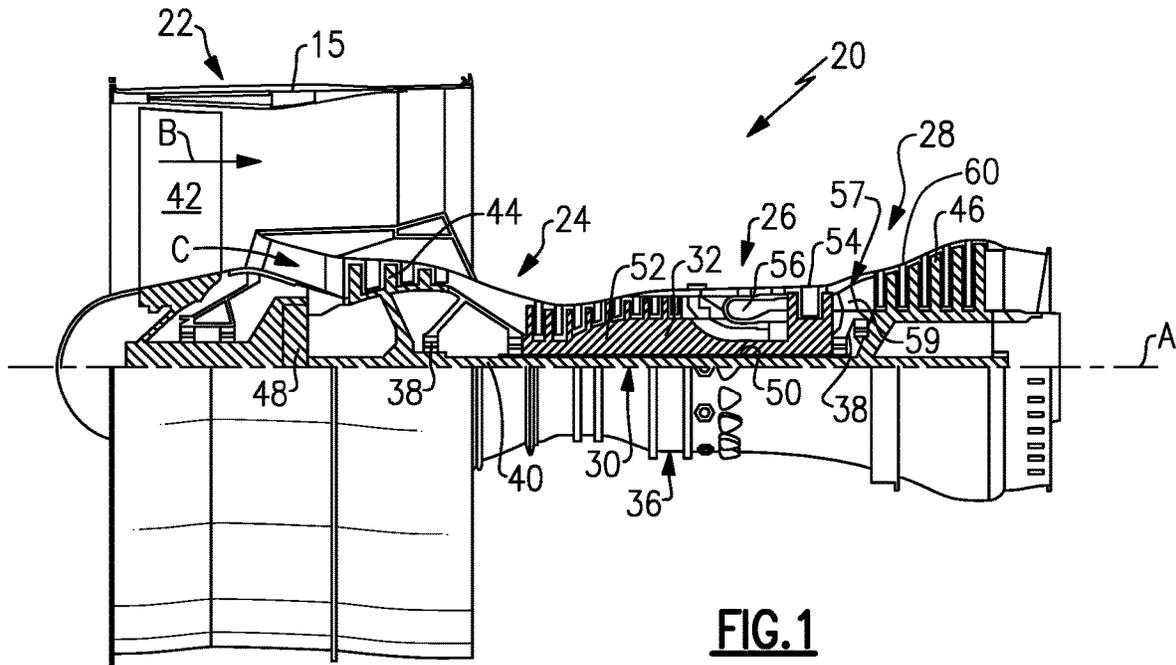
FIG. 1 illustrates an example gas turbine engine.

FIG. 1 schematically illustrates a gas turbine engine 20. The gas turbine engine 20 is disclosed herein as a two-spool turbofan that generally incorporates a fan section 22, a compressor section 24, a combustor section 26 and a turbine section 28. The fan section 22 drives air along a bypass flow path B in a bypass duct defined within a nacelle 15, and also drives air along a core flow path C for compression and communication into the combustor section 26 then expansion through the turbine section 28. Although depicted as a two-spool turbofan gas turbine engine in the disclosed non-limiting embodiment, it should be understood that the concepts described herein are not limited to use with two-spool turbofans as the teachings may be applied to other types of turbine engines including three-spool architectures.

The exemplary engine 20 generally includes a low speed spool 30 and a high speed spool 32 mounted for rotation about an engine central longitudinal axis A relative to an engine static structure 36 via several bearing systems 38. It should be understood that various bearing systems 38 at various locations may alternatively or additionally be provided, and the location of bearing systems 38 may be varied as appropriate to the application.

The low speed spool 30 generally includes an inner shaft 40 that interconnects, a first (or low) pressure compressor 44 and a first (or low) pressure turbine 46. The inner shaft 40 is connected to the fan 42 through a speed change mechanism, which in exemplary gas turbine engine 20 is illustrated as a geared architecture 48 to drive a fan 42 at a lower speed than the low speed spool 30. The high speed spool 32 includes an outer shaft 50 that interconnects a second (or high) pressure compressor 52 and a second (or high) pressure turbine 54. A combustor 56 is arranged in exemplary gas turbine 20 between the high pressure compressor 52 and the high pressure turbine 54. A mid-turbine frame 57 of the engine static structure 36 may be arranged generally between the high pressure turbine 54 and the low pressure turbine 46. The mid-turbine frame 57 further supports bearing systems 38 in the turbine section 28. The inner shaft 40 and the outer shaft 50 are concentric and rotate via bearing systems 38 about the engine central longitudinal axis A which is collinear with their longitudinal axes.

The core airflow is compressed by the low pressure compressor 44 then the high pressure compressor 52, mixed and burned with fuel in the combustor 56, then expanded over the high pressure turbine 54 and low pressure turbine 46. The mid-turbine frame 57 includes airfoils 59 which are in the core airflow path C. The turbines 46, 54 rotationally drive the respective low speed spool 30 and high speed spool 32 in response to the expansion. It will be appreciated that each of the positions of the fan section 22, compressor section 24, combustor section 26, turbine section 28, and fan drive gear system 48 may be varied. For example, gear system 48 may be located aft of the low pressure compressor, or aft of the combustor section 26 or even aft of turbine section 28, and fan 42 may be positioned forward or aft of the location of gear system 48.

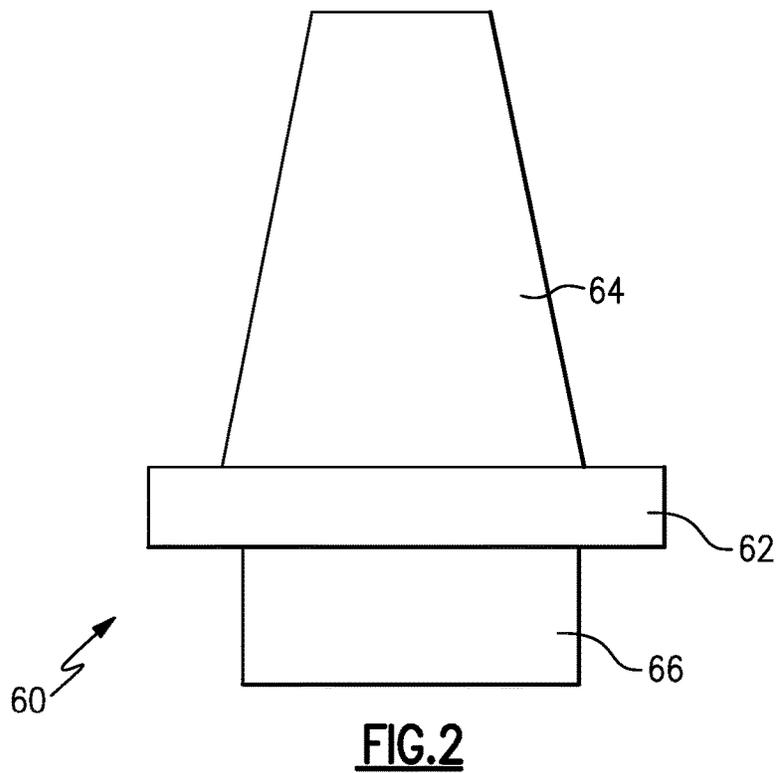
FIG. 2 illustrates an example article subject to repair.

FIG. 2 illustrates an example article 60. In this example, the article 60 is a rotatable turbine blade of the engine 20 (see also FIG. 1). It is to be understood that, although the examples herein may be described with reference to the turbine blade, this disclosure is also applicable to static turbine vanes, other types of airfoils, seals, combustors, or other gas turbine engine components.

The turbine blade generally includes a platform 62, an airfoil section 64 that extends from the platform 62, and a root 66. The article 60 is subjected during use to extreme temperatures in the engine 20. The article 60 includes a coating system to protect against the high temperatures and environmental effects that might otherwise damage the article 60. The coating system may include a ceramic barrier coating. Such ceramic barrier coatings can be subject to damage during use, such as damage from spalling, erosion, or wear. From time to time and inasmuch as feasible, such articles are repaired in order to extend use.

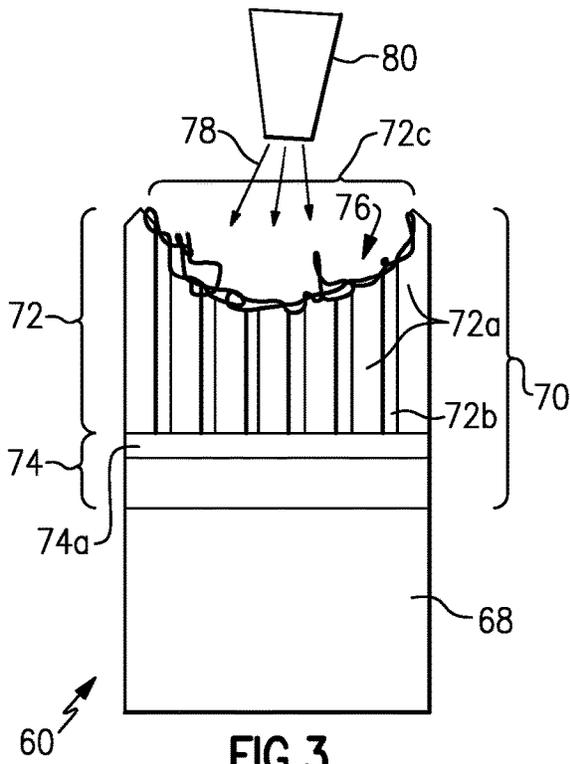
**FIG. 3**

FIG. 3 illustrates a view of a representative portion of the article of FIG. 2 during a repair process involving abrading the article.

FIGS. 3, 4, and 5 depict an example repair process for a representative portion of the article 60. For a turbine blade, the portion may be on the platform 62, airfoil section 64, or root 66. As will also be appreciated, the article 60 may have numerous portions which are repaired in a similar manner as described below.

The next step in the repair process includes abrading the damaged region **72c**. The depression **76** may contain debris or other undesirable substances which could be detrimental to the ceramic barrier coating **72** or hinder the remainder of the repair process. In this respect, the abrading facilitates removal of much or all of the debris, as well as possibly small portions of the ceramic barrier coating **72** in the vicinity of the damaged region **72c**. The abrading thereby produces a fresh, clean surface in the ceramic barrier coating **72**.

As an example, the abrading may include spraying an abrasive media **78** from a spray nozzle **80** onto the damaged region **72c**. For instance, the abrasive media **78** may be carried in a pressurized process gas. The abrasive media **78** strikes the damaged region **72c** and thereby removes the debris and possibly portion of the ceramic barrier coating **72**. The pressure of the process gas may be controlled in order to control removal of the debris and ceramic barrier coating **72**. In one example, the abrasive media **78** includes particles of dry ice, which is solid carbon dioxide. The dry ice facilitates clean removal because it is substantially non-reactive at normal pressure and temperature (NTP) with the ceramic barrier coating **72** and thus does not leave residue or stains. Additionally, the dry ice rapidly evaporates and thus does not leave a mess.

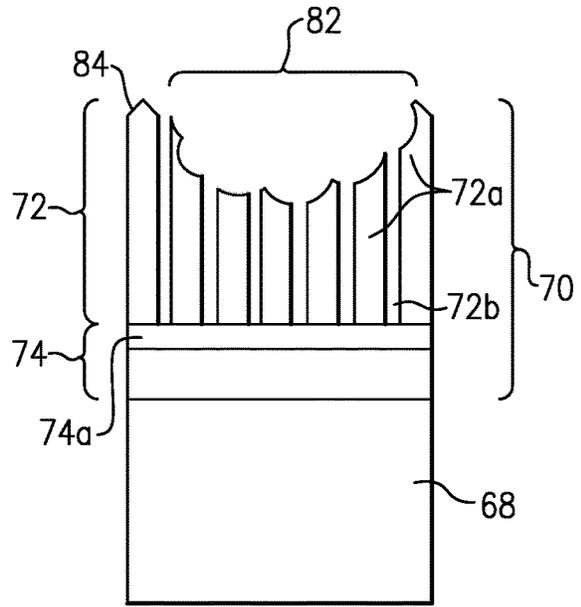
**FIG. 4**

FIG. 4 illustrates the article of FIG. 3 during the repair process after abrading the article.

FIG. 4 depicts the article **60** after the abrading. The abrading has removed debris and a portion of the ceramic barrier coating **72** such that a dimple **82** remains in the ceramic barrier coating **72**. A remaining region of the ceramic barrier coating, a representative portion of which is

shown at **84**, adjacent the dimple **82** remains intact after the abrading step. For instance, “intact” may refer to this region as being unchanged in physical character before and after the abrading. In this example, the dimple **82** is only modestly larger than the damaged region **72c** and does not extend entirely through the thickness of the ceramic barrier coating **72**.

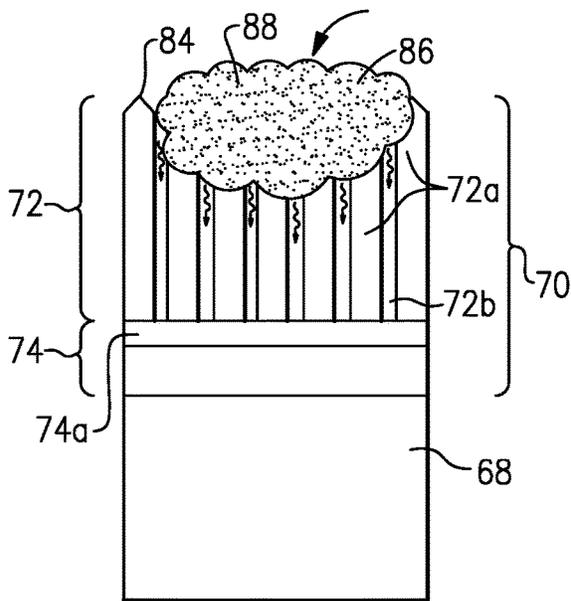
**FIG. 5**

FIG. 5 illustrates the article of FIG. 4 during the repair process involving deposition of a patch of networked ceramic nanofibers.

The next step in the repair process, depicted in FIG. 5, is the deposition of a patch **86** into the dimple **82**. The patch **86** is composed of networked ceramic nanofibers **88**. FIG. 6 illustrates a magnified view of the networked ceramic nanofibers **88**. The nanofibers **88** are elongated, randomly oriented filaments that have a maximum diameter of 1 nanometer to 500 nanometers. More typically, the diameter will be 1 nanometer to 250 nanometers, 1 nanometer to 100 nanometers, or 1 nanometer to 50 nanometers. The filaments are non-linear and curve or turn such that the filaments are intertwined to form a tangled porous network. As used herein, “networked” refers to the intertwining of the fibers or filaments. Where the filaments contact each other, they may be bonded together as a result of the process used to form the patch **86**.

The patch **86** of networked ceramic nanofibers **88** fills the dimple **82** and seals the pores **72b** of the ceramic barrier coating **72**. The nanofibers **88** may also mechanically interlock with the surface roughness in the dimple **82** that results from the abrading, thereby providing good bonding between the patch **86** and the ceramic barrier coating **72**. In that regard, the pressure of the process gas may also be controlled to produce a desirable level of roughness for mechanical interaction with the nanofibers **88**.

The patch **86** of networked ceramic nanofibers **88** may be deposited directly into the dimple **82**. For example, the patch **76** of networked ceramic nanofibers **88** may be deposited by a blow-spinning process. Blow-spinning involves spraying a precursor solution through an inner nozzle while flowing a process gas from an outer concentric nozzle such that the precursor when sprayed elongates into ultra-thin filaments. The filaments deposit in the dimple **82** and, after further processing, are converted into the ceramic nanofibers. The precursor solution includes binders and salts of the constituents that will form the ceramic, such as zirconium, oxygen, and any dopants. An example binder includes polyvinylpyrrolidone, and example salts may include aqueous oxynitrate, nitrate, nitrite, or chloride salts of zirconium and the selected dopants, zirconyl chloride, or metal organics such as zirconium isobutoxide or isopropoxide in a solvent. The amounts of the constituents may be controlled in order to control the final composition of the ceramic nanofibers. After spinning, the filaments are then thermally treated to remove binders, etc. and sinter the ceramic. The thermal treatment may include heating the filaments to temperatures from 800° C. to 1000° C., for example. It is during the thermal treatment that the filaments may diffuse and thereby bond together where they are in contact. The thermal treatment may also cause diffusion at points of contact between the nanofibers **88** and the ceramic barrier coating **72**, thereby providing additional bonding.

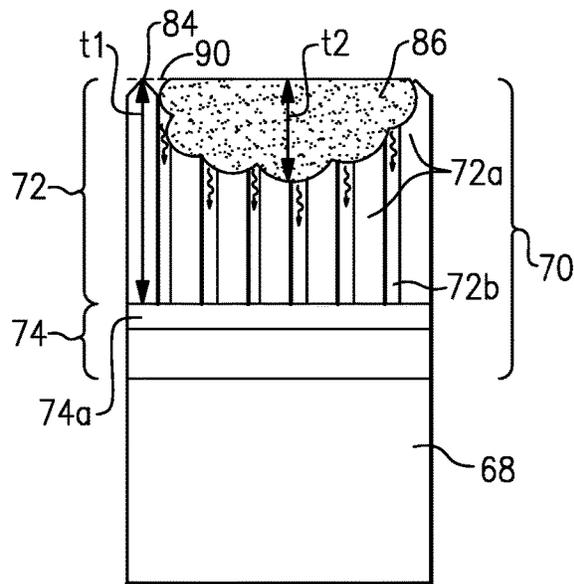
**FIG. 7**

FIG. 7 illustrates the article of FIG. 5 during the repair process involving polishing the patch of networked ceramic nanofibers.

After deposition, the patch **86** may project from the ceramic barrier coating **72**, which generally has a continuous, smooth outer surface. If desired, as depicted in FIG. 7, the patch **86** can be polished such that it is flush with the remaining region **84** of the ceramic barrier coating **72** adjacent the patch **86**, as represented at **90**.

At the remaining region **84**, the ceramic barrier coating **72** may define a thickness  $t_1$ . The patch **86** may also define a maximum thickness  $t_2$ , wherein the thickness  $t_2$  is less than the thickness  $t_1$ . The thickness  $t_2$  being less than the thickness  $t_1$  is a representation that the patch **86** is not as thick as the ceramic barrier coating **72**. That is, the patch **86** most typically will be a relatively small piece of material that mends a relatively small region of the coating **72**. In particular, the ceramic barrier coating **72** thus has a locally thin portion at the dimple **82**. This locally thin portion, but for the patch **86**, may otherwise be prone to CMAS or foreign substance infiltration.

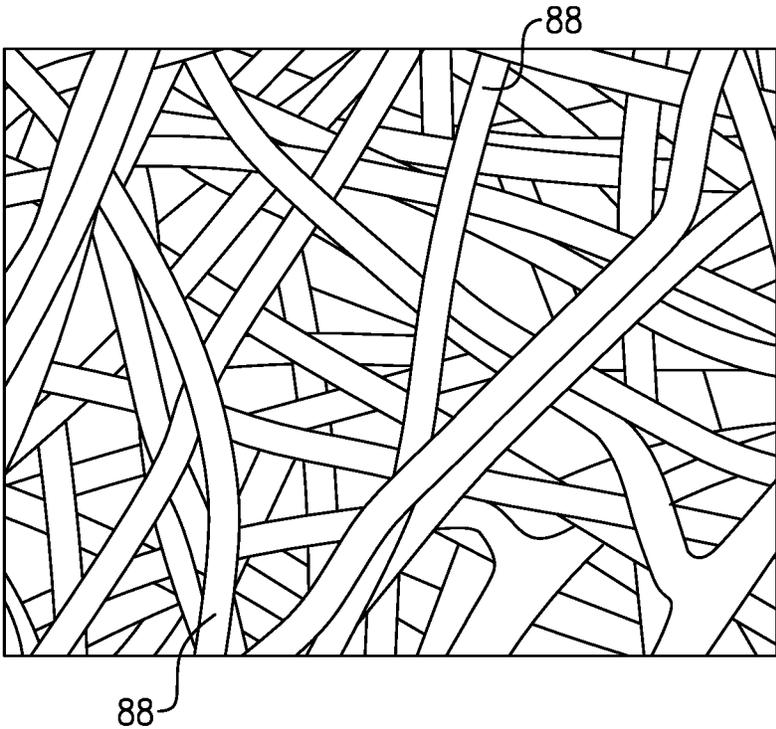
**FIG.6**

FIG. 6 illustrates a magnified view of networked ceramic nanofibers.

Although the patch **86** of networked ceramic nanofibers **88** is itself porous, the networked ceramic nanofibers **88** provide a sponge-like structure of smaller pores that provides superior thermal insulation. Therefore, the patch **86** of networked ceramic nanofibers **88**, even if formed of the same composition as the ceramic barrier coating **72**, provides thermal sealing of the ceramic barrier coating **72**. As an example based on zirconia, the patch **86** of networked ceramic nanofibers **88** may have a thermal conductivity of approximately 0.027 Watts per meter-Kelvin.

Additionally, the filaments of the networked ceramic nanofibers **88** are also flexible and strain tolerant. The flexibility of the filaments may further facilitate entrapment of foreign particles, debris, or materials, as well as act as “bumper” to absorb impact of particles and debris. The patch **86** of networked ceramic nanofibers **88** thereby provides thermal and physical sealing/protection.
