US008231142B2

(54) FLUID CONDUIT COUPLING WITH LEAKAGE DETECTION

- (75) Inventor: Bryan W. Olver, Nobleton (CA)
- (73) Assignee: **Pratt & Whitney Canada Corp.**, Longueuil (CA)
- (*) Notice: Subject to any disclaimer, the term of this patent is extended or adjusted under 35 U.S.C. 154(b) by 664 days.
- (21) Appl. No.: 12/372,017
- (22) Filed: Feb. 17, 2009

The application relates generally to fluid conduit couplings and, more particularly, to fluid conduit for a turbofan gas turbine engine.

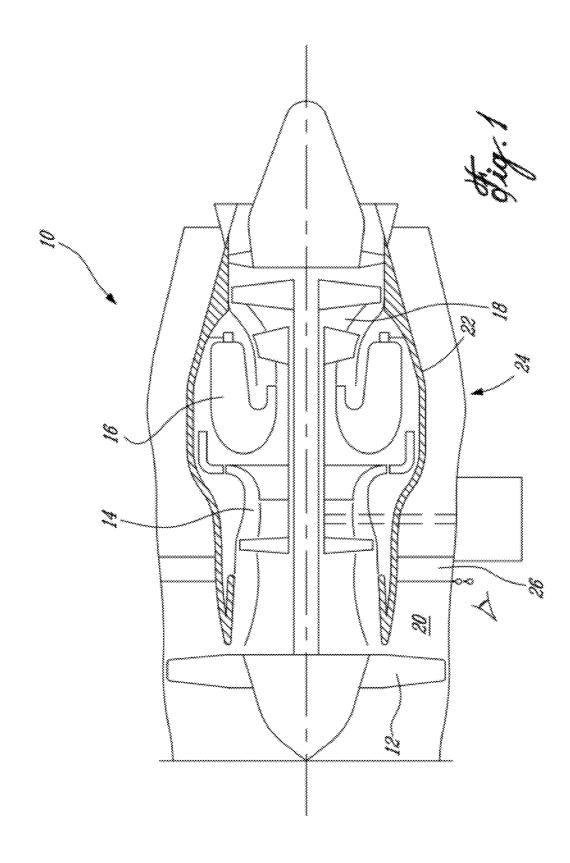
FIG. 1 is a schematic cross-sectional view of a turbofan gas turbine engine including one embodiment of the coupling assembly on a fuel line shrouded within a fairing;

FIG. 1 illustrates a turbofan gas turbine engine 10 of a type preferably provided for use in subsonic flight, generally comprising in serial flow communication a fan 12 through which ambient air is propelled, a multistage compressor 14 for pressurizing the air, a combustor 16 in which the compressed air is mixed with fuel and ignited for generating an annular stream of hot combustion gases, and a turbine section 18 for extracting energy from the combustion gases.

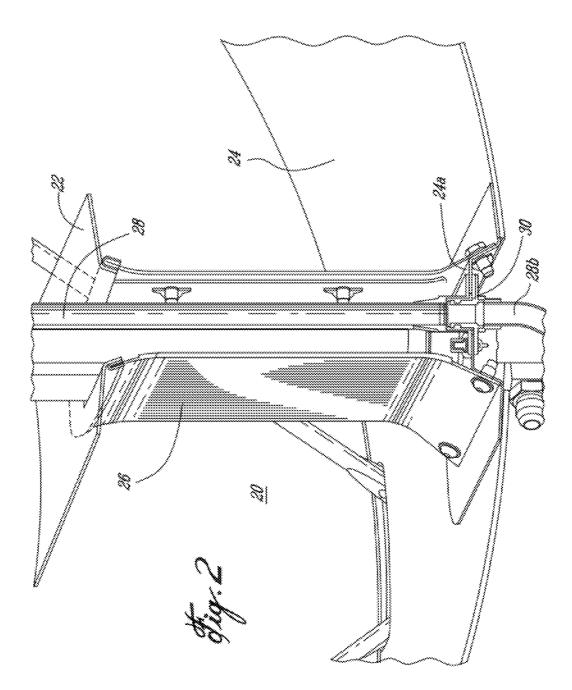
FIG. 2 is a is a fragmentary perspective view of FIG. 1, showing a gas path in the turbofan engine with a detail of one embodiment of the coupling assembly on a fuel line shrouded within a fairing;

FIG. 2 shows somewhat schematically a gas path 20, such as the bypass duct of the turbofan engine 10, defined by inner duct wall 22 and outer bypass duct wall 24. The outer bypass duct wall 24 forms a firewall. Generally when fluid lines extend across the gas path 20, fairings are provided. In this case, a fairing 26 extends between the bypass duct walls 22 and 24 and shrouds various fluid and utility lines as shown in FIGS. 2 and 3. The fluid line 28 may be a fuel line or oil line. It includes segmented tubular conduits that are generally joined at the bulkhead formed at the outer bypass duct wall 24.

The embodiments shown in FIGS. 2 through 5a and 5binclude a lightweight bulkhead 24a (FIG. 3) fixed to the outer bypass duct wall 24. This configuration is lightweight in comparison to the more bulky prior art fairings which have been used. The fairing 26 is bolted securely to the bulkhead 24a. A typical fuel or oil line 28 includes segments 28a and 28b joined at a coupling 30. The coupling 30 is coincident with the bulkhead 24a. Bulkhead 24a, forming part of the outer bypass duct wall 24, is generally available for visual inspection from the outside of the engine.

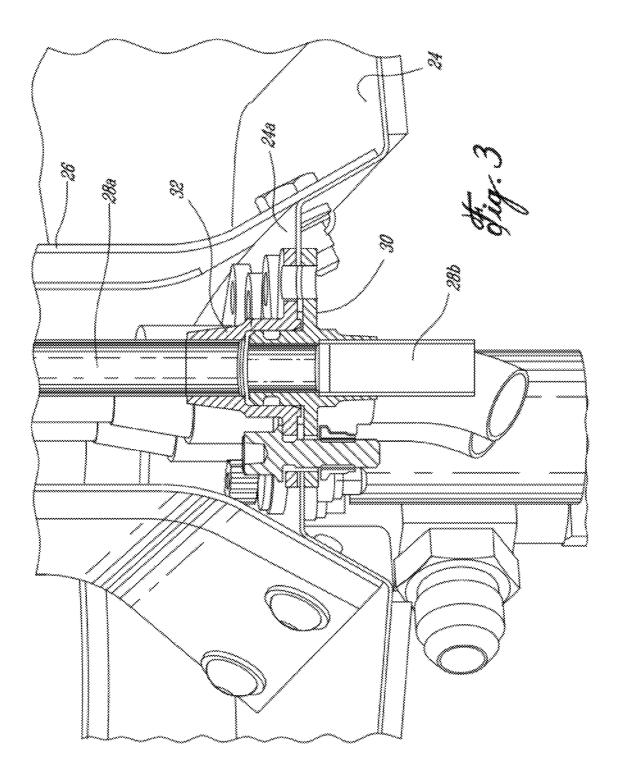
FIG. 3 is an enlarged fragmentary perspective view similar

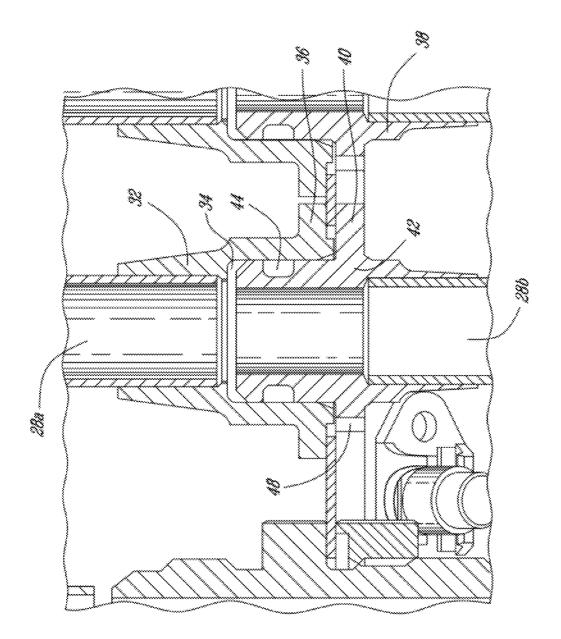
FIG. 4 is an enlarged radial cross section taken through line 4-4 in FIG. 3;

As shown in FIG. 4, the coupling 30 includes a female coupling member 32 and a male coupling member 38. The female coupling member 32 is affixed by swaging, welding, or brazing to the end of the conduit 28a while the male coupling member 38 is fixedly connected to the end of the tubular conduit 28b. The female coupling member 32includes a central recess 34 adapted to loosely receive the concentric wall 42 of the male coupling member 38. The male coupling member 38 includes an O-ring seat 43 adapted to receive an O-ring 44 which acts as a seal when the male coupling member 38 is inserted into the female coupling member 32.

As can be seen in FIG. **4**, there is a leakage path provided ¹⁰ between the concentric wall **42** and the surface forming the recess **34** towards the exterior of the outer bypass duct wall **24**. The male coupling member includes a flange **40** as shown in FIGS. **5***a* and **5***b* to allow the coupling member **30** to be 15 fixed to the bulkhead by way of bolts **41**.

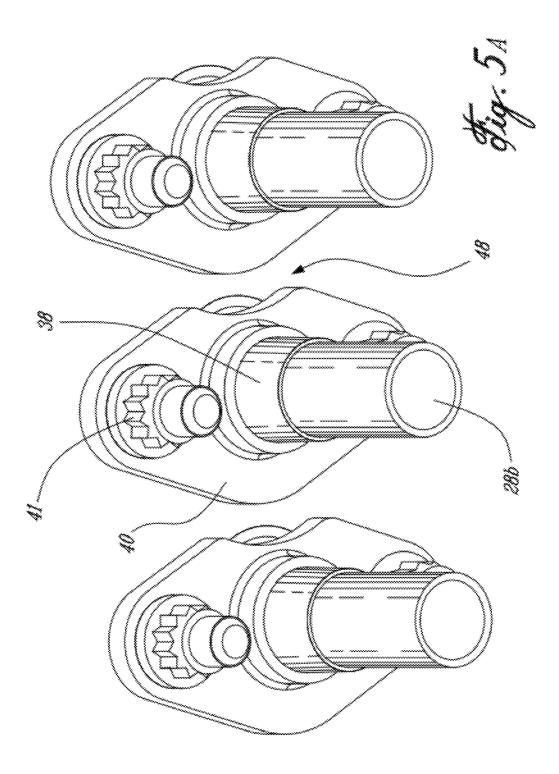
FIG. 5a is an enlarged fragmentary perspective view looking inwardly at the gas path duct wall, showing a further detail of the coupling assembly; and

In one embodiment as shown in FIG. **5***a* the flange **40** is scalloped at **48** and allows the leak path to communicate with the exterior of the bulkhead **2***4a*. Therefore, if there is a breach in the seal **44**, the fluid such as fuel will take the path of least ²⁰ resistance and follow the leak path through the opening **48** formed by the scallop in the flange **40**. Thus, if there is a breach in the seal **44**, the fluid will leak to the outside of the bypass duct or nacelle rather than the undetectable side inside the gas path where fluid would either be lost to the air in the ²⁵ gas path or would simply accumulate. Should a seal failure occur in flight, nacelles are protected from fluid accumulation by strategically placed drains which are in fact verified by flight tests during aircraft certification. This precludes the danger of excess fluid accumulating inside the nacelle. ³⁰

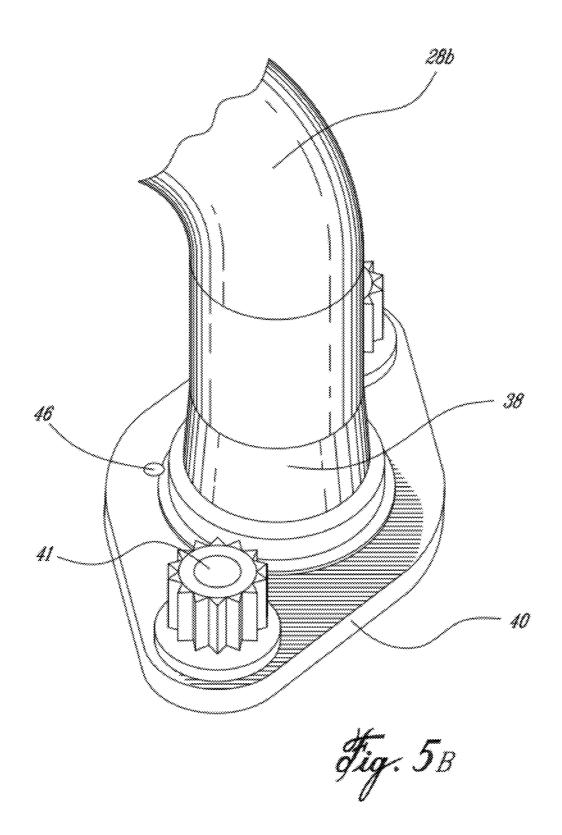
FIG. 5b is an enlarged fragmentary perspective view similar to FIG. 5a showing another embodiment thereof.

In another embodiment as shown in FIG. **5***b* a small deadhead hole **46** is formed in the flange **40** providing the fluid leak path to the exterior of the bypass duct for visual inspection purposes.
