(12) **United States Patent**
Llewellyn et al.

(10) **Patent No.:** **US 10,578,240 B2**
(45) **Date of Patent:** **Mar. 3, 2020**

(54) **EXPANDABLE PIPE INCLUDING A LINER FOR RESTORING A CONDUIT**

(57) **ABSTRACT**

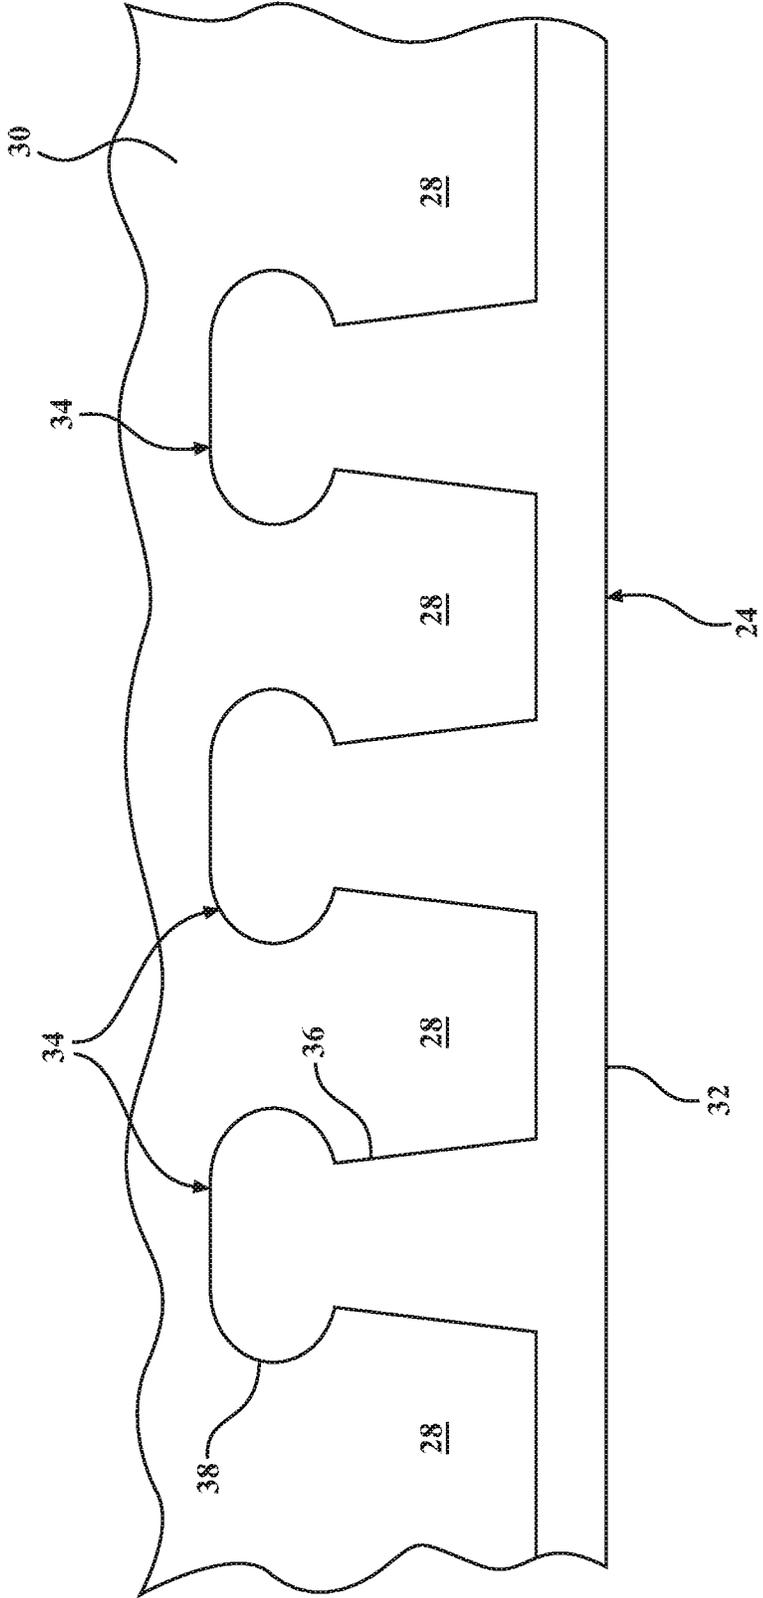
FIG. 1 is a cross-sectional view of a portion of a liner according to an example embodiment of the invention;

According to a preferred embodiment, the grooves 28 of the liner 24 are achieved by a profile on an exterior surface 26, also referred to as an outer diameter surface, of the liner 24, as shown in FIGS. 1 and 2. In the embodiment of FIGS. 1 and 2, the profile of the exterior surface 26 of the liner 24 includes flared tips 34 which act as a mechanical lock for the grout material 30 applied to the exterior surface 26 of the liner 24. FIG. 1 only shows the flared tips 34 along a portion of the exterior surface 26 of the liner 24, but the flared tips 34 are preferably located along the entire exterior surface 26 of the liner 24, and continuously around the outer circumference of the liner 24. In the example of FIGS. 1 and 2, each groove 28 is formed between two adjacent flared tips 34, and the grout material 30 is contained in those grooves 28. The flared tips 34 include a stem 36 extending perpendicular to the base of the liner 24, and an enlarged top 38 which flares outwardly relative to the stem 36. The diameter or width of the enlarged top 38 is greater than the diameter or width of the stem 36. The flared tips 34 shown in FIGS. 1 and 2 are only an example, as the shape and dimensions of the flared tips 34 can vary. Alternatively, other profiled shapes and dimensions can be used to achieve the grooves 28 in the liner 24. However, the flared tips 34 or other mechanical locking features are not required if a sufficient bond between the liner 24 and the grout material 30 is achieved.

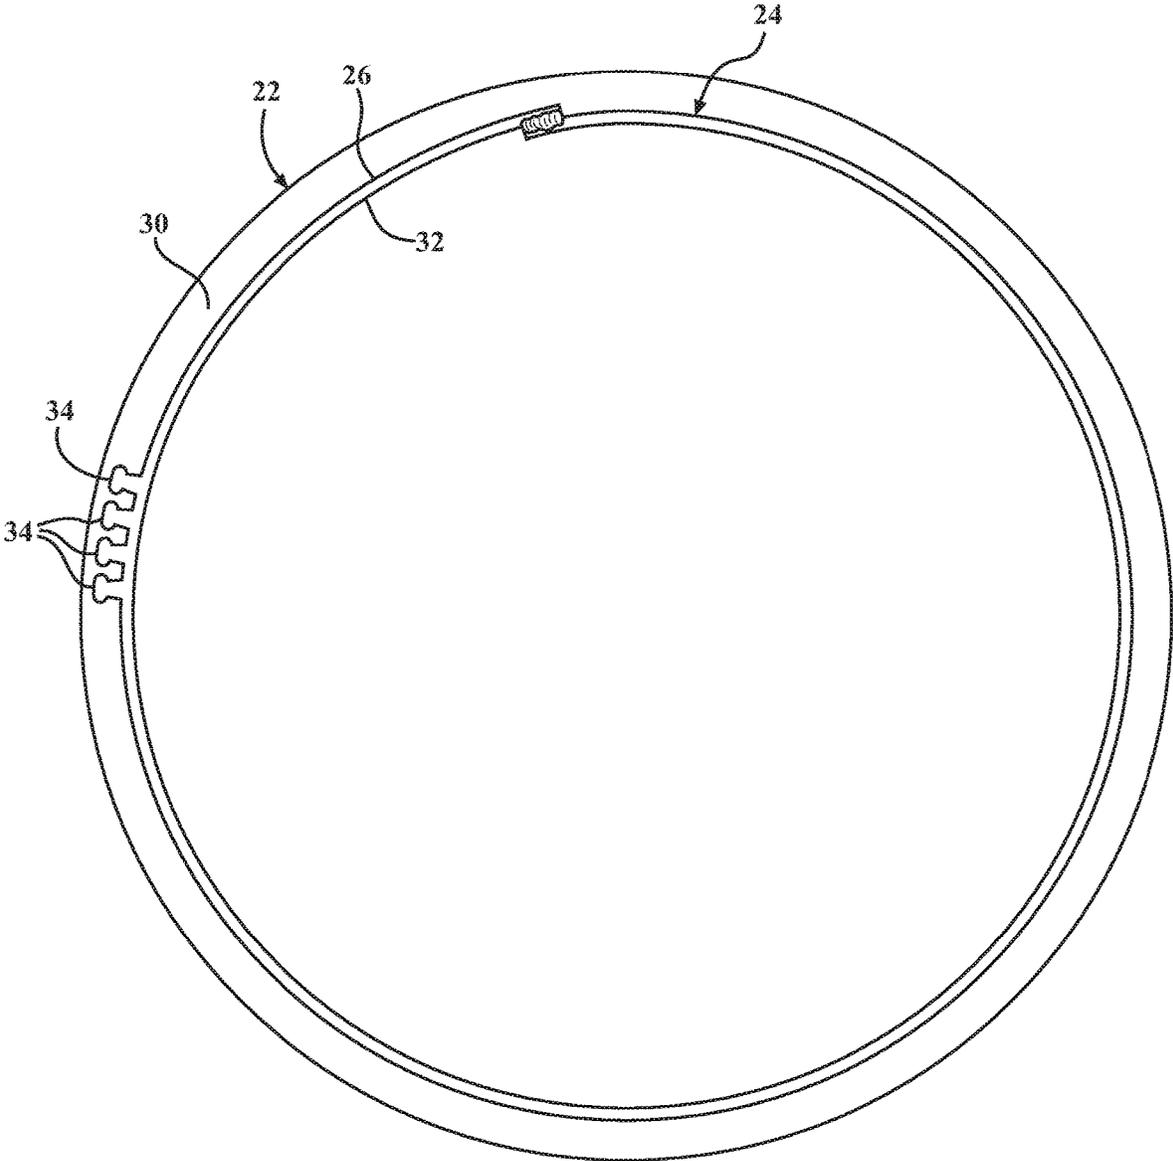
FIG. 2 is a cross-sectional view of the entire liner disposed inside of a host pipe according to the example embodiment of the invention;

The liner 24 can be formed by extrusion, preferably in a flat extrusion die to produce a flat product, such as a sheet of the TPU or another thermoplastic material. The flat extruded product is then welded into a circular pipe shape to produce the liner 24 and so as to reside inside the host pipe 22, as shown in FIG. 2. In other words, the flat product is welded it at a circumference that matches the required diameter for the liner 24. The diameter of the liner 24 should be less than the inner diameter of the host pipe 22 when the liner 24 is inflated. For example, the liner 24 of the example embodiment has a 7.5 inch inner diameter when inflated, and the host pipe 22 has an 8 inch inner diameter. The liner 24 could be extruded to size, as a circular tube, however certain raw materials are difficult to extrude into circular geometries due to a lack of melt strength. The other advantage of extruding flat and welding is the ability to obtain any diameter with limited tooling.

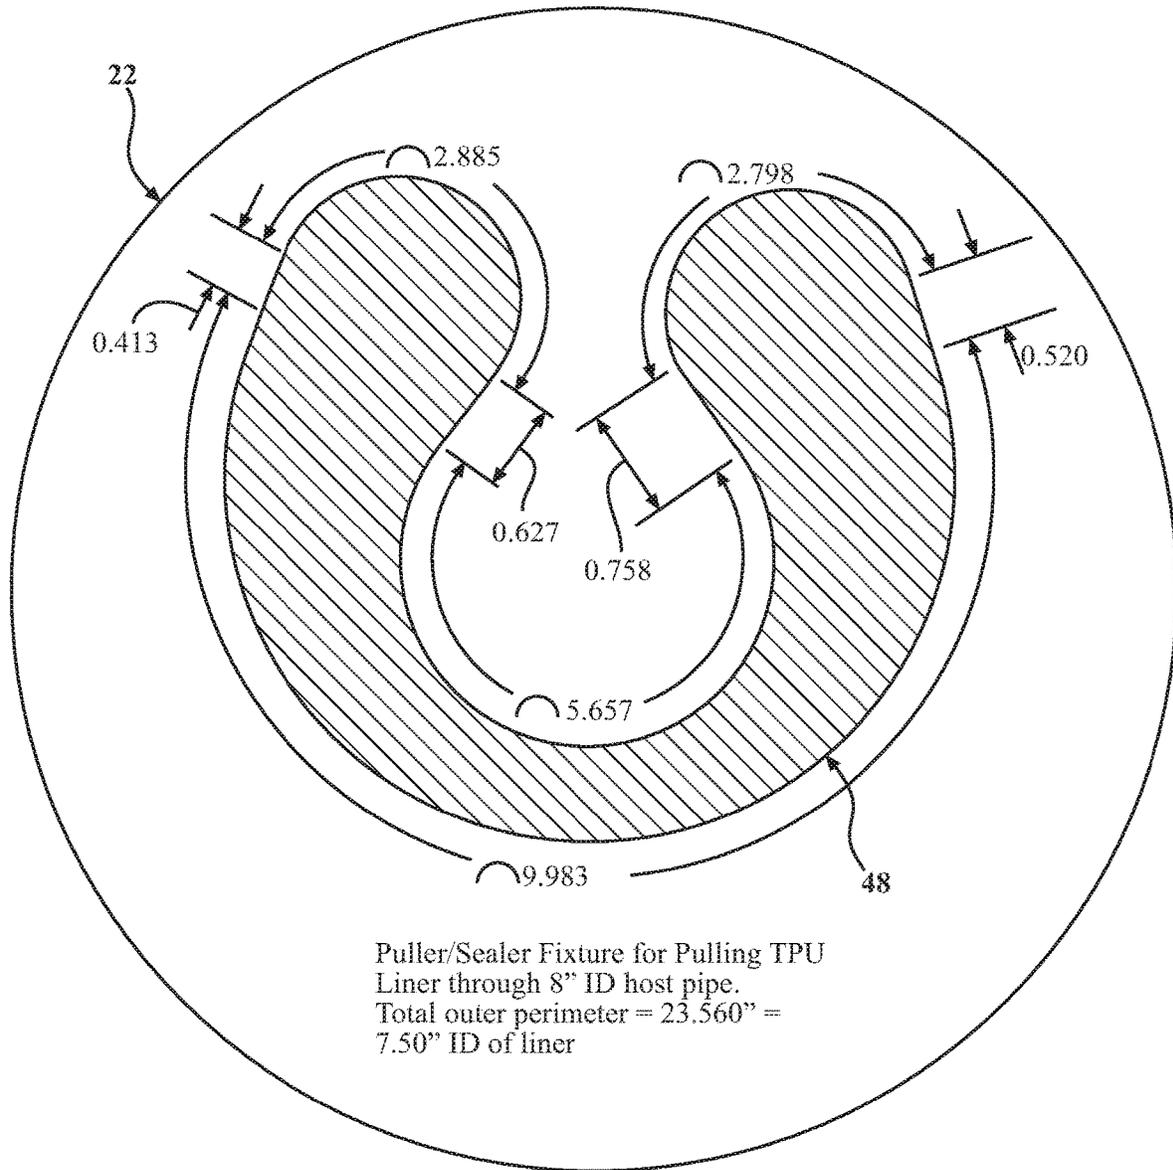
FIG. 3 is a cross-sectional view of a puller/sealer fixture disposed inside of the host pipe which configures the liner for passage through the host pipe with minimal interference

with the inner diameter of the host pipe and which seals an inner diameter of the liner from water, debris, and grout material;

The method of installing the liner 24 in the host pipe 22 according to example embodiments will now be described in more detail with reference to FIGS. 3 and 4. When the TPU liner 24 is ready for installation, it is coiled, laying flat like a fire hose, onto reels. At the jobsite where the host pipe 22 is located, the liner 24 is routed through a dip (or soaking) tank assembly 56 containing the 1-part moisture-curing urethane grout. FIG. 5 illustrates the liner 24 being routed through the dip tank assembly 56 according to an example embodiment. The dip tank assembly 56 is capable of uniformly coating the liner 24 with the 1-part moisture-curing urethane grout, for example an unactivated liquid polyurethane. The dip tank assembly 56 is also able to apply the 1-part moisture-curing urethane grout to liners 24 varying from 2 inches to 20 feet in diameter, for example 6 inches to 12 inches in diameter. The dip tank assembly 56 is robust in construction, easy to maintain and service, and is portable in nature. As shown in FIG. 5, the dip tank assembly 56 includes a coating tank 58 which guides the liner 24 through the liquid polyurethane using a series of vertical and horizontal rollers 60. Guide rollers G are used to guide the liner 24 from a supply into the coating tank 58, and guide rollers G are again used to guide the coated liner 24 from the coating tank 58 to a manhole where the liner 24 will be used to repair the damaged pipe 22. The coating tank 58 is typically formed of aluminum and includes a removable top 62 and a drain 64. However, the design and the material used to form the coating tank 58 can vary. The rollers 60 are typically formed of ultra-high density polyurethane. However, the dip tank assembly 56 could include a different array of rollers 60, and/or the rollers 60 could be formed of different materials. The dip tank assembly 56 also includes a mixing tank 66 acting as a reservoir to supply additional liquid polyurethane to the coating tank 58 on demand to maintain the liquid level in the coating tank 58. The mixing tank 66 can also be formed of aluminum, or another material. Example specifications of the coating tank 58 and the mixing tank 66 are provided in FIG. 6. These specifications are general in nature and can be adjusted as required prior to fabrication of the dip tank assembly 56.

The TPU liner 24, with its exterior surface 26 soaked in the urethane grout, is directed down into an opening of the host pipe 22. The TPU liner 24 is there attached to a spraying fixture 46 via the puller/sealer fixture 48, as shown in FIGS. 3 and 4. The puller/sealer fixture 48 is a solid piece of material which serves as a mounting fixture which configures the liner 24 for optimal passage through the host pipe 22, with minimal interference with the inner diameter surface of the host pipe 22. In the example embodiment, the puller/sealer fixture 48 has a U-shaped cross-section with no sharp edges. The puller/sealer fixture 48 maintains the liner 24 in an appropriate position, without any sharp edges along the liner 24. In the example embodiment, the puller/sealer fixture 48 has an outer perimeter of 23.560 inches, which is

equal to the length of the 7.5 inch inner diameter of the liner 24. Jigs or clamps 50 can be used to secure the liner 24 to the puller/sealer fixture 48. The puller/sealer fixture 48 also prevents debris, moisture, and/or the grout material 30 from entering the interior of the liner 24. For example, the clamps 50 can secure the liner 24 tightly against the puller/sealer fixture 48 to prevent the debris, moisture, and/or the grout material 30 from entering the interior of the liner 24. During installation, the puller/sealer fixture 48 is attached to the rolling dolly 42 and pulled by the cable 40 through the host pipe 22.

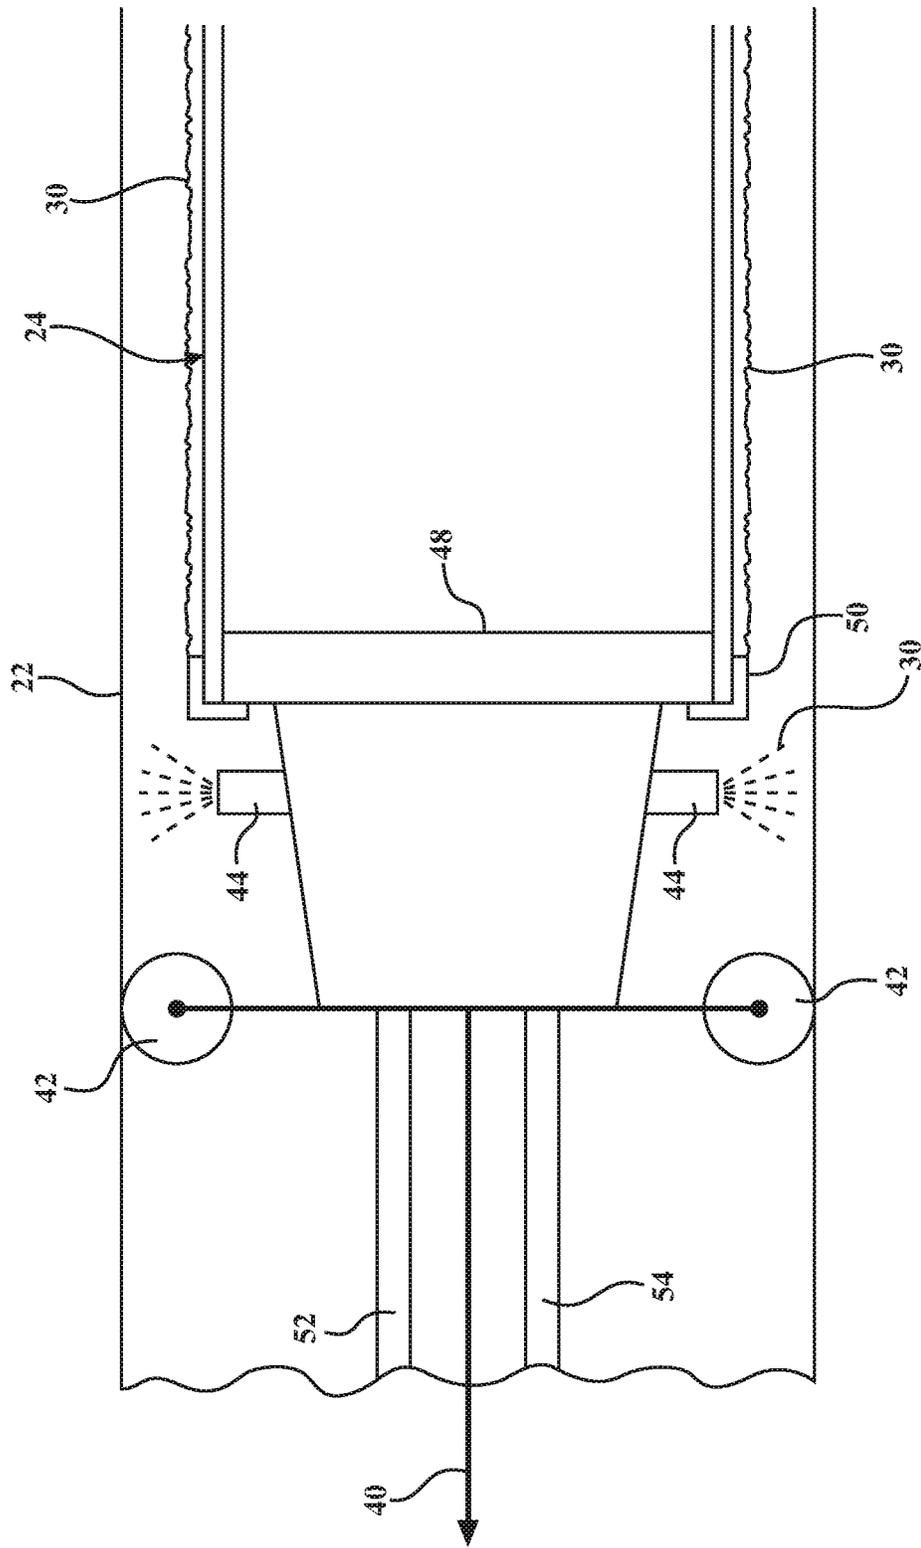
FIG. 4 illustrates the puller/sealer fixture attached to a spraying fixture and rolling dolly used to install the liner in the host pipe;

A set of the mixing/spraying heads 44 is also attached to the dolly 42 and are pulled through the host pipe 22 during installation. The mixing/spraying heads 44 receive two urethane grout feed lines 52, 54 routed from the pulling side, such as along the cable, that will mix the 2-part grout before spraying the mixture onto the inner diameter surface of the host pipe 22. One feed line 52 includes the urethane and a second feed line 54 includes a curing agent. The rate of flow into the mixing/spraying heads 44 will be controlled automatically as a function of the velocity of the dolly 42 and the entire assembly through the host pipe 22 so as to assure a consistent coating of the host pipe 22 throughout. Thus, the area between the liner 24 and the host pipe 22 is filled with both the 1-part and 2-part urethane grout. Once the full length of the TPU liner 24 has been pulled through the host pipe 22, the ends of the liner 24 are capped, and the liner 24 is inflated to a specific pressure. The grout material 30 is exposed to moisture, ultra violet radiation, heat, and/or ultrasonics and thus cures and expands to adhere to the liner 24 and the inner diameter surface of the damaged pipe 22. The grout material 30 is typically in the form of a foam and bonds to the extruded liner 24, forming an adhesive and preferably cohesive bond, such that the plurality of flared tips 34 are not required for the liner 24 and grout material to maintain contact. After an appropriate curing period, pressure is released from the interior of the liner 24. Ends of the liner 24, as well as access points for laterals (service lines), can then be trimmed.

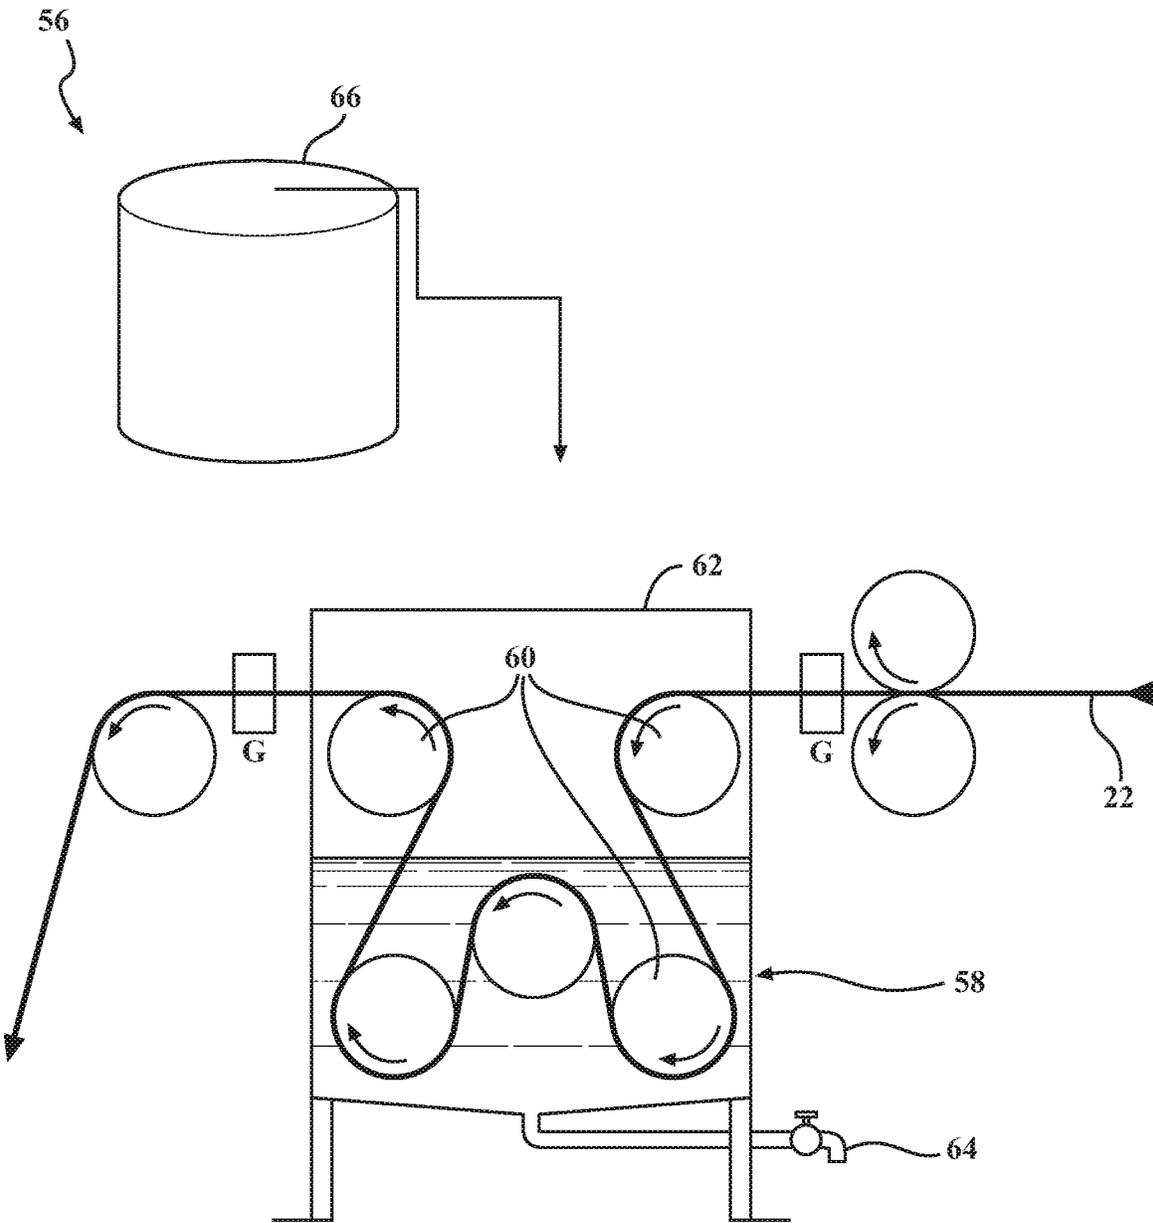
FIG. 5 illustrates an example of a dip tank assembly for coating the liner with a 1-part moisture-curing urethane grout according to an example embodiment; and
