(54) **REPAIRED INTERNAL HOLDING  
STRUCTURES FOR GAS TURBINE ENGINE  
CASES AND METHOD OF REPAIRING THE  
SAME**

A method of repairing a case for a gas turbine engine includes identifying areas of damage on its internal holding structures in a gas turbine case, and utilizing cold metal transfer to deposit weld material to the internal holding structures.

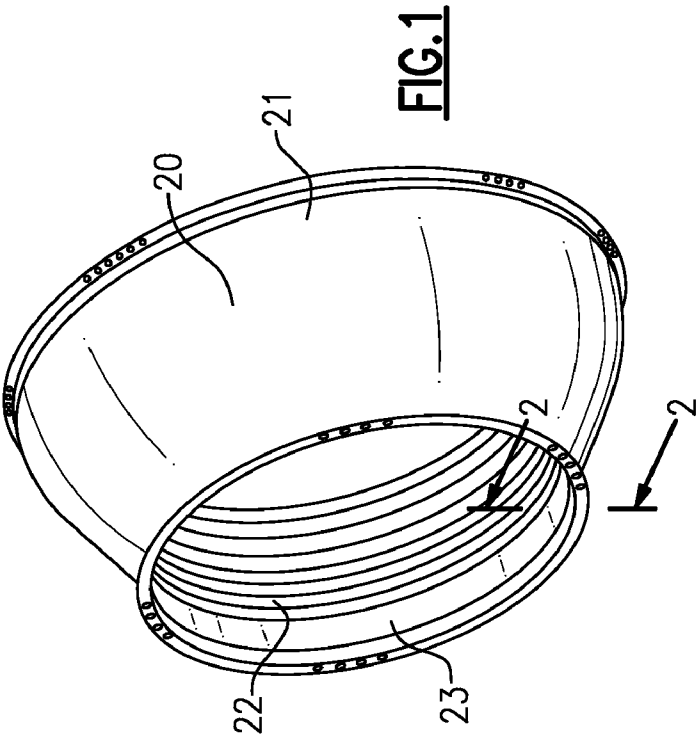
A case 20 for a gas turbine engine is illustrated in FIG. 1. The case 20 is a low pressure turbine case. It should be appreciated that the case 20 may also be a high pressure turbine case, a compressor case or a diffuser case. Case 20 is defined by a body having a radially outer wall 21 and a radially inner wall 23.

A plurality of rails or grooves 22 are formed on the inner wall 23 of the case 20. For purposes of this application, the rails or grooves will be referred to generically as "internal holding structures."

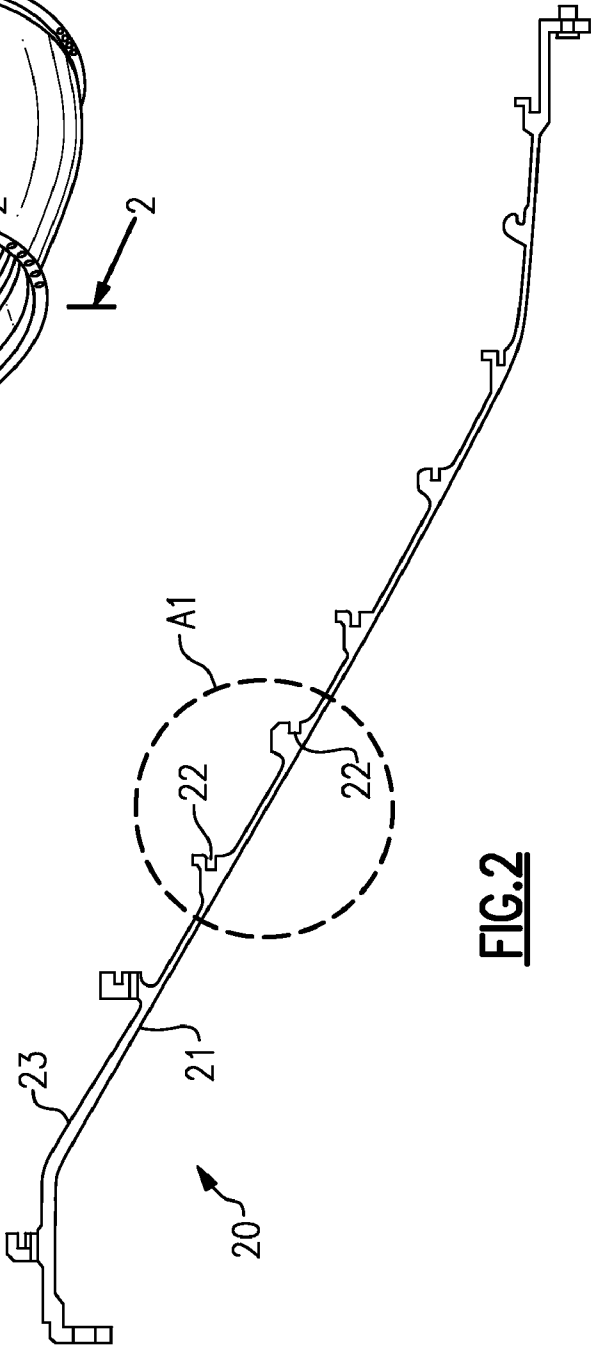
As shown in FIG. 2, the internal holding structures 22 have specific shapes to receive an engaging rail or seal. These shapes should be maintained at their desired configuration in order for the seals and rails to properly interact with the case 20.

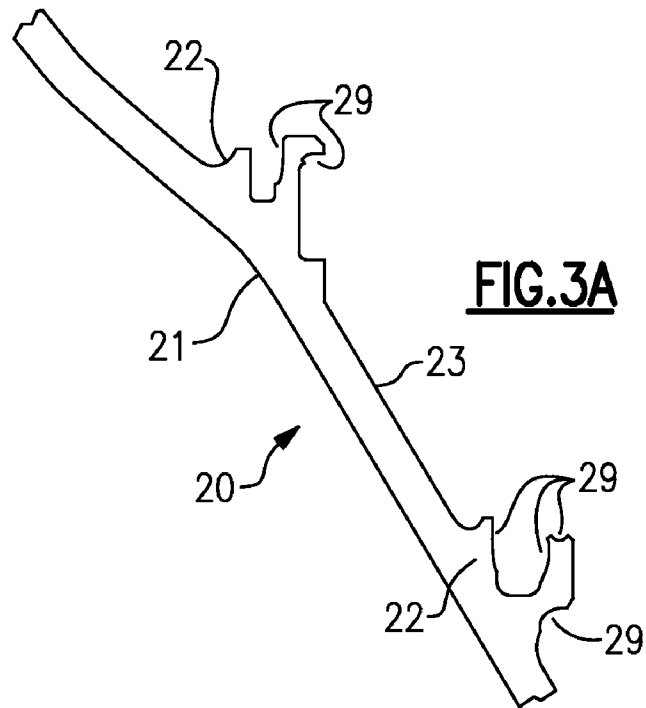
As shown in FIG. 3A, surfaces such as shown at 29 may wear away from the internal holding structures 22. In fact, the worn shapes are generally less smooth than is illustrated in FIG. 3A, and they may also include cracked areas, etc.

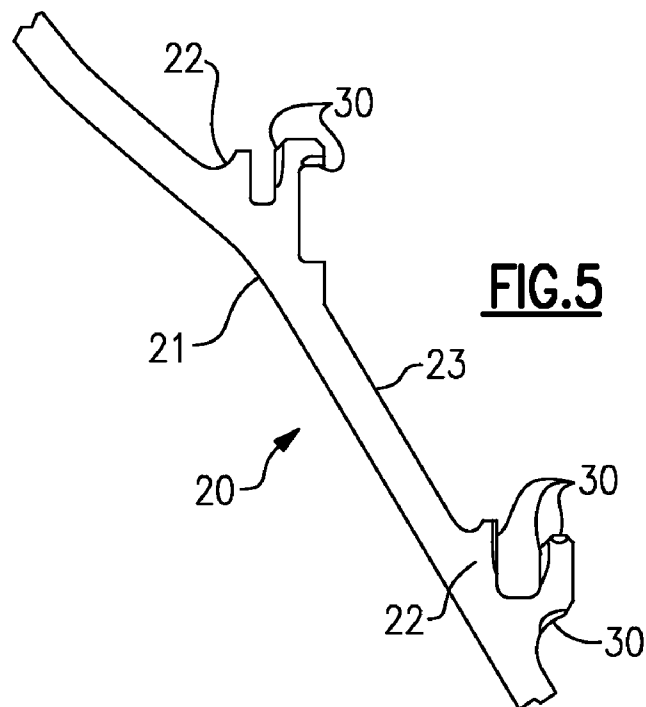
As shown in FIG. 5, after this method, the welding material 30 has returned the surfaces of the internal holding structures 22 to their desired shape. The case 20 will now be ready for return of service, and will function properly.

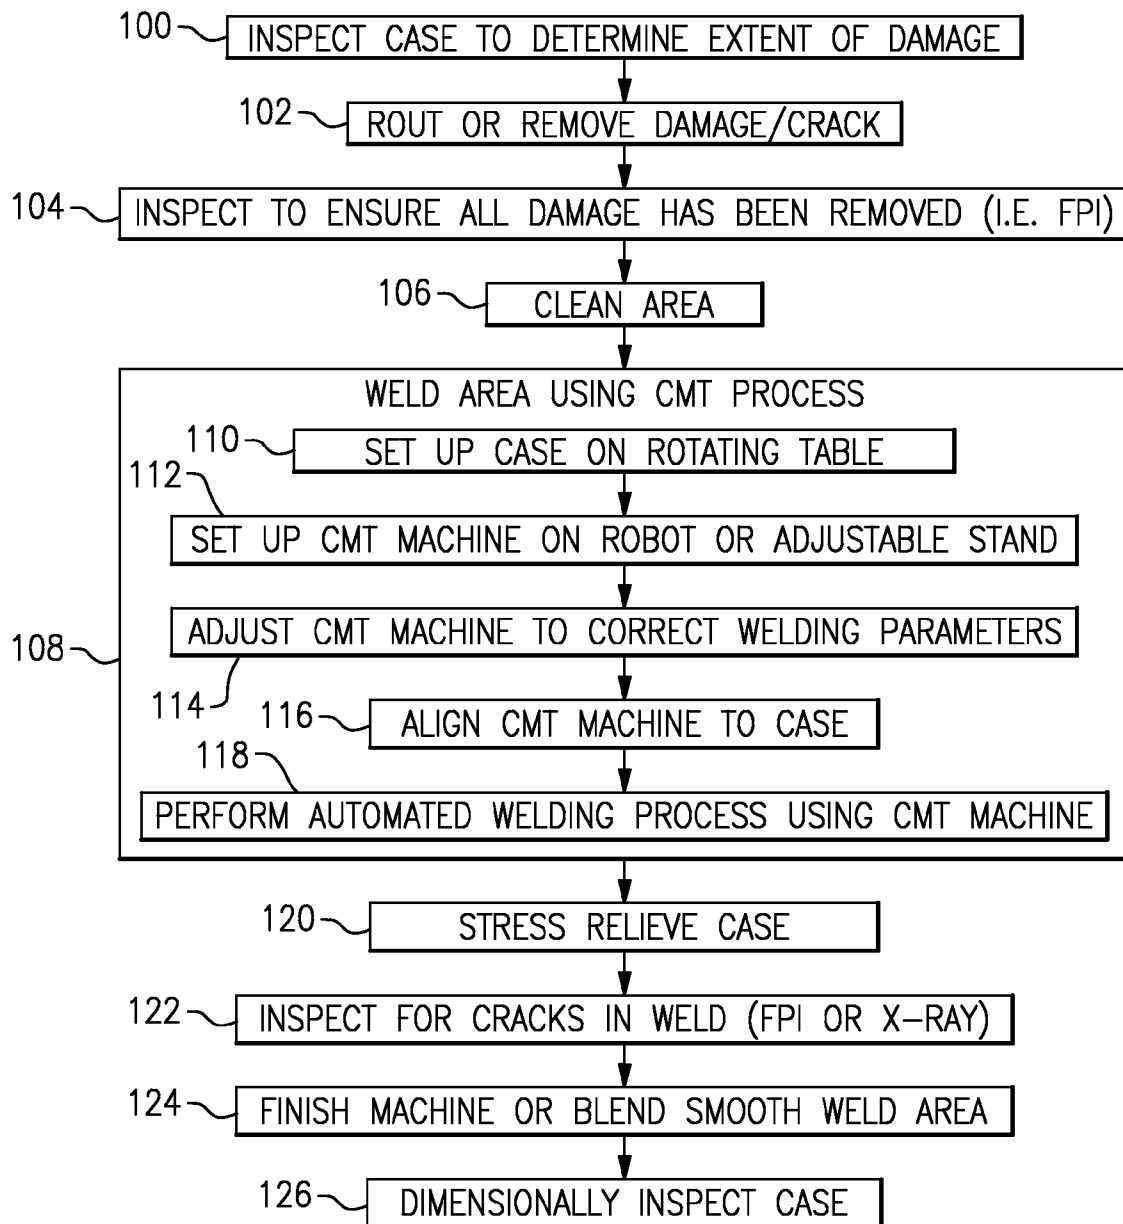
**FIG.3B**

A flow chart of a repair method is shown as FIG. 3B. At step 100, a case 20 is inspected to determine the extent of the damage to the grooves. The damages areas are then machined at step 102 to remove damaged and cracked areas. At step 104, one then inspects the part to ensure that all the damaged material has been removed, and the areas are cleaned at step 106.

Cold metal transfer techniques are utilized at step 108 to repair the part. The case 20 is initially set on a rotating table 56 at step 110, and as shown in FIG. 4A. A system 50 includes a robotic manipulator 52 moving a cold metal transfer deposition head 54 connected to a cold metal transfer machine 58.

After the part is on the rotating table, the cold metal transfer machine is placed adjacent the table at step 112, and is adjusted at step 114 to meet the desired welding parameters for the particular part. The cold metal transfer machine is then aligned to the case at step 116, and the automated welding process occurs at step 118.

After the cold metal transfer welding occurs, the part is stress relieved at step 120, and inspected for cracks in the weld at step 122. Finish machining or blending to smooth the welded areas may occur at step 124, and the part may then be dimensionally inspected at step 126 for return to service.

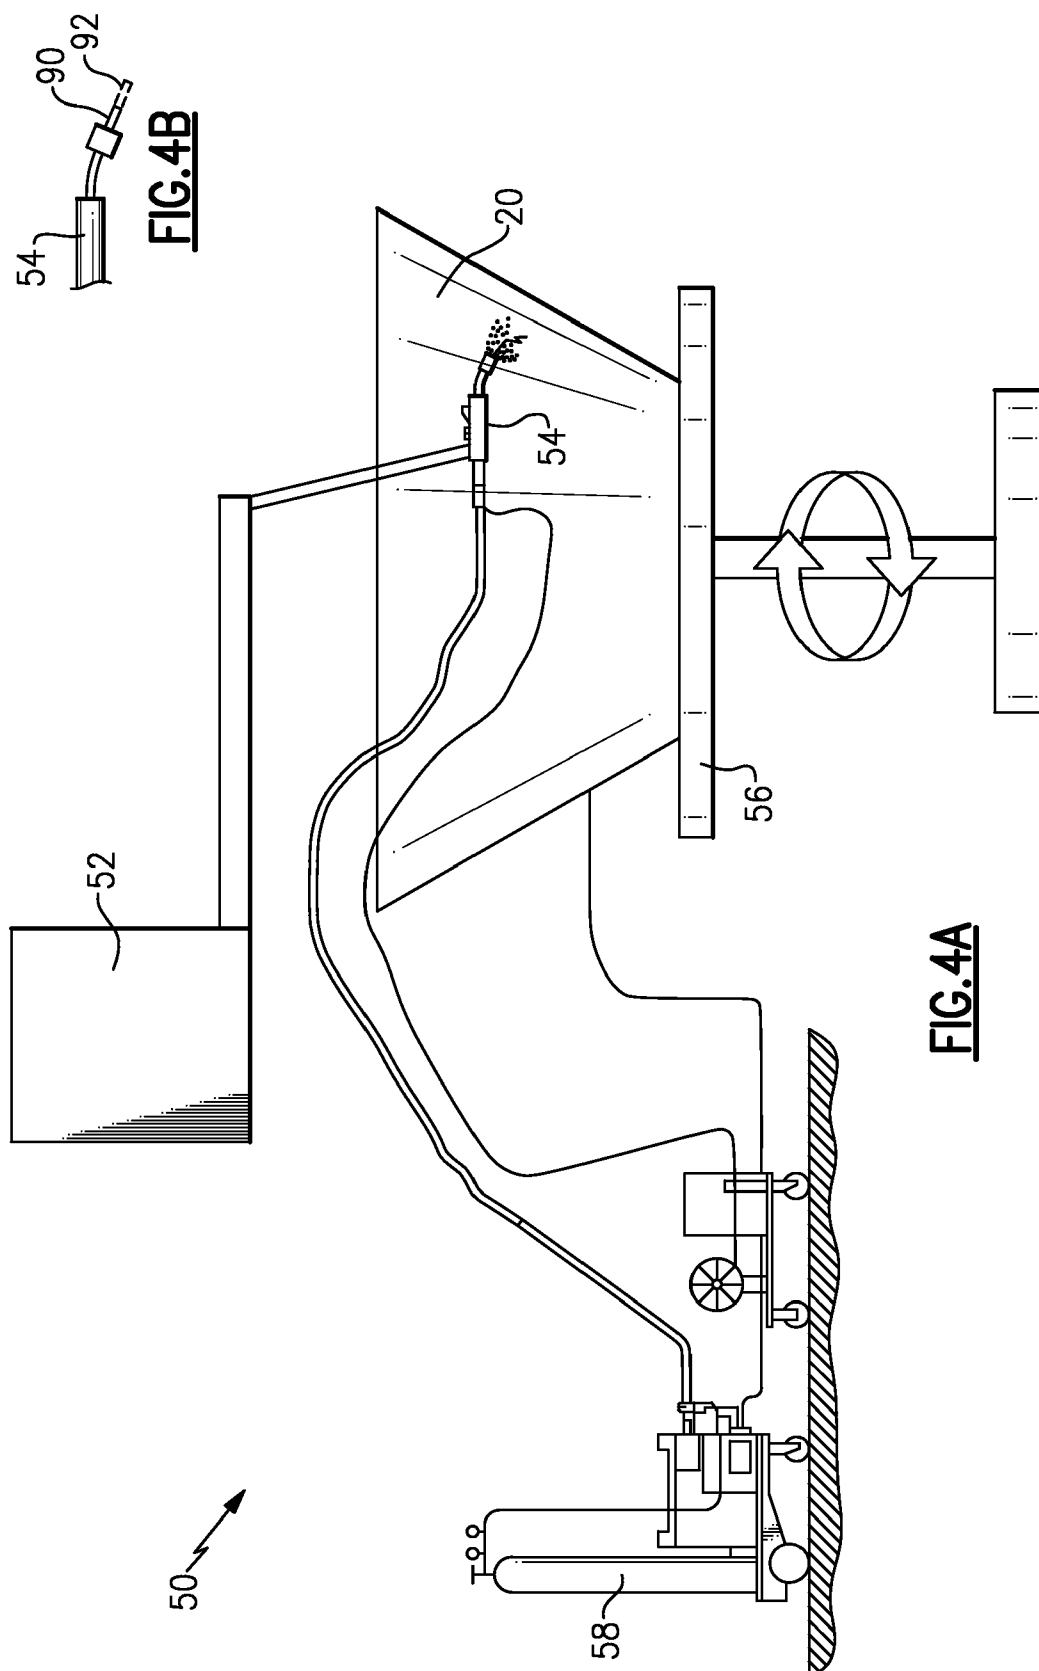
As can be appreciated from FIG. 4B, the cold metal transfer deposition head 54 includes a weld wire 90. The wire moves forward, as shown in phantom at 92 and into a weld pool. A short circuit occurs. As the short circuit happens, the wire is pulled back again. A weld arc only inputs heat very briefly in the arcing period, after which the thermal input is immediately reduced. In this way, the alternating hot and cold occurs.

While a particular assembly of cold metal transfer equipment has been illustrated in FIG. 4A, other assemblies may be utilized. As an example, the case 20 could be held stationary while the cold metal transfer deposition head could be rotated about the case 20. Further, other robotic machines may be utilized, beyond that shown in FIG. 4A.
