- [54] **METHOD OF MAKING AND REPAIRING TURBINE BLADES**
- [75] **Inventors:** John N. Cang, San Diego; Joseph R. Gast, Alpine; John J. Hensley; Christian M. Waldhelm, both of San Diego, all of Calif.
- [73] **Assignee:** Solar Turbines Incorporated, San Diego, Calif.
- [21] **Appl. No.:** 609,033
- [22] **Filed:** Nov. 8, 1990

METHOD OF MAKING AND REPAIRING TURBINE BLADES

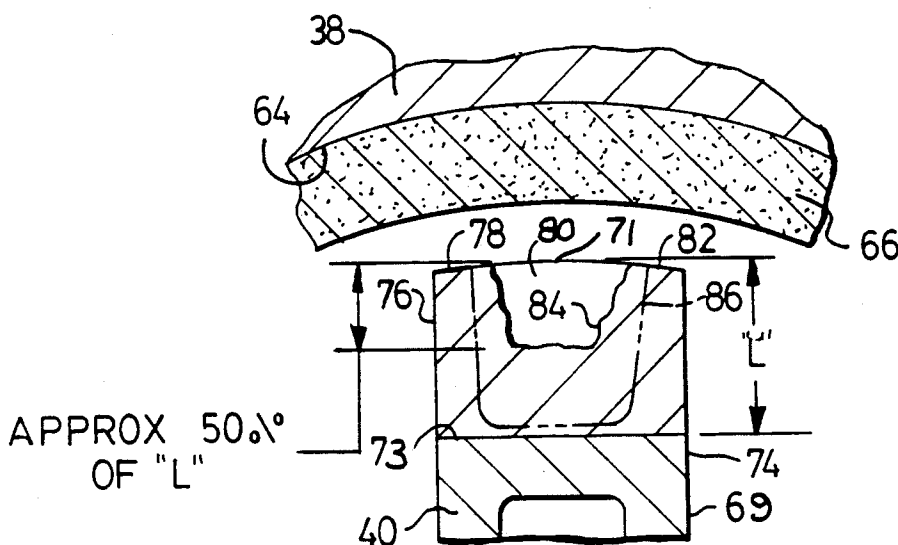
FIG. 2 is an enlarged sectional view of the turbine tip clearance area encircled by line II of FIG. 1.

As more clearly shown in FIG. 2, the shroud assembly 38 has a radially inwardly facing surface 64 positioned adjacent and radially outwardly of the turbine blade 40. A coating 66 is affixed to the surface 64 and is resistant to high temperature, oxidation, corrosion and sulfidation and is rub-tolerant. Rub-tolerant means that the coating will separate from itself in fine particle form or smear when rubbed by the blades rather than to break in larger pieces. The rub-tolerant coating is applied by a plasma spray process and has a thickness of approximately 0.7 mm. The coating is comprised of cobalt, nickel, chromium and aluminum. The coating has the physical characteristics and is applied in a process to result in a uniform, continuous surface free from spalling, cracking, chipping or flaking.

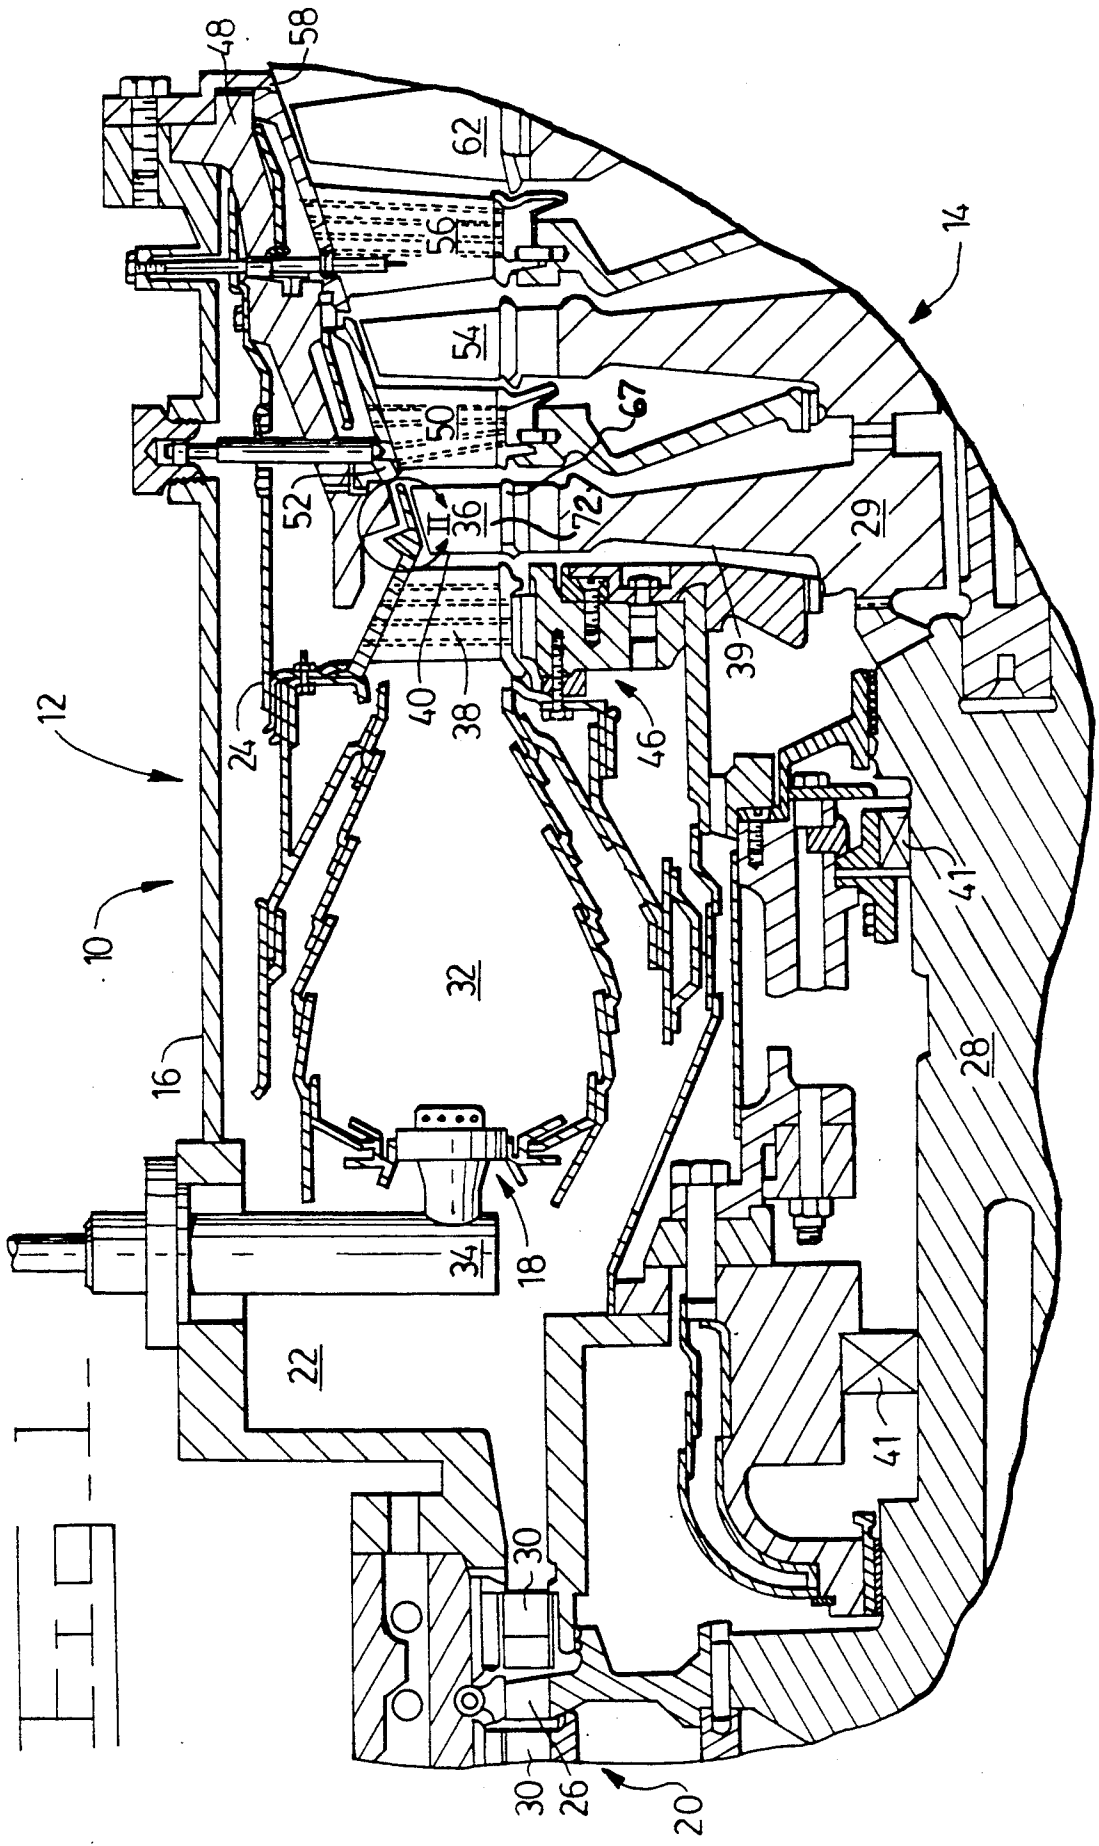
FIG. 1 is a partial sectional side view of a gas turbine engine disclosing the turbine blade tip control system of this invention.

Referring to FIG. 1, a gas turbine engine 10, not shown in its entirety, has been sectioned to show a turbine tip control system 12 for controlling internal leakage of a turbine section 14 of the engine. The engine 10 includes an outer case 16, a combustor section 18, a compressor section 20 and a compressor discharge plenum 22 fluidly connected to the compressor section 20. The plenum 22 is partially defined by the outer case 16 and a multipiece inner wall 24 partially surrounding the turbine section 14 and the combustor section 18. The compressor section 20 includes a plurality of rotatable blades 26 attached to a longitudinally extending center shaft 28 driven by a gasifier turbine section 29. A plurality of compressor stator blades 30 extend from the outer case 16 and are positioned between the rotatable blades. For illustration convenience, only a single stage of a multistage axial compressor 20 is shown. The combustor section 18 includes a combustion chamber 32 positioned in the plenum 22 and a plurality of fuel nozzles 34 (one shown) positioned in the chamber 32 at the end near the compressor section 20. The turbine section includes a first stage turbine 36 disposed partially within an integral first stage nozzle and shroud assembly 38. The first stage turbine 36 includes a rotatable turbine wheel 39 and an annular array of turbine blades 40 (one shown) attached thereto. The assembly 38 is attached to the inner wall 24 and supported from the center shaft 28 by a bearing arrangement 41 and a series of thermally varied masses 46 which are assembled to prevent rapid thermal variation during heating and cooling of such masses 46. A nozzle support case 48 is disposed within the outer case 16 and is attached to the case 16 by a plurality of bolts and dowels not shown. An integral second stage nozzle and shroud assembly 50 is attached to the nozzle support case 48 by a plurality of nozzle hooks 52 and a second stage turbine 54 is disposed partially within the assembly 50. An integral third stage nozzle and shroud assembly 56 is attached to the nozzle support case 48 by a plurality of nozzle hooks 58 and a third stage turbine 62 is disposed partially within the assembly 56. All the turbines 36, 54, 62 are connected to the longitudinally extending center shaft 28.

The turbine tip control system 12 of the present invention is part of a gas turbine engine 10. The compressor section 20 provides combustion air for the engine 10. The air is mixed with fuel from the fuel nozzles 34 in the combustion chamber 32. The mixture of fuel and air is combusted and the resulting gas expands and is used to drive the turbines 36, 54, 62. The gas is directed into the first stage turbine 36 through the first stage nozzle-and shroud assembly 38. The nozzle guides the gas so that it strikes the blades 40 at a preestablished angle to exert a maximum force, for rotating the turbine 36. Any leakage between the turbine blades 40 and the shroud assembly 38 results in reduced power and a loss of efficiency. Thus, the tightness or clearance between the outer extremity 73 of the turbine blade 40 and the shroud assembly 38 controls efficiency. For example, the clearance between the turbine 36, 54, 62 and the shroud assembly 38, 50, 56 in a typical application is approximately 0.5 mm.

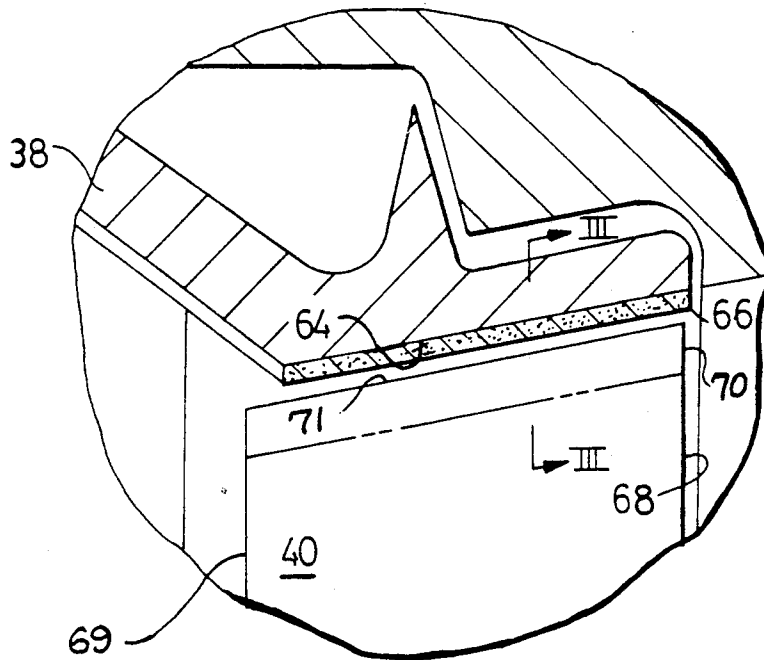
Each of the turbine blades 40 has an attaching base 67 connected to the turbine wheel 39 and a blade portion 68 attached to the base 67. The blade portion includes a metallic body 69 attached to the base 67 and an outer tip 70 formed outwardly on the body. The outer tip 70 has an outer face 71 thereon opposite the end formed on the body 69. The metallic body 69 has a root area 72 near the base 67, an outer extremity 73 outwardly of the root area 72 and a perimeter 74 around the body. The body 69 is of a material which has a predetermined strength sufficient to resist structural deformation at normal operating parameters of the engine 10. The outer extremity 73 is positioned adjacent the coating 66 to provide a normal operating clearance therebetween. The outer tip 70 can be formed to include a flat tip portion, not shown, or a squealer tip portion 76. The squealer tip portion 76 provides a better seal between the blade 40 and the coating 66 than does a flat tip portion. The squealer tip portion 76 is formed to have a ridge 78 positioned at and around the perimeter 74 of the metallic body 69 and a concave portion 80 is formed in the center of the ridge 78. The ridge 78 of the squealer tip portion 76 has a tip extremity 82 and a bottom portion 84. As best shown in FIG. 3 the thickness of the ridge 78 is of a thinner cross-sectional area near the tip extremity 82 than is the thickness of a cross-sectional area of the ridge 78 near the bottom portion 84 resulting in the squealer tip portion 76 including a tapered build-up being thinner near the tip extremity 82 than near the bottom portion 84 of the squealer tip portion 76. The above structure is a result of the welding process since the layered build-up results in a narrower pass per respective build-up pass or series of repetitive passes. Thus, the squealer tip portion 76 is approximately 50% shorter than a conventional squealer tip configuration shown by phantom line 86. The outer tip 70 is comprised of a material which has a predetermined strength less than that of the body 69 yet has sufficient strength to prevent breaking and/or separating from the metallic body 69 during hard rubbing contacts between the blade 40 and the coating 66 and/or the shroud 38. Thus, the outer tip 70 must have sufficient length to accept the wearing away of a portion of the material and yet not be totally removed from protecting the metallic body 69 from oxidation, sulfidation and corrosion. For example, the metallic body 69 has a tensile strength of approximately 1080 kPa at room temperature and approximately 750 kPa at 870° C. and a yield strength of approximately 930 kPa at room temperature and approximately 650 kPa at 870° C. The outer tip 70 has a tensile strength of approximately 870 kPa at room temperature and approximately 380 kPa at 870° C. and a yield strength of approximately 380 kPa at room temperature

and approximately 230 kPa at 870° C. Furthermore, the outer tip 70 is made of a nickel base material and is selected to include approximately 20%-24% chromium, 13%-15% tungsten, 1%-3% molybdenum and a trace of boron, lanthanum, silicon and manganese. A weld layered puddling build-up process is used to form the outer tip 70 on the metallic body 69. The process uses a filler rod having the nickel base material as described above as an ingredient thereof.

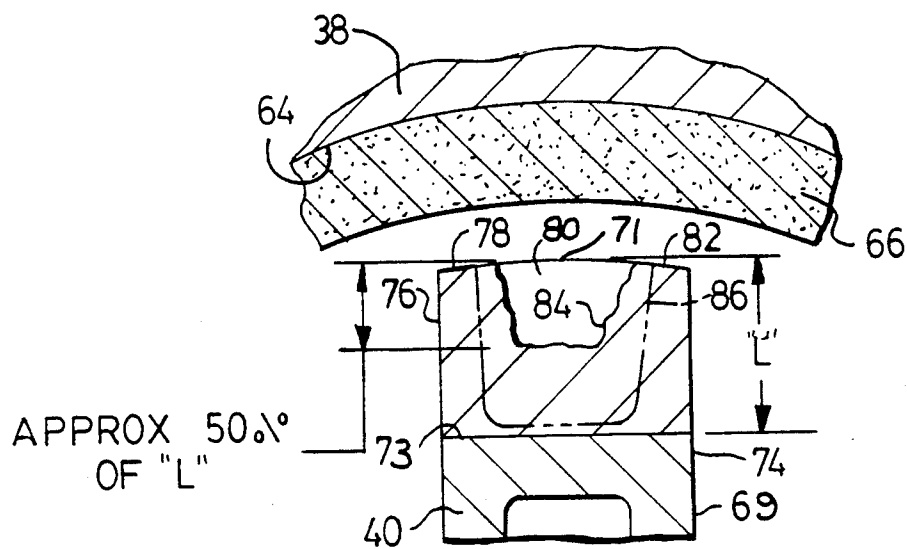
FIG. 3 is an enlarged sectional view taken along line III—III of FIG. 2.

As best shown in FIG. 3, the outer tip 70 has a radial length "L" sufficient to insure protection of the metallic body 69 from the corrosive gases at the highest operating temperature even after a plurality of rubs occur between the blade 40 and the coating 66 and/or the shroud 38. Thus, the length of the outer tip 70 is at least 1 mm to insure that if a portion of the tip 70 is worn away during the rubbing of the blade 40 and the coating 66 and/or shroud 38 a portion of the material remains on the metallic body 69.
