(10) **Patent No.:** **US 8,023,059 B2**

(54) **ARRAY SUBSTRATE OF LIQUID CRYSTAL DISPLAY, METHOD OF REPAIRING SAME, AND LIQUID CRYSTAL DISPLAY**

(73) Assignee: **Infovision Optoelectronics (Kunshan) Co., Ltd.**, Kunshan (CN)

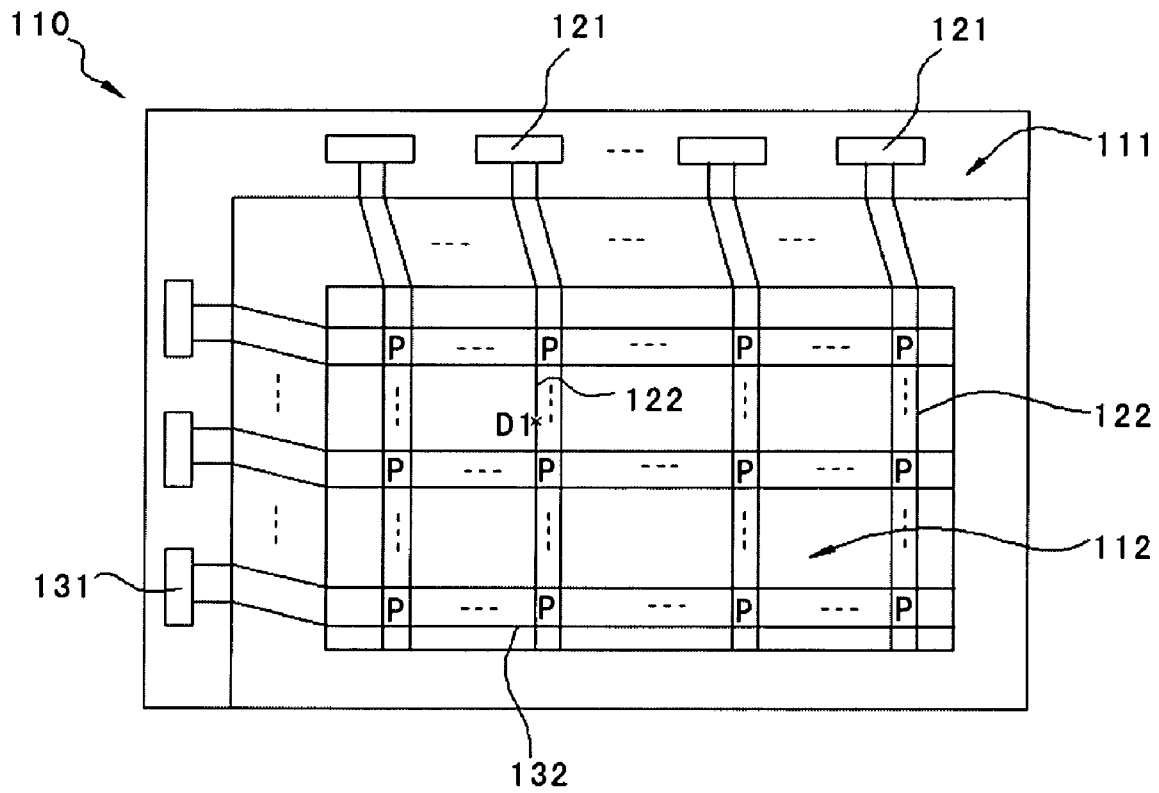
**FIG. 1**  
(Prior Art)

FIG. 1 shows an array substrate of a conventional liquid crystal display. The LCD array substrate **110** comprises a signal introducing region **111** and a display region **112**. Data line pads **121** and scanning line pads **131** are formed in the signal introducing region **111**. A plurality of data lines **122** and scanning lines **132** are respectively connected to the data line pads **121** and the scanning line pads **131**. A plurality of pixels **P** is defined in regions where the data lines and the scanning lines cross. External data signals and scanning signals are inputted via the data line pads **121** and the scanning line pads **131**, and then transmitted to the respective pixels **P** in the display region **112** through the data lines **122** and the scanning lines **132**.

FIG. 1 is a view showing an array substrate of a conventional liquid crystal display.

In a conventional process for fabricating LCD array substrates, defects such as breakage and the like may occur in the data lines. As shown in FIG. 1, the data line **122** breaks at point **D1** in the display region **112**. In this case, data signals cannot be transmitted to the portion of data line below the break point **D1**, thereby causing a line defect.

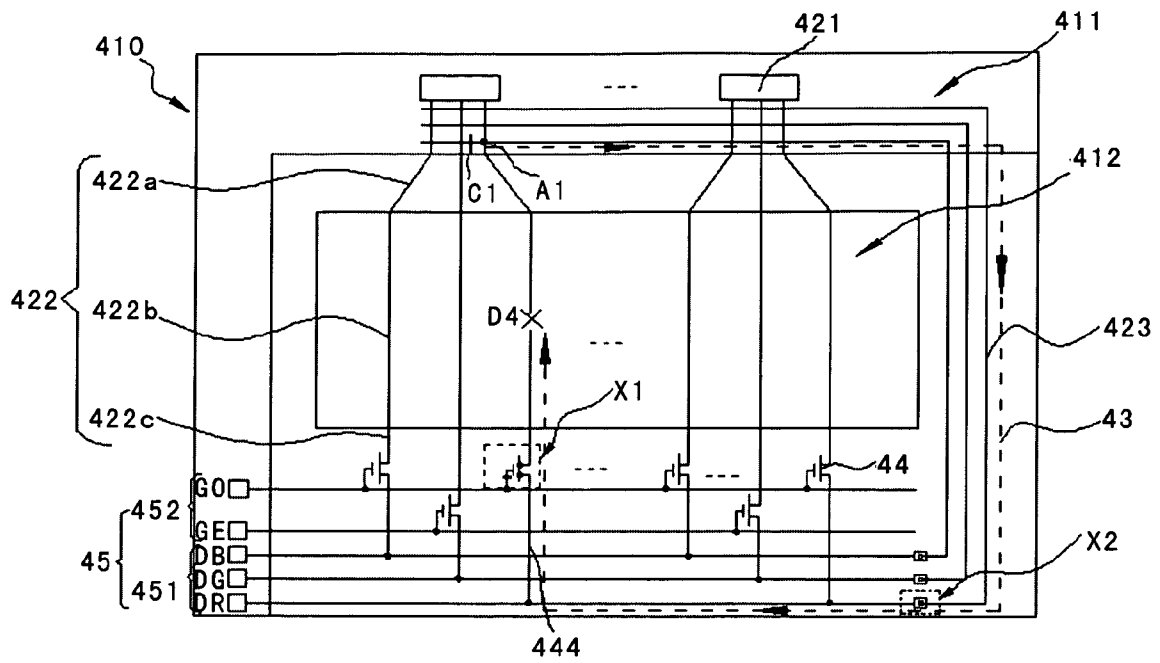
FIG. 2A is a view showing a repair line structure of an array substrate of a liquid crystal display in accordance with a first embodiment of the invention.

FIG. 2A is a plan view showing a repair line structure of an array substrate of a liquid crystal display (LCD) in accordance with a first embodiment of the invention. The LCD array substrate **410** comprises a display region **412** and a signal introducing region **411** outside the display region **412**. A plurality of data line pads **421** is formed in the signal introducing region **411** and electrically connected with corresponding data lines **422** respectively. Each of the data lines **422** comprises three portions, that is, a front data line portion **422a** outside the display region **412** and electrically connected with a corresponding data line pad **421**, a display region data line portion **422b** in the display region **412**, and an end data line portion **422c** outside the display region **412** and at the side away from the data line pad **421**. Data signals inputted from the data line pad **421** are transmitted on the whole data line **422** in an order of the front data line portion **422a**, the display region data line portion **422b** and the end data line portion **422c**. For the sake of clarity, scanning lines, which are provided crossing with the data lines **422**, and scanning line pads are not shown in FIG. 2A.

A repair line **423** is positioned outside the display region **412**. As shown in FIG. 2A, the repair line **423** is positioned on the upper and right sides of the display region **412**, but does not fully extend to the lower side of the display region. As

shown in the plan view of FIG. 2A, the repair line 423 crosses with the front data line portion 422a at a location A1 when viewed along a direction perpendicular to the surface of the array substrate 410. Along the direction perpendicular to the surface of the array substrate 410, the repair line 423 and the front data line portion 422a are positioned in different layers separated by an insulating layer therebetween. Hence the repair line 423 and the front data line portion 422a are normally not in an electrical connection. Although in the plan view of FIG. 2A, the repair line 423 and the front data line portion 422a are arranged perpendicularly, the invention is by no means limited to such a perpendicularly arranged manner. It is sufficient as long as there is a crossing point between them in the plan view.

As shown in FIG. 2A, test lines 45 are also provided outside the display region 412, and in the embodiment are positioned below the display region 412. The test lines 45 comprise test data lines 451 and test scanning lines 452. The test data lines 451 for transmitting test data signals comprise three test data lines DB, DG and DR for transmitting test data signals with respect to blue (B), green (G) and red (R) respectively. The test scanning lines 452 for transmitting test scanning signals comprise two test scanning lines GO and GE for transmitting test scanning signals with respect to the odd and even columns respectively. The test lines 45 transmit test signals to the data lines 422 via TFTs 44.

In the embodiment shown in FIG. 2A, the test lines 45 and the TFTs 44 are connected in the following manner. Gate electrodes of TFTs 44 in the odd and even columns counted from the left are respectively connected to the GO and GE lines of the test scanning lines 452, and source electrodes of TFTs 44 in the  $3n-2$ ,  $3n-1$  and  $3n$  ( $n=1, 2, 3 \dots$ ) columns counted from the left are respectively connected to the DB, DG and DR lines of the test data lines 451. It is noted that the connecting technique of FIG. 2A is merely an example, and it is possible to have other techniques, for example, providing only one test scanning line, or providing more test data lines, etc. In an embodiment, the test lines 45 and the repair line 423 may be arranged partly or entirely in a perimeter seal region so as to reduce the non-display area in the liquid crystal display panel. Here, the perimeter seal region is such a region in the array substrate that will be adhered to a color filter substrate so as to form a liquid crystal display.

With the above repairing technique, data signals on the defective data line 422 can be transmitted, along a path shown by the dashed line 43 of FIG. 2A, to the portion of this data line 422 below the break point D4. The specific transmitting path is: from the front data line portion 422a to the repair line 423 via the crossing point A1, then to the test data line 451 (in particular, the DR line) via the crossing point A4, then to the source electrode 442 of the TFT 44 via the test data line branch 444 connected with the test data line 451, then to the gate electrode 443 via the overlapping region A2, then to the drain electrode 441 via the overlapping region A3 and to the end data line portion 422c connected with the drain electrode 441 via the drain electrode 441, and finally to the portion of the display region data line portion 442b below the break point D4.

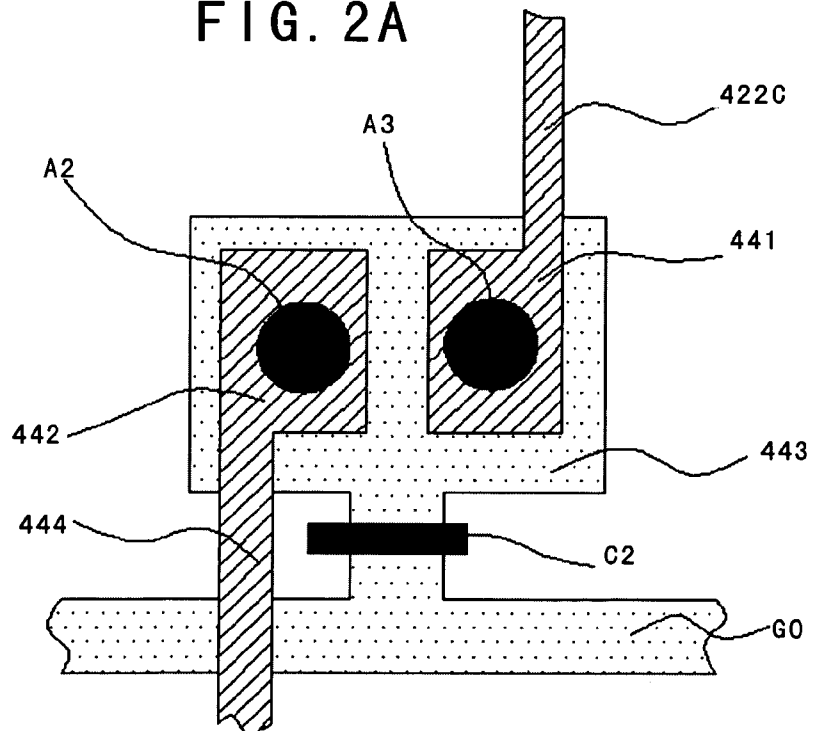
FIG. 2B is a detailed view of TFT in the region **X1** of FIG. 2A.

FIG. 2B shows a detailed view showing the TFT 44 in the region X1 of FIG. 2A. The TFT 44 has a source electrode 442, a drain electrode 441 and a gate electrode 443. The source electrode 442 is connected to a test data line branch 444, the drain electrode 441 is connected to the end data line portion 422c of corresponding data line 422, and the gate electrode 443 is connected to one of the test scanning lines 452 (in particular, to the GO line of the test scanning lines 452 in FIG. 2A). The test data line branch 444 is connected to one of the test data lines 451 (in particular, to the DR line of the test data lines 451 in FIG. 2A).

(3) Processing the TFT 44 to electrically connect the source electrodes 442 and the drain electrodes 441 and cut off the electrical connection between the gate line 443 and the test scanning line 452. For example, for the TFT 44 in the region X1 of FIG. 2A, as shown in FIG. 2B, the source electrode 442 and the drain electrode 441 are electrically connected with the gate electrode 443 at the respective crossing points A2 and A3 by laser melting, and the electrical connection between the gate electrode 443 and the test scanning line 452 is cut off at the point C2 by, for example, laser. Thus the gate electrode 443 becomes an isolated island structure and is no longer electrically connected with the test scanning line 452. As a result, data signals transmitted from the test data line branch 444 to the gate electrode 443 (repaired data signal) will not be transmitted to the test scanning line 452 to affect normal operation of the display.

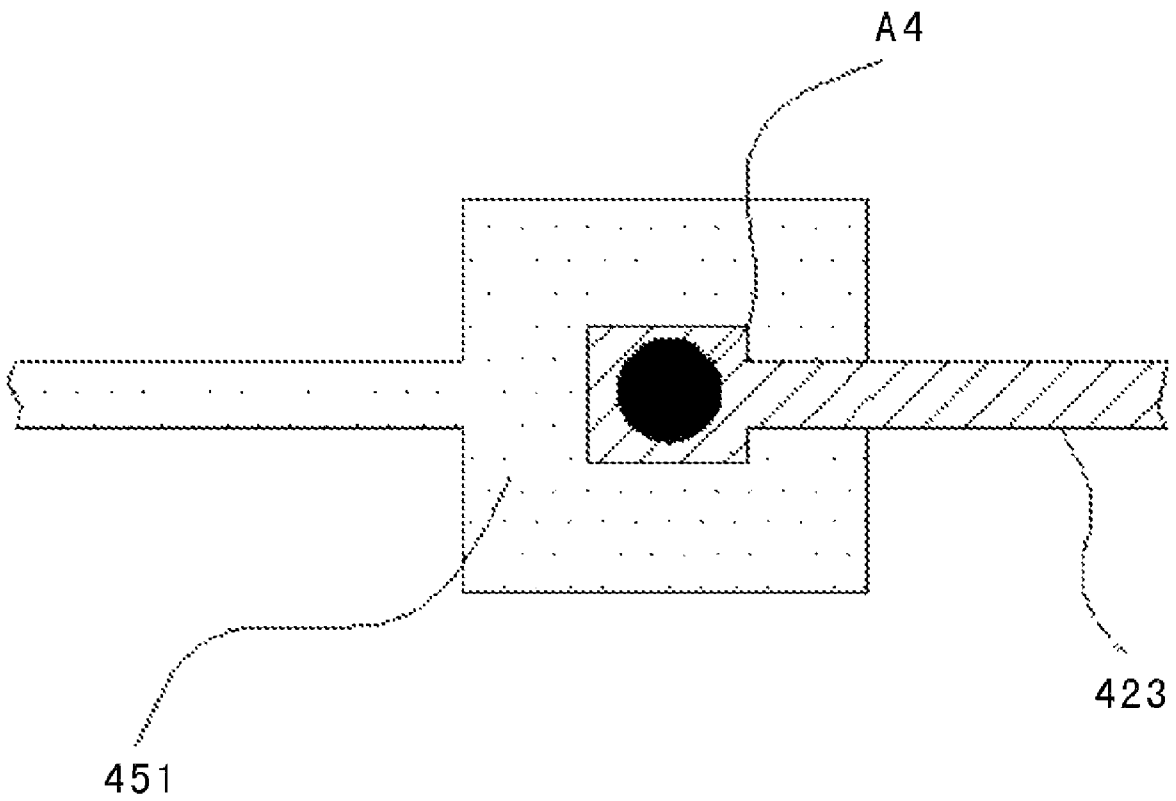
FIG. 20

FIG. 2C is a detailed view of the region **X2** of FIG. 2A.

FIG. 2C is a detailed view showing the test data line 451 and the repair line 423 in the region X2 of FIG. 2A. When viewed along a direction perpendicular to the surface of the array substrate, as shown in FIG. 2C, the test data line 451 (in particular, the DR line of the test data lines 451 in FIG. 2A) at least partly overlaps with an end of the repair line 423; that is, an overlapping region exists between them. However, in the direction perpendicular to the surface of the array substrate, the test data line 451 and the repair line 423 are positioned in different layers which are separated by an insulating layer therebetween. Therefore, the test data line 451 and the repair line 423 are in an insulated state when repair is not carried out.

(2) Electrically connecting the test data line 451 with the repair line 423. For example, an end of the test data line 451 (in particular, the DR line of the test data line 451 in FIG. 2A) may be electrically connected with an end of the repair line 423 at the crossing point A4 by laser melting, as shown in FIG. 2C.

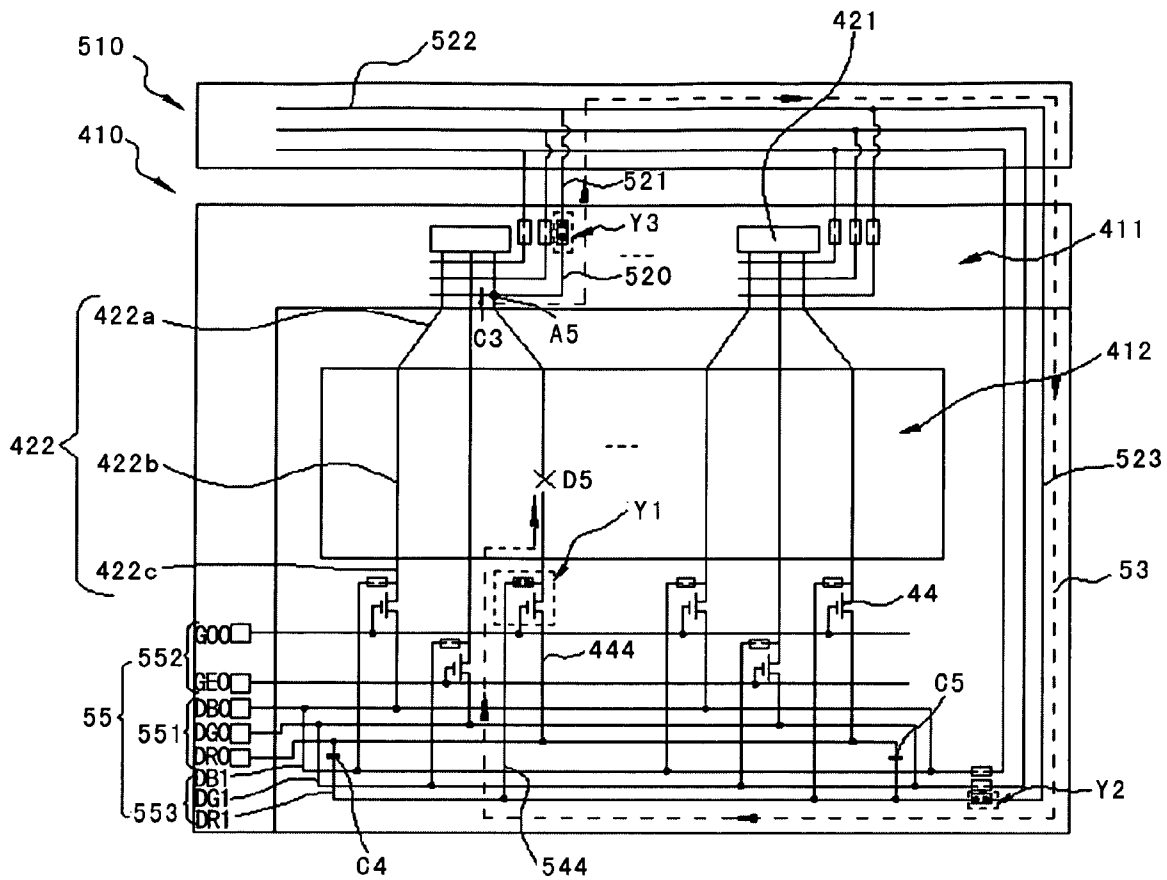
FIG. 3A is a view showing a repair line structure of an array substrate of a liquid crystal display in accordance with a second embodiment of the invention.

FIG. 3A is a plan view showing a repair line structure of an array substrate of liquid crystal display in accordance with a second embodiment of the invention. Similar to FIG. 2A, the array substrate **410** of the liquid crystal display comprises a display region **412** and a signal introducing region **411** outside the display region **412**. A plurality of data line pads **421** are formed in the signal introducing region **411** and electrically connected with the data lines **422**. Each data line **422** comprises three portions, that is, a front data line portion **422a** outside the display region **412** and connected with a corresponding data line pad **421**, a display region data line portion **422b**, and an end data line portion **422c** outside the display region **412** and at the side away from the data line pad **421**. Data signals inputted from the data line pad **421** are transmitted on the whole data line **422** in an order of the front data line portion **422a**, the display region data line portion **422b** and the end data line portion **422c**. For the sake of clarity, scanning lines crossing with the data lines **422**, and scanning line pads are not shown in FIG. 3A.

The repair line comprises a data connection line **520**, a connection element **547** (see FIG. 3D), a repair connection line **521**, a common repair line **522** on a printed circuit board (PCB) **510**, and a data repair line **523** outside the display region **412**. The data repair line **523** extends at the right side of the display region **412** and does not fully extend to the lower side of the display region **412**. In order to facilitate the description, the connecting technique between the common repair line **522** on the PCB **510** and the data repair line **523** on the array substrate **410** will not be described in detail. However, it is apparent to those skilled in the art that connection techniques such as Chip On Film (COF) and Tape Carrier Package (TCP) and the like may be used. The data connection line **520** crosses with the front data line portion **422a** when viewed along a direction perpendicular to the surface of the array substrate **410**; however, the data connection line **520** and the front data line portion **422a** are positioned in different layers in the direction perpendicular to the surface of the array substrate **410** and are separated by an insulating layer therebetween. Thus the data connection line **520** and the front data line portion **422a** are not in an electrical connection when repair is not carried out with the repair line. Although in the plan view of FIG. 3A, the data connection line **520** and the front data line portion **422a** are arranged perpendicularly, the invention is by no means limited to such a perpendicularly arranged manner. It is sufficient as long as there is a crossing point between them in the plan view.

As shown in FIG. 3A, test lines **55** are provided outside the display region **412**, and comprise test data lines **551**, test scanning lines **552** and auxiliary test data lines **553**. The test data lines **551** are used to transmit test data signals and include three test data lines  $DB_0$ ,  $DG_0$  and  $DR_0$ . The test scanning lines **552** are used to transmit test scanning signals and include two test scanning lines  $GO_0$  and  $GE_0$ . The auxiliary test data lines **553** include three lines  $DB_1$ ,  $DG_1$  and  $DR_1$ . As shown in FIG. 3A, the two ends of the test data line  $DB_0$  and the two ends of the auxiliary test data line  $DB_1$  are connected respectively. Similarly, the two ends of the test data line  $DG_0$  and the two ends of the auxiliary test data line  $DG_1$ , and the two ends of the test data line  $DR_0$  and the two ends of the auxiliary test data line  $DR_1$ , are also connected respectively. That is, the auxiliary test data lines  $DB_1$ ,  $DG_1$  and  $DR_1$  are in parallel with the corresponding test data lines  $DB_0$ ,  $DG_0$  and  $DR_0$  respectively. Data test signals are transmitted to the data lines **422** via the TFTs **44** from the test lines **55**.

As shown in FIG. 3A, in order to carry out tests more effectively, the test lines **55** and the TFTs **44** are connected such that the gate electrodes of the TFTs in the odd and even columns counted from the left are respectively connected to the  $GO_0$  and  $GE_0$  lines of the test scanning lines **552**, and the source electrodes of TFTs in the  $3n-2$ ,  $3n-1$  and  $3n$  ( $n=1, 2, 3 \dots$ ) columns counted from the left are respectively connected to the  $DB_0$ ,  $DG_0$  and  $DR_0$  lines of the test data lines **551**. It is noted that that the connecting technique in FIG. 3A is merely an example, and it is possible to use other techniques, for example, providing only one test scanning line, or providing more test data lines, etc. In an embodiment, the test lines **55** and the data repair line **523** may be arranged partly or entirely in a perimeter seal region so as to reduce the non-display area in the liquid crystal display panel.

With the above repair technique, data signals on the defective data line 422 can be transmitted, along a path shown by the dashed line 53, to the portion of this data line 422 below the break point D5. The specific transmitting path is: from the front data line portion 422a to the data connection line 520 via the crossing point A5, then to the connection element 547 via the crossing point A11, then to the repair connection line 521 via the crossing point A10, then to the data repair line 523 via the common repair line 522 on the PCB, then to the connection element 546 via the crossing point A9, then to the DR<sub>1</sub> line of the auxiliary test data lines 553 and to the auxiliary test data line branch 544 via the crossing point A8, and to the connection element 545 via the crossing point A6, to the end data line portion 422c via the crossing point A7, and finally to the portion of the display region data line portion 442b below the break point D5.

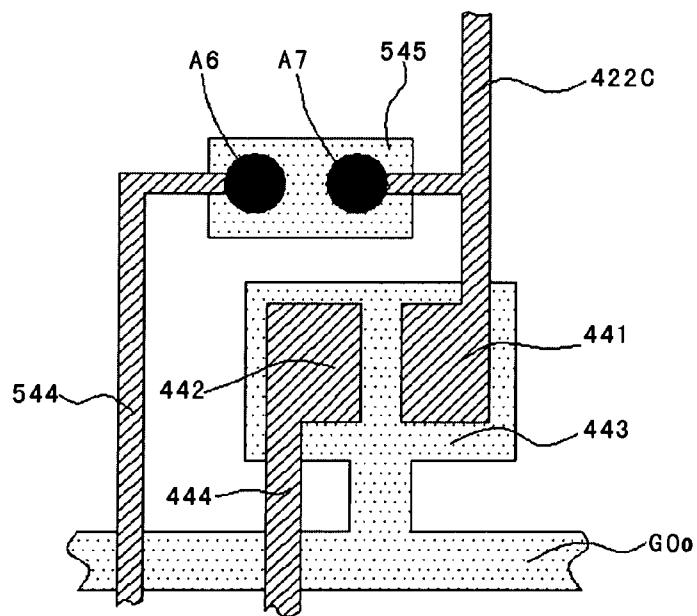
FIG. 3B is a detailed view of TFT in the region **Y1** of FIG. 3A.

FIG. 3B shows a detailed view of the region Y1 of FIG. 3A, which mainly discloses a TFT **44** and a connecting element **545** made of conductor. The TFT **44** has a source electrode **442**, a drain electrode **441** and a gate electrode **443**. The source electrode **442** is connected to the test data line branch **444**, the drain electrode **441** is connected to the end data line portion **422c** of the corresponding data line **422**, and the gate electrode **443** is connected to the test scanning line **552** (in particular, to the  $GO_0$  line of the test scanning line **552** in FIG. 3A). The test data line branch **444** is connected to one of the test data lines **551** (in particular, to the  $DR_0$  line of the test data lines **551** in FIG. 3A). In addition, when viewed along a direction perpendicular to the surface of the array substrate, an overlapping region exists at a point A6 between an auxiliary test data line branch **544** and the connecting element **545** which are positioned in different layers in the direction and are separated by an insulating layer therebetween; an overlapping region exists at a point A7 between the end data line portion **422c** and the connecting element **545** which are positioned in different layers in the direction and are separated by an insulating layer therebetween. The auxiliary test data line branch **544** is connected to one of the auxiliary test data lines **553** (in particular to the line  $DR_1$  of the auxiliary test data lines **553**). When repair is not carried out using the repair line, any two among the auxiliary test data line branch **544**, the connecting element **545** and the end data line portion **422c** are not electrically connected.

(4) electrically connecting the auxiliary test data line branch 544 corresponding to the defective data line 422 with the end data line portion 422c of the data line 422, and cutting off the connection between the test data auxiliary line 553 (in particular, the DR<sub>1</sub> line in FIG. 3A) used for repair and the corresponding test data line 551 (in particular, the DR<sub>0</sub> line in FIG. 3A). As shown in FIG. 3A, when the DR<sub>1</sub> line of the auxiliary test data lines 553 is used as a repair line, the auxiliary test data line branch 544 may be electrically connected with the connection element 545 at the crossing point A6 and the end data line portion 422c may be electrically connected with the connection element 545 at the crossing point A7, for example, by laser melting (see FIG. 3B), while the connection between the DR<sub>1</sub> line and the DR<sub>0</sub> line may be cut off at points C4 and C5, for example, by laser.

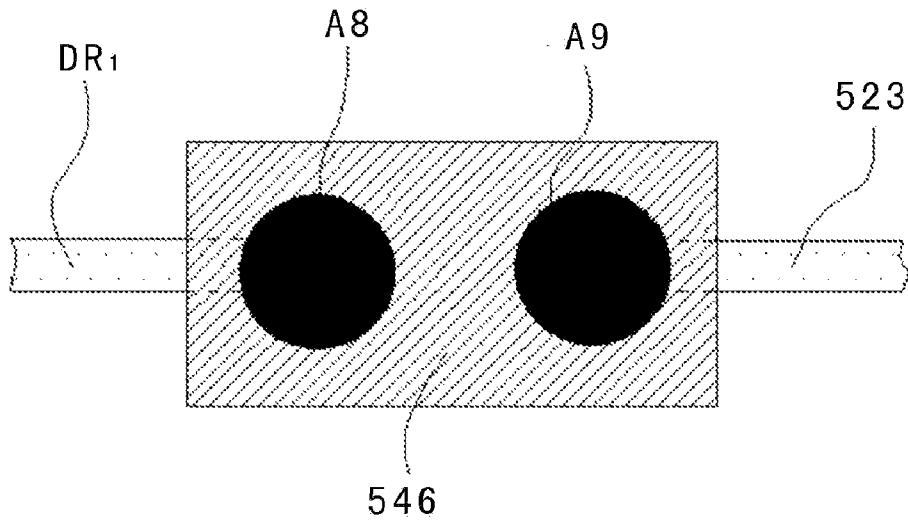
FIG. 3C is a detailed view of the region **Y2** of FIG. 3A.

the direction and are separated by an insulating layer therebetween. Also, when viewed along a direction perpendicular to the surface of the array substrate 410, an overlapping region exists at a point A9 between the data repair line 523 and the connecting element 546 which are positioned in different layers in the direction and are separated by an insulating layer therebetween. Therefore, when repair is not carried out using the repair line, any two among the auxiliary test data line 553, the connecting element 546 and the data repair line 523 are not electrically connected.

(3) Electrically connecting the test data line 551 with the data repair line 523. For example, the auxiliary test data line 553 (in particular, the DR<sub>1</sub> line in FIG. 3A) may be electrically connected with the connection element 546 at the crossing point A8 and the data repair line 523 may be electrically connected with the connection element 546 at the crossing point A9 by laser melting, as shown in FIG. 3C.

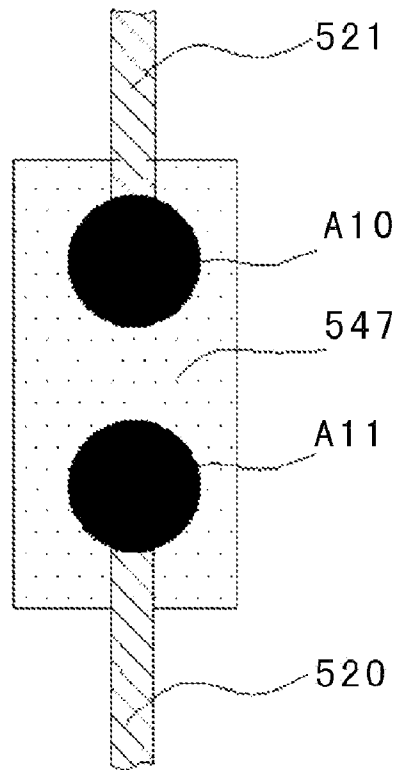
FIG. 3D is a detailed view of the region **Y3** of FIG. 3A.

FIG. 3D is an enlarged view of the region Y3 of FIG. 3A. When viewed along a direction perpendicular to the surface of the array substrate 410, as shown in FIG. 3D, an overlapping region exists at a point A11 between the data connection line 520 and a connecting element 547 made of conductor which are positioned in different layers in the direction and are separated by an insulating layer therebetween. Also, when viewed along a direction perpendicular to the surface of the array substrate 410, an overlapping region exists at a point A10 between the repair connection line 521 and the connecting element 547 which are positioned in different layers in the direction and are separated by an insulating layer therebetween. Therefore, when repair is not carried out using the repair line, any two among the data connection line 520, the connecting element 547 and the repair connection line 521 are not electrically connected.

(2) Electrically connecting the data connection line 520 with the repair connection line 521. For example, the data connection line 520 may be electrically connected with the connection element 547 at the crossing point A11 and the repair connection line 521 may be electrically connected with the connection element 547 at the crossing point A10 by laser melting, as shown in FIG. 3D.
