(10) **Patent No.:** **US 10,872,391 B2**

(54) **METHOD AND MEANS TO ANALYZE THERMOGRAPHIC DATA ACQUIRED DURING AUTOMATED FIBER PLACEMENT**

**METHOD AND MEANS TO ANALYZE
THERMOGRAPHIC DATA ACQUIRED
DURING AUTOMATED FIBER PLACEMENT**

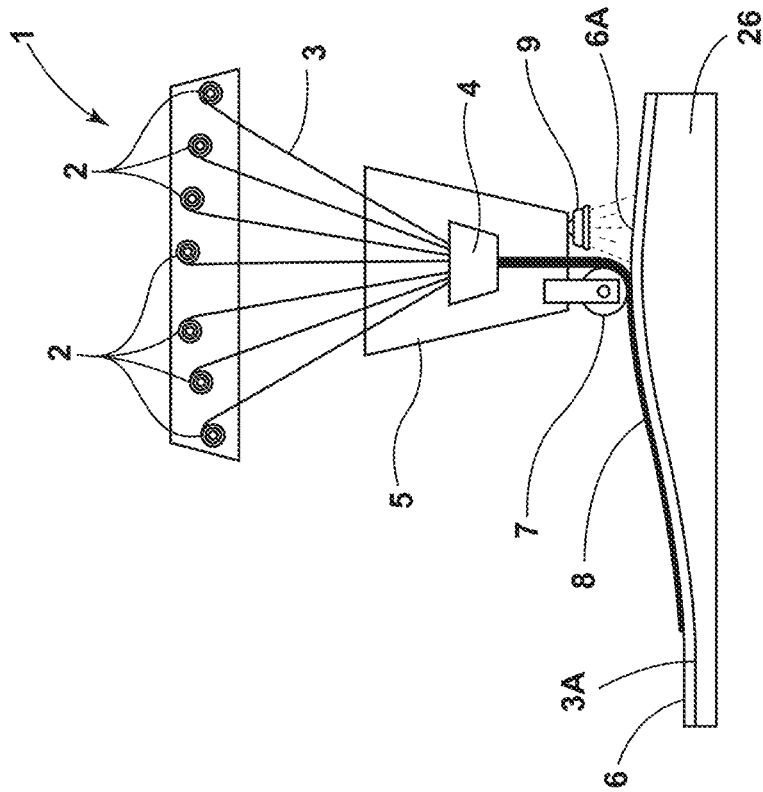
FIG. 1 (PRIOR ART)

FIG. 1 is a schematic view of a prior art automated fiber placement (AFP) device;

With reference to FIG. 1, a known AFP system 1 may include a plurality of spools 2 that feed carbon fiber tape 3 to a collimator 4 of AFP head 5. The AFP head 5 may be mounted on a robotic arm (not shown) that is controlled by a control system to move the head 5 in a predefined manner relative to a substrate 6. An applicator such as a compaction roller 7 compacts and positions a layer of tape 8 onto substrate 6. A heat source such as lamp 9 mounted on AFP head 5 heats a region 6A of substrate 6 before the carbon fiber tape 3 is deposited onto substrate 6. The heating facilitates bonding between the carbon fiber tape 3 that is being applied and the substrate 6. Substrate 6 may comprise layers 3A of carbon fiber tape 3 that have previously been deposited onto a tool 26 corresponding to a surface shape of a finished part that is to be fabricated by the AFP system 1.

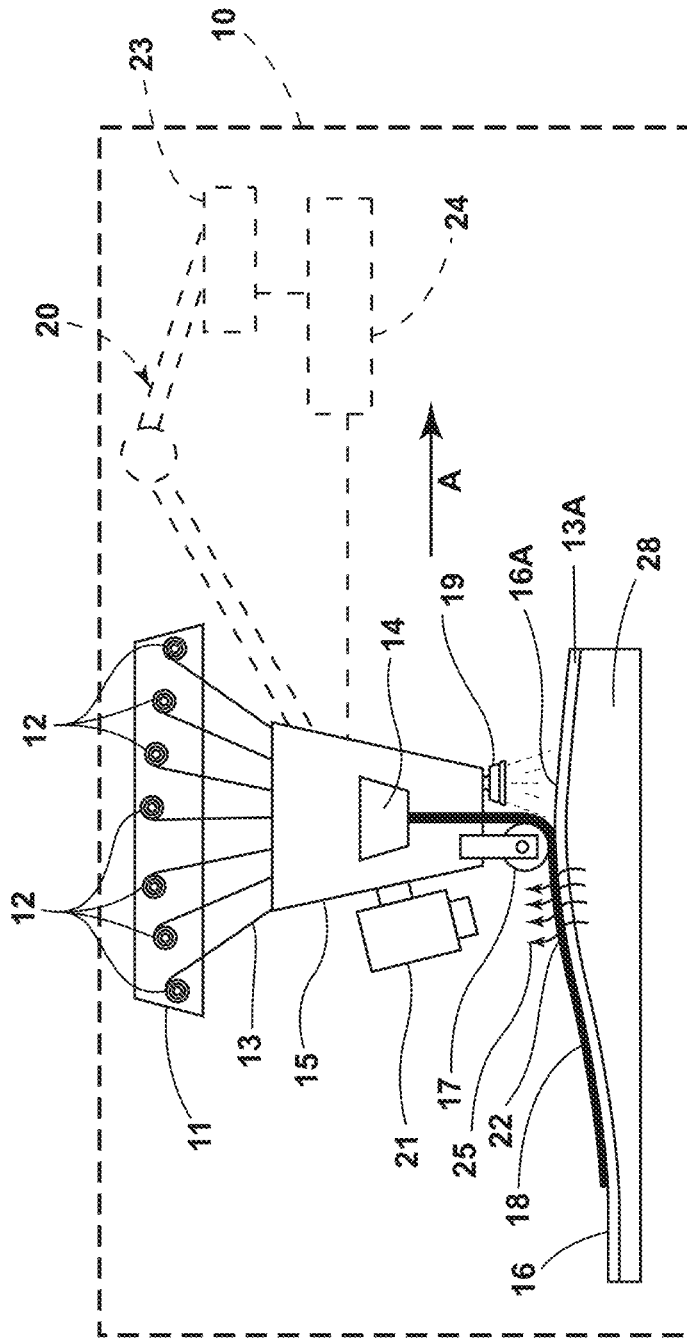
FIG. 2 is a schematic view of an AFP system and infrared camera according to one aspect of the present invention;

Thermal energy 25 from substrate 16 raises the temperature of surface 22 of layer 18 due to heat transfer from heated surface 16A through layer 18. Camera 21 is positioned to generate thermal images of surface 22 immediately after the composite layer 18 is applied to heated substrate surface 16A by compaction roller 17. As discussed in more detail below, variations in layer 18 and/or substrate 16 result in variations in the temperature of surface 22. These temperature variations may be evaluated to detect and identify defects in layer 18 and/or substrate 16.

The AFP system 10 may include a robotic arm 20 having a base 23. The head 15 is mounted to robotic arm 20, and a controller 24 may be programmed to cause robotic arm 20 to move head 15 relative to substrate 16 along a plurality of predefined paths to thereby position the composite tape according to a predefined design or configuration. During operation, the head 15 may move relative to substrate 16 in the direction of the arrow “A.” The substrate 16 may be stationary relative to robotic arm 20, or the substrate 16 may be movable (e.g., rotatable) relative to the robotic arm 20. The robotic arm 20 comprises a modified industrial robotic arm that is movably mounted on a linear track (not shown) whereby the base 23 of robotic arm 20 travels along a horizontally linear path relative to substrate 16. The robotic arm 20 may comprise an existing robotic arm developed for the Integrated Structural Assembly of Advanced Composites (ISAAC) project. However, it will be understood that various automated fiber placement (AFP) systems have been developed, and the present invention is not limited to a particular AFP device or system.

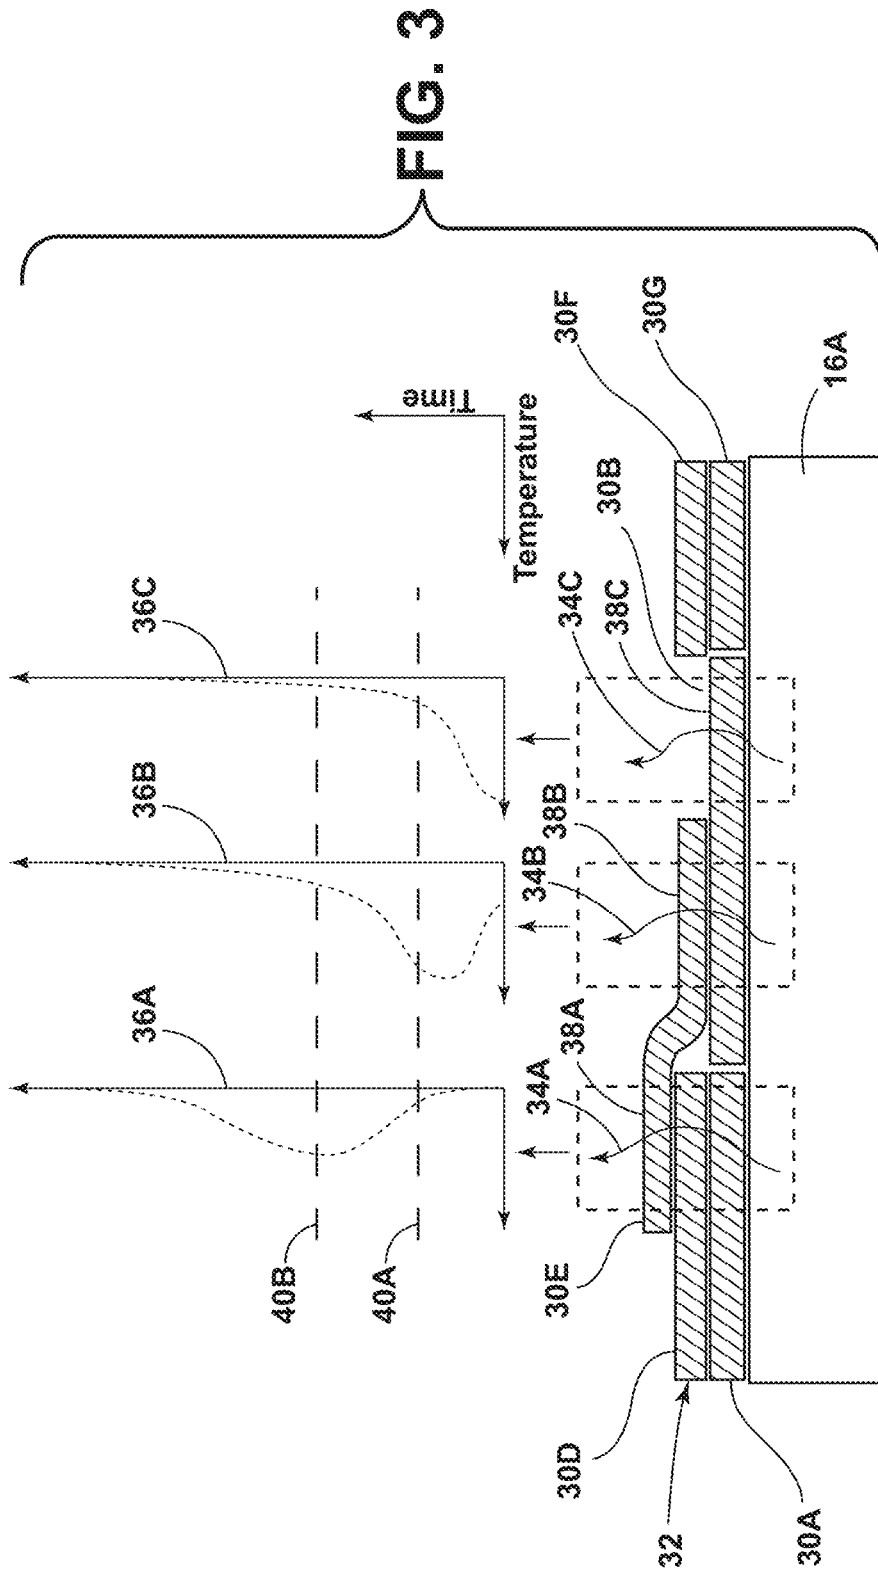
FIG. 3A is an image showing temporally aligned (“composite”) in situ thermography data, showing deviation from an expected value before a debulking cycle;

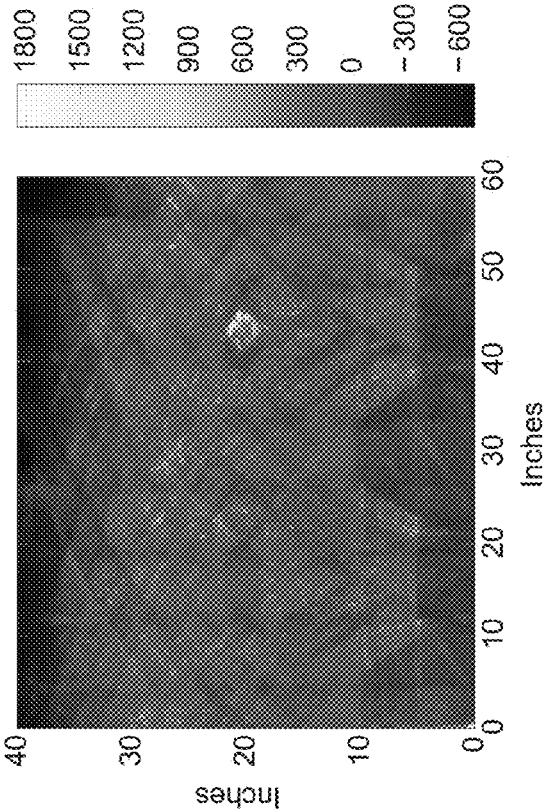
FIG. 3B is an image showing temporally aligned in situ thermography data, deviation from an expected value after debulking cycle;

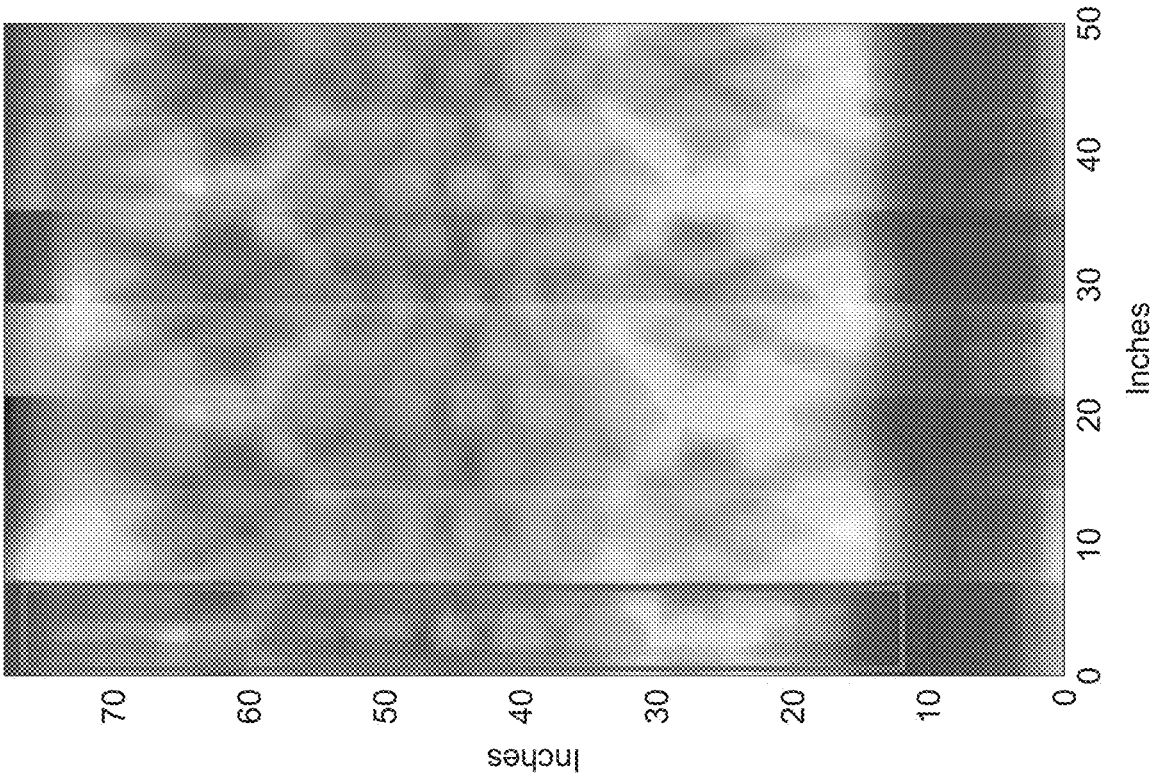
FIG. 3C is a post cure thermal line scan of a part, wherein the data is temporally aligned and spatially registered;

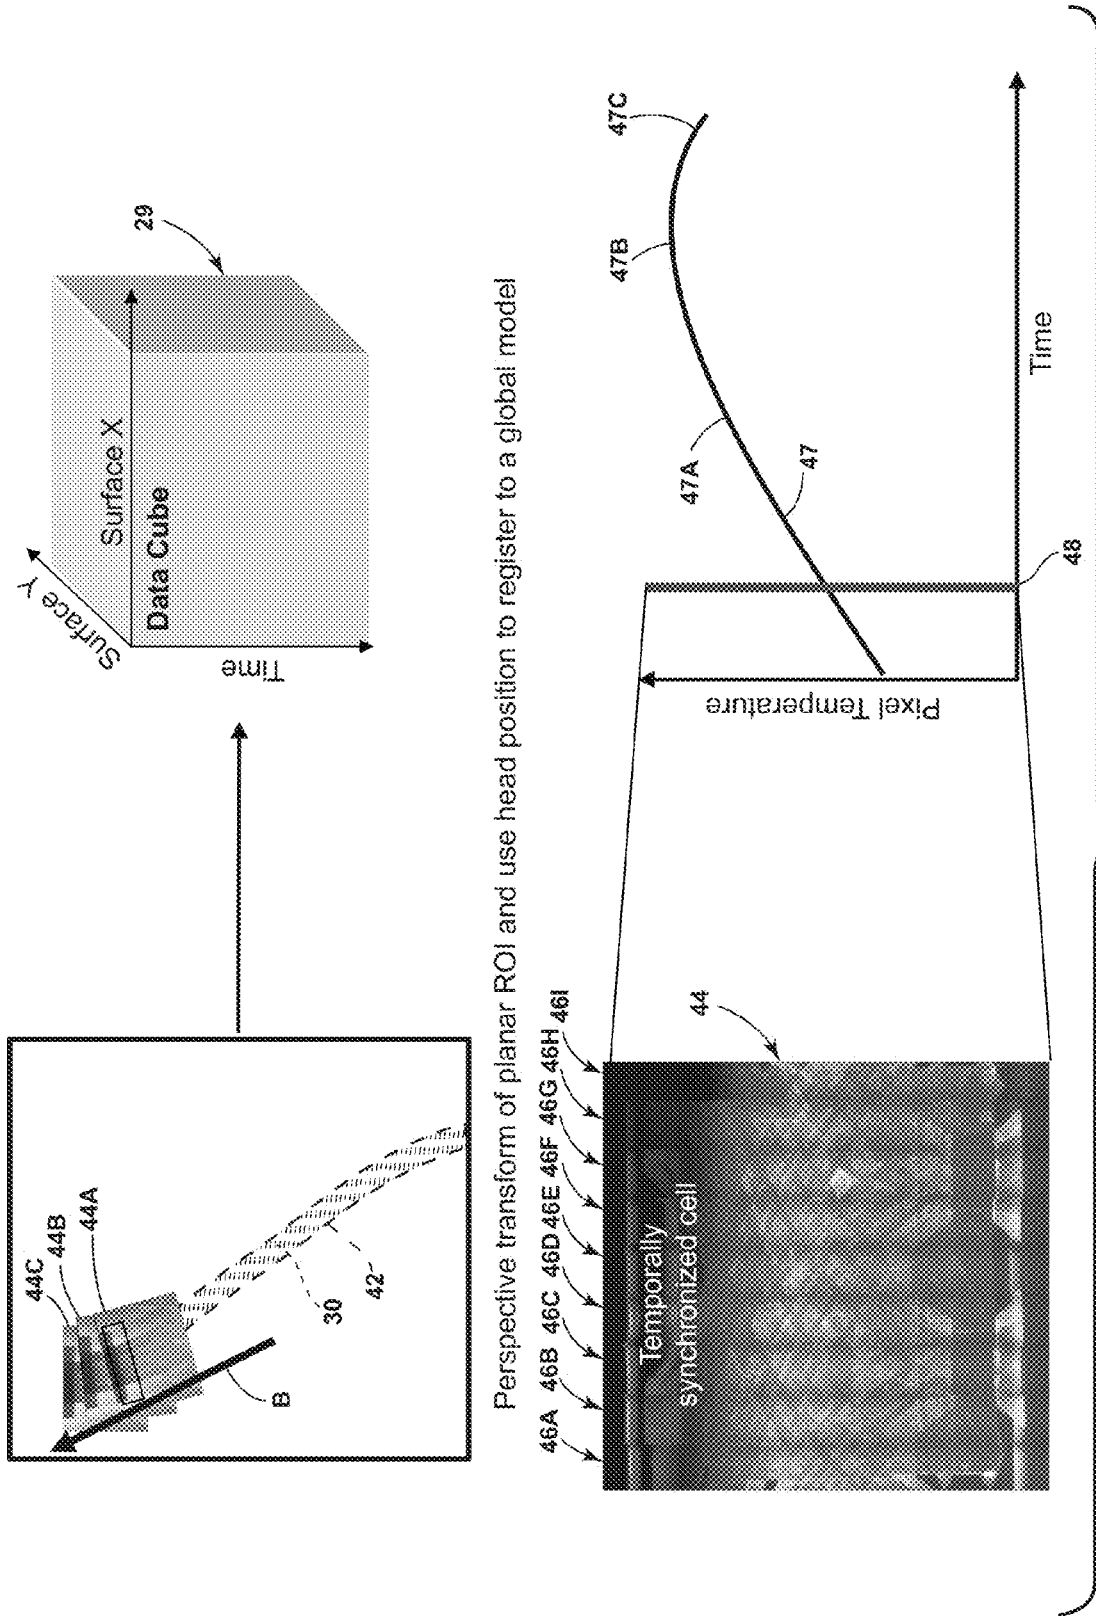
FIG. 4 is a schematic view of a material course, a thermal image, and a graph showing temperature of the tow surface over time;

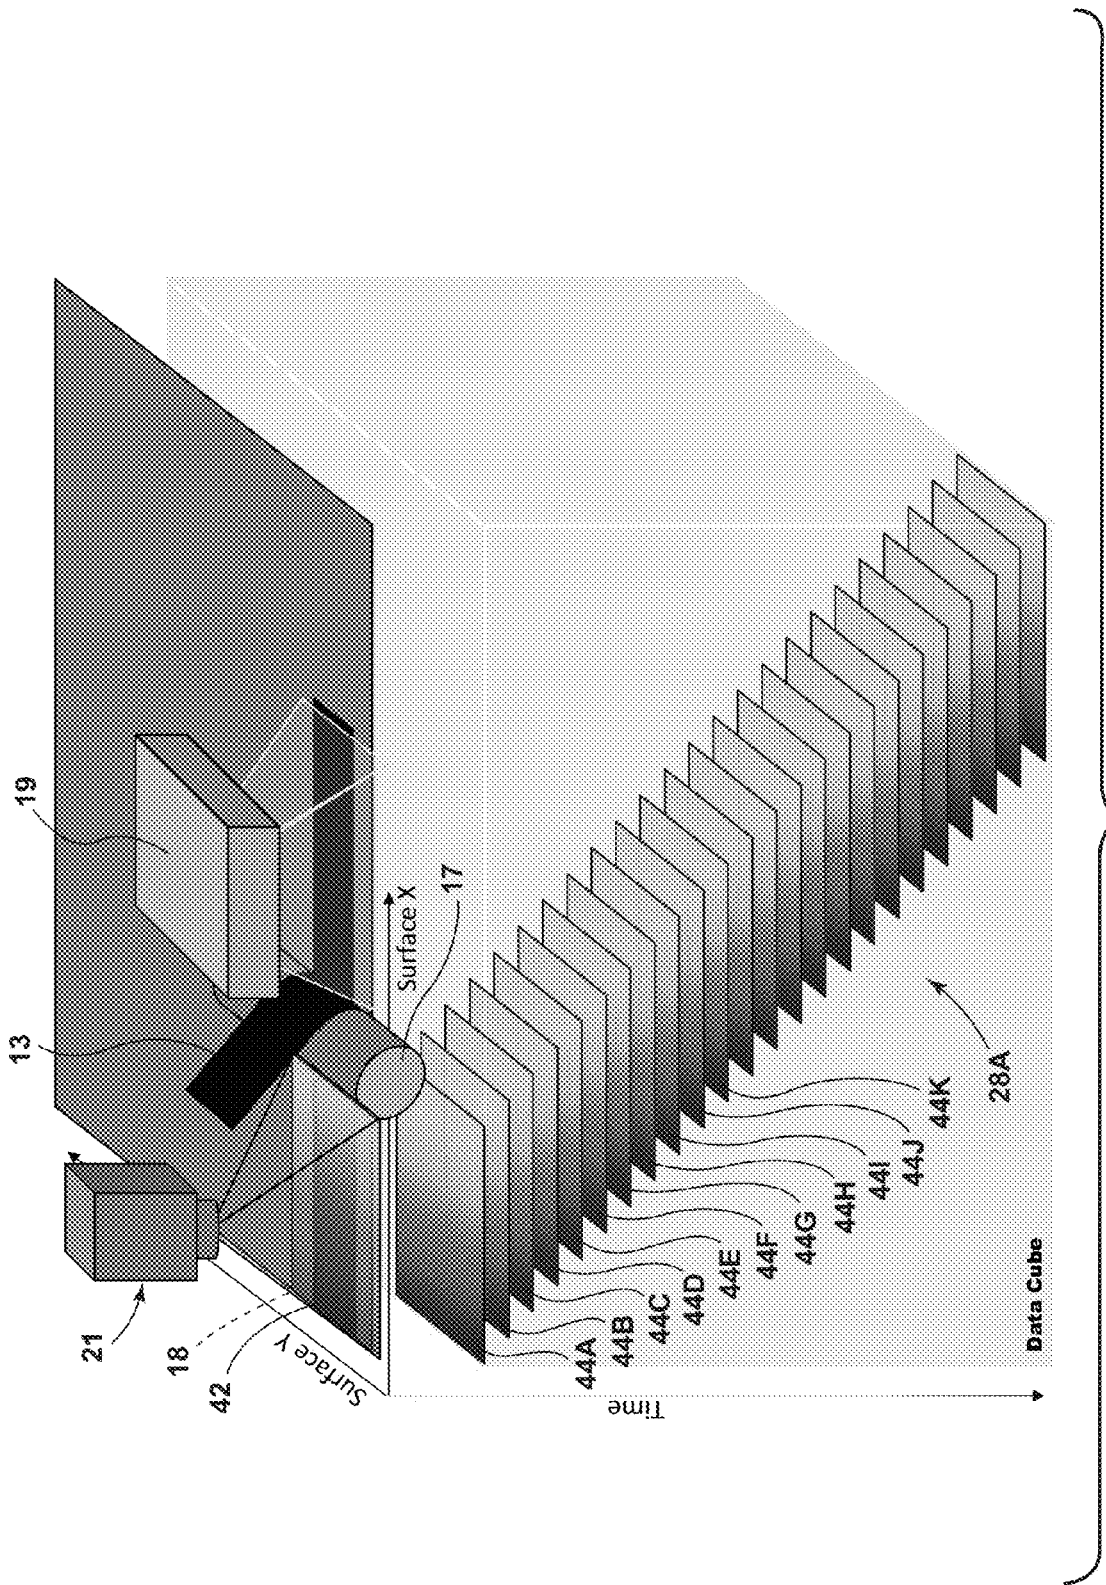
FIG. 4A is an isometric schematic view of an AFP system, infrared camera, and image data;

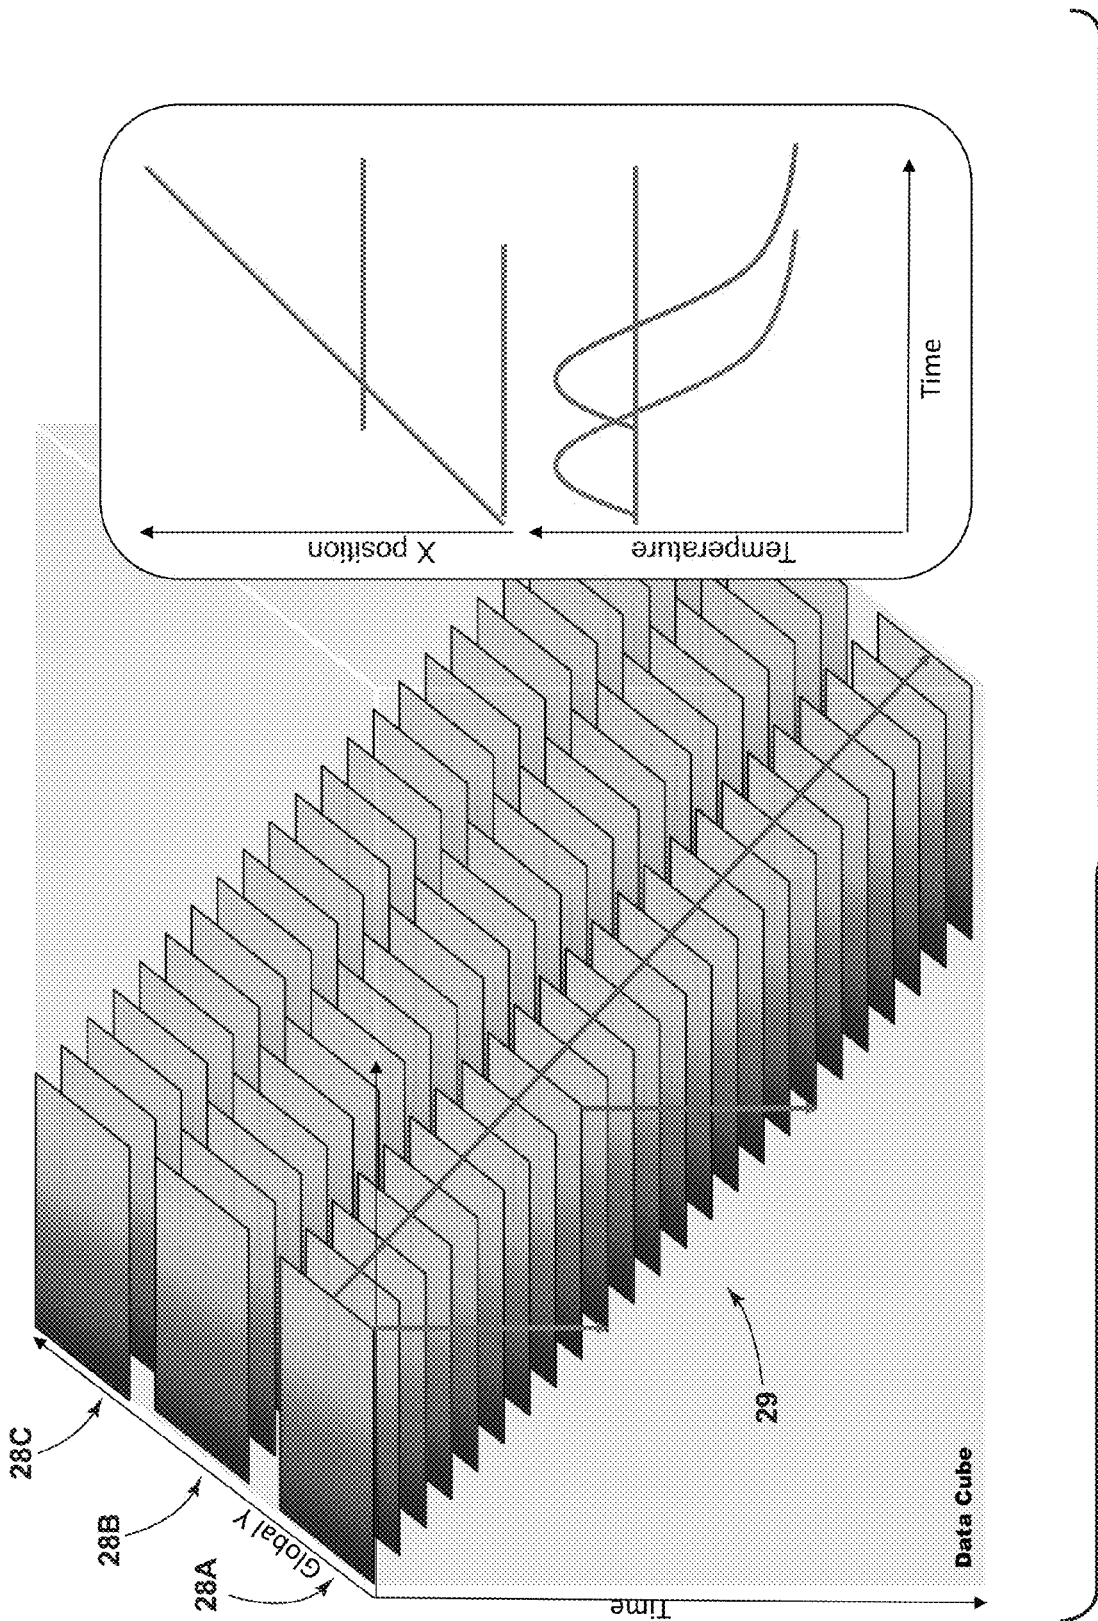
FIG. 4B is a schematic showing image data generated by the infrared camera of FIG. 4A;

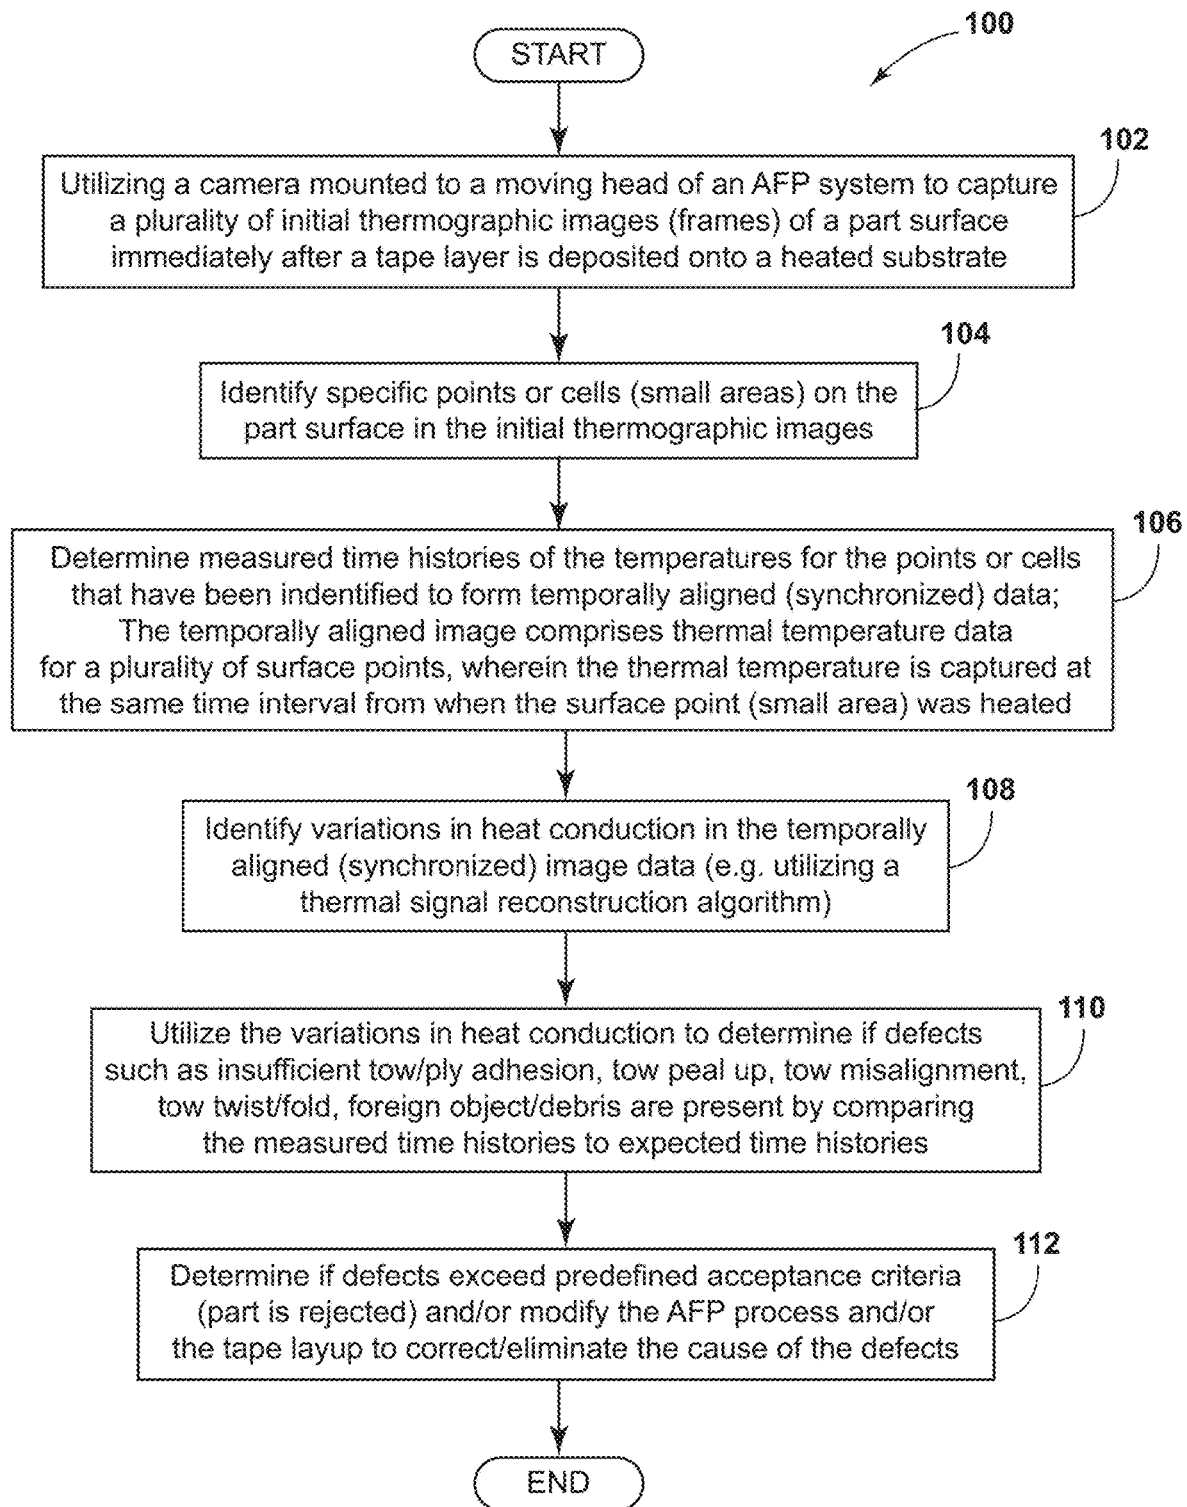
FIG. 4C is a flowchart showing thermographic data processing according to one aspect of the present invention;

At step **108**, variations in the temporally aligned image data (caused by variations in heat conduction) are identified. A thermal signal reconstruction algorithm or other suitable approaches may be utilized to identify and/or evaluate variations. The variations may comprise variations from expected data, or the variations may comprise "absolute" variations in the data.

At step **110**, variations in the data (e.g. due to variations in heat conduction) are utilized to determine if defects are present. The temporally aligned data may be evaluated utilizing algorithms (software) previously utilized to analyze thermal image data generated by flash thermography or other such processes. The defects may comprise insufficient tow/ply adhesion, tow peel up, tow misalignment, tow twist/fold, foreign objects/debris, etc. Defects may be detected by comparing the measured time histories to expected time histories. At step **112**, if defects exceed predefined acceptance criteria a part may be rejected and/or the layup or process may be modified. The AFP process, tape layup etc. may be modified to correct or eliminate the cause of the defects even if defects do not exceed predefined criteria.

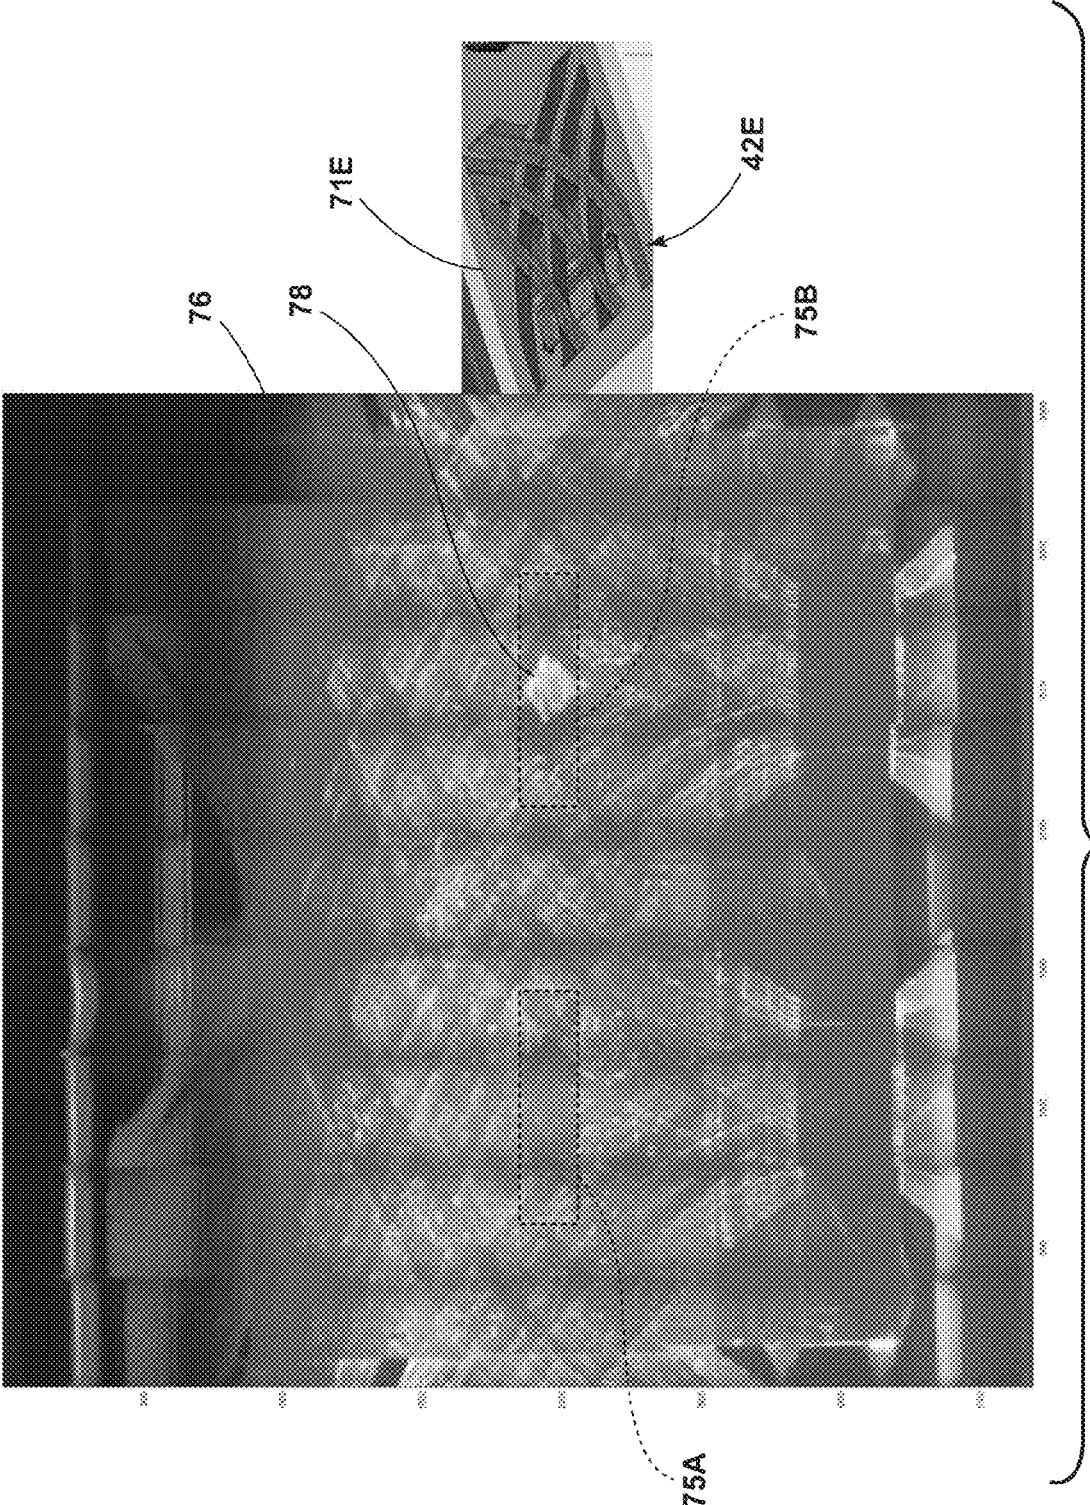
FIG. 9 is a temporally aligned (composite) image generally using a line scan process of a region of a composite structure prior to a debulk process;

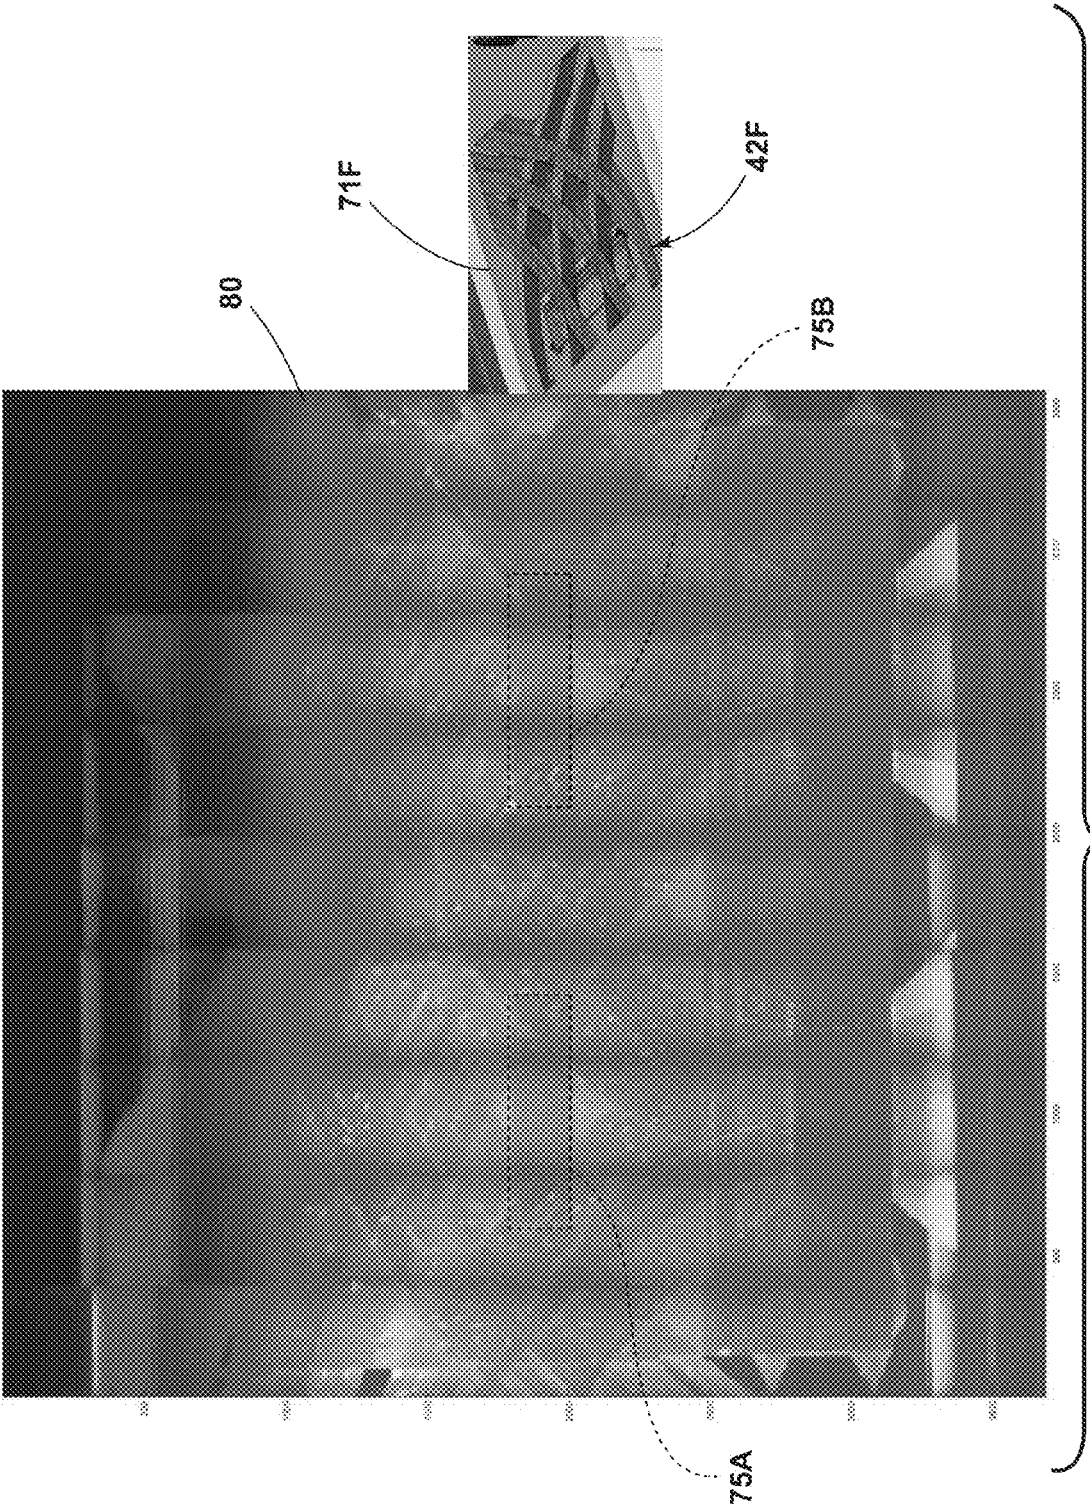
FIG. 10 is a temporally aligned (composite) image generally using a line scan process showing the same region as FIG. 9 after a debulk process;

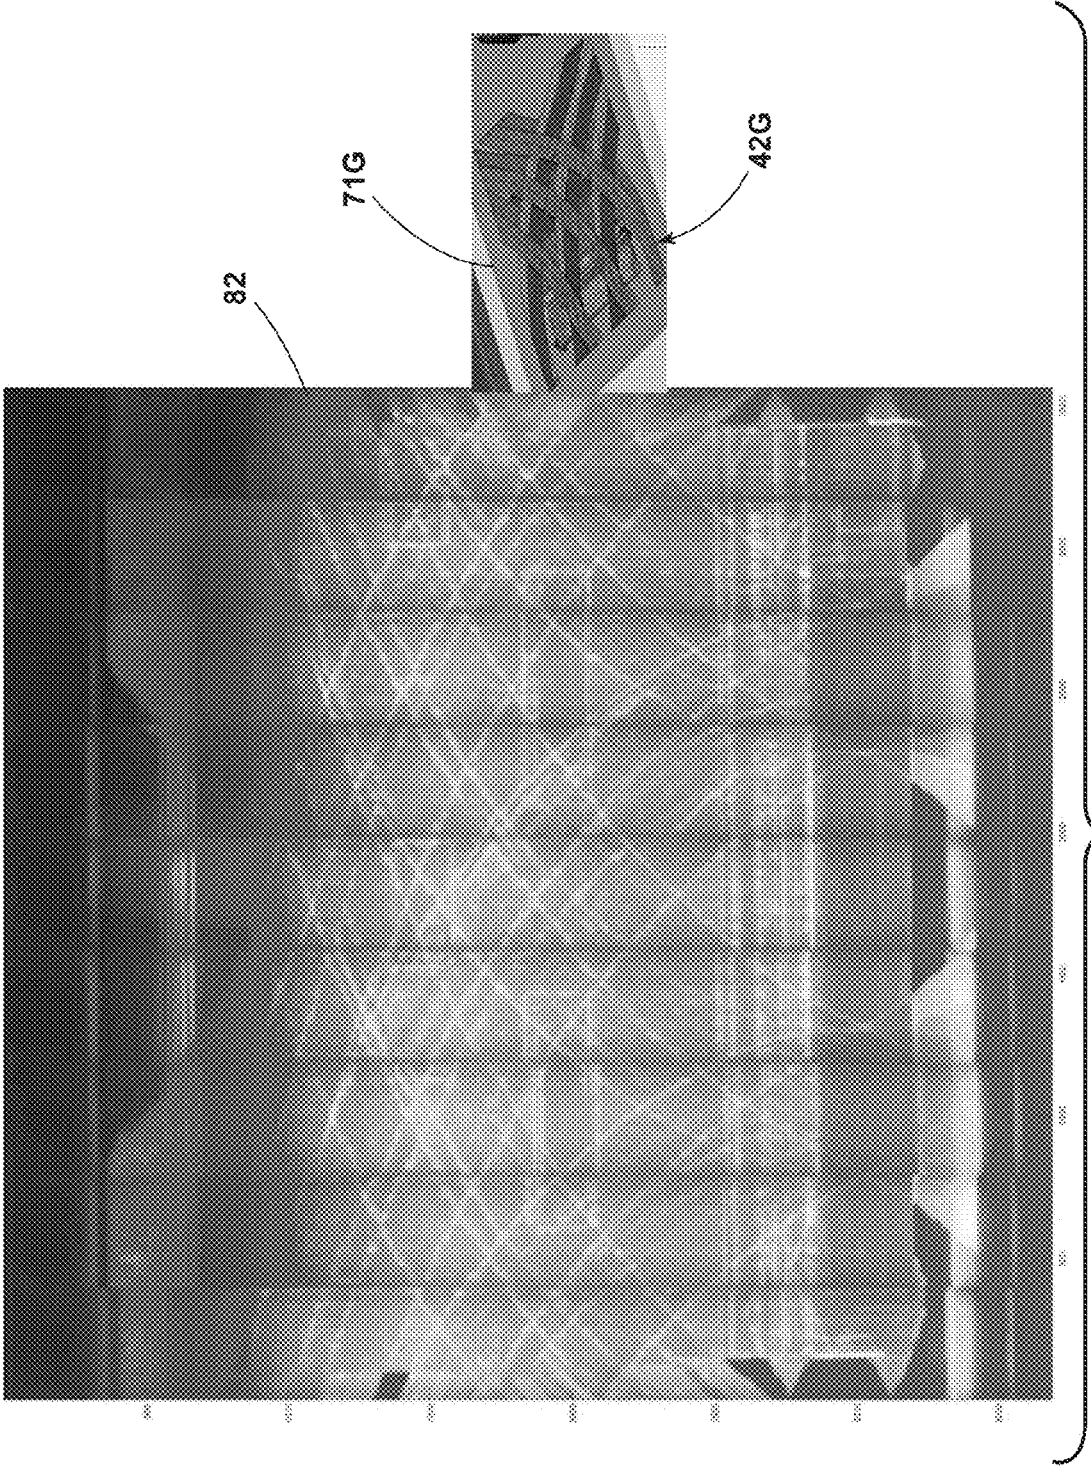
FIG. 11 is a temporally aligned (composite) image of data taken during layup of a final acreage ply, wherein all three images are processed to view a single time step;

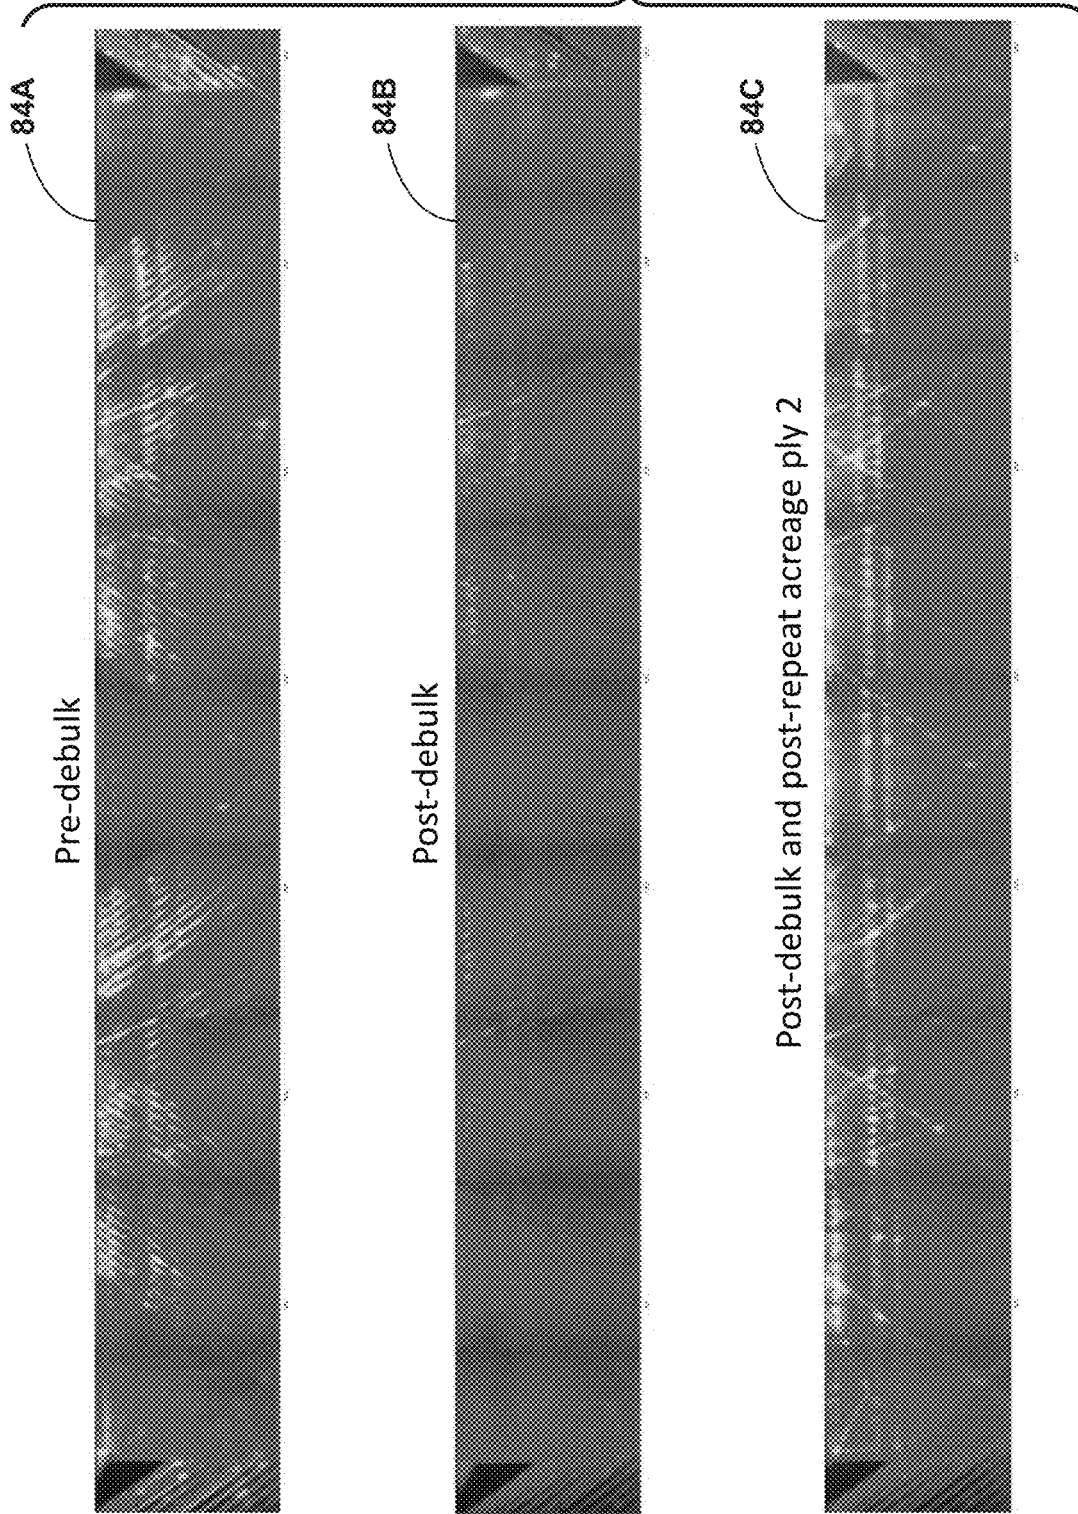
FIG. 12 comprises temporally aligned thermographic image data from FIGS. 9, 10, and 11 for a composite structure pre-debulk, post-debulk, and post-repeat acreage ply 2; and

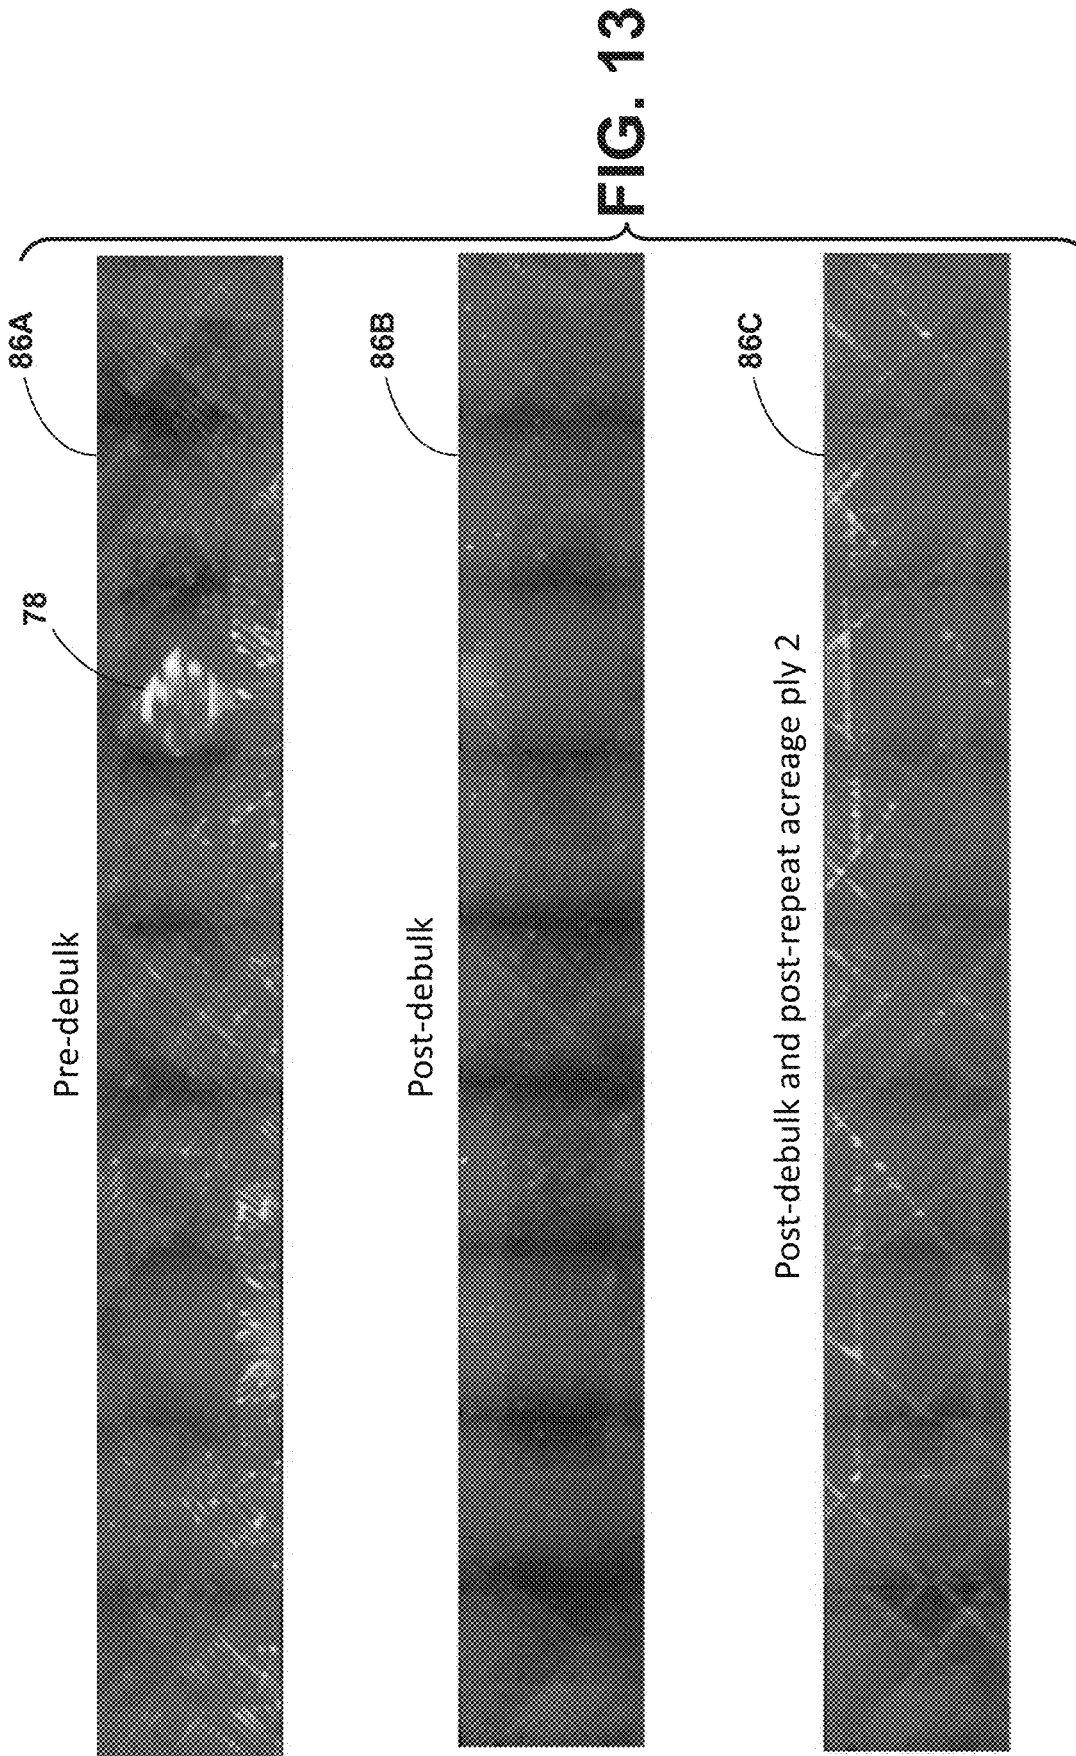
FIG. 13 comprises temporally aligned thermographic image data for a composite structure pre-debulk, post-debulk, and post-repeat acreage ply 2.

With further reference to FIG. **13**, a thermal image **86A** was generated pre-debulk as prepreg tow was being applied. Thermal image **86B** is the same area of a composite structure after a debulk procedure. As discussed above in connection with FIGS. **9** and **10**, a bright spot **78** in thermal image **86A** corresponds to a region or patch of material that disbonded from the substrate when new material was laid over it. The pressure and direction of the roller **17** may cause it to ‘bunch up’ and disbond (lose adhesion), resulting in a defect due to poor adhesion. Image **86B** shows that the defect was eliminated by the debulking process. Thermal image **86C** shows the same surface region of a composite structure post-debulk and post-repeat acreage ply **2**. The images show that the debulk cycle reduced the areas of poor adhesion, except in areas where poor adhesion is expected as a result of geometry.
