US005834321A

[11] **Patent Number:** **5,834,321**
[45] **Date of Patent:** **Nov. 10, 1998**

[54] **LOW NOISE ADDRESS LINE REPAIR METHOD FOR THIN FILM IMAGER DEVICES**

[73] Assignee: **General Electric Company**, Schenectady, N.Y.

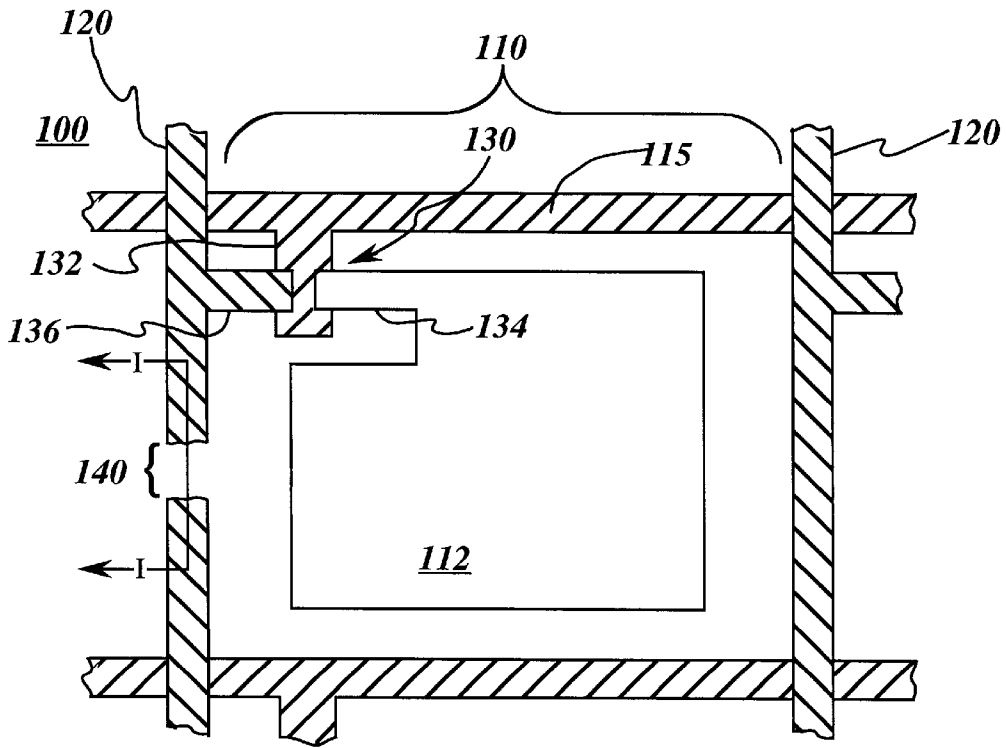
fig. 1

FIG. 1 is a plan view of a portion of a thin film electronic imager array having a damaged address line.

A thin film electronic imager device **100**, such as a solid state radiation imager array, typically comprises a plurality of pixels **110** arranged in a matrix of rows and columns (a representative one of which is illustrated in FIG. 1). Pixels in the array are coupled to address lines which include rows of scan lines **115** and columns of data lines **120** via a thin film field effect switching transistor **130** (referred to as a "TFT" or a "FET") such that the charge accumulated by the photosensor in each pixel can be selectively read out during imager operations. Each switching transistor comprises a

FIG. 1 illustrates imager array **100** at an interim step in the fabrication process known as the "FET complete" step. At this point in the fabrication process imager array comprises layers of conductive, semiconductive, and dielectric material that are respectively arranged to form scan lines **115**, data lines **120**, FETs **130**, and pixel electrodes **112**; in the typical fabrication process, the next step in the formation of silicon photosensor bodies on pixel electrode **112** and the deposition of multiple layers of organic and inorganic dielectric material to form barriers to protect the photosensors, after which a common electrode is formed over the photosensors and scintillator material is disposed over the common electrode on the array. Often imager fabrication processes do not provide for repair of defects in address lines until after photosensors and barrier layers have been formed; repair at this stage in the fabrication process necessitates removal of barrier layer material from the region of the address line defect prior to being able to repair the defect.

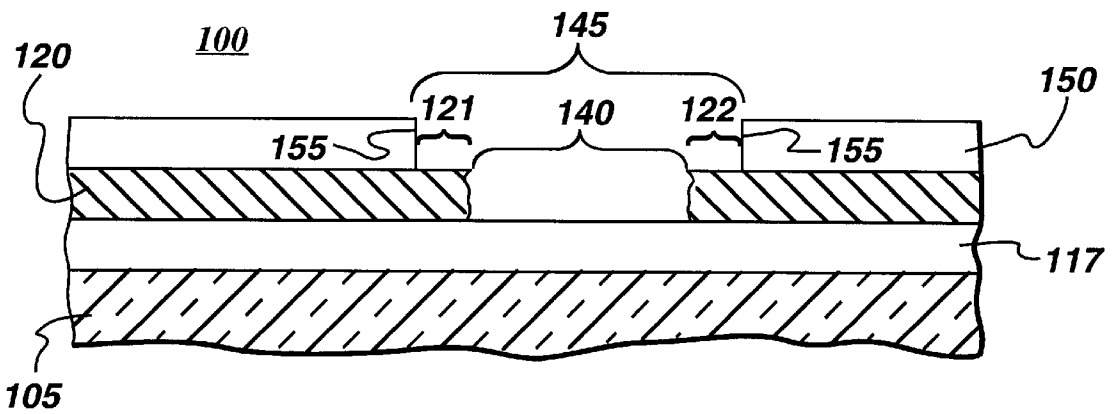
fig. 2

FIG. 2 is a cross-sectional view of the damaged imager array taken along line I—I in FIG. 1 following deposition of a first protective layer and formation of a repair area over the defect in the address line in accordance with this invention.

A portion of address line **120** having a defect **140** is illustrated in cross section in FIG. 2. At the FET complete stage of the fabrication process a gate dielectric layer **117** is disposed on a substrate **105**; gate dielectric layer comprises a dielectric material, such as silicon oxide (SiO_x) or silicon nitride (SiN_x), that is disposed over array **100** to electrical insulate scan lines **115** and insulate associated gate electrodes **132** from succeeding layers of semiconductive and conductive materials (not shown) in TFT **130**. Data line **120** is disposed on gate dielectric layer **117** and typically comprises a conductive material such as molybdenum, titanium, aluminum and chromium, or the like. Data line **120** typically has a thickness in the range between about 0.2 μm and 1 μm.

Next, a repair area **145** (FIG. 2) is formed to expose defect **140**, a first address line portion **121**, and a second address line portion **122** that adjoin defect **140**. Typically, portions of first protective layer **150** disposed over repair area **145** are removed by laser ablation to expose defect **140** and adjoining address line segments **121**, **122**. For example, a Flord brand Model LCM 308 excimer laser has been used at about 7% power (total power being about 350 microjoules) to ablate non-conductive material to form repair area **145** having dimensions of about 10 μm by 20 μm (width, depth, etc.). First and second address line segments **121**, **122** collectively comprise areas on each portion of data address line adjoining by open circuit defect **145**. Segments **121** and **122** are sufficiently large to allow subsequently deposited conductive material (as discussed below) to make satisfactory electrical contact to data line **120** and to form a stable structure. For example, in a typical imager in which address line **140** has a width of about 7 μm, segments **143** and **144** each have a length of about 10 μm. Additionally, sidewalls **155** of first protective layer **150** are typically also substantially planar (that is, relatively smooth surfaces that are typically disposed substantially vertically between the bottom surface of selected repair area **145** and the upper surface of first protective layer **150**). At the completion of this step, repair area **145** is formed with first protective layer **150** surrounding the repair area on the exposed surface of array **100**.

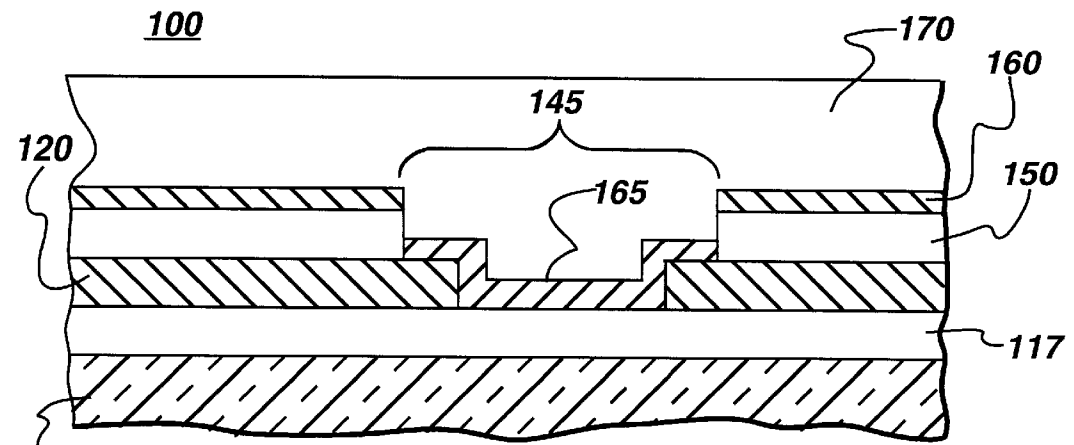
fig. 3

FIG. 3 is a cross-sectional view of the damaged imager array following deposition of the conductive repair material and second protective layer in accordance with the present invention.

Next, a conductive repair material layer **160** is deposited over array **100**, typically in a plasma enhanced chemical vapor deposition process or the like, such that the conductive repair material is disposed over the array surface, and a portion of the conductive repair material is disposed in repair area **145** so as to form a repair shunt **165** that electrically couples first data address line segment **121** to second data address line segment **122**. Conductive repair material layer comprises the same type of conductive material that comprises data line **120**, or alternatively a different type of conductive material. For example, conductive repair material may comprise a metal such as molybdenum, titanium, aluminum, chromium, or the like, or alternatively metal oxide combinations, such as indium tin oxide or the like. Conductive repair material is typically selected to provide a low bulk resistance (e.g., about 100 ohms per square or less) so as to reduce electrical noise in the repaired data line, and such that repair shunt **165** is robust, that is, provides a connection that is electrically and physically sound and that withstands the subsequent fabrication steps to complete that array. Conductive repair material layer **160** typically has a thickness in the range between about 0.8 μm and 1.2 μm.

array **100**. Second protective layer **170** is deposited in a spin process, meniscus coat process, or the like, over the surface of the array that results in the upper surface of second protective layer having a planarized surface, that is, a surface that is substantially parallel to the surface of substrate **105**. Second protective layer **170** typically comprises an insulative material that can be removed with laser ablation (e.g., similar to the material comprising first protective layer **150**). For example, second protective layer comprises photoresist, polyimide, or similar materials. The thickness of second protective layer **170** is typically in the range between about $1\ \mu\text{m}$ and $4\ \mu\text{m}$, and commonly has a thickness of about $2\ \mu\text{m}$ in the region outside of repair area **165** (due to the planarized surface, the thickness of second protective layer is greater in repair area **165**). At the completion of the formation of planarized second protective layer **170** array **100** appears as illustrated in FIG. 3.

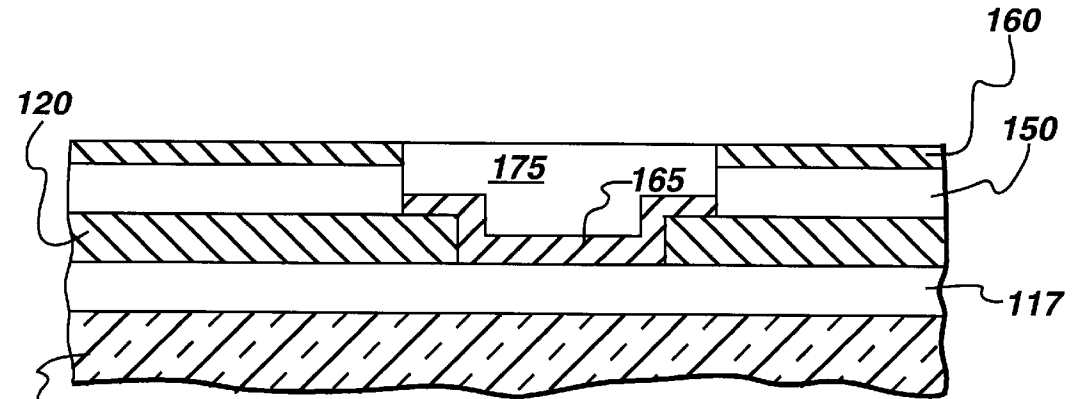
fig. 4

FIG. 4 is a cross-sectional view of the damaged imager array in which the conductive repair material has been exposed except for the repair area in accordance with the present invention.

Portions of second protective layer **170** are then removed so as to form a planarized intermediate surface **168** on array **100** in which conductive repair material layer **160** is exposed (that is, constitutes the upper surface of array **100** at this stage in the process) except for a repair area plug portion **175** disposed over repair area **145**. Formation of planarized intermediate surface **168** is accomplished by, for example, a planarized etching process such as oxygen plasma etching device, such as a parallel plate asher or the like. The etch is continued until the surface of conductive repair material **160** is exposed except in repair area **145**; protective plug **175** remains disposed over repair shunt **165**. At the completion of this step of the process, imager array **100** appears as is illustrated in FIG. 4.

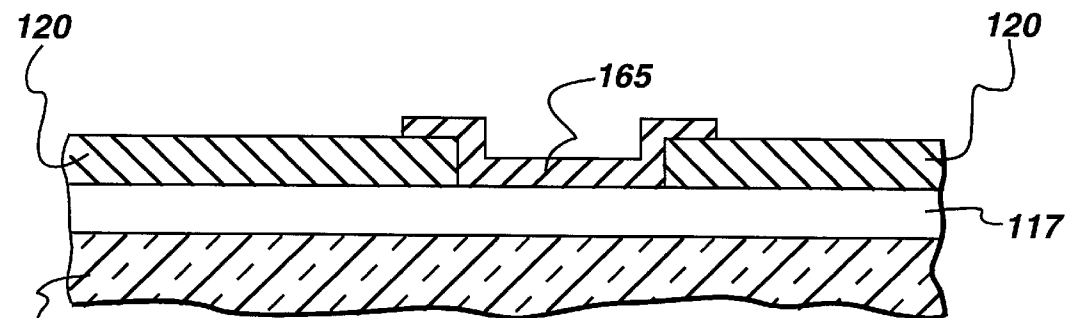
fig. 5

FIG. 5 is a cross-sectional view of an imager array after completion of the address line repair in accordance with the present invention.

To complete the repair process, remaining portions of first protective layer **150** and protective plug **175** are then removed from the array, for example in an oxygen plasma etching process as described above with respect to removal of portions of second protective layer **170**. The repaired array appears as illustrated in FIG. 5, with an operation data address line **120** having repair shunt **165**. At this point, tests can be performed to confirm the electrical integrity of the array (with additional repairs performed as necessary) and fabrication of array **100** can proceed with formation of photosensors, barrier layers, common electrode, and scintillator (not shown).
