(54) **Titre : TROUSSE DE REPARATION DE TUYAU DE RGE**
 (54) **Title: EGR PIPE REPAIR KIT**

An improved apparatus for repairing pipes and tubes, such as EGR pipes, is disclosed. The apparatus can be readily mounted to the pipe or tube via a flange that fits inside the pipe or tube and thus generally avoids the need to remove any adjacent components. The apparatus further provides holes or bushings that allow for the precise alignment of various repair tools.

EGR PIPE REPAIR KIT

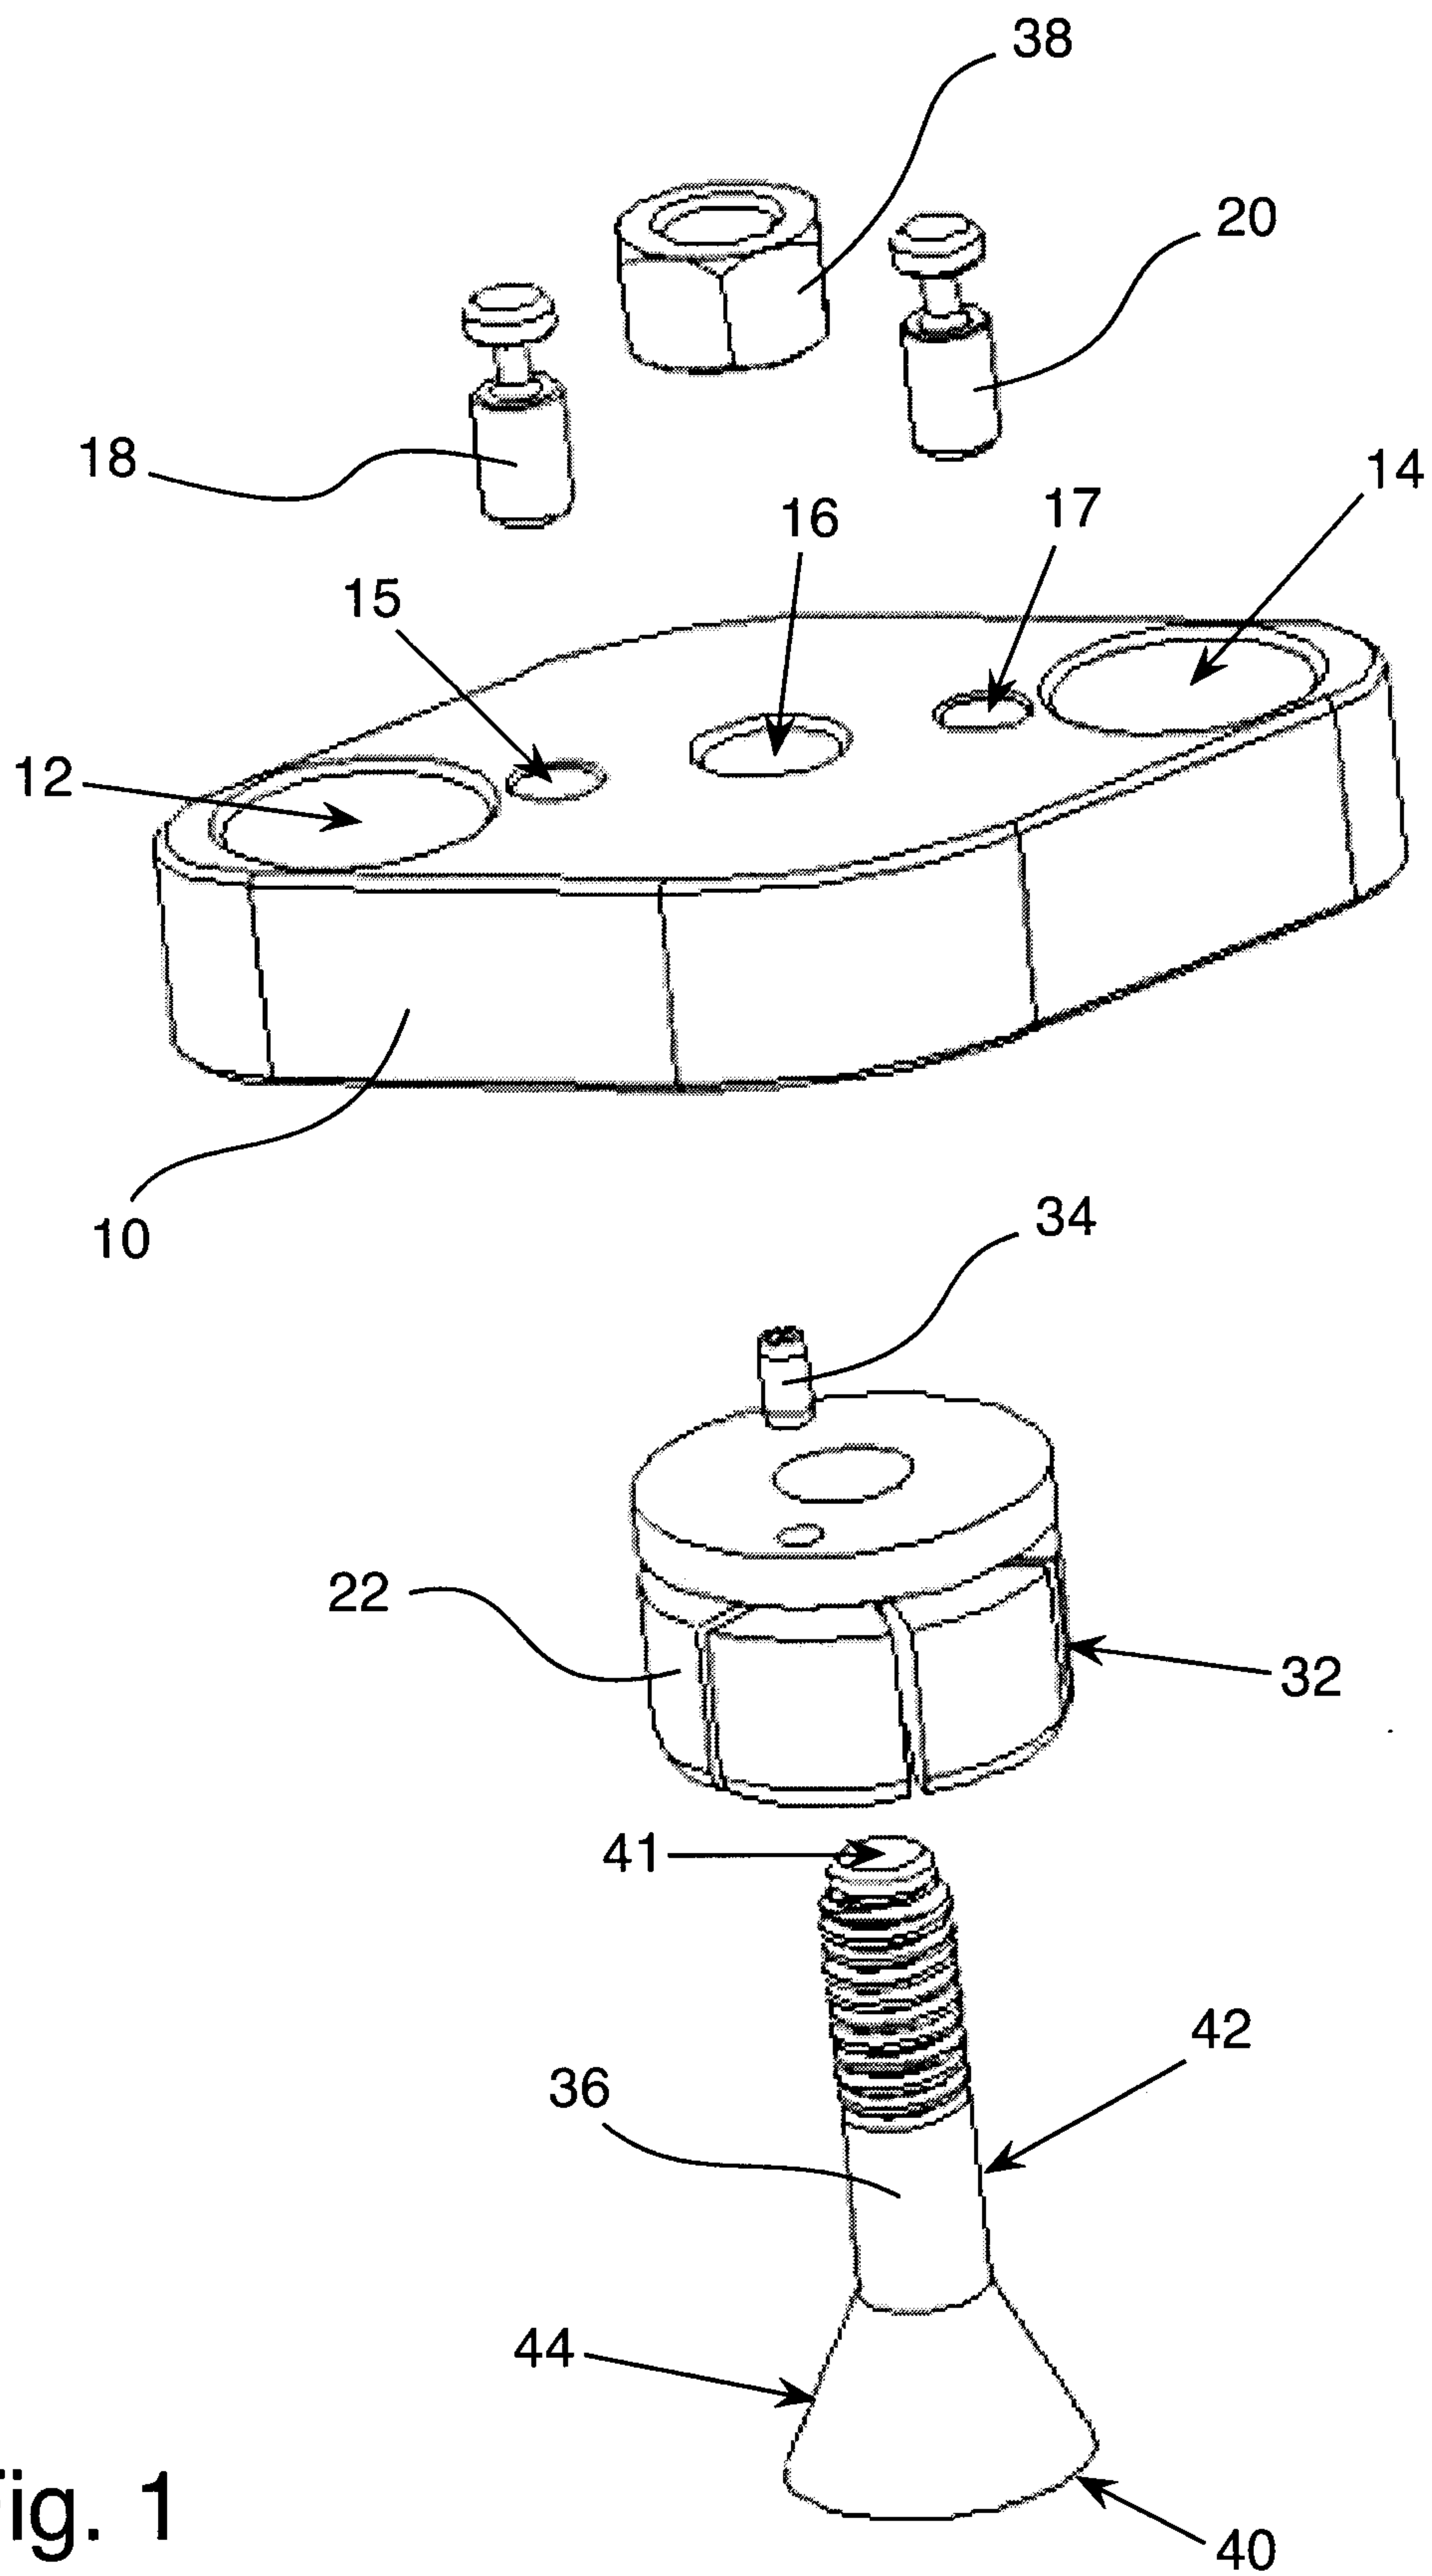
Fig. 1

- [14] Figure 1 is an exploded side view of one embodiment of the invention.
- [15] Figure 2 is a top view of one embodiment of the invention.
- [16] Figure 3 is a side view of one embodiment of the invention.
- [17] Figure 4 is a side view of a flange.
- [18] Figure 5 is a perspective view of a flange.
- [19] Figure 6 is a side view of an arbor.
- [20] Figure 7 is a side view of a pin.
- [21] Figure 8 is an exploded side view of another embodiment of the invention.
- [22] Figure 9 is a side view of another embodiment of the invention.
- [23] Figure 10 is a perspective view of another embodiment of the invention.
- [24] Figure 11 is an exploded side view of yet another embodiment of the invention.
- [25] Figure 12 is a perspective view of yet another embodiment of the invention.
- [26] Figure 13 is a side view of yet another embodiment of the invention.

[27] As shown in Figures 1–3, one embodiment of the invention consists of body 10 that is generally rhomboid in shape (with four curved vertices) and formed from a rigid material, such as type 6061 hard-coated aluminum, for example. Body 10 has two repair holes 12 and 14 oriented perpendicular to the top surface 11 of body 10. Body 10 has a long axis (defined by a line running between the vertices adjacent to repair holes 12 and 14) and a short axis (defined by a line running between the other two vertices and perpendicular to the long axis). At the center of body 10 (at the intersection of the long and short axes) is mounting hole 16. Body 10 is approximately 3.25” long along the long axis, 1.85” wide along the short axis, and 0.625” thick in the direction perpendicular to the plane defined by the long and short axes. While this embodiment has a body with a generally rhomboid shape, other body shapes (such as rectangular, square, or other geometric or non-geometric shapes) could be used and fall within the scope of the invention.

[29] As shown in Figures 1–3, mounting pins 18 and 20 are located between repair holes 12 and 14 and mounting hole 16. Pins 18 and 20 are also made from a rigid material, such as type 304 stainless steel, for example. Pins 18 and 20 extend outward perpendicularly from top

[31] As shown in Figures 1 and 3, threaded shaft or arbor 36 then slides through flange 22 and mounting hole 16 in body 10 and is secured by nut 38 on the opposite side of body 10 from flange 22. Arbor 36 is made from type 304 stainless steel, but other rigid materials could also be used. In order to prevent flange 22 from rotating relative to body 10, roll pin 34 is used. Roll pin 34 fits into holes in both bottom surface 13 of body 10 and flange 22 to prevent the rotation of flange 22 relative to body 10. As shown in Figure 6, threaded arbor 36 is approximately 1.8" long, with a diameter of approximately 0.875" at frustoconical end 40, which is nearest to flange 22 when engaged, and a diameter of approximately 0.37" along shaft 42 towards threaded end 41. Arbor 36 also has a frustoconical portion 44, whose angle matches slant angle 26 of inside portion 24 of flange 22.
