(10) **Patent No.:** **US 9,415,746 B1**  
(45) **Date of Patent:** **Aug. 16, 2016**

(54) **VEHICLE SAFETY BELT BYPASS WARNING SYSTEM**

(71) Applicant: **INTERNATIONAL BUSINESS MACHINES CORPORATION**,  
Armonk, NY (US)

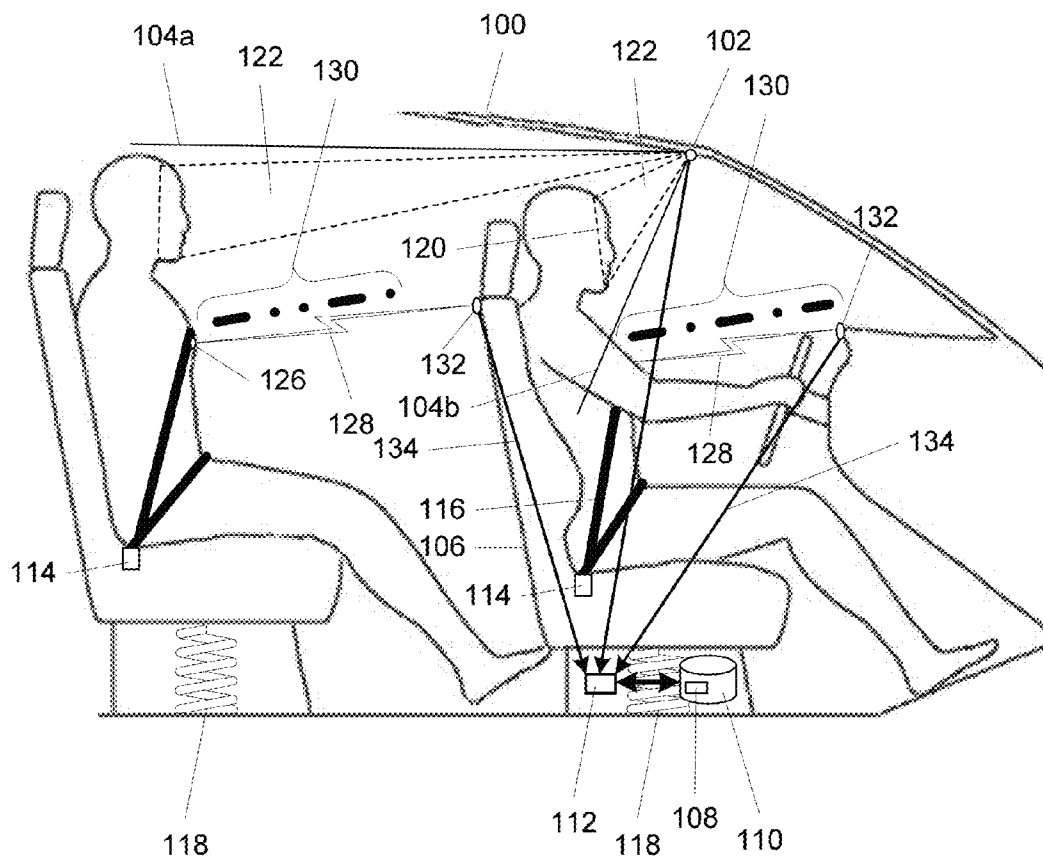
FIG. 1 illustrates, a simplified cutaway view of a portion of the interior of a vehicle incorporating one example implementation of a safety belt bypass warning system as described herein;

FIG. 1 illustrates, a simplified cutaway view of a portion of the interior of a vehicle 100 incorporating one example implementation of a safety belt bypass warning system as described herein.

As shown in FIG. 1, the system includes at least one video camera 102 located within the vehicle, for example, in the dashboard, binnacle, headliner, windshield frame, center console, etc. such that it has a field of view (between by the extreme lines 104a, 104b) encompassing the upper portion of at least two seats 106 within the vehicle 100.

Referring now to FIG. **1** and FIG. **2** in combination, the processor **112** running the face detection software **108** searches for faces in the vehicle within the field of view boundaries **104a**, **104b** of the video camera **102**. The face detection software **108** program is a computer program that can detect a human face and differentiate it from the face of, for example, a dog. The program is implemented as a less sophisticated version of facial recognition software because it need only recognize the existence of a human face, as opposed to being able to discern human features at a resolution sufficient to match them with other images to detect the same person.

As shown, using this approach, human faces **120** have been detected for three of the seats **106** within parts **122** of the field of view. In contrast, despite a heavy dog **124** being present behind the driver **126**, since the face detection software **108** did not detect a human face, only the driver's seat, front passenger seat and rear seat behind the front passenger seat are each considered an "occupied seat" for purposes of the safety belt bypass warning system as described herein.

Returning now to FIG. **1**, the safety belt bypass warning system also includes at least one, and possibly more, IR receiver(s) **132** positioned within the vehicle **100**, for example, in one or more of the dashboard, binnacle, rearview mirror or its mount, the sun visor mountings, A pillar, B-pillar, C-pillar, headliner, center console, etc. and directed towards at least one seat **106** such that the coded IR signal from at least one IR emitter output **126** of an occupied seat **106** can be received. The IR receiver(s) **132** are each enabled when an IR emitter output **126** is enabled.

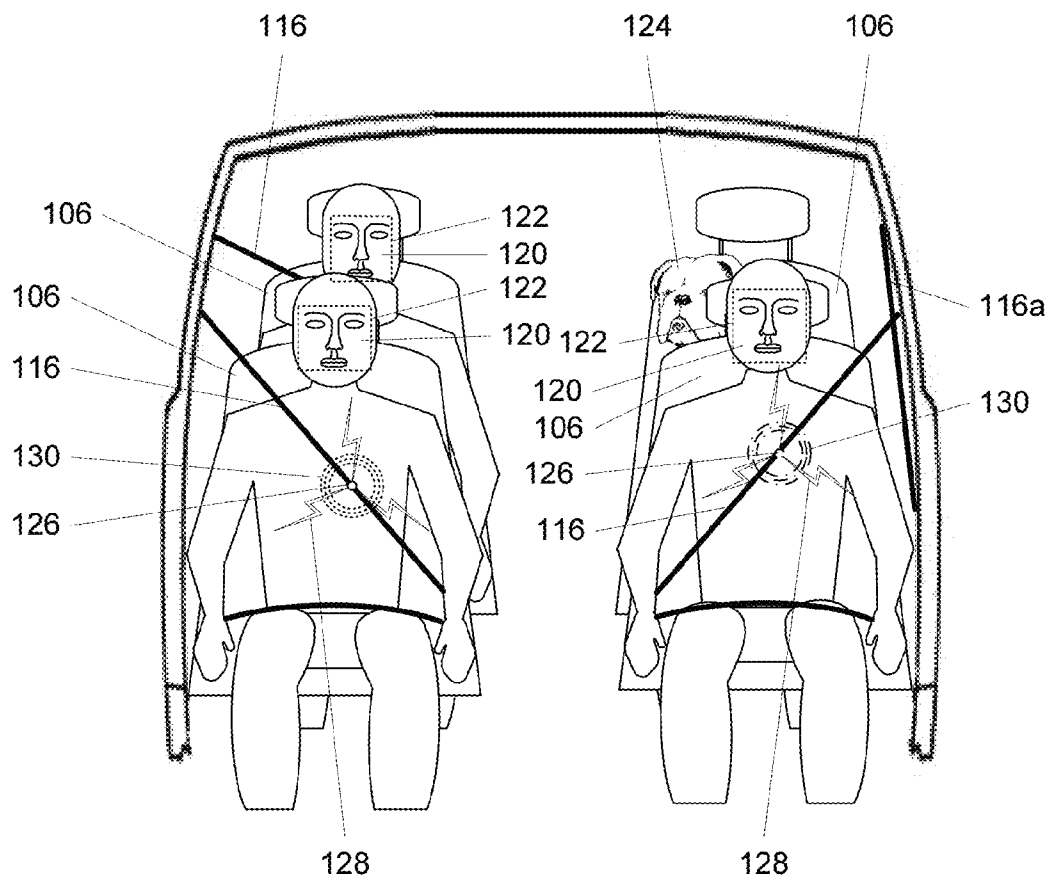
FIG. 2 illustrates, in simplified form, a cutaway view of a vehicle, viewed from the front of the vehicle;

FIG. **2** illustrates, in simplified form, a cutaway view of a vehicle **100**, viewed from the front of the vehicle **100**. As shown in FIG. **2**, the vehicle has four occupants.

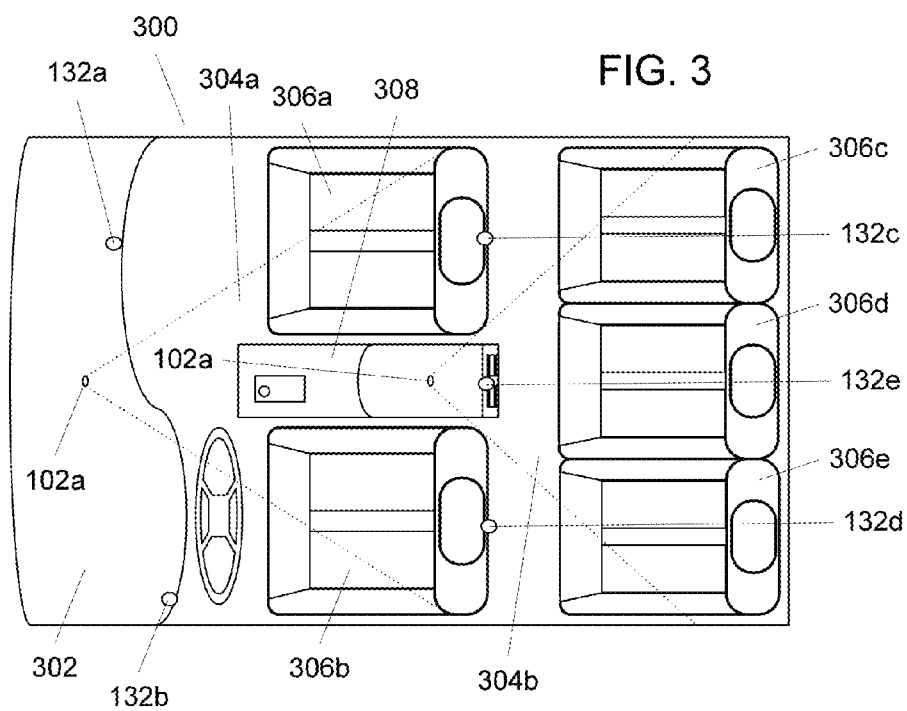
FIG. 3 illustrates, in simplified form, an overhead view of a vehicle interior showing one example placement for video camera(s) and IR receiver(s) as described herein;

FIG. 3 illustrates, in simplified form, an overhead view of a vehicle interior 300 showing one example placement for video camera(s) 102 and IR receiver(s) 132 as described herein. As shown, in FIG. 3, a video camera 102a near the headliner (not shown) above the dashboard 302 has a field of view 304a (between the dotted lines) encompassing the two front seats 306a, 306b and the center seat 306d in the rear. The video camera 102b near the headliner (not shown) above the center console 308, or in the center console 308, has a field of view 304b (between the dotted lines) encompassing all three back seats 306c, 306d, 306e.

There are also two IR receivers 132a, 132b on the dashboard 302, two IR receivers 132c, 132d in the back of the head restraints of the front seats 306a, 306b, and one in the center console 308, each directed at an individual corresponding seat such that each will receive coded IR light pulses from one safety belt's IR emitter output(s) 126.

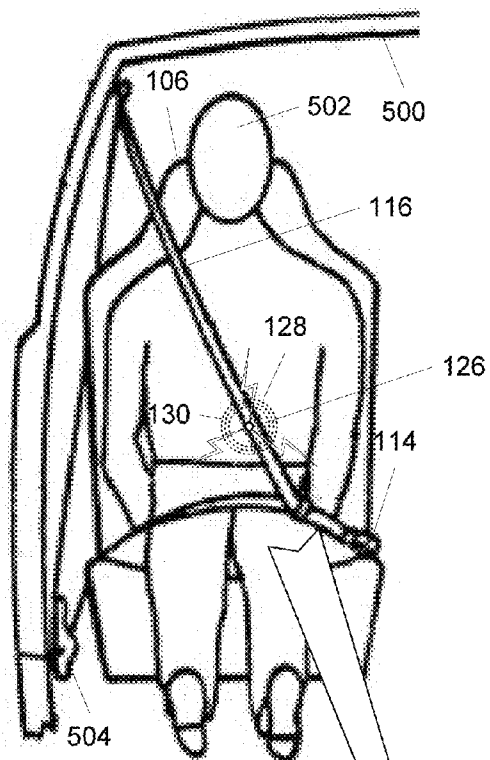
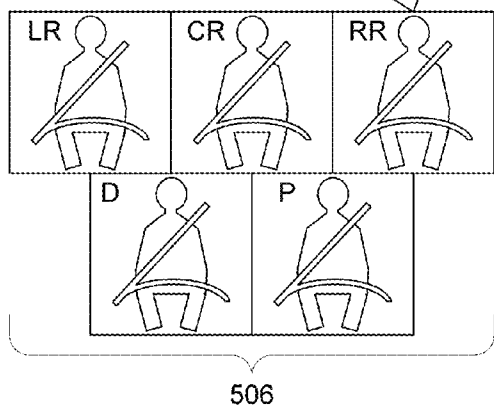
FIG. 6

In contrast, as shown in FIG. 6, the vehicle's 500 occupant 502 is now seated in the same seat 106 of the vehicle 500 but latched the safety belt before sitting so that the safety belt engagement sensor circuit 114 indicates that the occupant 502 is wearing their safety belt 116. As a result, although the IR emitter output 126 is outputting its coded 128 light pulses 130, since it is behind and blocked by the occupant 502, the corresponding IR receiver in the vehicle 500 cannot receive them. As a result, the processor (not shown) does not receive the coded electrical signal for this occupied seat, so it triggers a warning indication 600 on the corresponding dashboard warning indicators 506 to indicate that the safety belt for that particular seat has been bypassed.
