(11) (21) (C) **2,232,178**  
(22) 1998/03/13  
(43) 1999/01/12  
(45) 1999/07/27

(73) DAMOTECH INC., CA

(54) **PALLET RACK REPAIR SYSTEM**

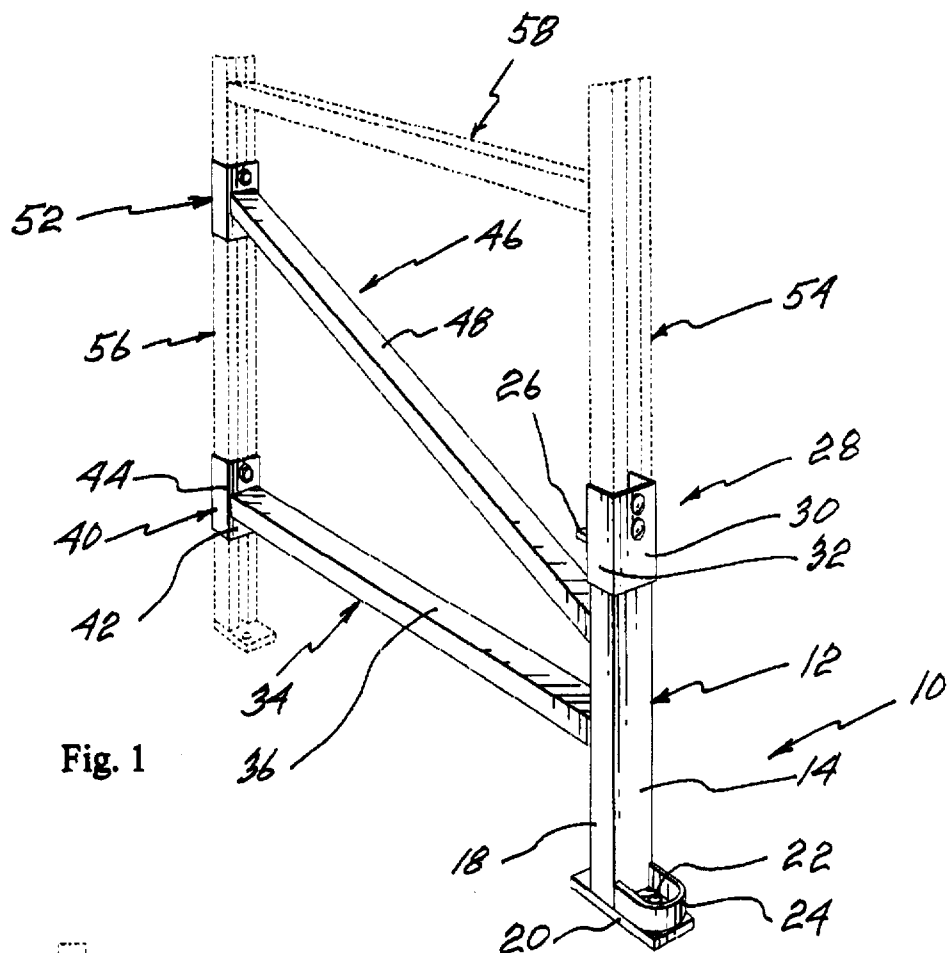
Figure 1 is a perspective view of a repair system according to the present invention;

Referring to the drawings in greater detail, and by reference characters thereto, there is illustrated in Figure 1 a repair assembly which is generally designated by reference numeral 10.

Repair assembly 10 includes a tubular post 12, having a front wall 14, an opposed side wall 16, and a pair of side walls, only one side wall 18 being shown.

Located at the bottom of tubular post 12 is a floor bearing plate 20. Floor bearing plate 20 extends beyond both

front wall 14 and back wall 16; the portion extending past front wall 14 has an aperture 22 therein to receive a fastening member such as a bolt which will be secured to the floor. A C-shaped bolt guard 24 extends substantially about the periphery of the portion extending beyond front wall 14 to protect the bolt from damage. Similarly, an aperture is provided in the portion of floor bearing plate 20 extending past back wall 16.

At the upper end of tubular post 12 there is a horizontal plate 26 welded thereto. Also surrounding horizontal plate 26 and the upper portion of tubular post 12 is a C-shaped connector 28 having a front wall 30, a portion of which lies in juxtaposition with front wall 14 of tubular post 12, the remaining portion extending upwardly to receive the existing post of the pallet rack as will be discussed in greater detail hereinbelow. Similarly, side wall 32 lies in juxtaposition to side wall 18 of tubular post 12.

A horizontal brace 34 extends outwardly from back wall 16. Horizontal brace 34 has an upper wall 36 and a bottom wall 38 which are substantially the same as back wall 16 to thereby provide a very strong connection. Similarly, a diagonal brace 46 extends diagonally outwardly and upwardly from back wall 16. In this respect, it will be noted that diagonal brace 46 is located a distance above horizontal brace 34 and extends at an angle of approximately 26 degrees. Diagonal brace 46 includes a top wall 48 and a

A C-shaped connector generally designated by reference numeral 40 is located at the distal end of horizontal beam 34 and includes a front wall 42 and a pair of side walls, only one side wall 44 being shown. Similarly, a C-shaped connector 52 is provided at the distal end of diagonal brace 46.

Repair assembly 10, in Figures 1 and 2, is shown after having replaced a portion of a damaged post 54 as used in a conventional pallet rack arrangement. In the pallet rack arrangement there is also provided a rear post 56 and an upper horizontal brace 58.

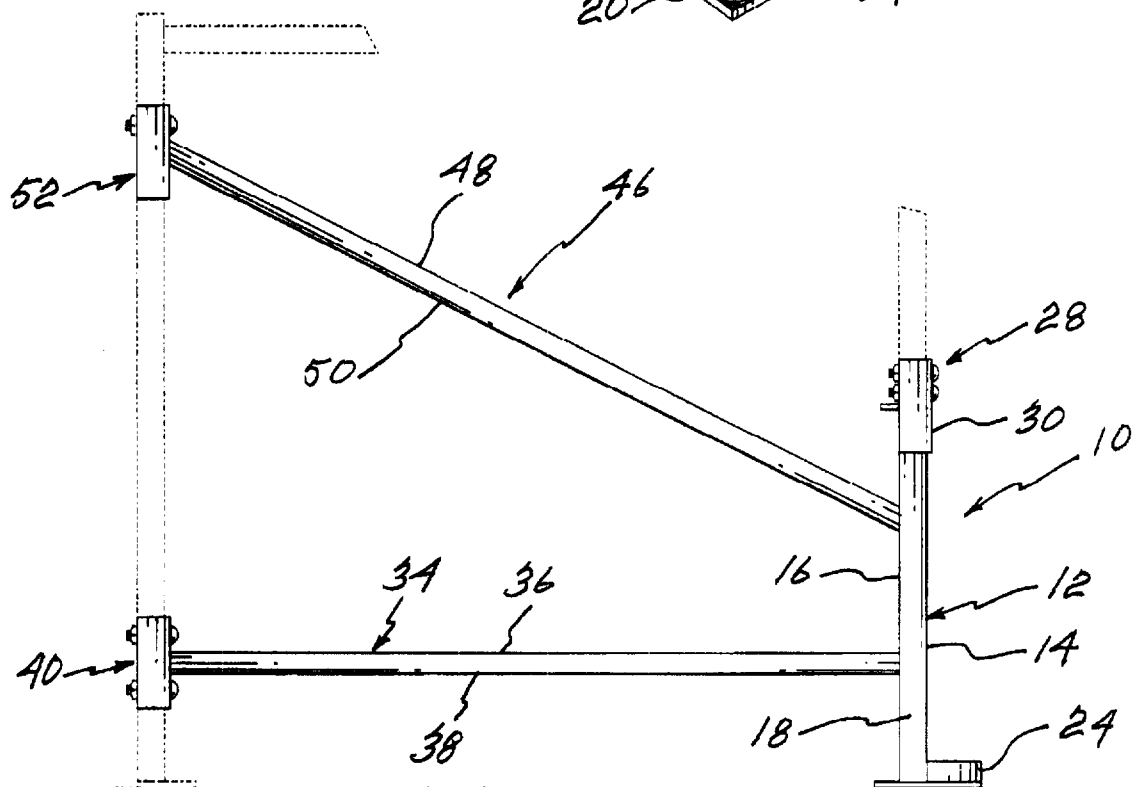
Figure 2 is a side elevational view thereof;

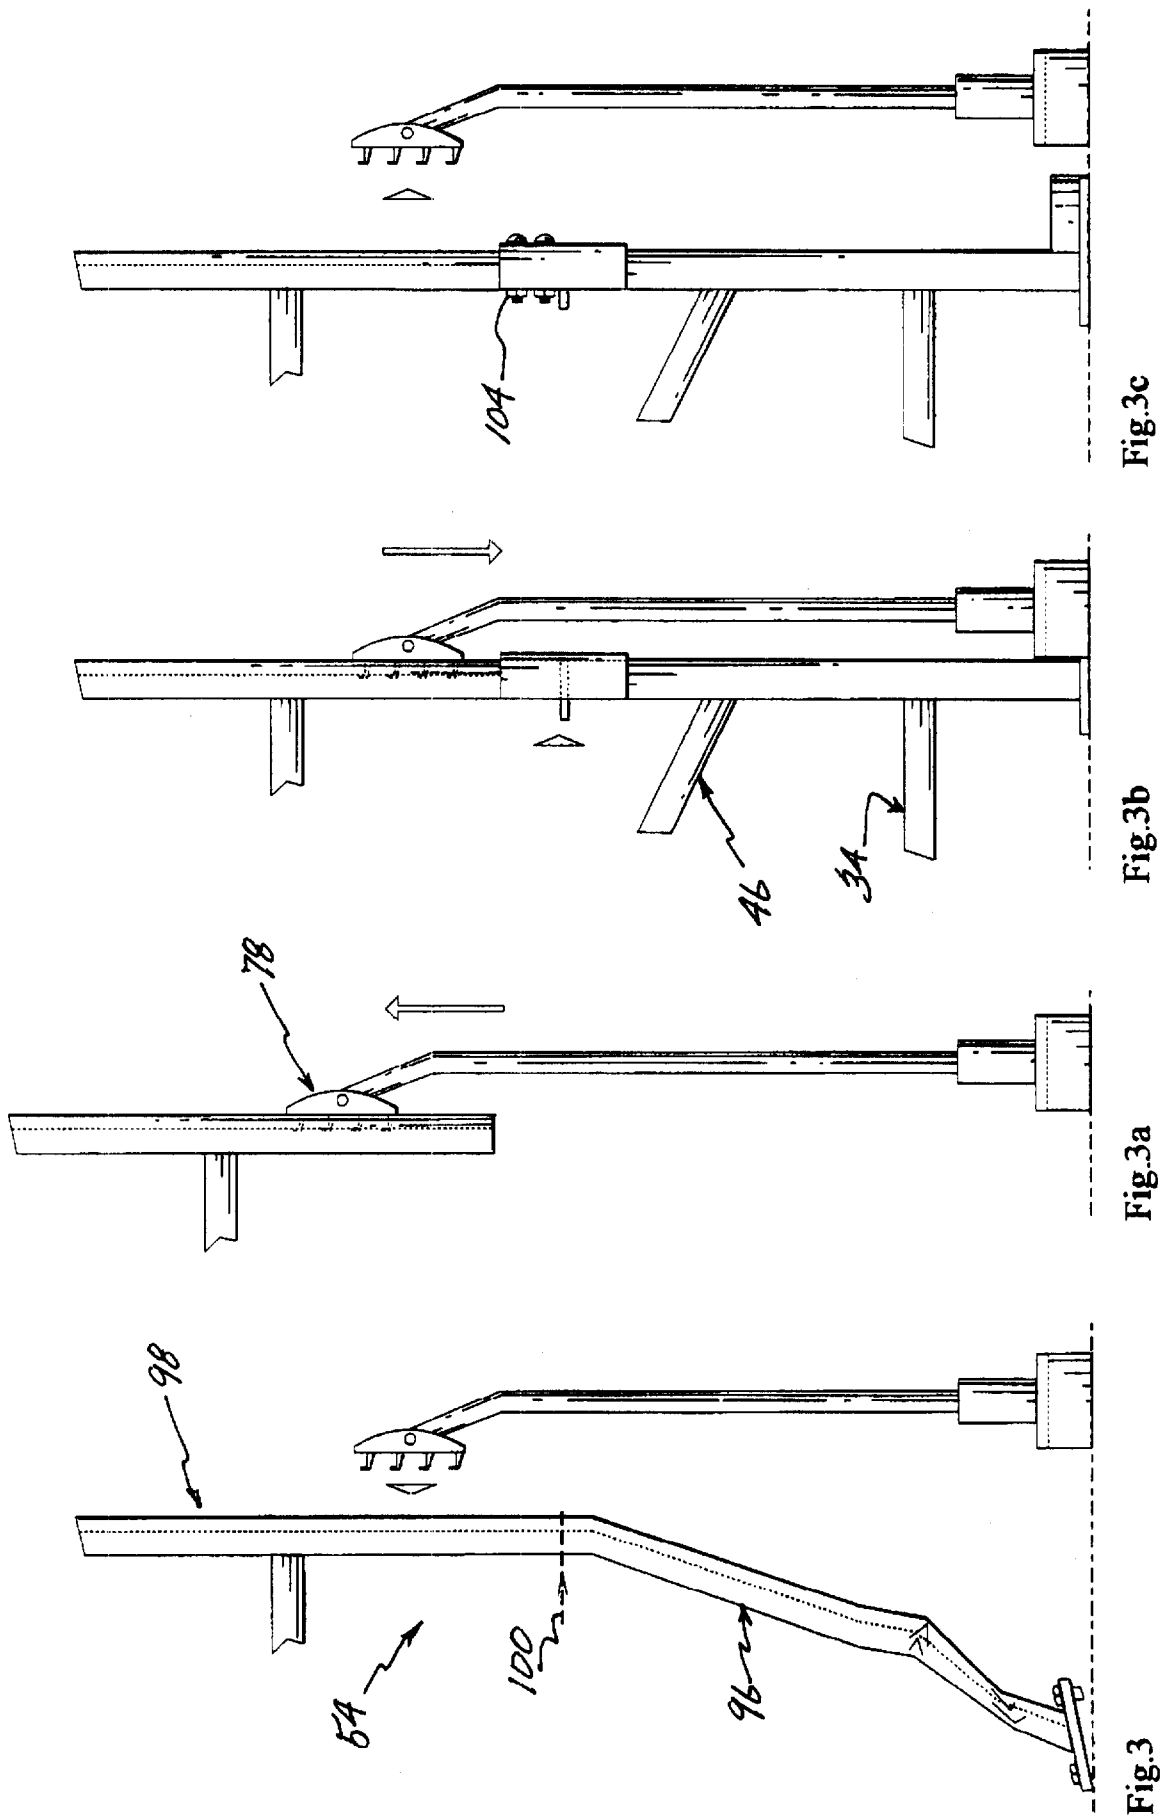
Figures 3, 3a, 3b and 3c illustrate the replacement of a damaged post of a pallet rack;

Referring to Figures 3, 3a, 3b and 3c, there is illustrated front post 54 which has been hit by a lift truck and has a lower damaged portion 96 and an upper undamaged portion 98 (horizontal and diagonal braces not shown). Initially, lifting mechanism 68 is placed into position whereby members 82 extending from front wall 80 will engage with upper undamaged portion 98 through apertures 66. Hydraulic jack 74 is then operated to lift post 54 to the extent necessary to remove any weight bearing on lower damaged portion 96. Lower damaged portion 96 is then removed as indicated by cut line 100.

Subsequently, repair assembly 10 is moved into position as shown in Figure 3b and hydraulic jack 74 is then lowered to permit the bottom end of upper undamaged portion 98 to rest on horizontal plate 86. A rear C-shaped reinforcing plate 106 is placed inwardly of channel 64 and

bolts 104 are then secured through C-shaped connector 28. A similar procedure is followed with respect to connectors 40 and 52 located at the distal ends of horizontal brace 34 and diagonal brace 46 respectively.

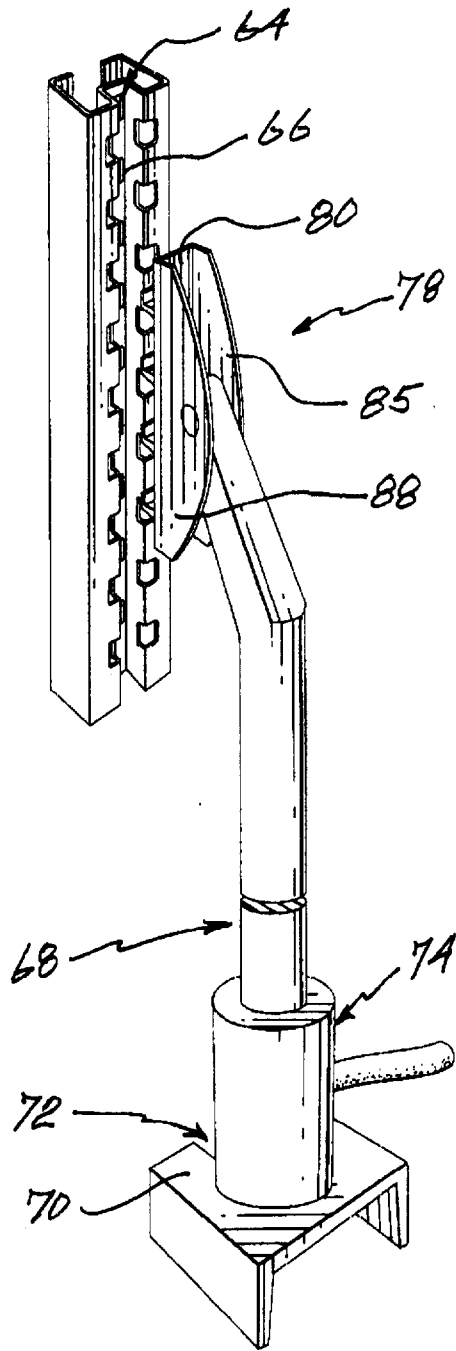
Fig. 4

Figures 4 is a perspective view of the equipment utilized during replacement of the damaged post of the pallet rack;

Each of posts 54 and 56, and as may be best seen in Figure 4, is of a formed steel having an inwardly extending channel 64 with apertures 66 located therein. This is similar to the arrangement shown, for example, in U.S. Patent 4,064,996 to Shillum.

There is provided a lifting mechanism generally designated by reference numeral 68 and which includes a base 70 having a recess 72 formed therein to permit placement of the lifting mechanism proximate to front post 54. Mounted on base 70 is a hydraulic jack 74 having an arm 76 extending upwardly therefrom. At the distal end of arm 76 there is provided a post engaging attachment

generally designated by reference numeral 78. Post engaging attachment 78 will be specific to the type of post being repaired and thus a number of different attachments may be employed.

Post engaging attachment 78 includes a front wall 80 from which a plurality of members 82 extend. Each member 82 has a horizontal portion 84 which is substantially perpendicular to front wall 80 and an upwardly extending portion 86. A pair of side walls 88 extend rearwardly from front wall 80, each side wall 88 having an aperture 90 formed therein to receive a pin 92 for attachment to arm 76.

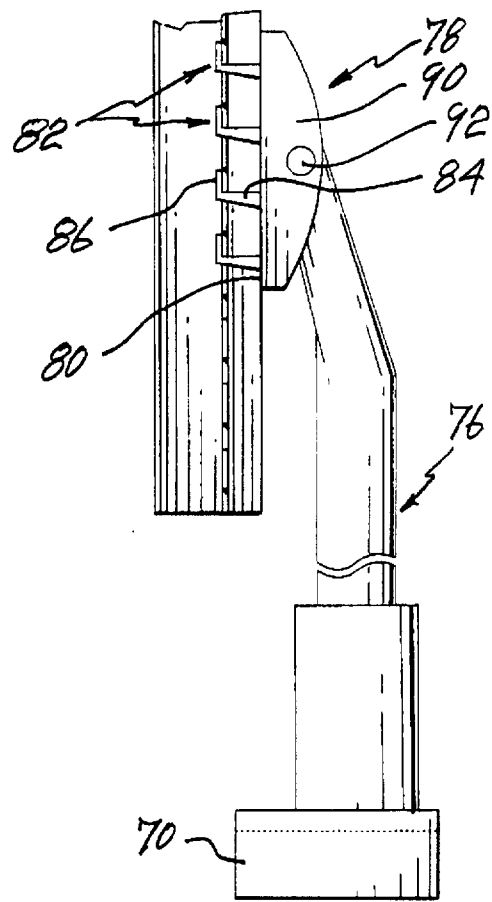
Fig. 5

Figures 5 is a side view illustrating engagement of the equipment with the damaged post;
