(12) **United States Patent**
Farhid

(10) **Patent No.:** **US 9,989,418 B2**
(45) **Date of Patent:** **Jun. 5, 2018**

(54) **DISC CAVITY THERMOCOUPLE UPGRADE**

- (71) Applicant: **Siemens Energy, Inc.**, Orlando, FL (US)
 (72) Inventor: **Seyed N. Farhid**, Orlando, FL (US)
 (73) Assignee: **SIEMENS ENERGY, INC.**, Orlando, FL (US)
 (*) Notice: Subject to any disclaimer, the term of this patent is extended or adjusted under 35 U.S.C. 154(b) by 311 days.

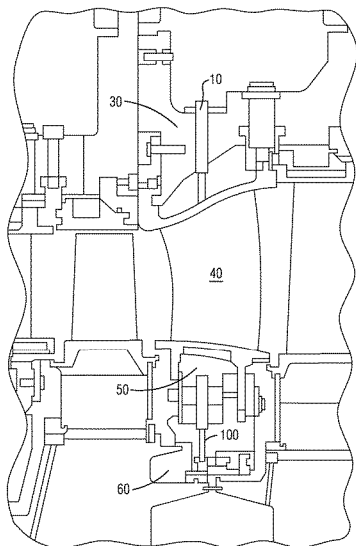
An arrangement to prevent thermocouple chafing with a guide tube within a rotor disc cavity during gas turbine operation is provided. The arrangement includes an interstage seal housing, a guide tube, and a thermocouple including a tip portion, an elongated portion, a head portion, and an antichafing strip. The guide tube is disposed in a radially extending bore of the interstage seal housing. The tip portion extends radially inward into the rotor disc cavity, the elongated portion is disposed at least partially within the guide tube, and the head portion is disposed radially outward of the casing. The tip portion includes a temperature sensing element which measures the temperature of the rotor disc cavity. The antichafing strip is disposed along the length of the elongated portion so that it is at least partially disposed within the guide tube. A method to prevent premature gas turbine shutdown due to thermocouple failure is also provided.

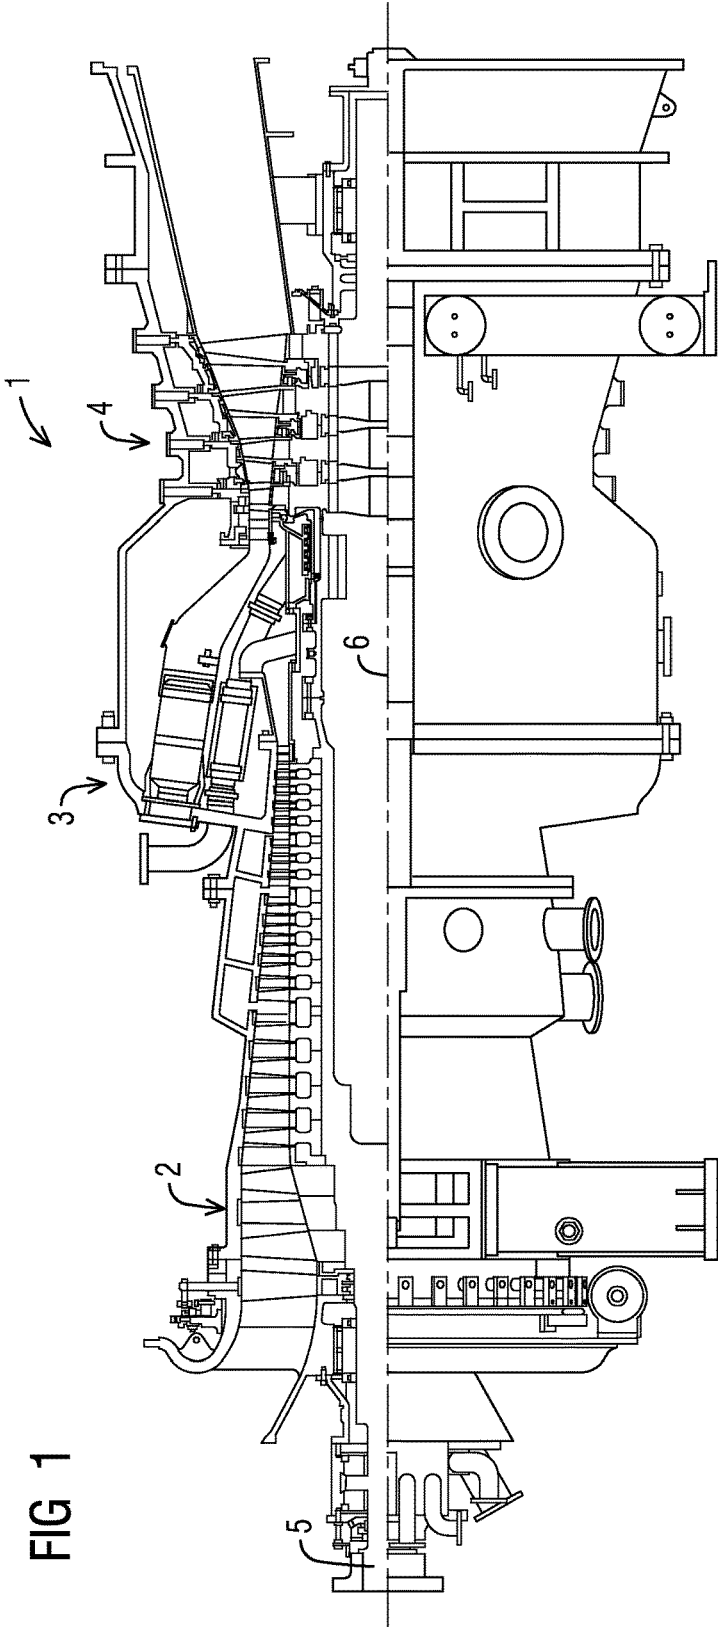
FIG 1

FIG. 1 . . . illustrates a longitudinal view of gas turbine engine,

FIG. 1 illustrates a gas turbine engine (1) including a compressor section (2), an intermediate section (3), and a turbine section (4). The turbine section (4) usually includes at least 4 stages of blades and vanes. A rotor (5) is arranged along the longitudinal centerline (6) of the gas turbine (1).

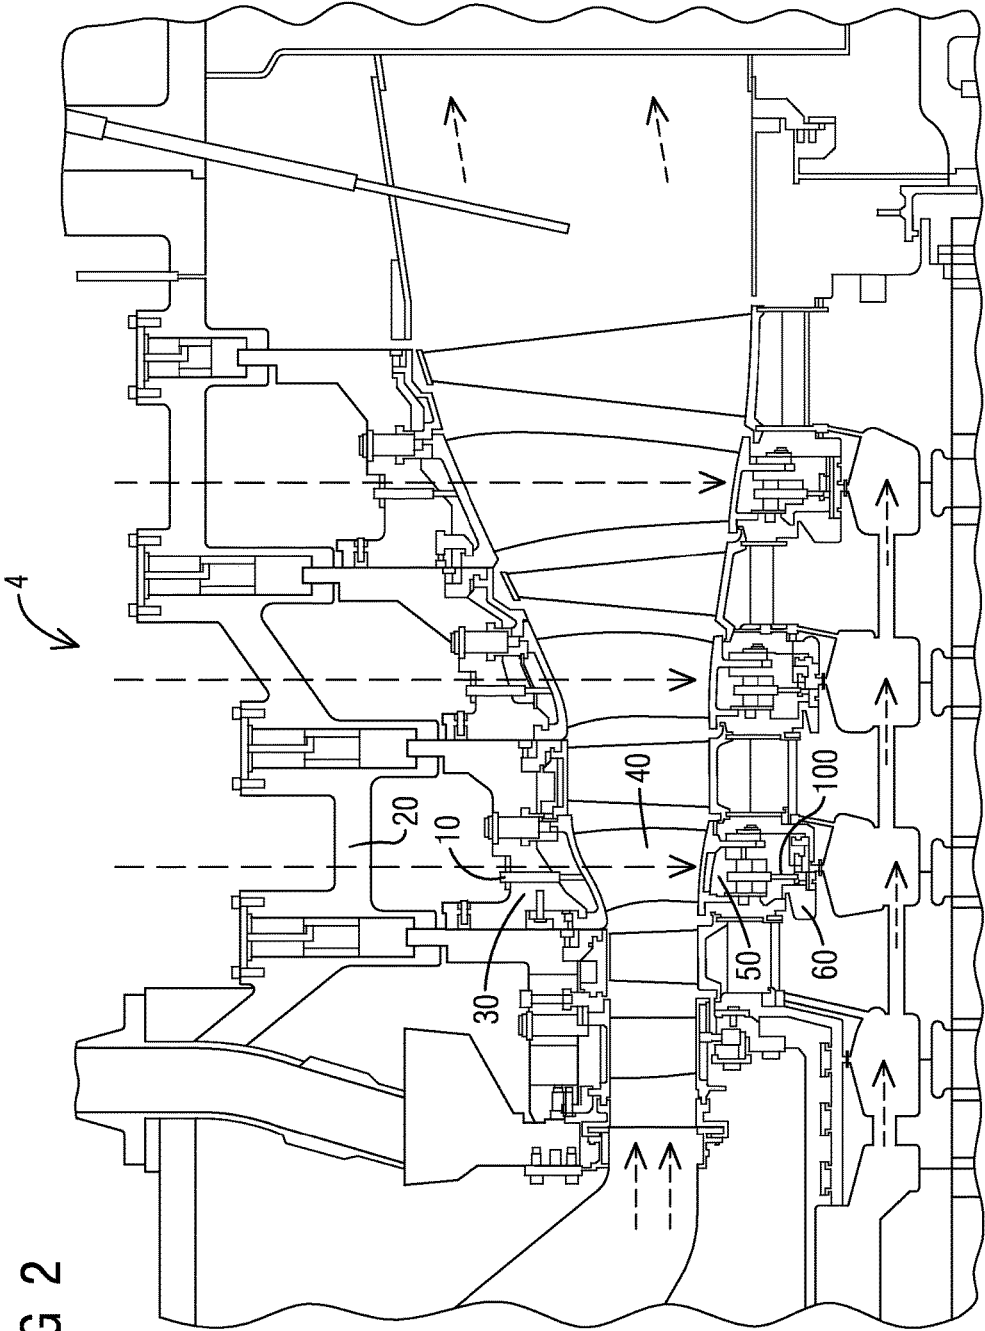
FIG 3

FIG. 3 . . . illustrates a portion of the turbine section of a gas turbine engine, and

FIG. 3 shows a zoomed in portion of FIG. 2 illustrating the vane (40) and the interstage seal housing (50) through

which the thermocouple (10) extends. A tip portion of the thermocouple (10) which includes a temperature sensing element (100) extends into the rotor disc cavity (60). The temperature sensing element (100) detects the temperature of the rotor disc cavity (60) which may be used as an indicator of the inner operation of the gas turbine engine (1).

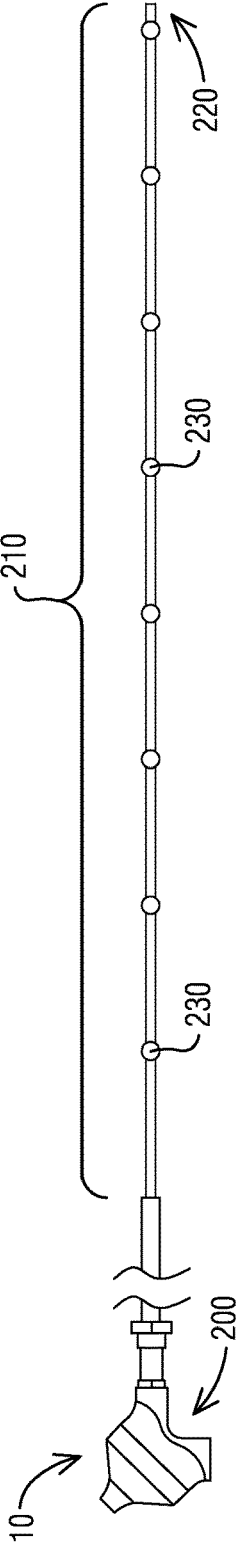
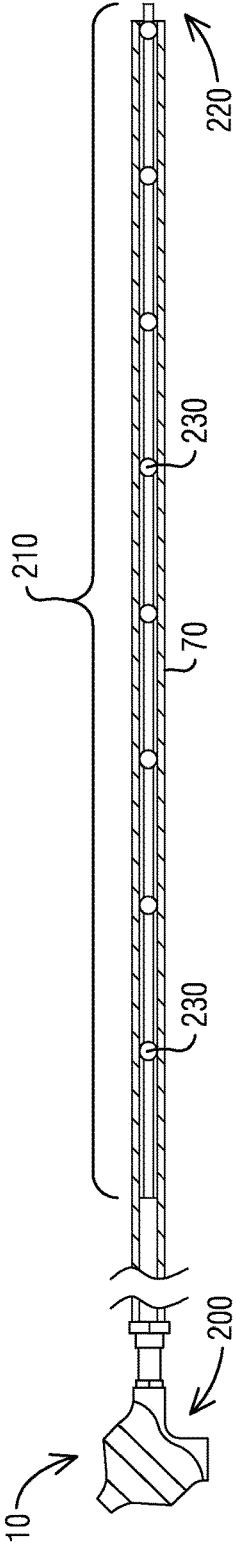
FIG 5

FIG. 5 . . . illustrates a longitudinal view of a thermocouple within a guide tube.

FIG. 5 illustrates a thermocouple (10) within a guide tube (70). As illustrated, the antichafing strips (230) maintain contact with the guide tubes (70) such that the tubular elongated portion (210) does not contact the guide tube (70). The antichafing strips (230) also assist in centering the elongated portion (210) within each guide tube (70).

The antichafing strips (230) each include a hole through which the elongated portion (210) extends. Each antichafing strip (230) may be attached to the elongated portion (210) by welding, however, other methods of attachment may also be possible. The material of the antichafing strips (230) may all be the same. The shape of antichafing strips (230) include spherical and/or cylindrical, however, other shapes may be possible such that the antichafing strip (230) maintains contact with the guide tube (70) during turbine operation.

In the illustrated embodiment of FIG. 5, the thermocouple (10) is disposed within a plurality of guide tubes (70) such that the antichafing strips (230) maintain contact with the guide tube (70) while the gas turbine engine (1) is operating. The plurality of antichafing strips (230) deteriorate due to friction with the guide tubes (70) during normal operation of the gas turbine engine (1). The friction is created when the antichafing strips (230) rub or chafe against the guide tube (70) caused by repeated vibrations within the turbine section (4) of the gas turbine engine (1). However, typically this deterioration occurs slowly and the antichafing strip (230) will continue to maintain contact with the guide tube (70) until at least the gas turbine engine is shutdown for routine maintenance. At this time, the antichafing strips (230) on the thermocouples (10) or the thermocouples (10) including antichafing strips (230) may be replaced.
