(10) **Patent No.:** **US 11,524,799 B2**  
(45) **Date of Patent:** **Dec. 13, 2022**

(54) **AEROSPACE-GRADE SENSOR REPLACEMENT METHOD**

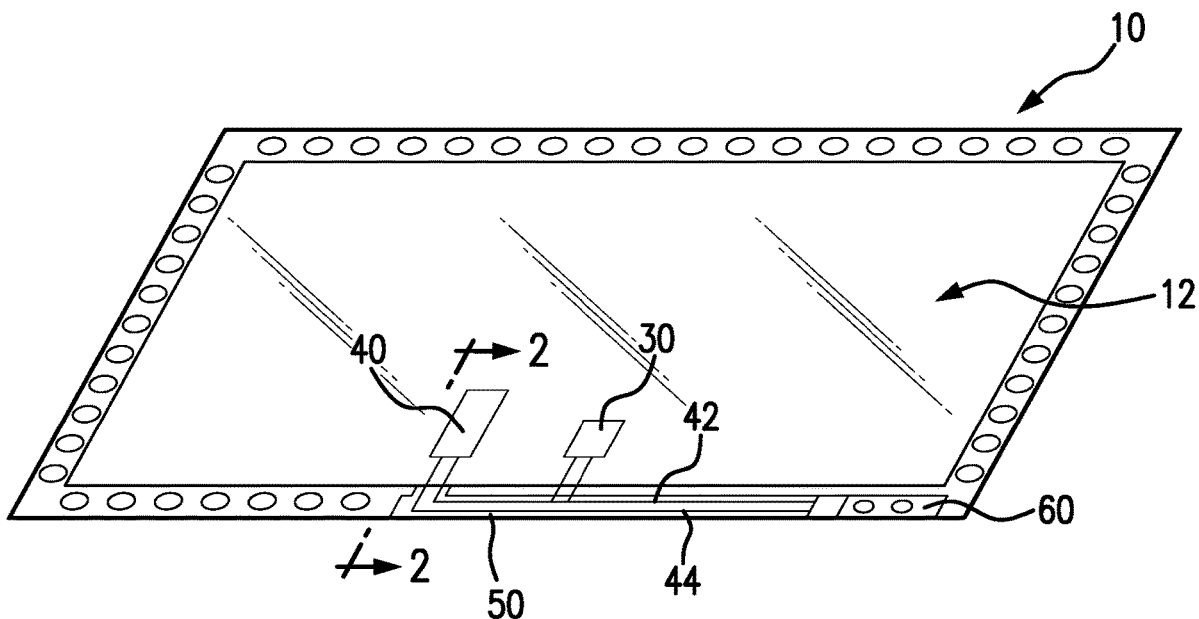
FIG. 2 is a partial cross-sectional view of the aircraft window laminate showing the position of the original OEM sensor and a replacement sensor installed within the laminate in accordance with the method of the invention; and

FIG. 3 is side elevational view of a replacement sensor for use in conjunction with the method of the present invention.

The electrical sensor repair method of the invention comprises steps for installing a new heat sensor **40** in substitution for the original OEM heat sensor **30**. The steps of the method of the present invention are as follows:

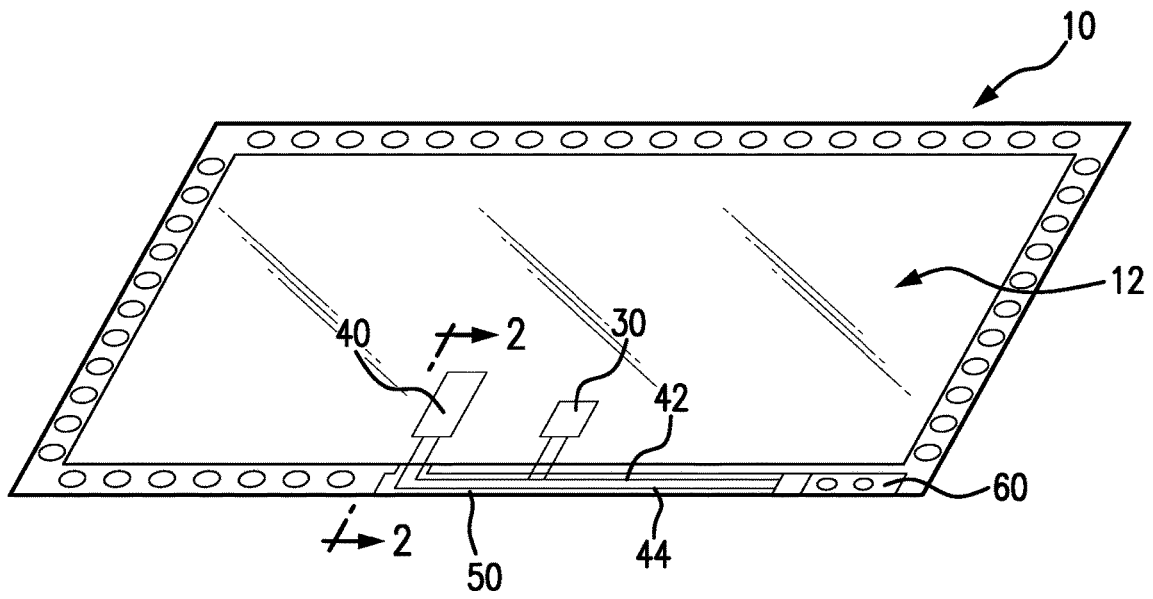
FIG. 1 is a perspective view of an aircraft window showing electrical sensors positioned therein in relation to a bus bar;

Referring to FIGS. 1 and 2, a typical aircraft window 10 comprises a transparent laminate structure 12 having several glass and/or acrylic plies 14 that are adhered together by means of interposed polyvinyl adhesive plies 16. At least one of these plies 16 and preferably the ply closest to the outermost glass/acrylic ply 14 of the window laminate structure, is structured to be electrically resistive such that when electrical energy is applied thereto, the outer glass/acrylic ply 14 providing the outer window surface is heated to a temperature that is sufficient to prevent ice formation about the entire exterior surface of the aircraft window 10.

A seal member 20 is positioned about and overlaps the peripheral edge of the laminate 12. A pull of opposing frame members 22 and 24 are positioned about opposing sides of the seal member 20 in order to provide rigidity thereto.
