(12) **United States Patent**
Savitski

(54) **NON-DESTRUCTIVE BUTT WELD INSPECTION METHOD**

(73) Assignee: **Edison Welding Institute, Inc.**, Columbus, OH (US)

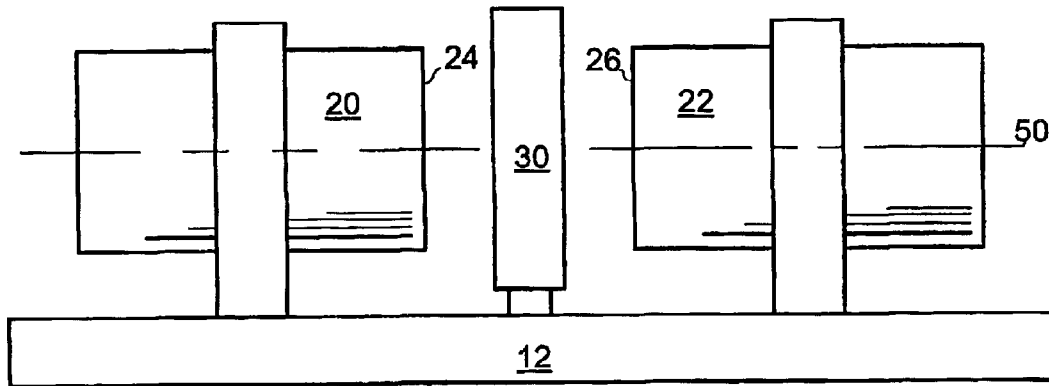
Fig. 1

FIG. 1 is a plan view of two pipe sections placed in a axial aligning clamping device with a hot plate between the ends of the pipe sections.

In forming a typical butt weld as shown initially in FIGS. 1-2, sections 20, 22 of a thermo-plastic material such as poly-ethylene pipe are placed in a clamping device 12 and aligned with each other as noted by the common longitudinal center axis 50. The ends 24, 26 are planed until the ends are smooth and parallel. The ends 24, 26 are then brought in contact with a heated hot plate 30 (FIG. 2) until a uniform bead 32, 34 becomes visible around the perimeter of both ends 24, 26. The ends 24, 26 are retracted from the hot plate 30 which is removed. As seen in FIG. 3, the ends 24, 26 are quickly brought together with pressure to form a weld at the interface of the ends 24, 26 of each section 20, 22, respectively. Some of the molten thermoplastic material oozes from the interface of the ends 24, 26 of the two sections 20, 22 to form a weld bead 42. FIG. 4 is a right end view of FIG. 3 showing the weld bead 42. FIG. 5 is a cross section that illustrates the small weld bead 46 that is formed on the interior surface of the joined pipes 20, 22 as well as the weld zone region 44 in which the molten plastic from each section 20, 22 are thoroughly intermixed and fused to each other.

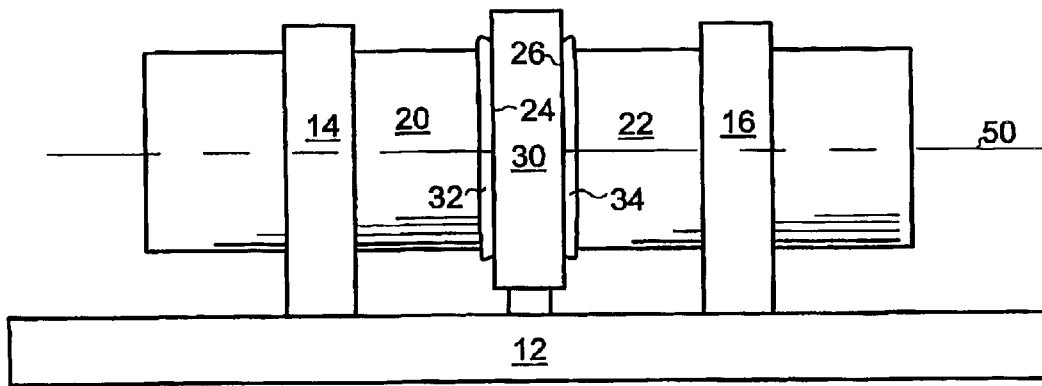
Fig. 2

FIG. 2 is a plan view of the two pipe sections shown in FIG. 1 in which the ends of the pipe sections have been brought in contact with the hot plate and heated sufficiently to melt the end of the pipe sections.

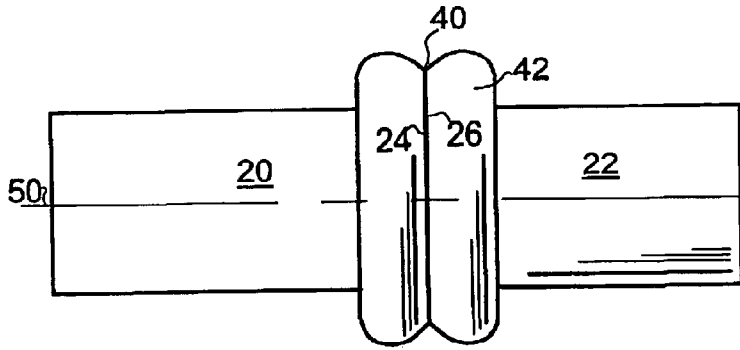
Fig. 3

FIG. 3 is a plan view of the resulting butt weld of the two pipe sections shown in FIG. 2 after the hot plate has been removed and the ends brought in contact with each other under pressure.

As shown especially in FIGS. 3 and 6, to practice the method of the current invention, the exterior weld bead 42 is removed, typically by cutting with a suitable cutting tool. At this point, the exterior surface of the joint is perfectly smooth and it is impossible to differentiate a good joint from a defective joint. After the exterior weld bead 42 has been completely removed, the weld zone region 44 is heated with a convenient heating device to a temperature sufficient to render visible the bonding between the sections 20, 22 of plastic material. After this secondary heating, the weld zone region 44 is visibly inspected and any weld exhibiting a

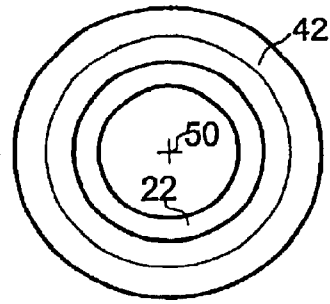
Fig. 4

FIG. 4 is a right end view of the butt weld joint shown in FIG. 3.

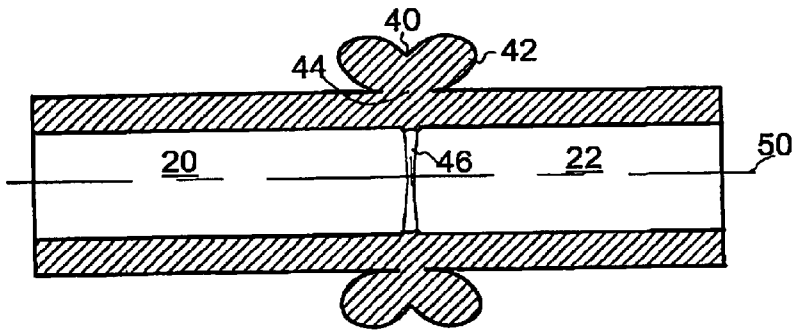
Fig. 5

FIG. 5 is a cross-sectional view through the longitudinal axis of the butt weld joint of FIG. 3 illustrating the uniform intermixing of the ends of the two pipe sections in the weld zone region throughout the thickness of the pipe when the joint is formed under optimal conditions.

bond line 40 is rejected. FIG. 6 illustrates a heated weld zone region 44 in which the butt-joint between the two sections 20, 22 was made under optimal conditions. It is to be noted that no bond line 40 between the two sections 20, 22 is visible nor are any surface distortions present. As seen in the cross section view of FIG. 5, the plastic from each section 20, 22 has fused and intermingled to produce a smooth continuous region throughout the weld region that is at least as thick as the thickness of the pipe.

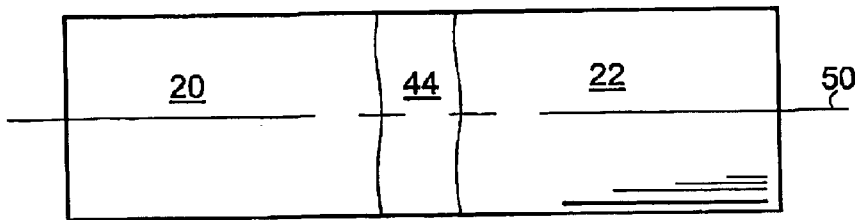
Fig. 6

FIG. 6 is a plan view of the butt weld joint of FIG. 3 from which the weld bead has been removed and the weld zone

region heated. Lack of the observation of a bond line in the weld zone region demonstrates the formation of a satisfactory weld (butt joint).

The weld zone **44** was then made visible by carrying out a secondary heating of the butt joint weld region **44**. This heating can be done with any convenient heat source such as a radiant, convection or contact heat source. In the present instance, the weld zone **44** was visualized by directing the flow of hot air from a hot air gun on the sanded surface, keeping the nozzle approximately 3/8 inch (1 cm) from the surface. The surface was heated until the outline of the weld zone **44** became visible. The temperature setting for the hot air gun (Leister CH 6056 Hot Air Blower type Ghibli) was 480° F.–500° F. (249° C.–260° C.). FIG. 6 shows the exterior weld zone **44** of a joint made under optimal conditions after the secondary heating. The absence of the bond line or surface distortion shows good fusion between two sections **20**, **22**.

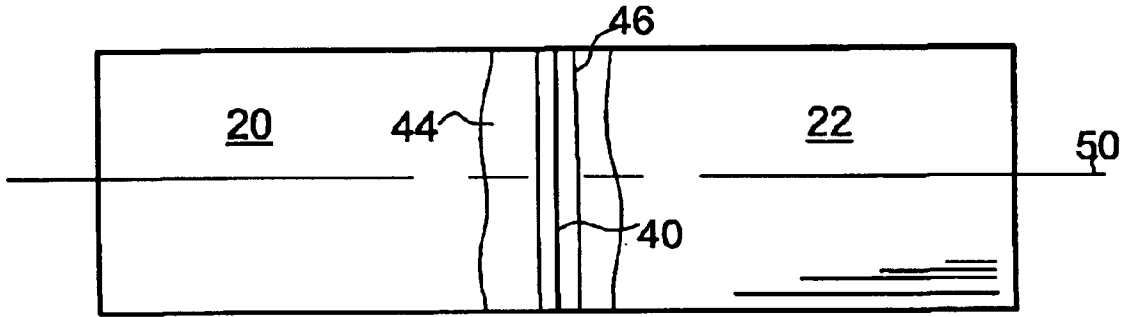
Fig. 7

FIG. 7 is a plan view of a butt weld joint weld made with insufficient interfacial pressure in the initial joining step. The observation of the bond line and other deformities after the secondary heating step clearly shows the formation of a defective joint.

FIG. 7 illustrates the presence of a bond line 40 between the two sections 20, 22 along with ridges 46 in the weld zone region 44 when the two sections 20, 22 are joined with insufficient interfacial pressure. FIG. 8 shows the presence of bond line 40 when the two sections 20, 22 are joined after heating the ends of the two sections 20, 22 to too high a temperature prior to the joining operation. In addition to the appearance of the defect indicating bond line 40, ridges 46 and valleys 48 may also develop on either side of the bond line 40 during the heating step. However, the observation of a bond line 40 is clear evidence of a defect weld. Butt weld failures are caused by weakened or incomplete fusion of the mating surfaces 24, 26 which give rise to the bond line 40. This can arise for a variety of reasons including insufficient pressure at portions or the entire interface of the joint, solidification of the material in the contact zone due to weather conditions, an over extended open time, contamination, and other factors. Regardless of the cause of the weak bond. Its presence can be readily identified by the appearance of the bond line 40 when the weld zone region 44 is rendered visible by a secondary heating step once the bond has been formed and allowed to cool.

The weld illustrated in FIG. 7 was prepared according to the method described above for Example I except that the

interfacial pressure applied to the two pieces of pipe during the welding process was reduced by approximately 50%. The incompleteness of the weld is evident by the appearance of a bond line **40** between the two pipe segments **20**, **22** along with slight ridges **46** on each side of the bond line **40**.

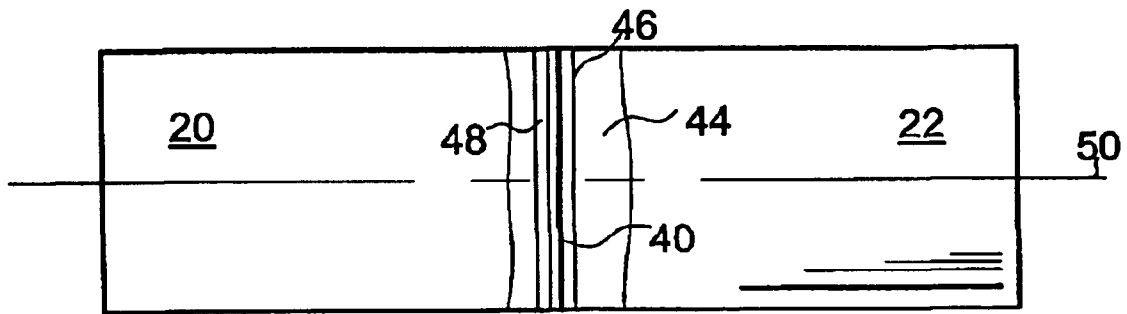
Fig. 8

FIG. 8 is a plan view of the weld zone region after secondary heating. Illustrating the appearance of a bond line when the ends of the pieces are overheated prior to the initial joining step. The observation of the bond line after the secondary heating step clearly shows the formation of a defective joint.

The weld illustrated in FIG. 8 was prepared according to the method described above for Example I except that the ends of the pipe were overheated during the initial welding process, that is, to a temperature of about 2800° C. As a result, the incompleteness of the weld is clearly evident by the appearance of the bond line **40** between the two pipe segments **20**, **22** as well as ridges **46** and valleys (indentations) **48** on either side of the bond line **40**.
