**EP 2 039 882 A2**

(54) **Methods for performing gas turbine engine casing repairs and repaired cases**

(57) Methods for repairing gas turbine engine casings and repaired casings are provided. In this regard, a representative method for repairing a gas turbine engine

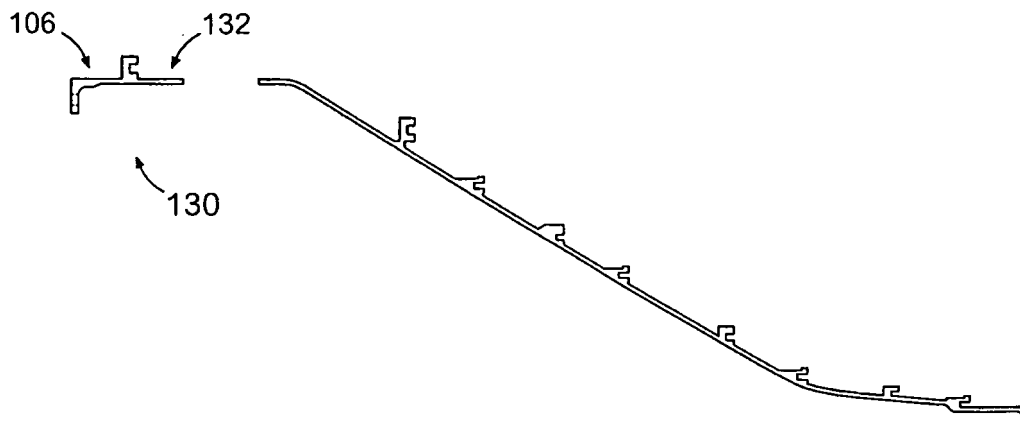
**FIG. 3**

casing (100) includes: removing an annular portion (110) of the engine casing (100); and attaching an annular replacement portion (106) to the engine casing (100).

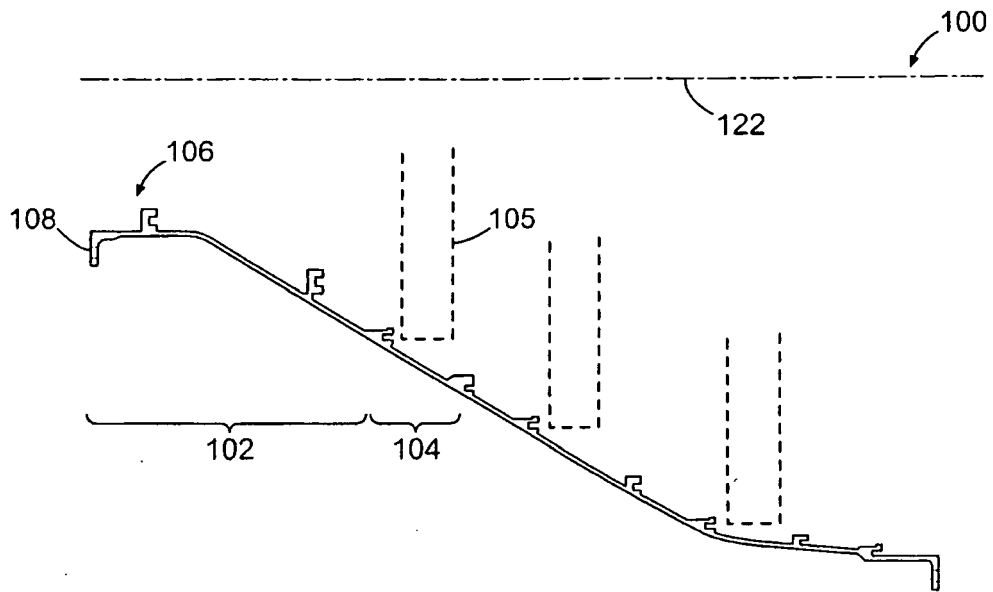
**FIG. 1**

[0008] FIG. 1 is a schematic diagram depicting a portion of a representative repaired engine casing.

[0014] An exemplary embodiment of a repaired engine casing is depicted schematically in FIG. 1. As shown in FIG. 1, engine casing 100 includes non-containment zones (e.g., non-containment zone 102) and containment zones (e.g., a containment zone 104). Specifically, each containment zone is located in a vicinity of corresponding rotating blades (e.g., blade 105) of a turbine that are positioned within the casing. In this embodiment, the non-containment zone 102 is associated with a replacement portion 106 that includes a front flange 108 of the casing. The front flange is used to attach the casing to an adjacent casing. Notably, a front flange (flange 110 of FIG. 2) that was previously attached to the case was considered unsuitable for continued use, such as by exhibiting severe cracking or wear, and was removed.

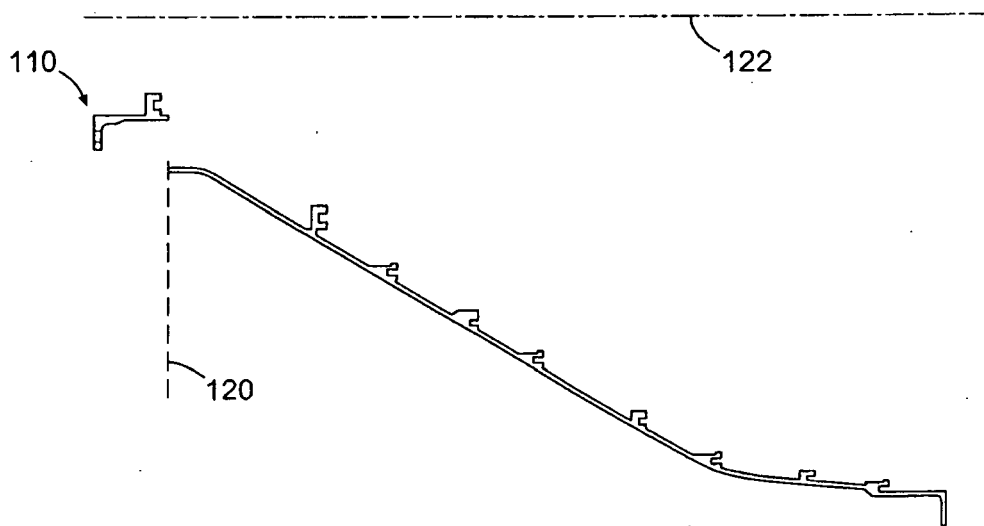
**FIG. 2**

[0009] FIG. 2 is a schematic diagram depicting a step of an exemplary embodiment of a method for repairing a gas turbine engine casing.

[0015] As shown in FIG. 2, removal of front flange 110 from case is accomplished by cutting the case along the cut plane 120. The cut plane is oriented perpendicular to the longitudinal axis 122 of the casing although other cut plane orientations can be used in other embodiments. Cutting can be accomplished in various manners, such as by machining, turning, milling, sawing, or laser cutting. Notably, the cut plane is located outside of a containment zone of the casing in this embodiment. However, in other embodiments, the cut plane may be associated with a containment zone.

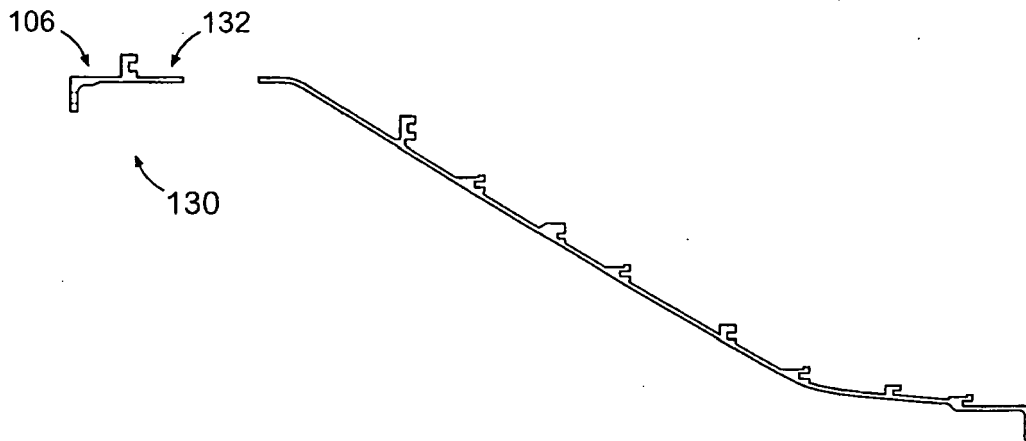
**FIG. 3**

[0010] FIG. 3 is a schematic diagram depicting another step of an exemplary embodiment of method.

[0016] In FIG. 3, annular replacement component 130 is provided that includes replacement portion 106 and an optional trim portion 132. The trim portion is formed of excess material that can be trimmed to form an appropriate mating surface for engaging a corresponding surface of the casing 100. In this regard, the trim portion can be suitably dimensioned for attachment to the casing using various techniques, such as using a technique similar to that use in removing the front flange (shown in FIG. 2). After the replacement component is trimmed, attachment to the casing 100 can be accomplished by using

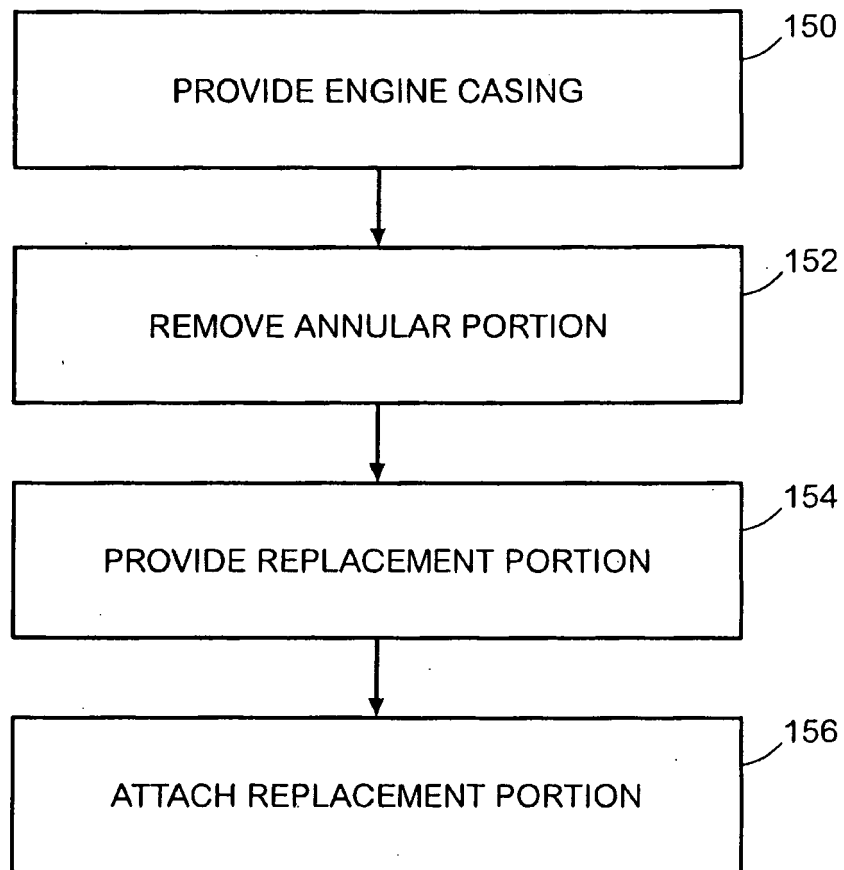
**FIG. 4**

[0011] FIG. 4 is a flowchart depicting an embodiment of a method for repairing a gas turbine engine casing.

**[0017]** As shown in FIG. 4 an exemplary embodiment of a method for repairing a gas turbine engine casing includes providing an engine casing (block 150). In block 152, an annular portion of the engine case is removed, and a replacement portion is provided (block 154). In some embodiments, the portion removed is restricted to non-containment portion of the casing. Thereafter, such as depicted in block 156, the replacement portion is attached to the engine casing.

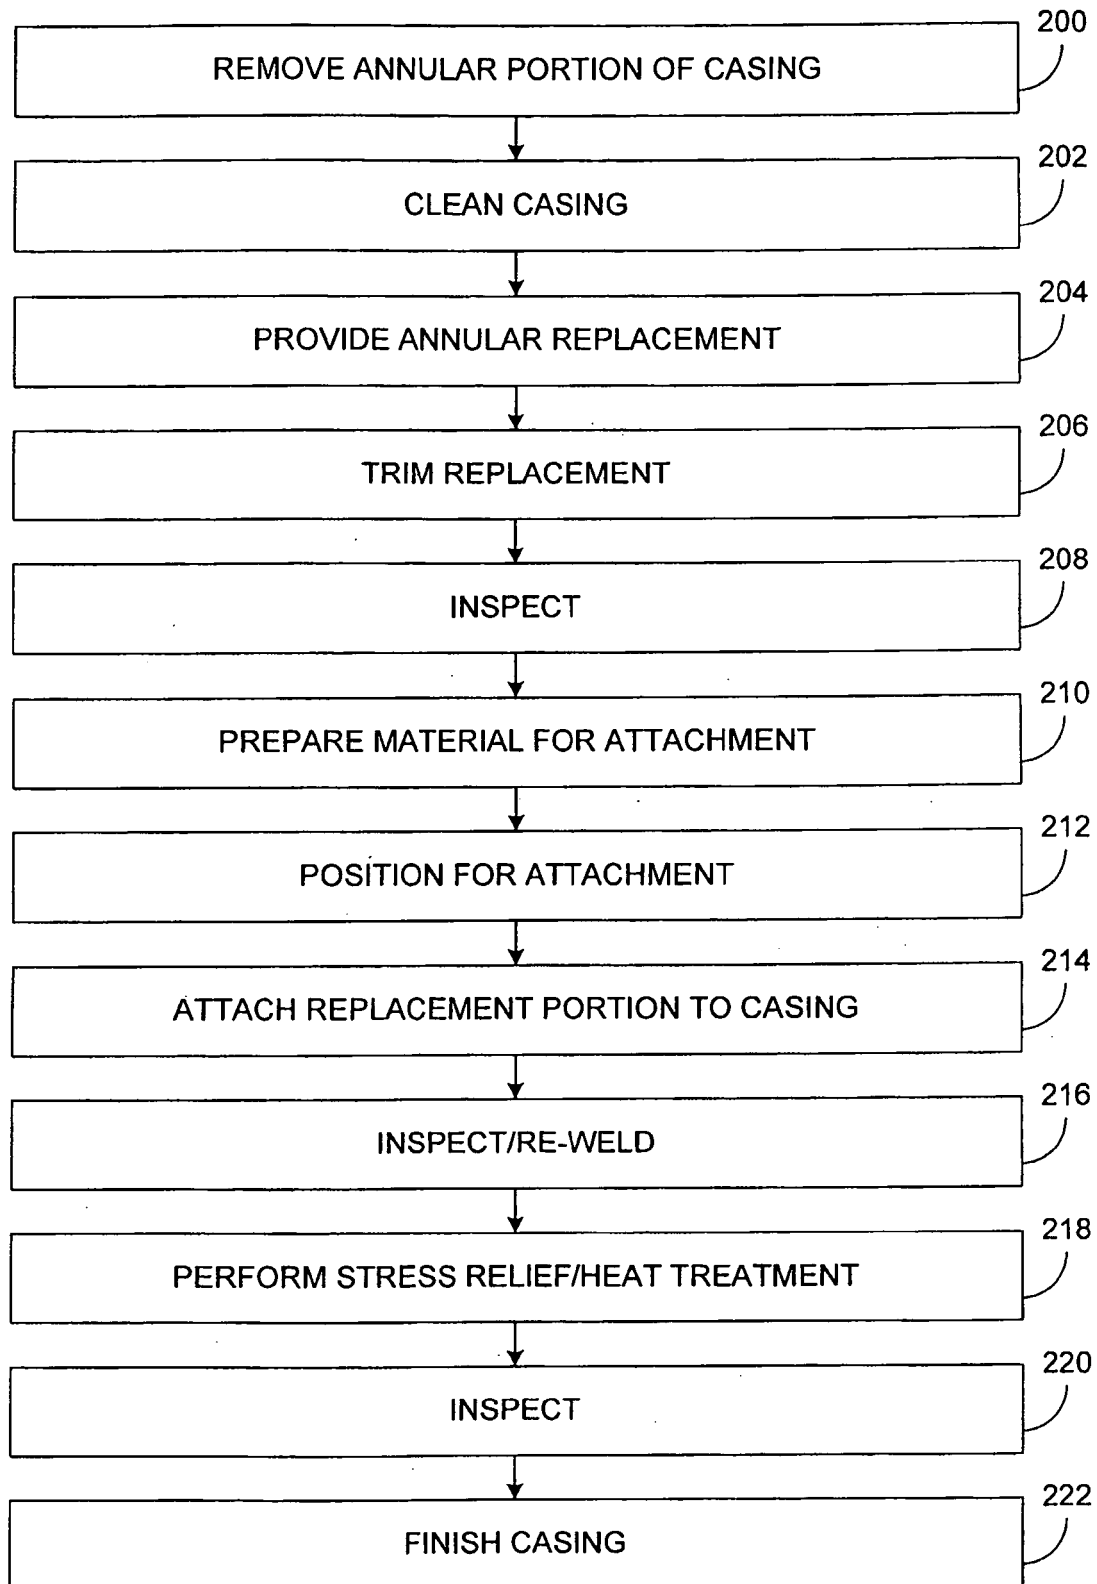
**FIG. 5**

[0012] FIG. 5 is a schematic diagram depicting another embodiment of a method for repairing a gas turbine engine casing.

**[0018]** Another exemplary embodiment of a method for repairing a gas turbine engine casing is depicted in the flowchart of FIG. 5. As shown in FIG. 5, the method may be construed as beginning at block 200, in which an annular portion of a gas turbine engine casing is removed. By way of example, the portion can be a front flange portion of a turbine casing. In block 202, the remaining casing can be cleaned.

**[0019]** In block 204, a replacement component (e.g., a forged replacement flange with a trim portion) is provided and a hardness check is performed. In some embodiments, such as when the casing is a precipitation-hardened nickel alloy turbine casing, the hardness should be at least approximately HRC36 (or equivalent). If it is determined that the hardness is adequate, the process may proceed to block 206, in which the replacement component is trimmed. For instance, the replacement component can be machined (and optionally cleaned) in order to provide appropriate mating tolerance for the attachment technique that is to be used for attaching the replacement portion to the casing. In block 208, an inspection can be performed such as a fluorescent penetrant inspection, x-ray inspection and/or hardness inspection in order to identify any defects.

**[0020]** In block 210, material in a vicinity of the attachment can be prepared (such as by cleaning with a silicon carbide rag wheel or a stainless steel wire brush, for example) in order to prepare the mating surfaces for attachment. In some embodiments, this can involve preparing an approximately one inch (25.4 mm) wide area adjacent to the cut line at the front face of the case and the corresponding mating surface of the replacement portion. Preparation also can include additional cleaning steps in some embodiments, such as by cleaning the surfaces with a solvent wipe method.

**[0021]** In block 212, the replacement portion is positioned for attachment. Notably, this can involve inspection to confirm that any gaps between the replacement portion and the casing do not exceed acceptable tolerances. If tolerances are met, the process may proceed to block 214, in which the replacement portion is attached to the casing, such as by welding, for example. In this regard, various welding techniques, such as electron beam welding (EBW), machine TiG welding and plasma arc welding can be used. Inspection and optional re-welding then can be performed such as depicted in block 216. Thereafter, such as depicted in block 218, stress relief/heat treatment can be performed in order to relieve in-

ternal stresses. In block 220, various inspections, such as a hardness check, fluorescent penetrant inspection and/or x-ray inspection can be performed to insure completeness of the weld. Finishing then can be performed in block 222. By way of example, the weld can be machine finished to ensure a smooth continuous surface with no undercuts. Final cleaning and inspection then can be performed.
