(12) **United States Patent**
Buergel et al.

(10) **Patent No.:** **US 8,252,376 B2**
(45) **Date of Patent:** **Aug. 28, 2012**

(54) **METHOD FOR RESTORING THE MICROSTRUCTURE OF A TEXTURED ARTICLE AND FOR REFURBISHING A GAS TURBINE BLADE OR VANE**

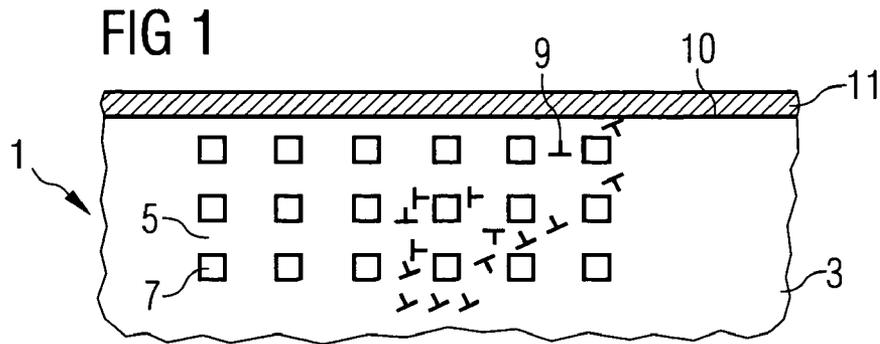
FIG. 2 shows another schematic view of the microstructure of a superalloy.

In the case of directionally solidified articles (FIG. 2) there are grain boundaries 35 only along the z-axis 33. The z-axis is e.g. a radial direction of a turbine blade when in use in a gas turbine. The grain boundaries extend mainly along dotted lines along the z-axis 33.

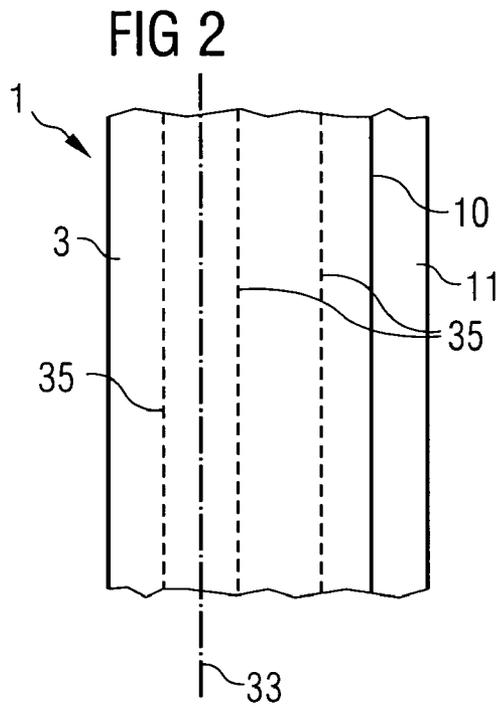
FIG 3

FIG. 3 shows a further schematic view of the microstructure of a superalloy.

FIG. 3 illustrates this recrystallization. A new grain 15 is developed by growth into the original grain 13. A high dislocation concentration 9 as shown in FIG. 1 is the source for the recrystallization.

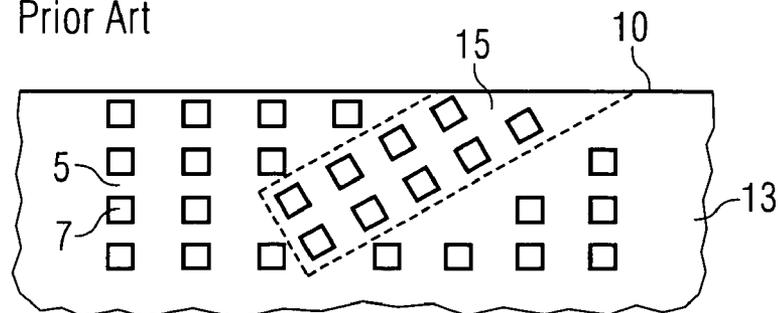
FIG. 4 shows a gas turbine blade.

A gas turbine blade 21 made from a single crystal nickel-based superalloy is shown in FIG. 4. The body 23 of the blade 21 is coated with a corrosion protective coating 29. On the protective coating 29, a thermal barrier coating 31 is placed. After a certain time period of operation, the blade 23 needs to be refurbished because the coating system is at least partially worn off by oxidation, corrosion and erosion.

The thermal barrier coating 31 and/or the protective coating 29 is removed by chemical and/or mechanical stripping, e.g. by grinding. During this procedure of mechanical strip-

ping often a surface damaged surface rim is generated, usually with a depth of 20 μm from the surface.

The surface coating 11 is deposited on the remainder of the protective coating 29, thereby closing the complete surface of the body 23. Subsequently the solution heat treatment is applied, as described above. After the heat treatment, the surface coating 11, the protective coating 29 and the thermal barrier coating 31 are removed by mechanical stripping and chemical treatment and a new protective coating as well as a new thermal barrier coating are provided.

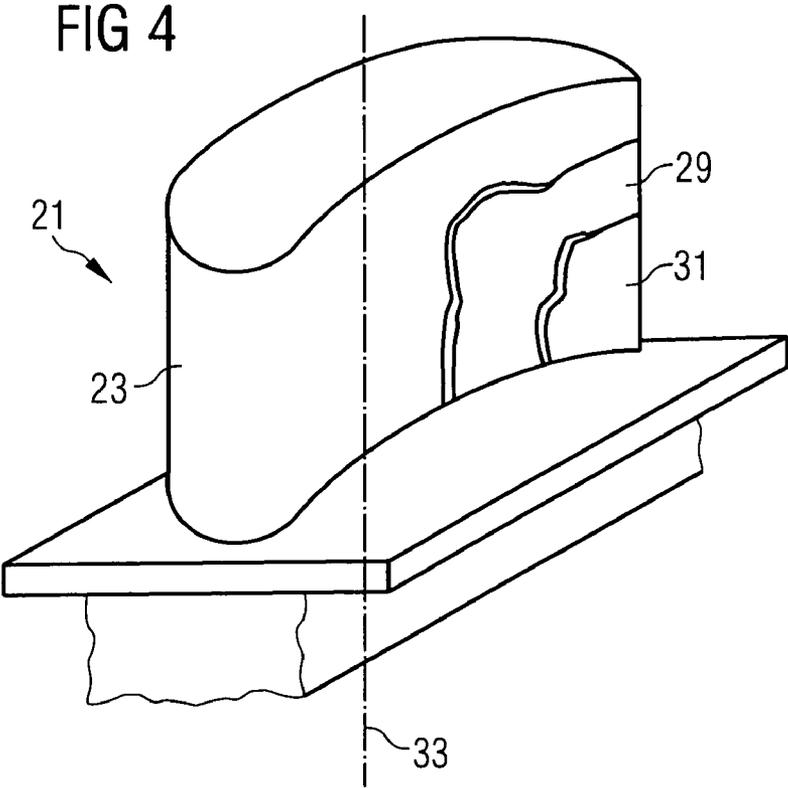
FIG. 5 shows the article 1 with the body 3 having a dislocation accumulation 9. On the body 3 there is e.g. a layer 38 with corrosion products on which the protective layer 29 and thermal barrier coating 30 is laying.

FIGS. 5 to 11 show schematically the steps of restoring the microstructure of a textured article and/or the refurbishing of a textured article.

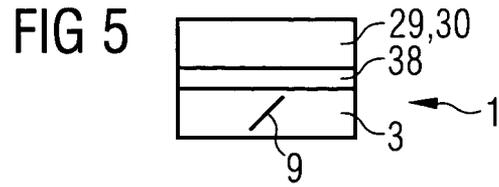
In a first step of the inventive method the protective layer 29, the thermal barrier coating 30 and the corrosion products in the layer 38 are removed (FIG. 6).

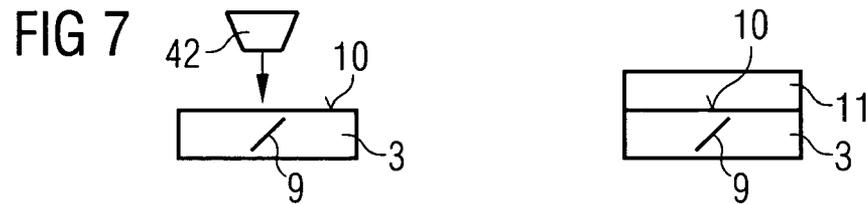
Secondly, on the surface 10 of the body 3 the surface coating 11 is applied by a coating apparatus 42 (FIG. 7). Different kinds of coating apparatus or processes can be used.

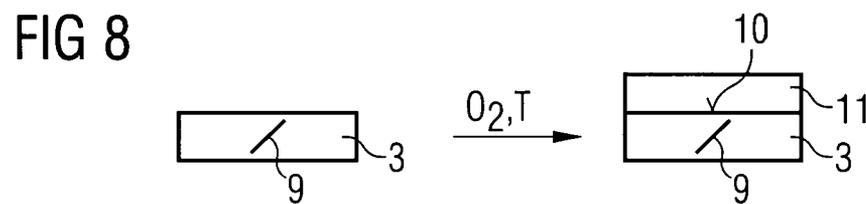
The surface coating 11 can also be applied by oxidising the body 3 at higher temperatures HT (FIG. 8) in an atmosphere with oxygen O_2 .

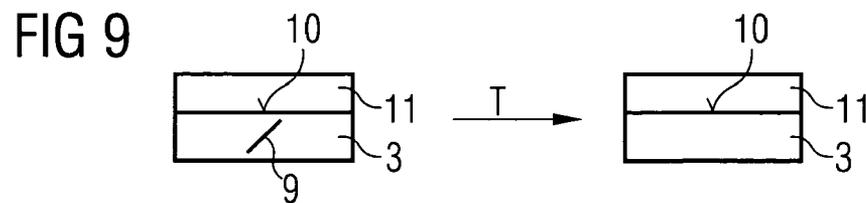
The article with the surface coating 11 according to FIG. 7, 8 is now applied to a solution heat treatment as indicated in FIG. 9. The thermal stable surface coating 11 is maintained during the hole solution heat treatment.

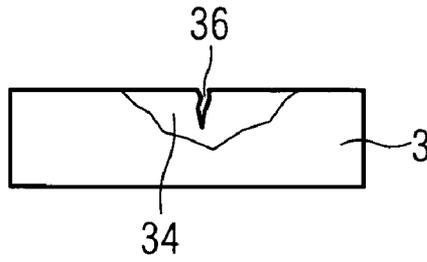
FIG 12

FIG. 12 shows a further application example of the method of the invention.

The substrate 3 may have a crack 36 or relatively large regions 34 comprising defective material. However, for the substrate 3 to be reused, it is necessary for the crack 36 or the regions 34 comprising defective material no longer to be present.

This is achieved, for example, by soldering up the crack 36 or by removing a region 34 which surrounds the crack 36. The region 34 is, for example, built up by build-up welding, resulting in a newly built-up region 39.

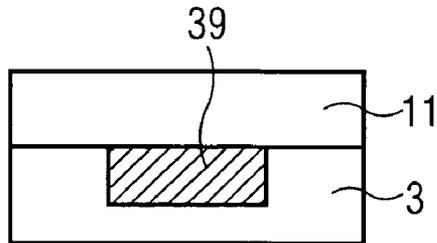
FIG 13

The surface layer 11 may also extend over these newly built-up regions 39 (FIG. 13) in which new material has been newly added, for example by build-up welding or in which a crack 36 has been filled with solder or weld metal.

The solution heat treatment or another heat treatment which will lead to recrystallization is then carried out using a component as shown in FIG. 13.
