(12) **United States Patent**  
Nagaya et al.

(10) **Patent No.:** US **6,620,274 B1**  
(45) **Date of Patent:** Sep. 16, 2003

(54) **METHOD OF REPAIRING ALUMINUM HEAT EXCHANGER**

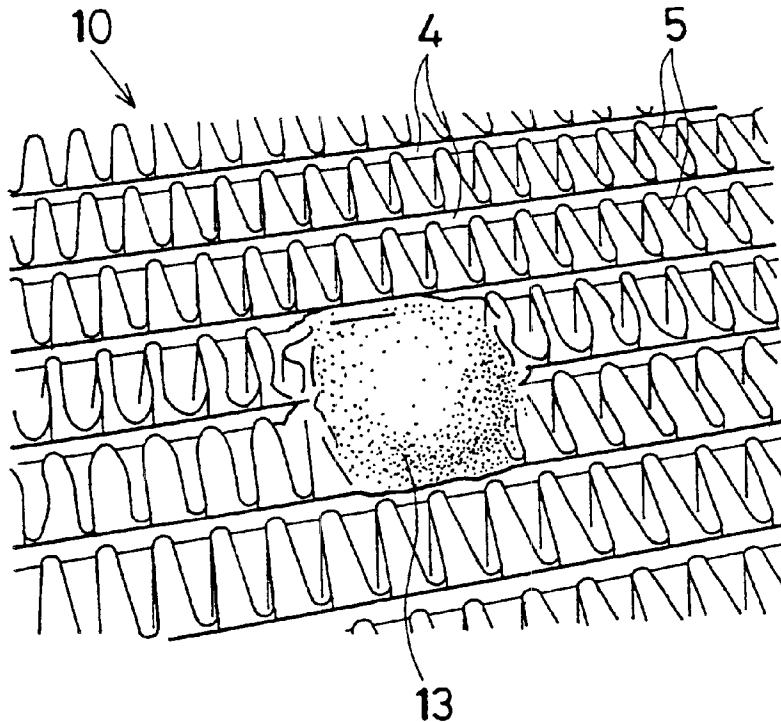
FIG. 1 is a front view showing an aluminum heat exchanger;

A preferred embodiment the present invention will be described with reference to FIGS. 1–3C. First, referring to FIG. 1, the structure of a heat exchanger to which the repairing method of the present invention is applied will be described. The aluminum heat exchanger **1** shown in FIG. 1 is used as a radiator for cooling an internal combustion engine of an automobile vehicle. The aluminum heat exchanger **1** is a conventional radiator composed of a lower tank **2**, an upper tank **3** and a heat exchange core **10** having plural tubes **4** and plural corrugated fins **5**. The tubes **4**

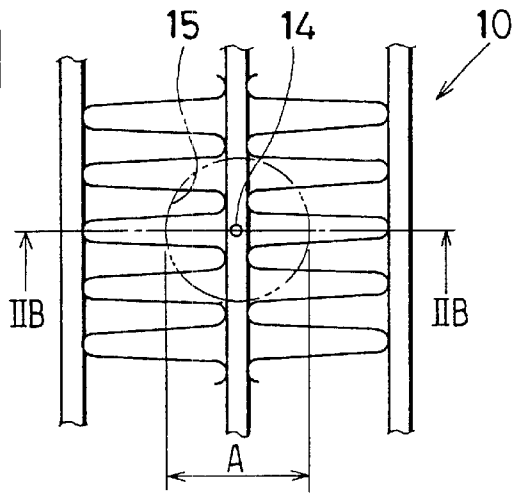
FIG. 2A is a partial front view showing a damaged portion of a heat exchanger tube and a depressed portion formed for repairing the damaged portion;

When the aluminum core 10 is damaged and the coolant in the heat exchanger leaks out, the aluminum core has to be repaired. First, a portion of the core 10 around the damaged portion 14, i.e., a hole formed in the tube 4, is deformed by hitting with a hammer or the like to form a depressed portion 15, as shown in FIGS. 2A and 2B. The depressed portion 15 is formed, so that the diameter "A" thereof becomes in a range of 2-20 times the diameter of the hole 14 and the depth "B" thereof becomes in a range of 1-8 mm.

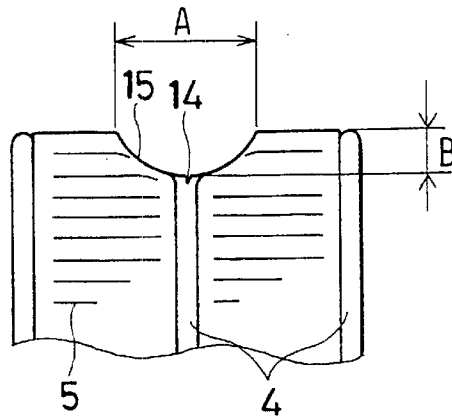
FIG. 2B is a cross-sectional view showing the depressed portion, taken along a line IIB—IIB in FIG. 2A;

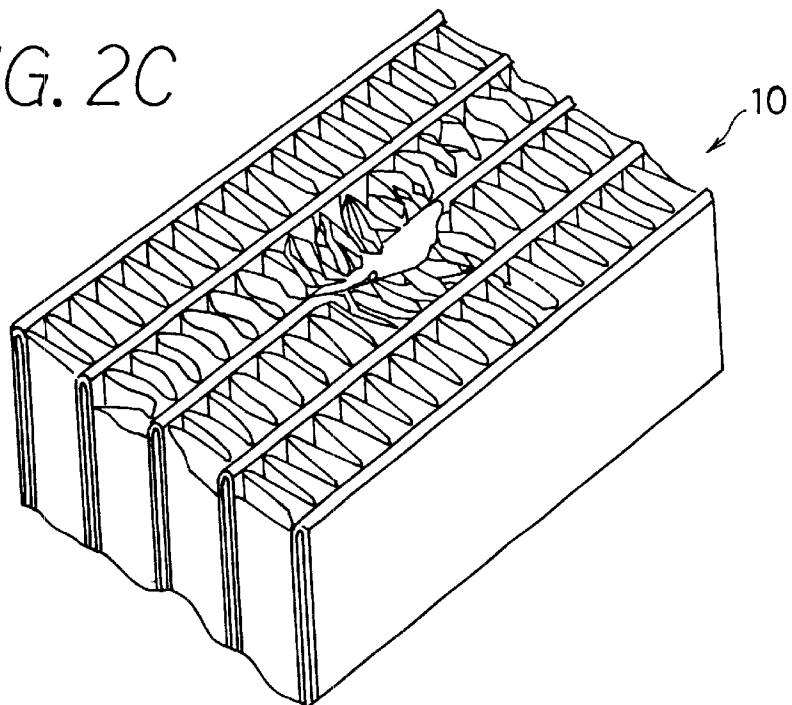
FIG. 2C is a perspective view showing the damage portion on a heat exchanger core;

A perspective view of the depressed portion 14 thus formed is shown in FIG. 2C. The aluminum corrugated fins 5 around the hole 14 are bent down and flattened to form a cup-shaped depressed portion 15. The cup-shaped depressed portion 15 is so made that the acrylic-resin-type adhesive material is retained therein while the adhesive material is being cured. The size of the depressed portion 15 has to be sufficiently large to secure a certain thickness and an adhesive surface area of the adhesive material and to prevent the adhesive material from being peeled off.

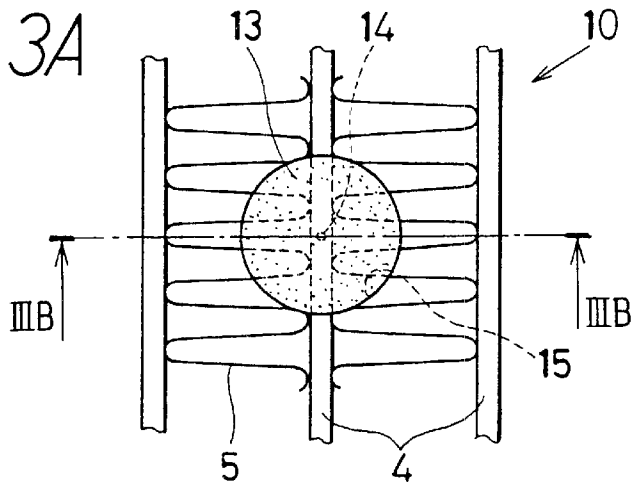
FIG. 3A is a partial front view showing a repaired portion with an adhesive material filling the depressed portion;

a form of paste, is supplied to the depressed portion 15, as shown in FIGS. 3A and 3B. The supplied adhesive material 13 is retained in the depressed portion 15, and some part thereof is impregnated into the corrugated fins 5 as shown in FIG. 3B. The adhesive material 13 is supplied so that the depth "C" of the impregnation measured from the surface of the core 10 becomes deeper than, e.g., 5 mm. To supply the adhesive material 13 to the depressed portion 15, the capsule containing the adhesive material may be set to a machine for injecting the adhesive material.

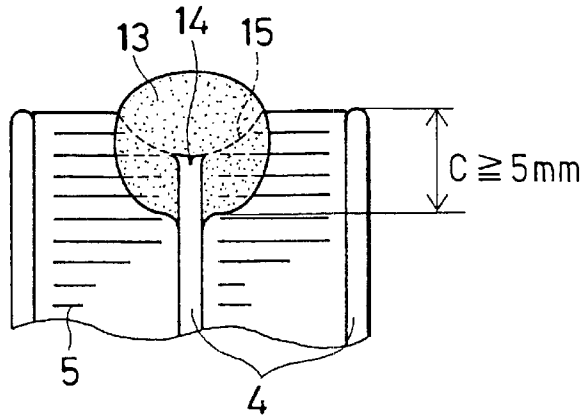
FIG. 3B is a cross-sectional view showing the repaired portion, taken along a line IIIB—IIIB in FIG. 3A;

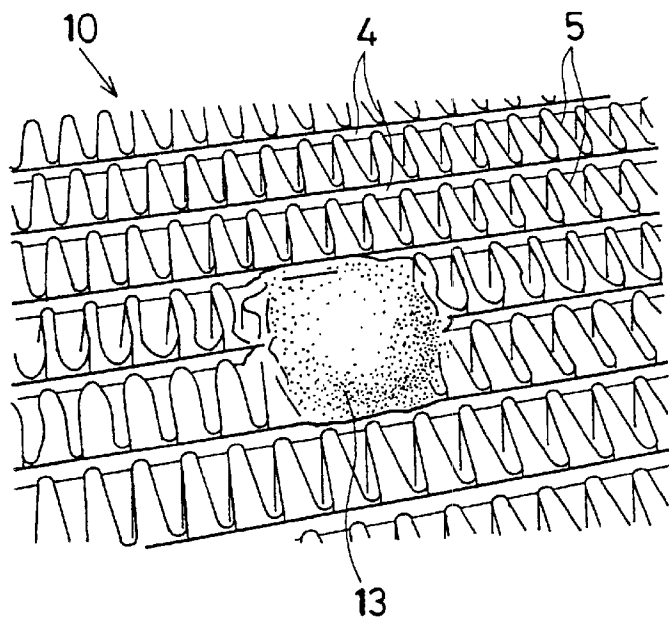
FIG. 3C is a perspective view showing the repaired portion;

The adhesive material 13 retained in the depressed portion 15 and impregnated into the corrugated fins 5 is cured under the room temperature for a predetermined period, e.g., for about 20 minutes. The hardened adhesive material 13 firmly closes the hole 14, and thus the repair work is completed. The reason why the acrylic-type resin is used as the adhesive material in place of a conventional epoxy-type resin is that the acrylic resin can be hardened under the room temperature in a shorter period. The adhesive material 13 includes a hardener in addition to the acrylic-type resin as the main component. FIG. 3C shows a perspective view of the portion repaired under the above-described method.

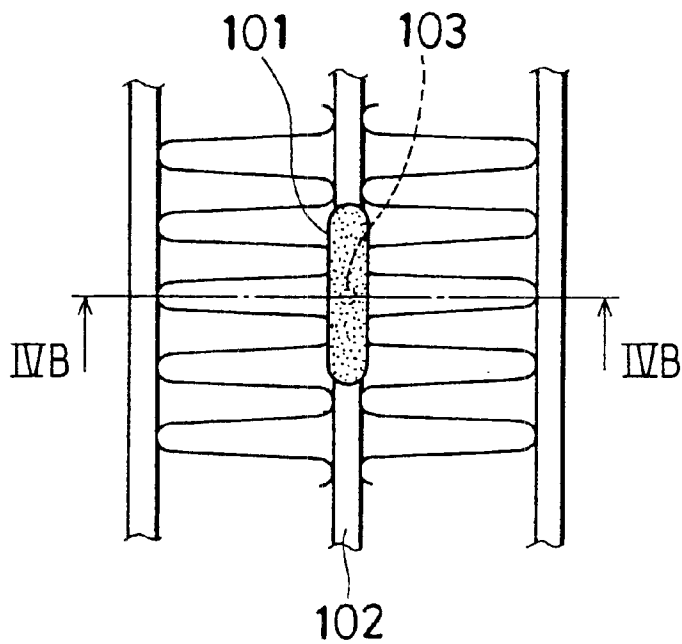
FIG. 4A PRIOR ART

FIG. 4A is a partial front view showing a portion repaired under a conventional method; and

Further, the conventional repair work has not been sufficiently complete because the aluminum heat exchanger is repaired under a method as shown in FIGS. 4A and 4B. That is, the epoxy-resin-type adhesive material **101** is directly coated on a damaged aluminum tube **102** to close a hole **103** formed therein, and then the adhesive material is cured. Therefore, the adhesive material flows over the vicinity of the hole **103**, thereby making the coated layer thin. The hole **103** is not completely closed, or the once coated adhesive material tends to be peeled off in a short time.

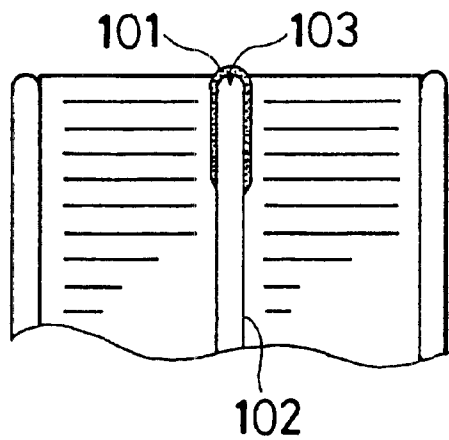
FIG. 4B PRIOR ART

FIG. 4B is a cross-sectional view showing the conventional repaired portion, taken along a line IVB—IVB in FIG. 4A.
