(12) **United States Patent**  
**Hirtz**

(10) **Patent No.:** **US 11,028,956 B2**  
(45) **Date of Patent:** **\*Jun. 8, 2021**

(54) **LINER FOR LATERAL PIPE LINE**

(71) Applicant: **SAK CONSTRUCTION, LLC**,  
O'Fallon, MO (US)

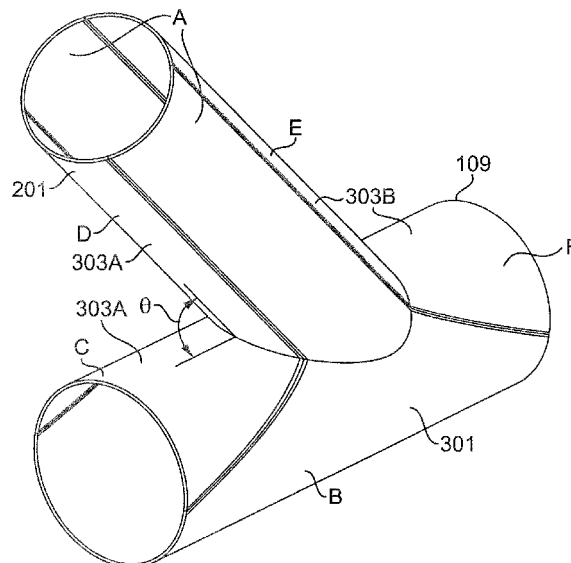
Systems and methods for forming and deploying a pipe liner  
in a pipe main having a service lateral. The line is formed  
from three pieces of material. The piece of material forming  
the front top and of the main liner and the front of the lateral  
line has a cutout at the joint to reduce bunching, which can  
result in non-uniform liner thickness and may form obstruc-  
tions at the joint.

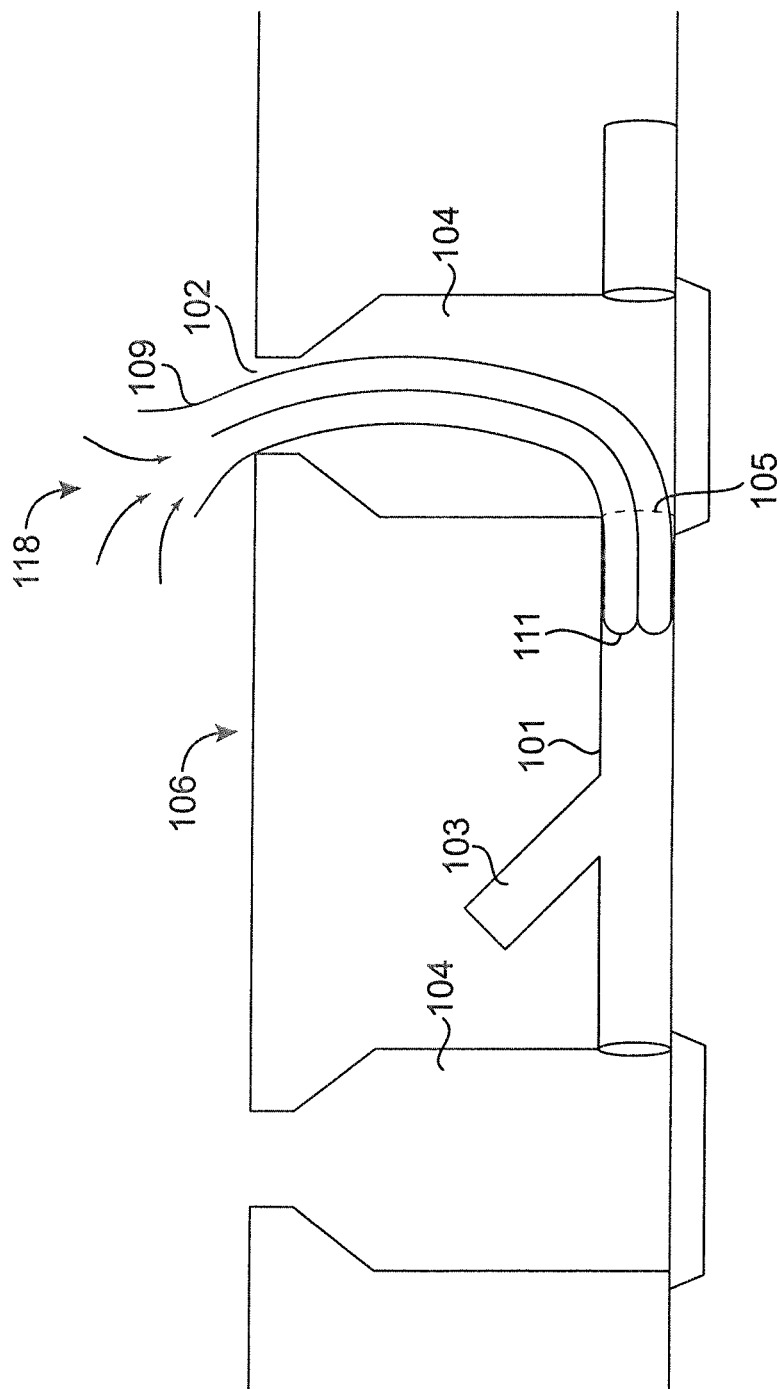
FIG. 1 depicts a diagram of a prior art cured-in-place pipe ("CIPP") liner installation process.

An embodiment of this prior art process is depicted in FIG. 1. Underground pipes typically comprise a main service line **101**. In the depicted figure, the main line **101** is buried underground and accessible through a number of vertical tunnels **104**. These tunnels **104** are accessible through an opening **102** at the surface **106**. The opening **102** may be, for example, a manhole **102**. Usually, the main **101** is connected to one or more service laterals **103**, which are small service lines **103** that direct flow to/from the main **101** to service points, such as a building.

Over time, the main **101** becomes clogged with debris and natural obstructions, such as roots and pieces of broken pipe. Typically, pipe rehabilitation begins by cleaning out the main **101**. This may be done using any number of techniques, ranging from manual removal to use of remote cleaning technology, such as a high-pressure water jetter. Next, the cleaned pipe **101** interior is visually inspected, such as by using a remote camera system. This system is generally a mobile closed circuit camera system providing illuminated real-time images of the pipe **101** interior to a remote operator by wired or wireless connection. In this stage, the camera inspects the pipe **101** interior for remain-

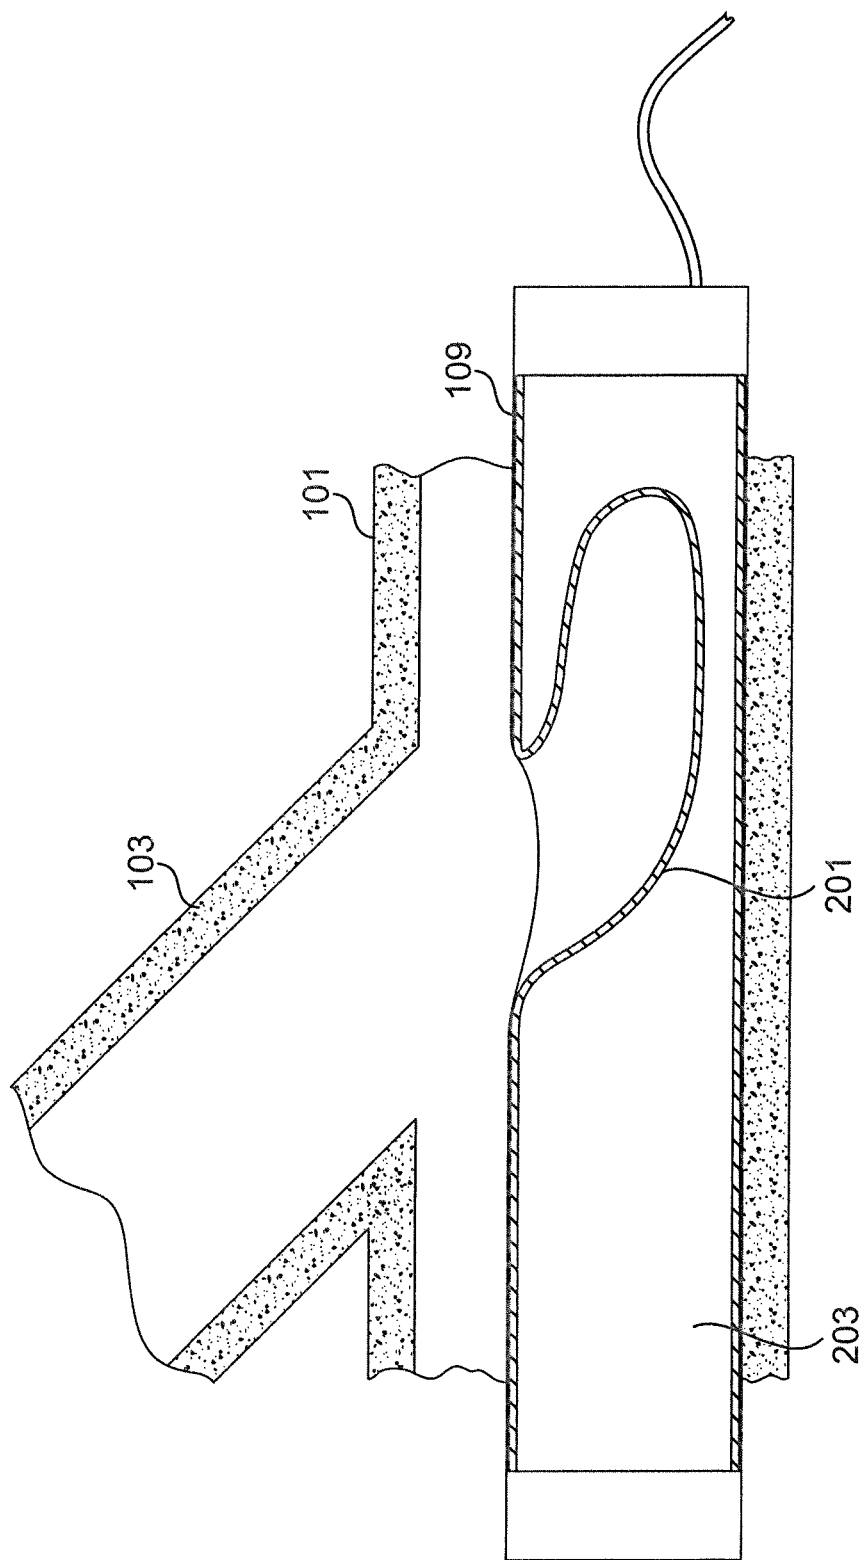
FIG. 2A

FIGS. 2A and 2B provide a diagram of a service lateral liner.

Described herein, among other things, is a CIPP liner including a branch liner for a service lateral which is designed to limit or inhibit material bunching. An embodiment of such a liner is depicted in FIG. 2A. In the depicted embodiment of FIG. 2A, a main liner 109 is disposed within a main 101 having at least one service lateral 103. The main liner 109 includes a lateral liner 201 inverted within the main liner 109. To install the lateral liner 201, the main liner 109 is positioned so that the joint between the main liner 109 and lateral liner 201 is situated at the joint 203 between the main line 101 and the service lateral 103. Next, pressure is applied to cause the branch liner 201 to invert into the service lateral 103. This is depicted in FIG. 2B. This installation has the advantage of providing a seamless and jointless liner between the main 101 and lateral 103, reducing the problems caused by spaces between the liner 109 and main 101.

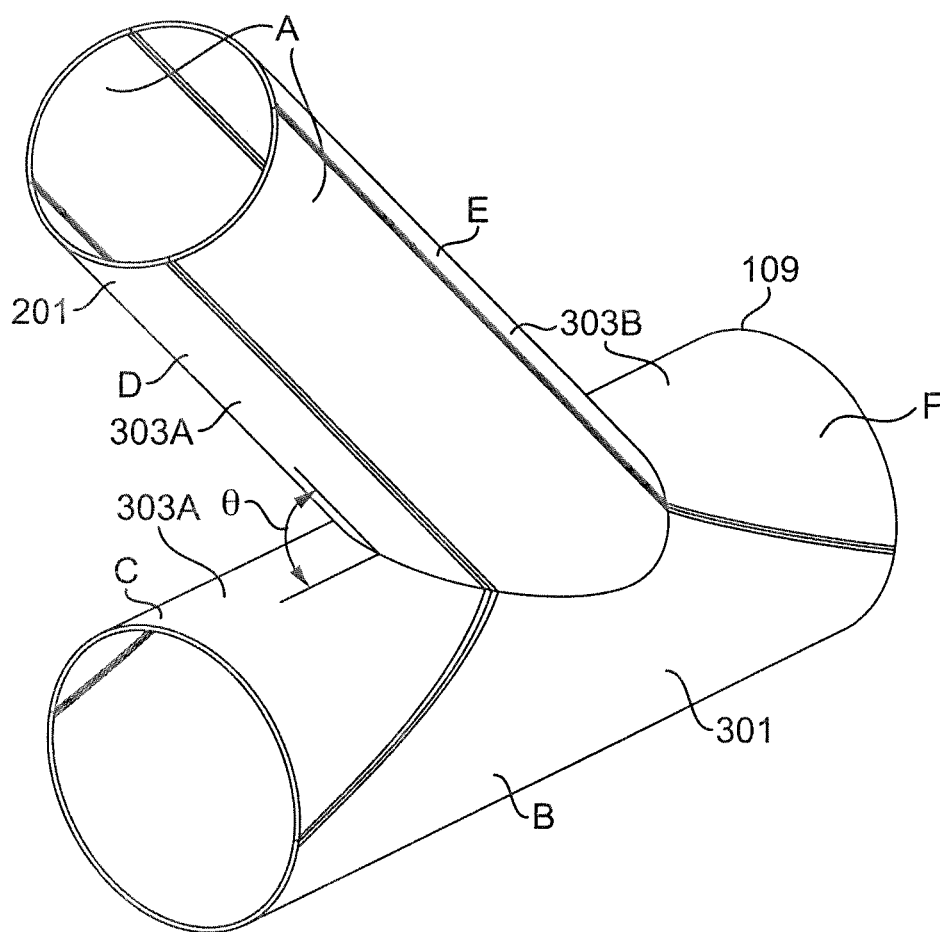
FIG. 3 depicts an embodiment of a CIPP liner for a service lateral according to the present disclosure.

In FIG. 3, an embodiment of such a liner 109 is shown. In the depicted embodiment of FIG. 3, the liner 109 is constructed of three different pieces 301, 303A and 303B, which are assembled to form the liner 109. In the depicted embodiment, the lateral sides A of the service liner 201 and the bottom portion B of the main liner 109 comprise a first contiguous piece 301 of liner material. The front D of the service liner 201 and the front top C of the main liner 109 comprise a second contiguous piece 303A of liner material. The back E of the service liner 201 and the back top F of the main liner 109 comprise a third contiguous piece 303B of liner material. The relative directional terms "front," "back," and "lateral sides" should be understood with respect to the axial length of the main 101, as in, for example, FIG. 3.

The depicted liner 109 is configured for use with a service lateral that connects to the main 101 at a non-perpendicular angle  $\theta$ . In the depicted embodiment,  $\theta$  is about sixty degrees as measured from the axis of main 101.

To assemble the liner 109, the rectangular arms A of piece 301, shown in FIG. 4B, are folded towards each other, forming the sides A of the lateral liner 201. The hexagon B forms the bottom B of the main liner 109. Piece 303B is folded 401 at about the connection point between the rectangle E and the trapezoid F, and piece 303A is likewise folded 403 at about the connection point between rectangle D with trapezoid C. The three pieces 301, 303A and 303B are sewn together to form the depicted liner of FIG. 3. FIG.

In the depicted embodiment of FIGS. 3 and 4A-4D, the angle  $\theta$  between the service lateral 103 and the main line 101 is non-perpendicular. If the fold 403 is made in piece 303A to assemble the liner 109, trapezoidal portion C is at an acute angle to the rectangular portion D. This acute angle causes the material of piece 303A around the fold 403 to crinkle, or bunch up. This in turn can result in non-uniform thickness, and may form an obstruction at the joint between the main 101 and service lateral 103. It is thus desirable to prevent or inhibit bunching up of the felt material of the liner tube 109.

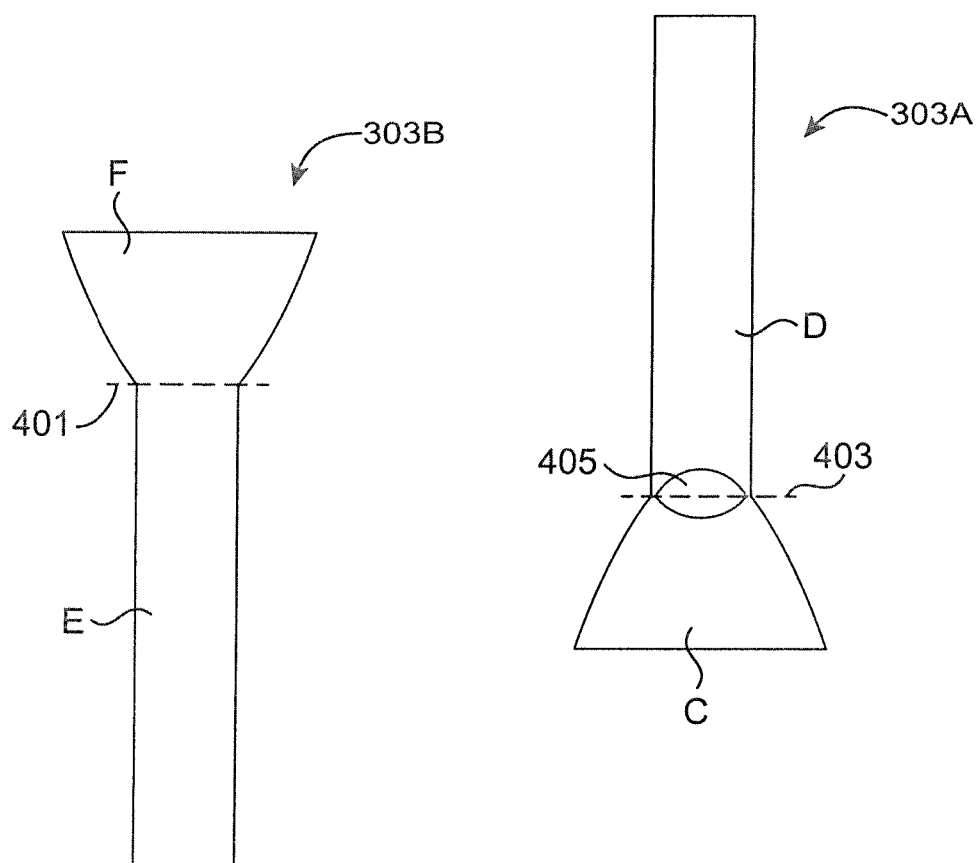
FIG. 4A depicts embodiments of front and back pieces for a CIPP liner for a service lateral according to the present disclosure.

Pieces 301, 303A, and 303B are further depicted in FIGS. 4A and 4B. As shown in FIG. 4B, the first piece 301 comprises a generally hexagonal center B with two generally rectangular arms A attached thereto and extending therefrom at opposing sides of the hexagon, the piece 301 being generally symmetrical at a midline 407. The angle  $\theta$  between the midline 407 and the major length of the arms A is about the same as the angle  $\theta$  of the lateral 103 to the main 101. As shown in FIG. 4A, the second piece 303A is comprised of a generally rectangular arm D corresponding to the front D of the lateral liner 201, and connected to a generally trapezoidal element C corresponding to the front top C of the main liner 109. The third piece 303B is also comprised of a generally rectangular arm E corresponding to the back side E of the lateral liner 201, and is connected to a generally trapezoidal component F corresponding to the back top F of main liner 109.

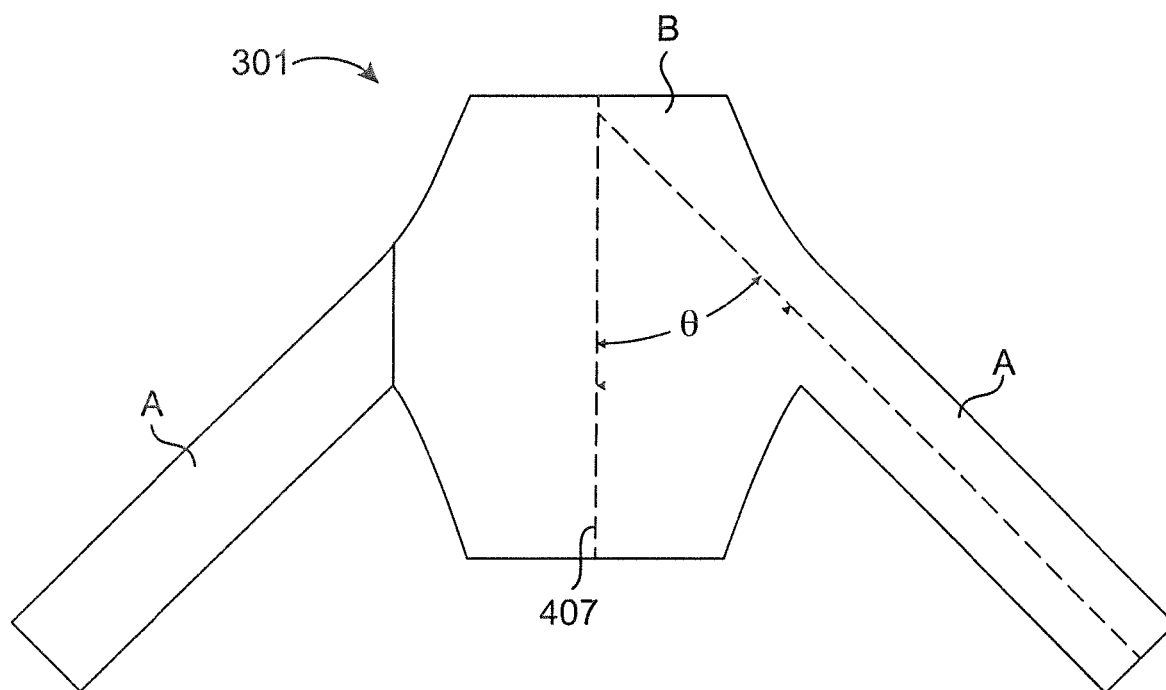
FIG. 4B depicts an embodiment of a bottom/side piece of a CIPP liner for a service lateral according to the present disclosure.

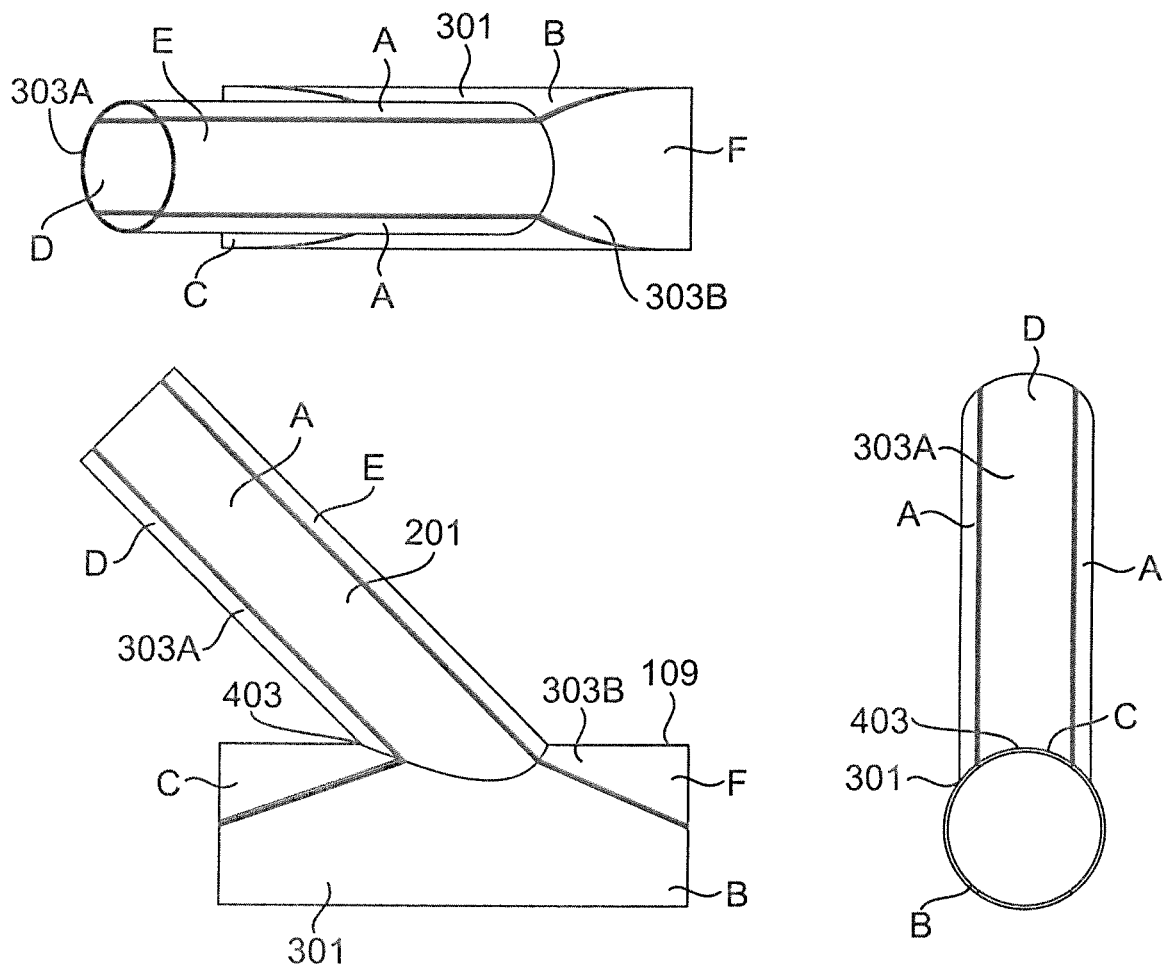
FIG. 4C provides a set of perspective drawings of an embodiment of an assembled CIPP liner for a service lateral comprised of a plurality of connected pieces according to the present disclosure.

4C depicts perspective drawings of the assembled liner 109 showing the corresponding connection of pieces 301, 303A, and 303B. Similarly, FIG. 4D depicts a cutaway diagram of the assembled liner 109.

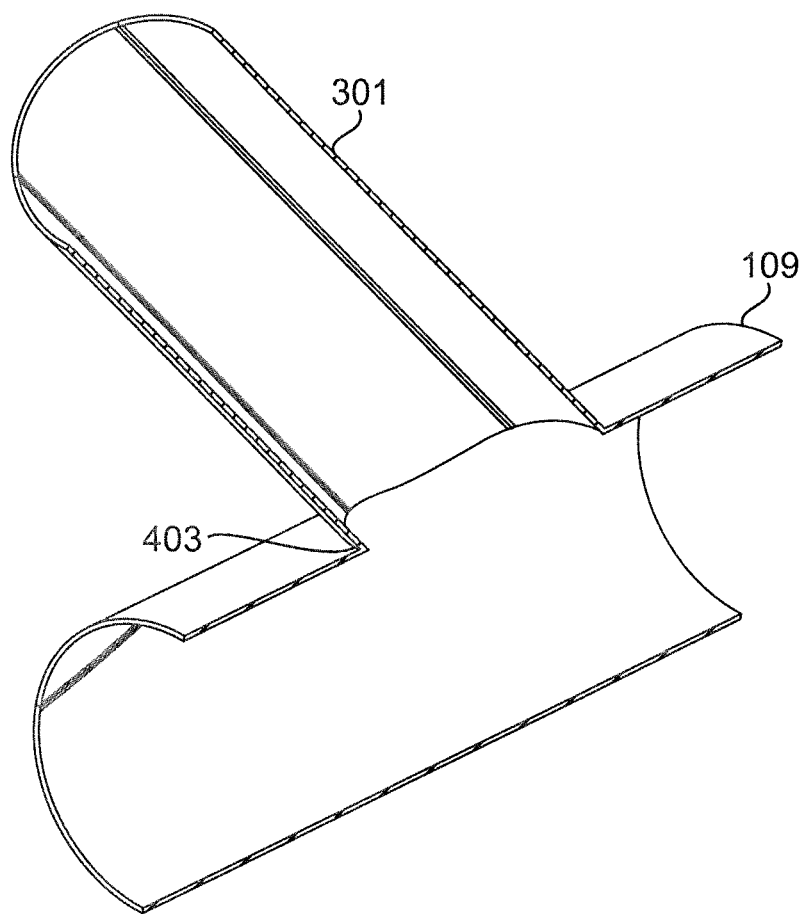
FIG. 4D depicts a cutaway diagram of an embodiment of a CIPP liner for a service lateral according to the present disclosure.

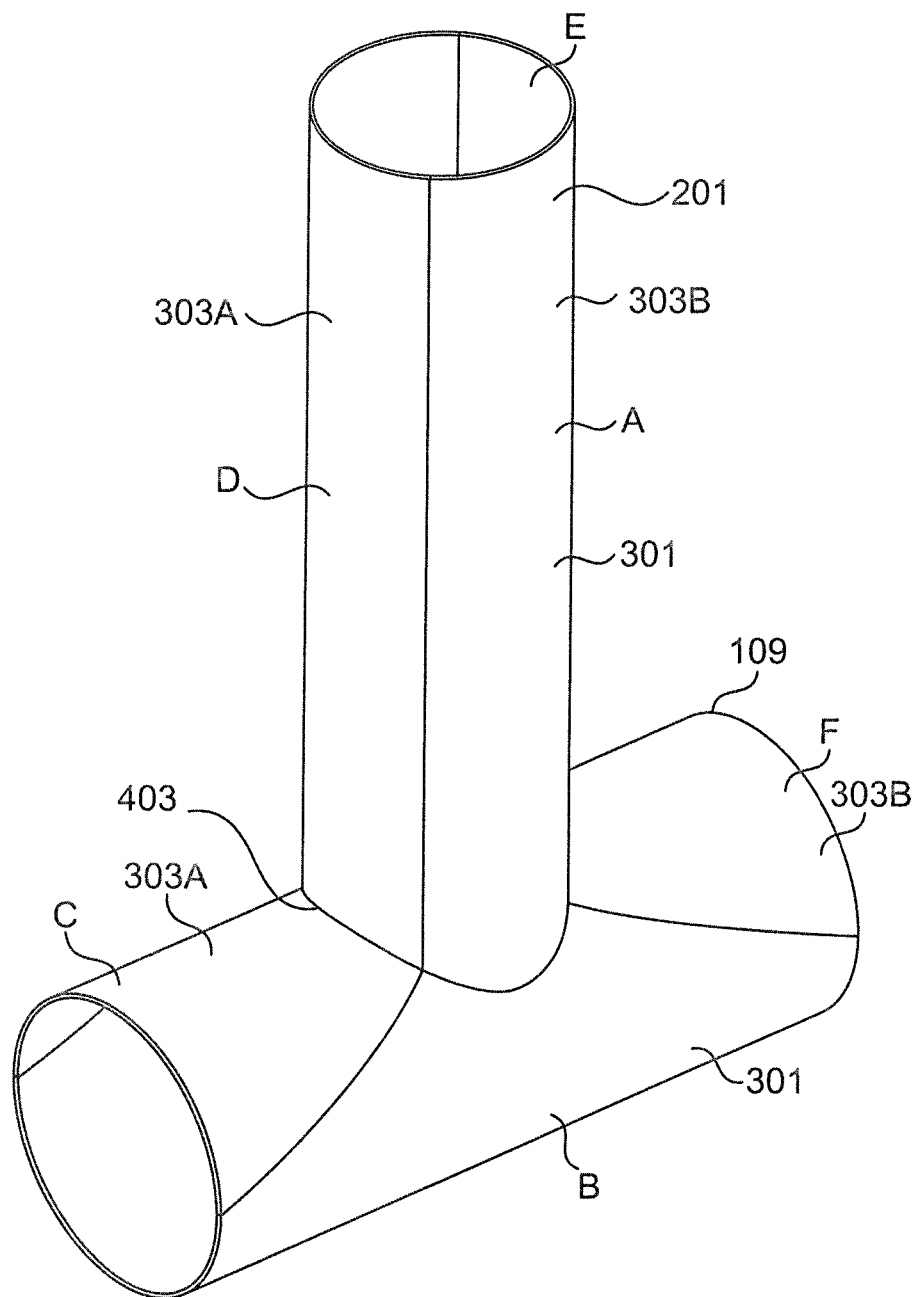
FIG. 5A depicts an alternative embodiment of a CIPP liner for a service lateral according to the present disclosure.

While this technique is perhaps most applicable to an acute angle  $\theta$ , due to the propensity for bunching with such an angle, it is also useful with any angle, including a perpendicular angle. As shown in the depicted embodiment of FIG. 5, a liner 109 with a lateral 201 at a generally perpendicular angle may also use the formulae described in Equations 1 and 2 to cut out an amount of fabric 405 at the folding point 403 in order to reduce or inhibit bunching during assembly. FIG. 5B depicts an embodiment of a first piece 301 for use in assembling a perpendicular lateral liner

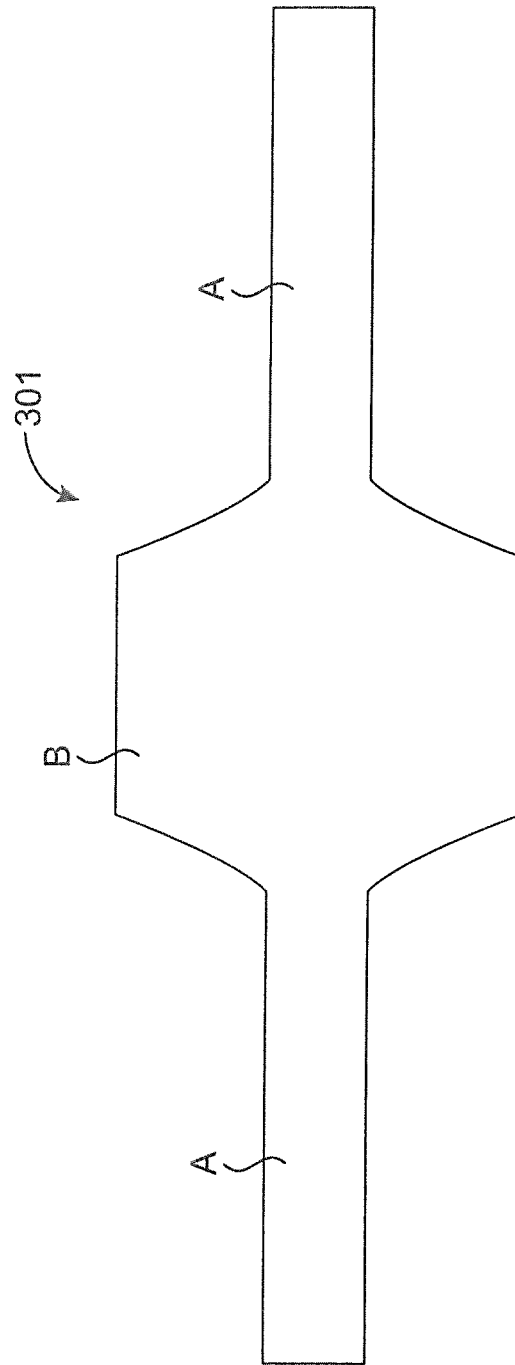
FIG. 5B depicts an alternative embodiment of a bottom and side piece of a CIPP liner for a service lateral according to the present disclosure.

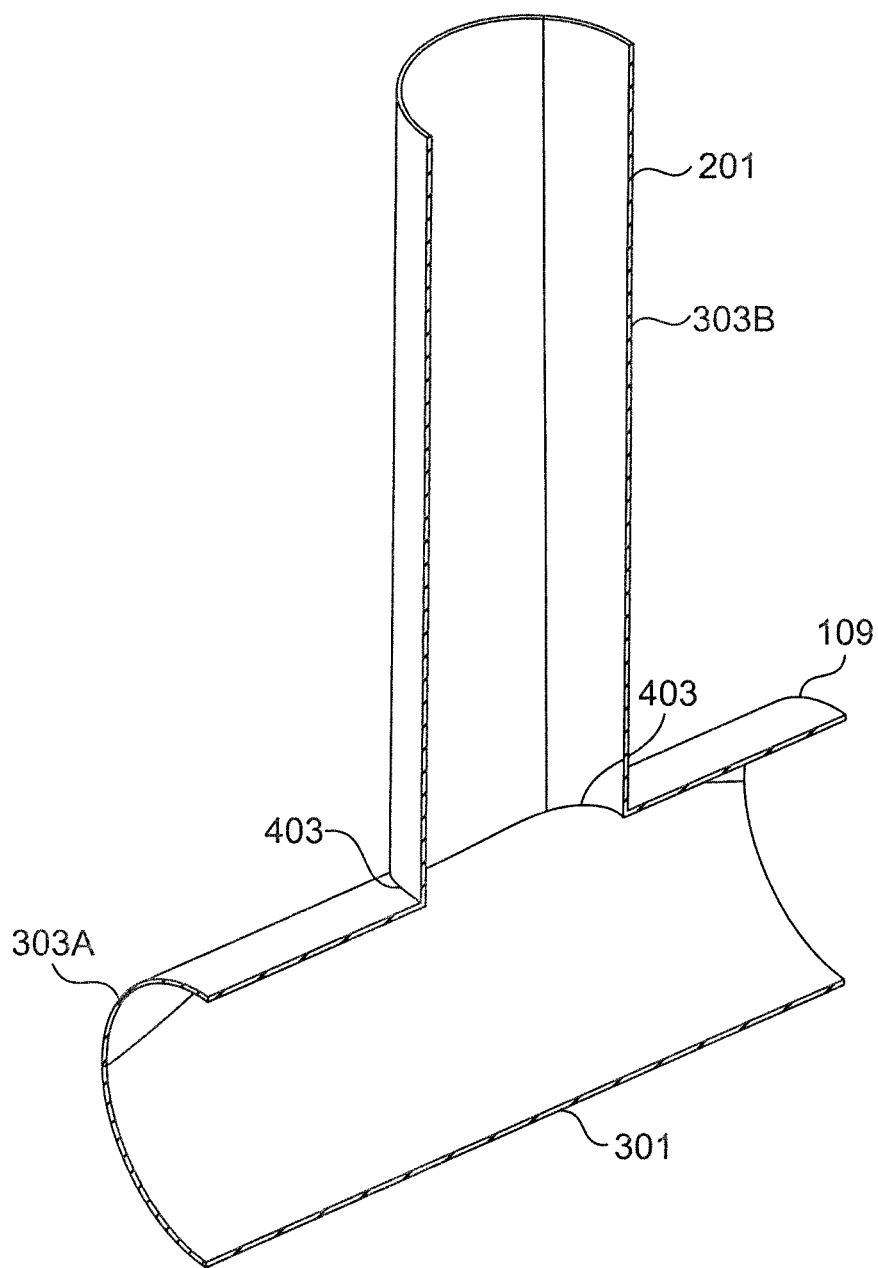
FIG. 5C depicts a cutaway diagram of an alternative embodiment of a CIPP liner for a service lateral.

201, and FIG. 5C depicts a cutaway diagram of an assembled liner 109 having perpendicular lateral 201.

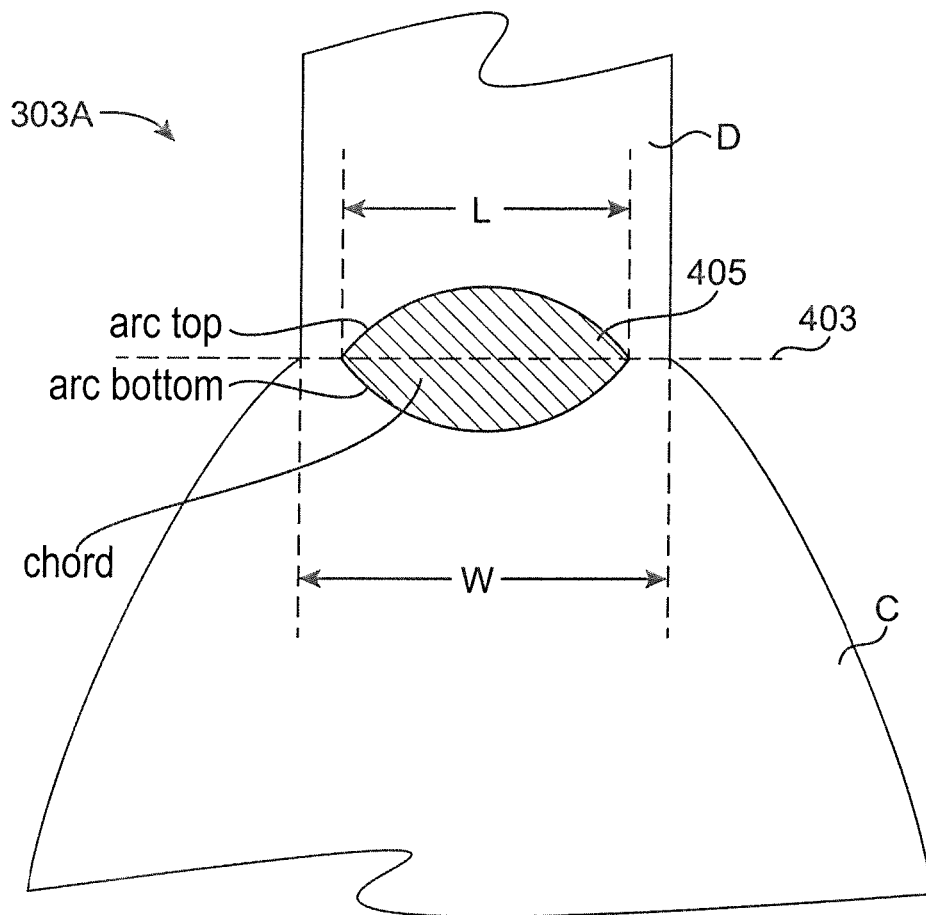
FIG. 6 depicts an embodiment of a CIPP liner for a service lateral having a cutaway area according to the present disclosure.

To do this, an amount of material is removed 405 at the folding point 403. The amount and shape of the material to be removed 405 varies with the angle and size of the piece, and is generally configured in the shape of two opposing arcs joined at their end points, or a "football" shape. This shape 405 is shown in FIG. 4A, and is shown in more detail in FIG. 6. In the depicted embodiment, the shape 405 of the removed material is defined by two circular arcs,  $\text{arc}_{\text{top}}$  and  $\text{arc}_{\text{bottom}}$ . In the depicted embodiment,  $\text{arc}_{\text{top}}$  is defined as that portion of the circular arc defined by Equation 1 located above the x-axis (positive y-value).

By removing the football-shaped portion 405, bunching is inhibited because the fabric which would normally crinkle or bunch up is no longer present. This allows the piece 303A to be assembled in an acute angle with reduced risk of improper curing or forming an obstruction. It should be noted that the length  $L$  of the chord defining the midpoint of the shape 405 is generally less than the width  $W$  of the rectangular portion D of the piece 303A. This allows for at least some amount of fabric to remain connecting portions C and D together.

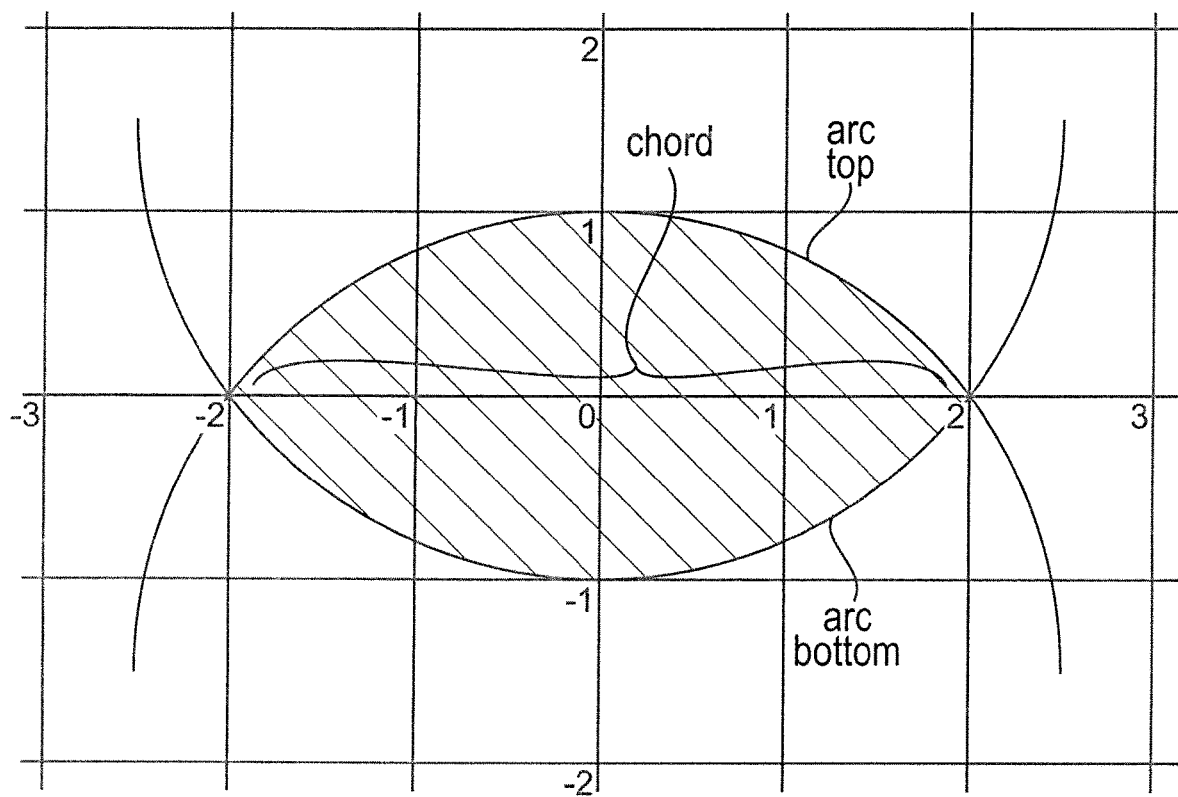
= cutout areas 405

$L = 4$

FIG. 7 depicts a graph of an embodiment of a cutaway area for use with a CIPP liner according to the present disclosure.

$$y = \left( \sqrt{\frac{25}{64}L^2 - x^2} \right) - \frac{3}{8}L \quad \text{Equation (1)}$$

In the depicted embodiment, the shape of  $\text{arc}_{\text{bottom}}$  is defined as that portion of the circular arc defined by Equation 2 located below the x-axis (negative y-value).

$$y = - \left( \sqrt{\frac{25}{64}L^2 - x^2} \right) - \frac{3}{8}L \quad \text{Equation (2)}$$

Illustrative examples of these two arcs, having an  $L=4$ , are shown in FIG. 7.
